August 23, 2002

RE: Kenai Airport Fuel Service—Interim Remedial Action Report #4
UST Facility ID #2187, Reckey #90230026801

This document reports the installation of three additional monitor wells (MW-9, MW-10 and MW-11), construction of the evaporative pond, and results of water sampling of: MW-7, MW-8, MW-9, MW-10, and MW-11. The work was done in accordance with the Interim Remedial Action Plan Revision #2 we submitted to you May 7, 2002 and your approval on May 8, 2002.

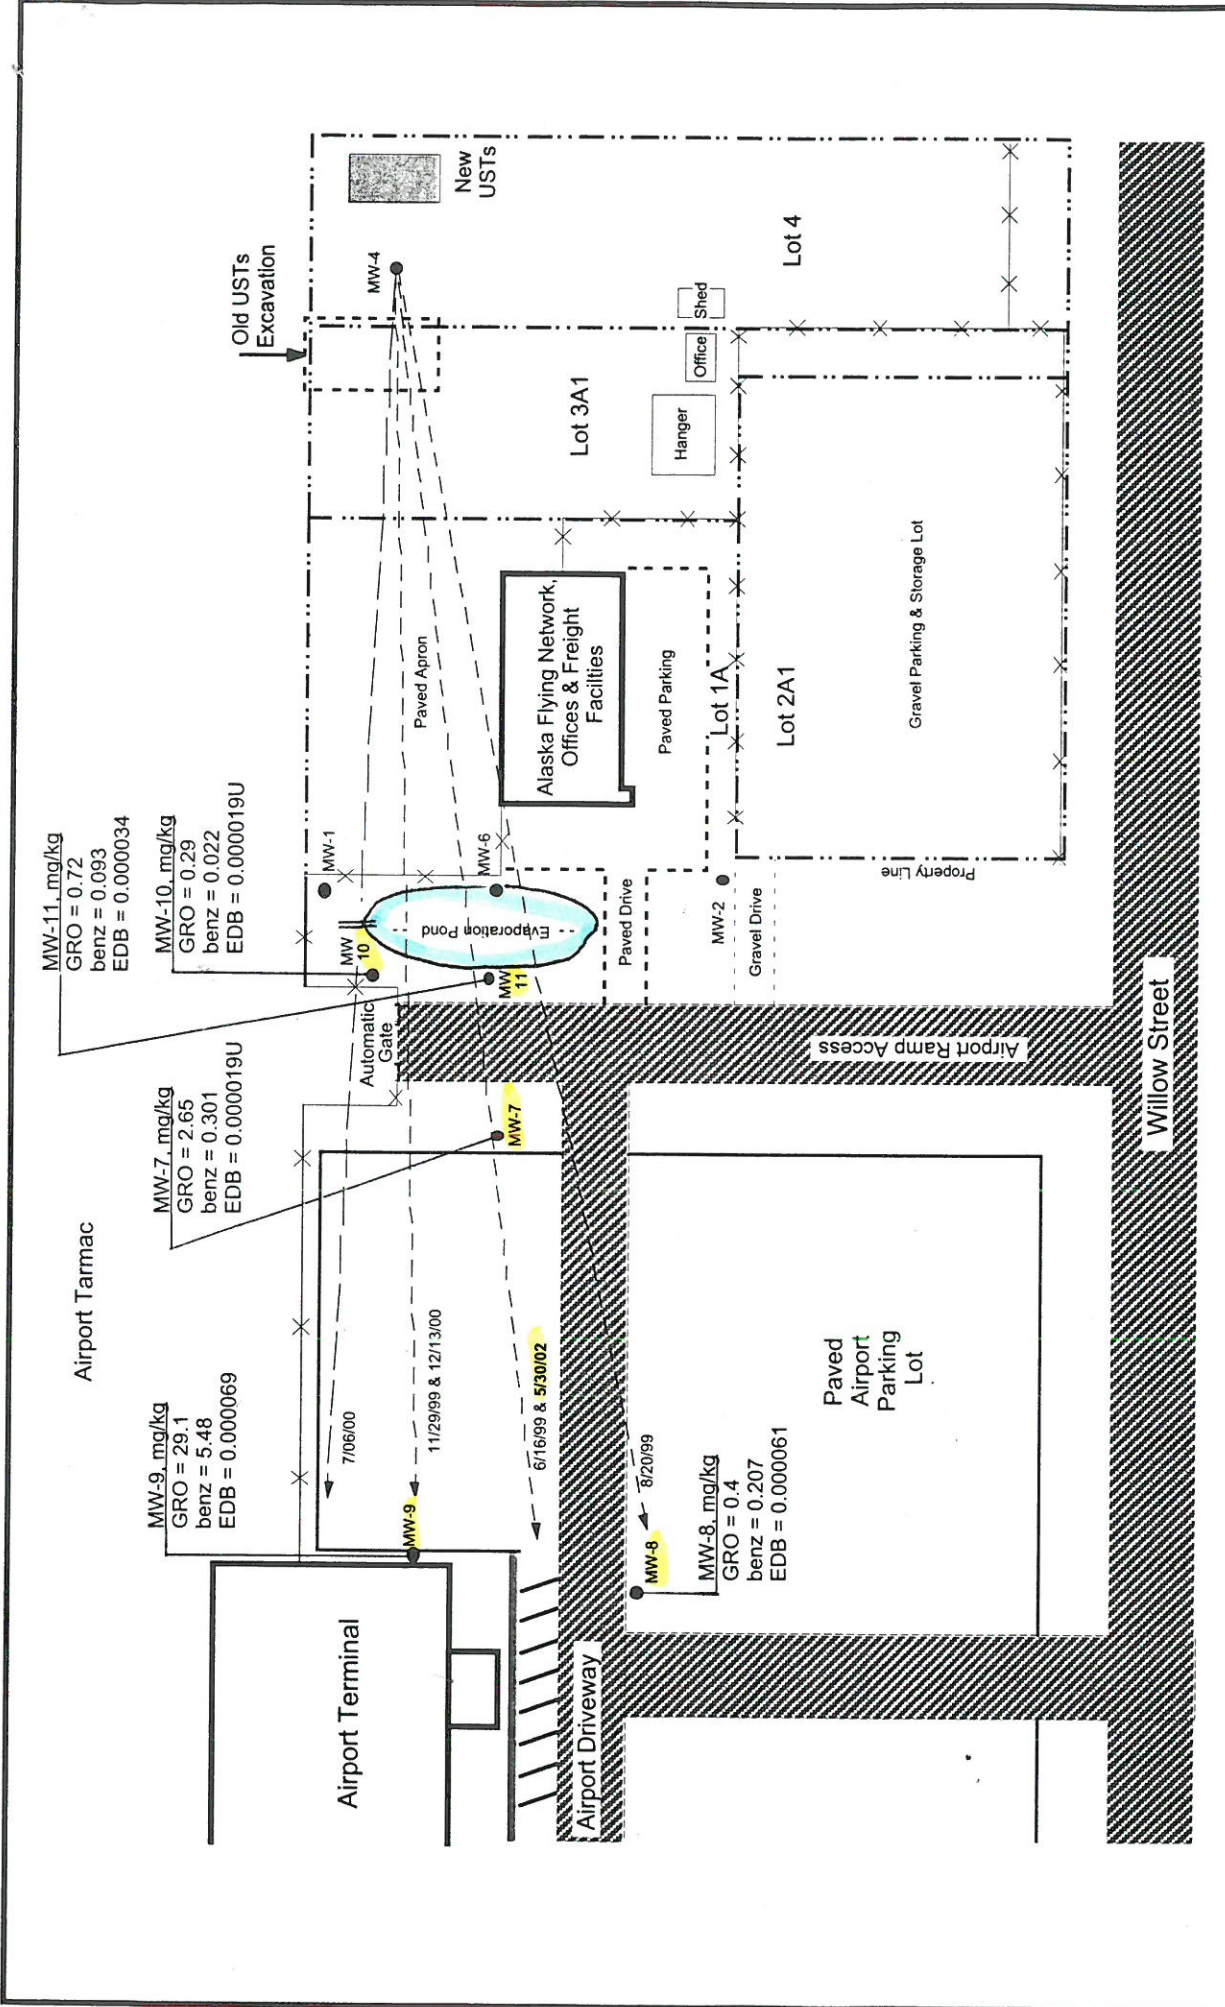
Figure 1. Groundwater Contamination Results for 5-30-02

The groundwater flow during the last sample event was south to southeast (Figure 1), similar to the last four sample events. The flow has fluctuated a little but generally has been south to southeast and the gradient has been from 0.0021 to 0.0025 ft/ft. Figure 2 shows groundwater contours after the pond excavation work was completed on May 24, 2002. Figure 3 shows groundwater contours five weeks after excavation work was completed. These surveys show the groundwater flowed from the UST site toward MW-8 and MW-9. A comparison of the May and July 2002 surveys shows the contours were affected near the pond; however, this was localized and the pond is not expected to affect the overall direction and flow rate of the groundwater.

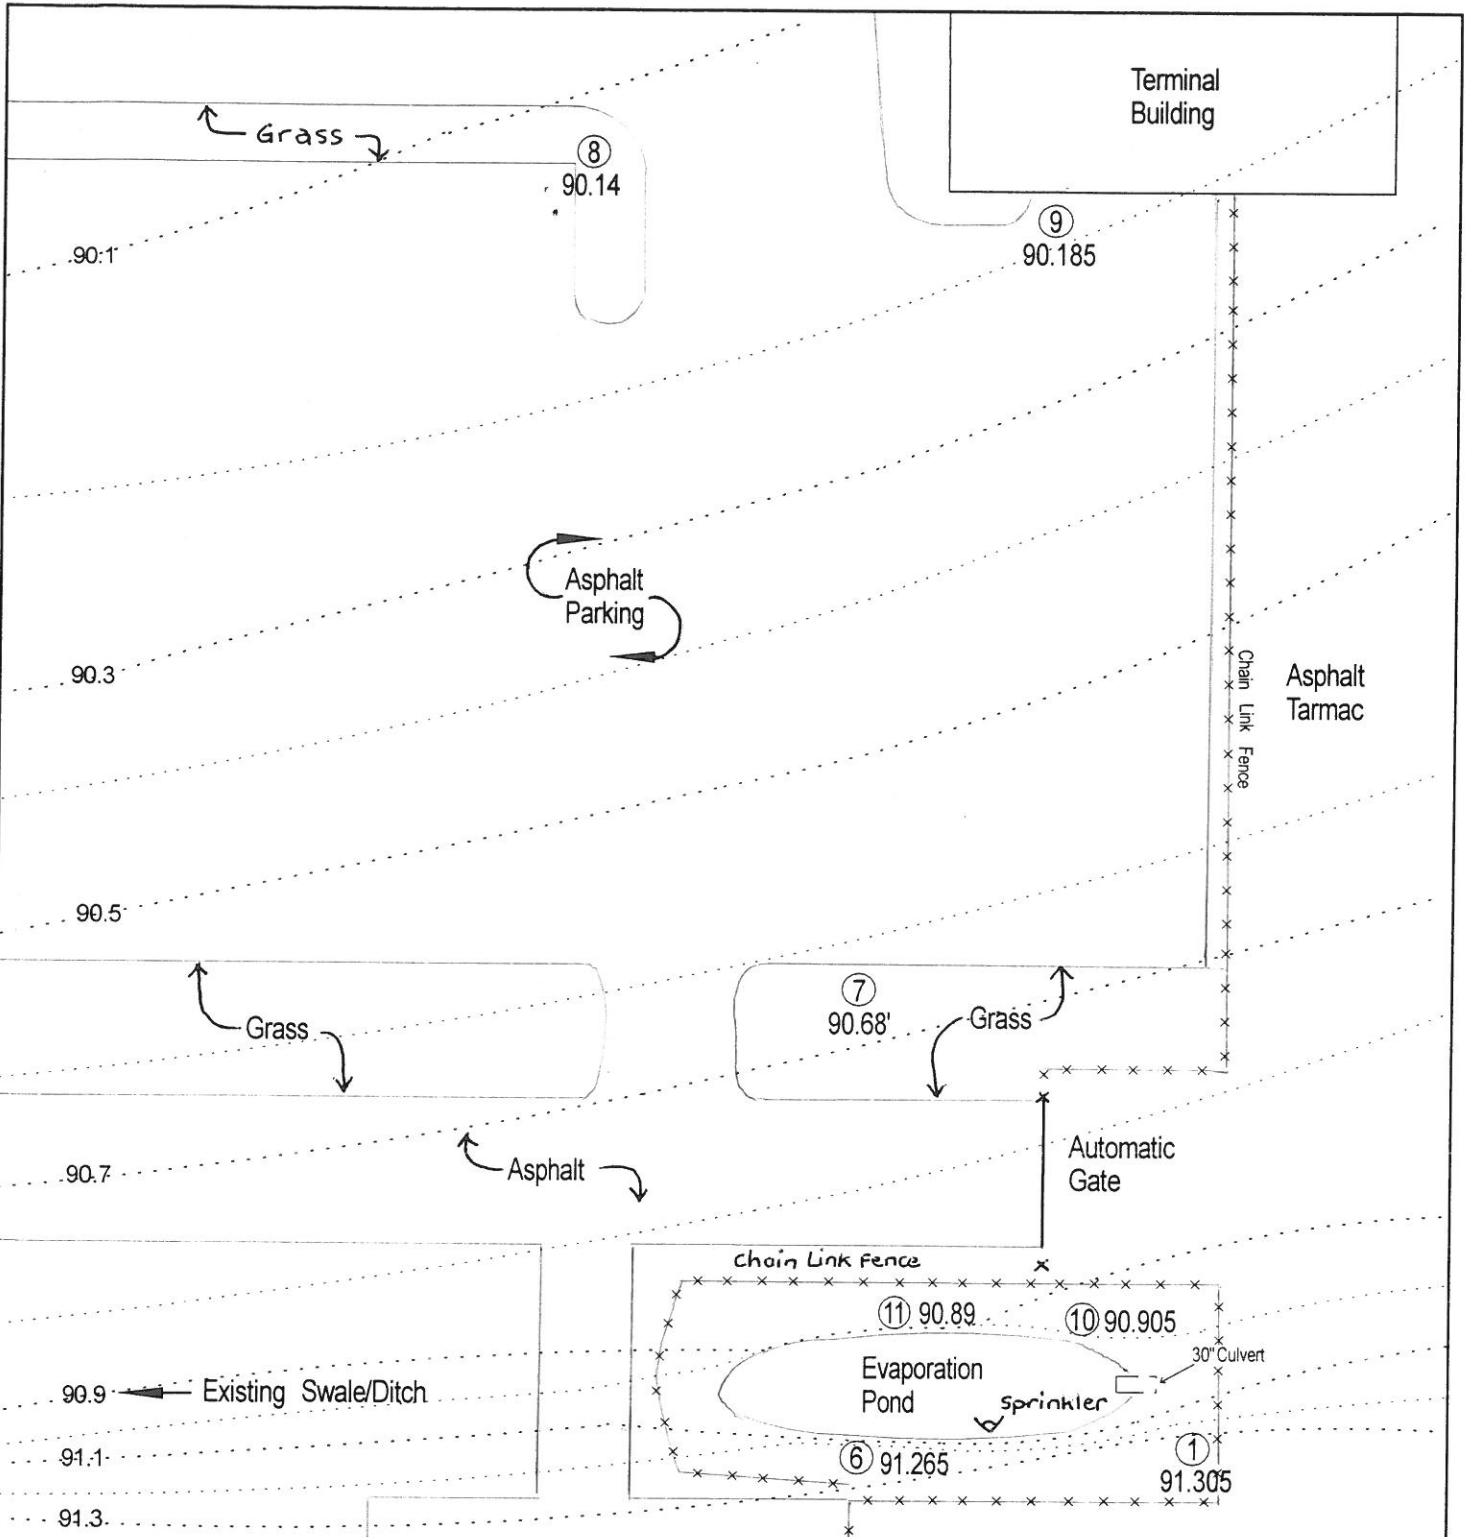
Figure 2

A groundwater survey was done May 31, 2002, shortly after excavation of the evaporation pond was completed. Groundwater elevations measured during this survey are shown in Figure 2. Another groundwater survey was done on July 2, 2002, to determine if there were any changes in groundwater contour and direction of flow. Groundwater elevations from the July survey can be seen in figure 3. A significant alteration in groundwater contour around the evaporation pond was observed in the July 2nd survey.

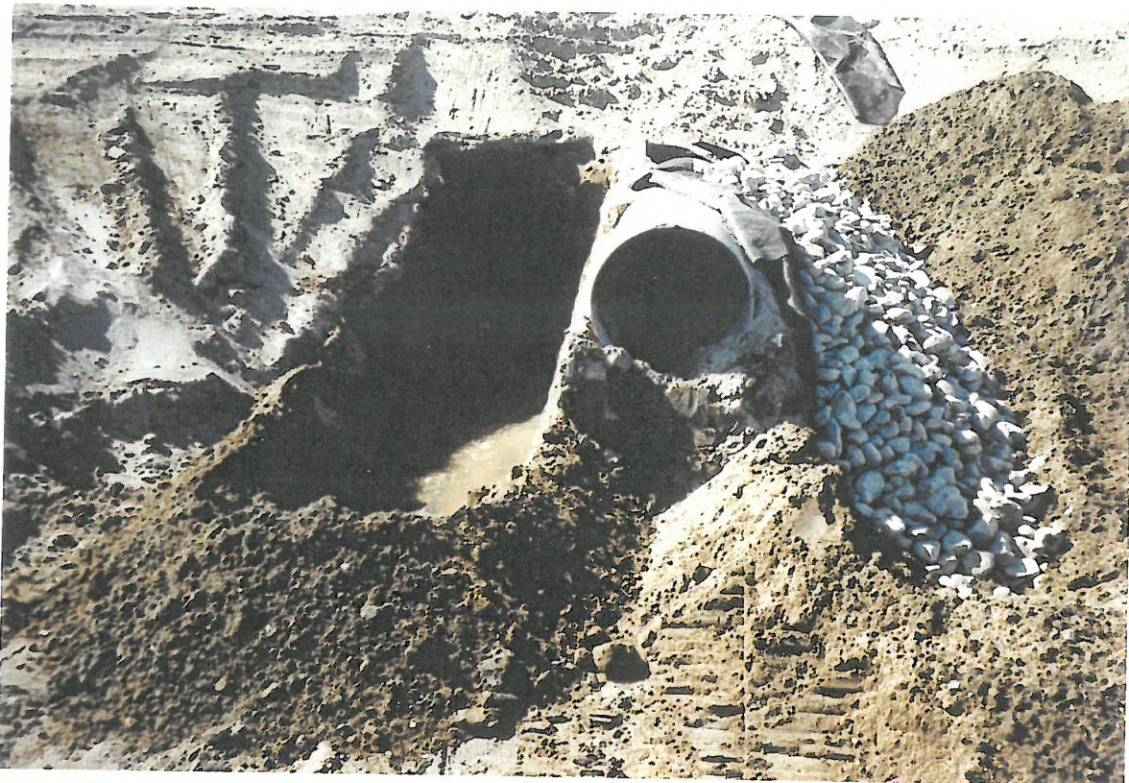
1) View to the West. Excavating around culvert. Note groundwater at the left side of culvert.

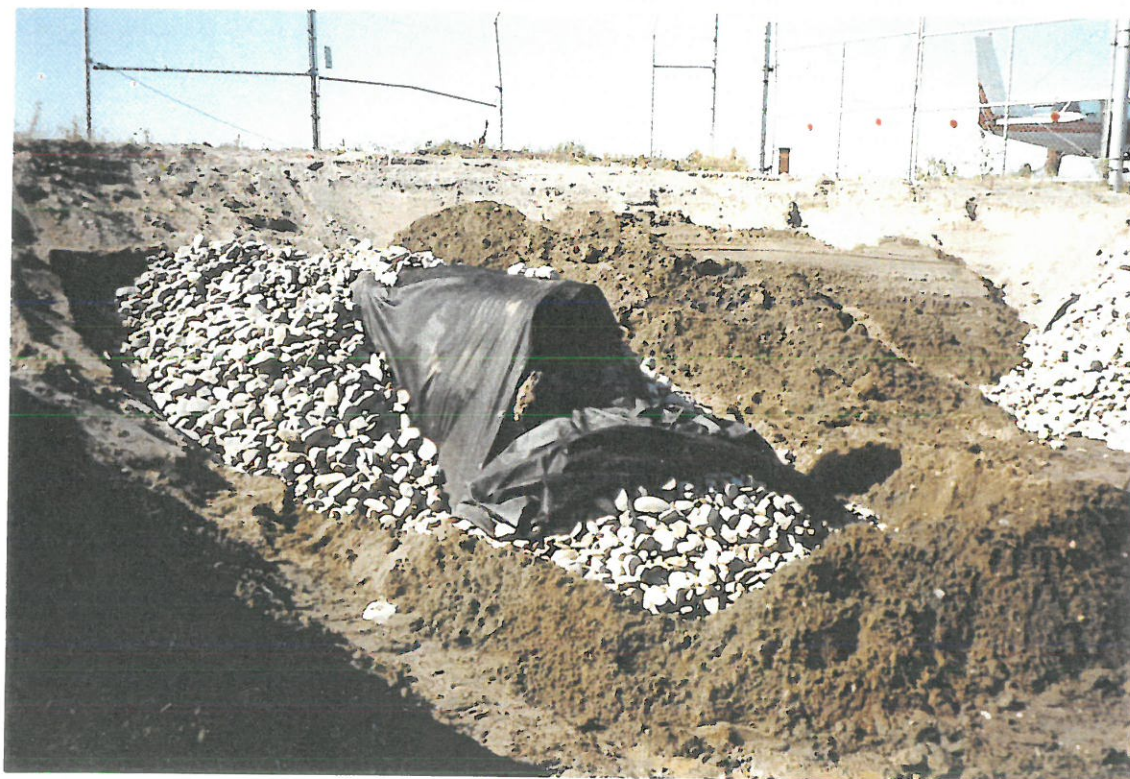
2) View to the Northwest. After drain rock and filter fabric were placed.

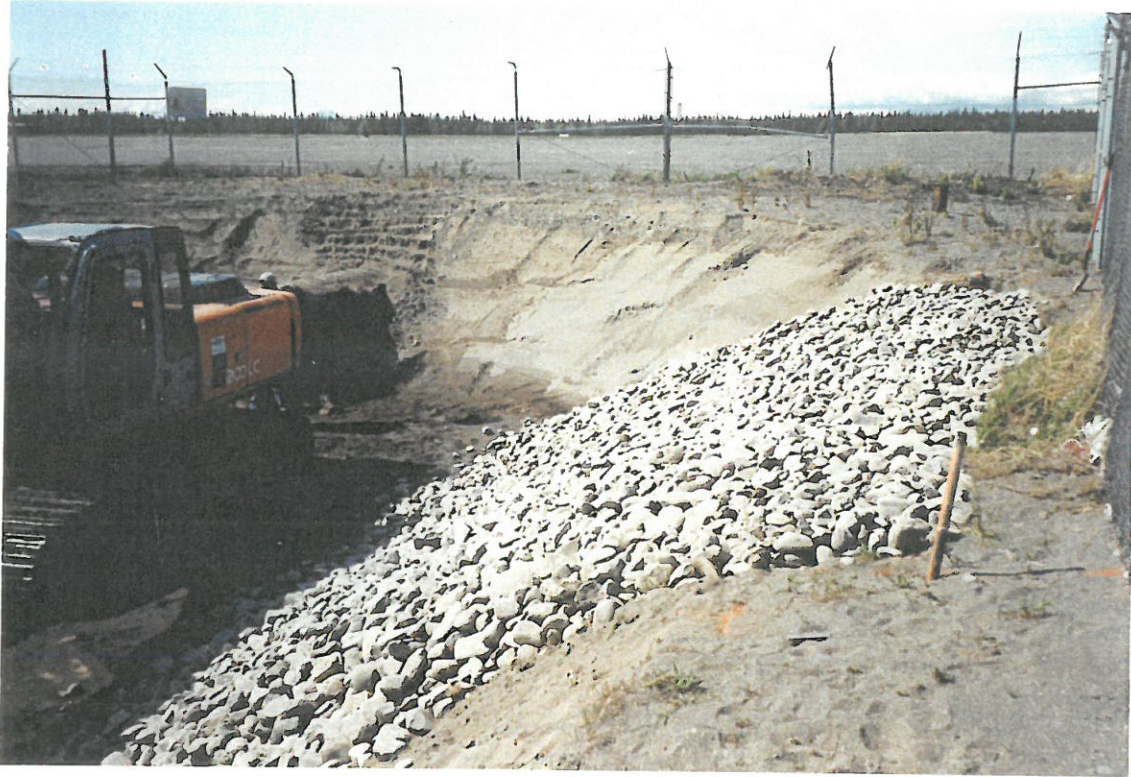
3) View to the Southwest. Drain rock on the North bank to prevent erosion from runoff.

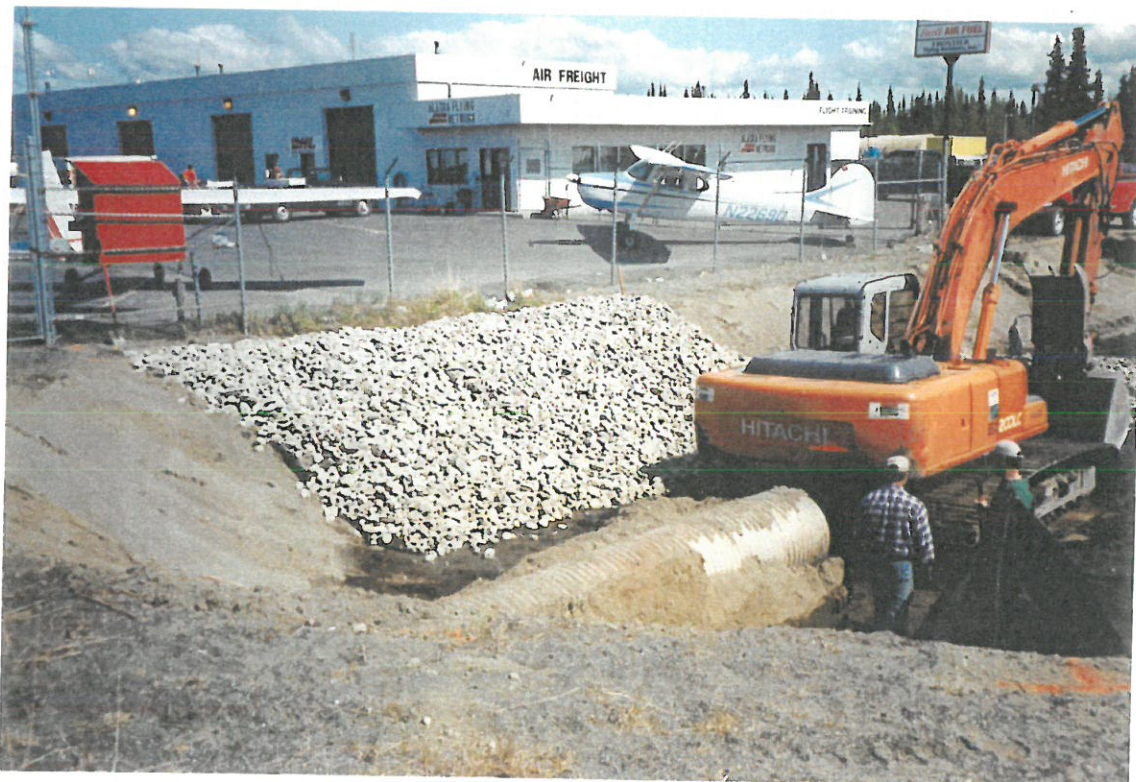
4) View to the Northeast. Placing filter fabric around culvert before placing drain rock.

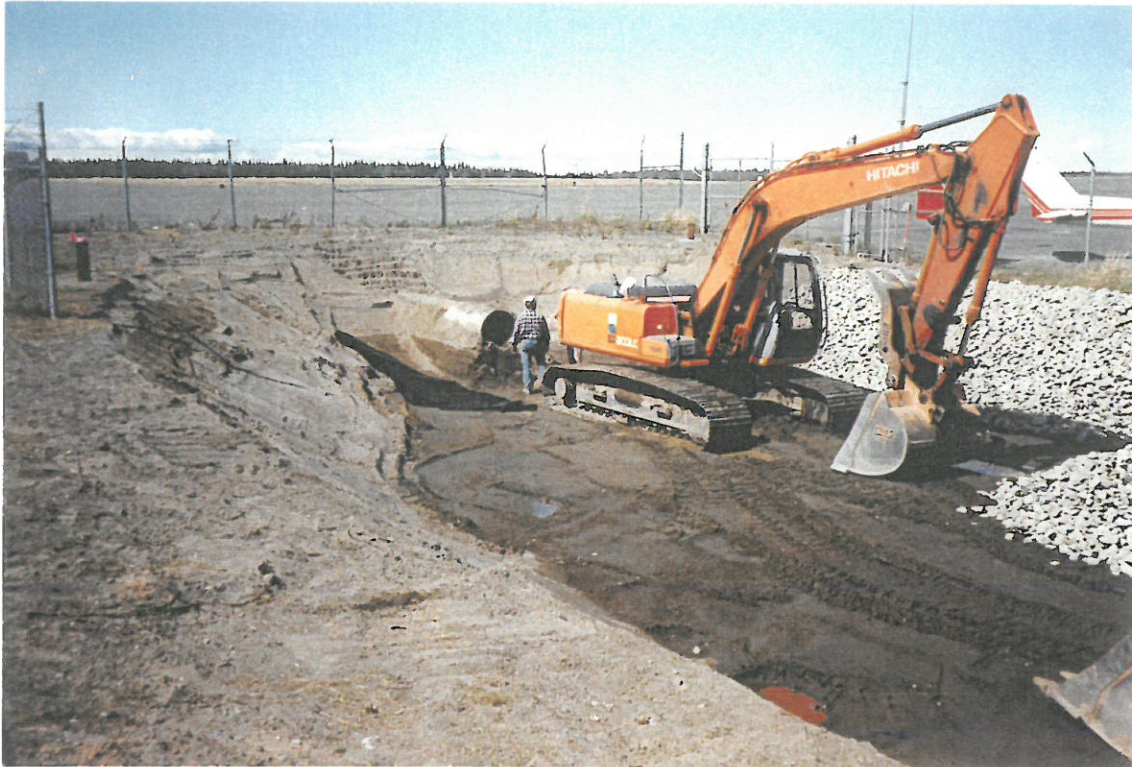
5) View to the Northwest. Pond excavated to groundwater level.

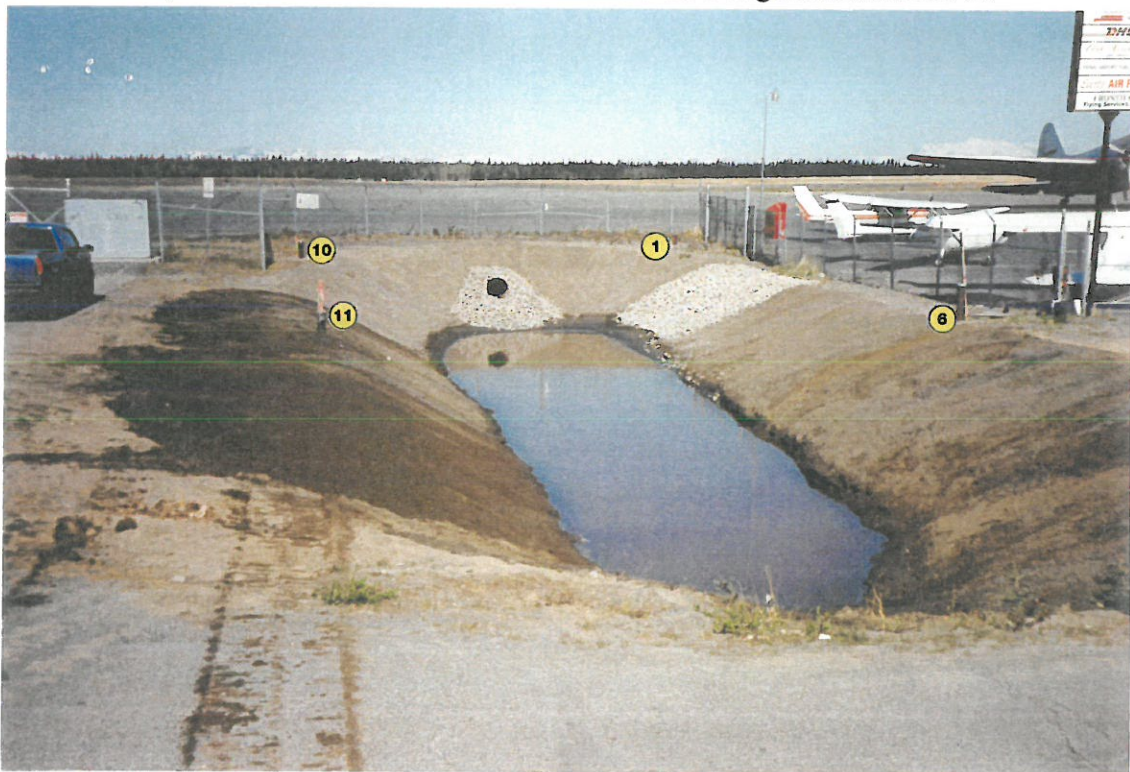
Monitor wells MW-10 and MW-11 (both new) are about 35 feet down-gradient and across the pond from MW-1 and MW-6. MW-10 and MW-11 have significantly lower contaminant levels than previously detected at MW-1 and MW-6. This occurrence suggests that the drainage swale has contributed to the volatile loss between the monitor wells. The recent excavation to create the evaporation pond should continue to enhance volatile loss in this area. The low volume aeration process provides some water circulation in the west end and volatilization by spraying, but the results cannot be measured separately from the overall benefit of the pond.

6) View to the West after excavation completed, before hydroseeding and fencing installed.
Note location of existing MW-1 & 6 and new MW-10 & 11.
