RE: Kenai Airport Fuel Service—Interim Remedial Action Report #5
UST Facility ID #2187, Reckey #90230026801

Figure 1. Groundwater Contamination Results for 10-31-02

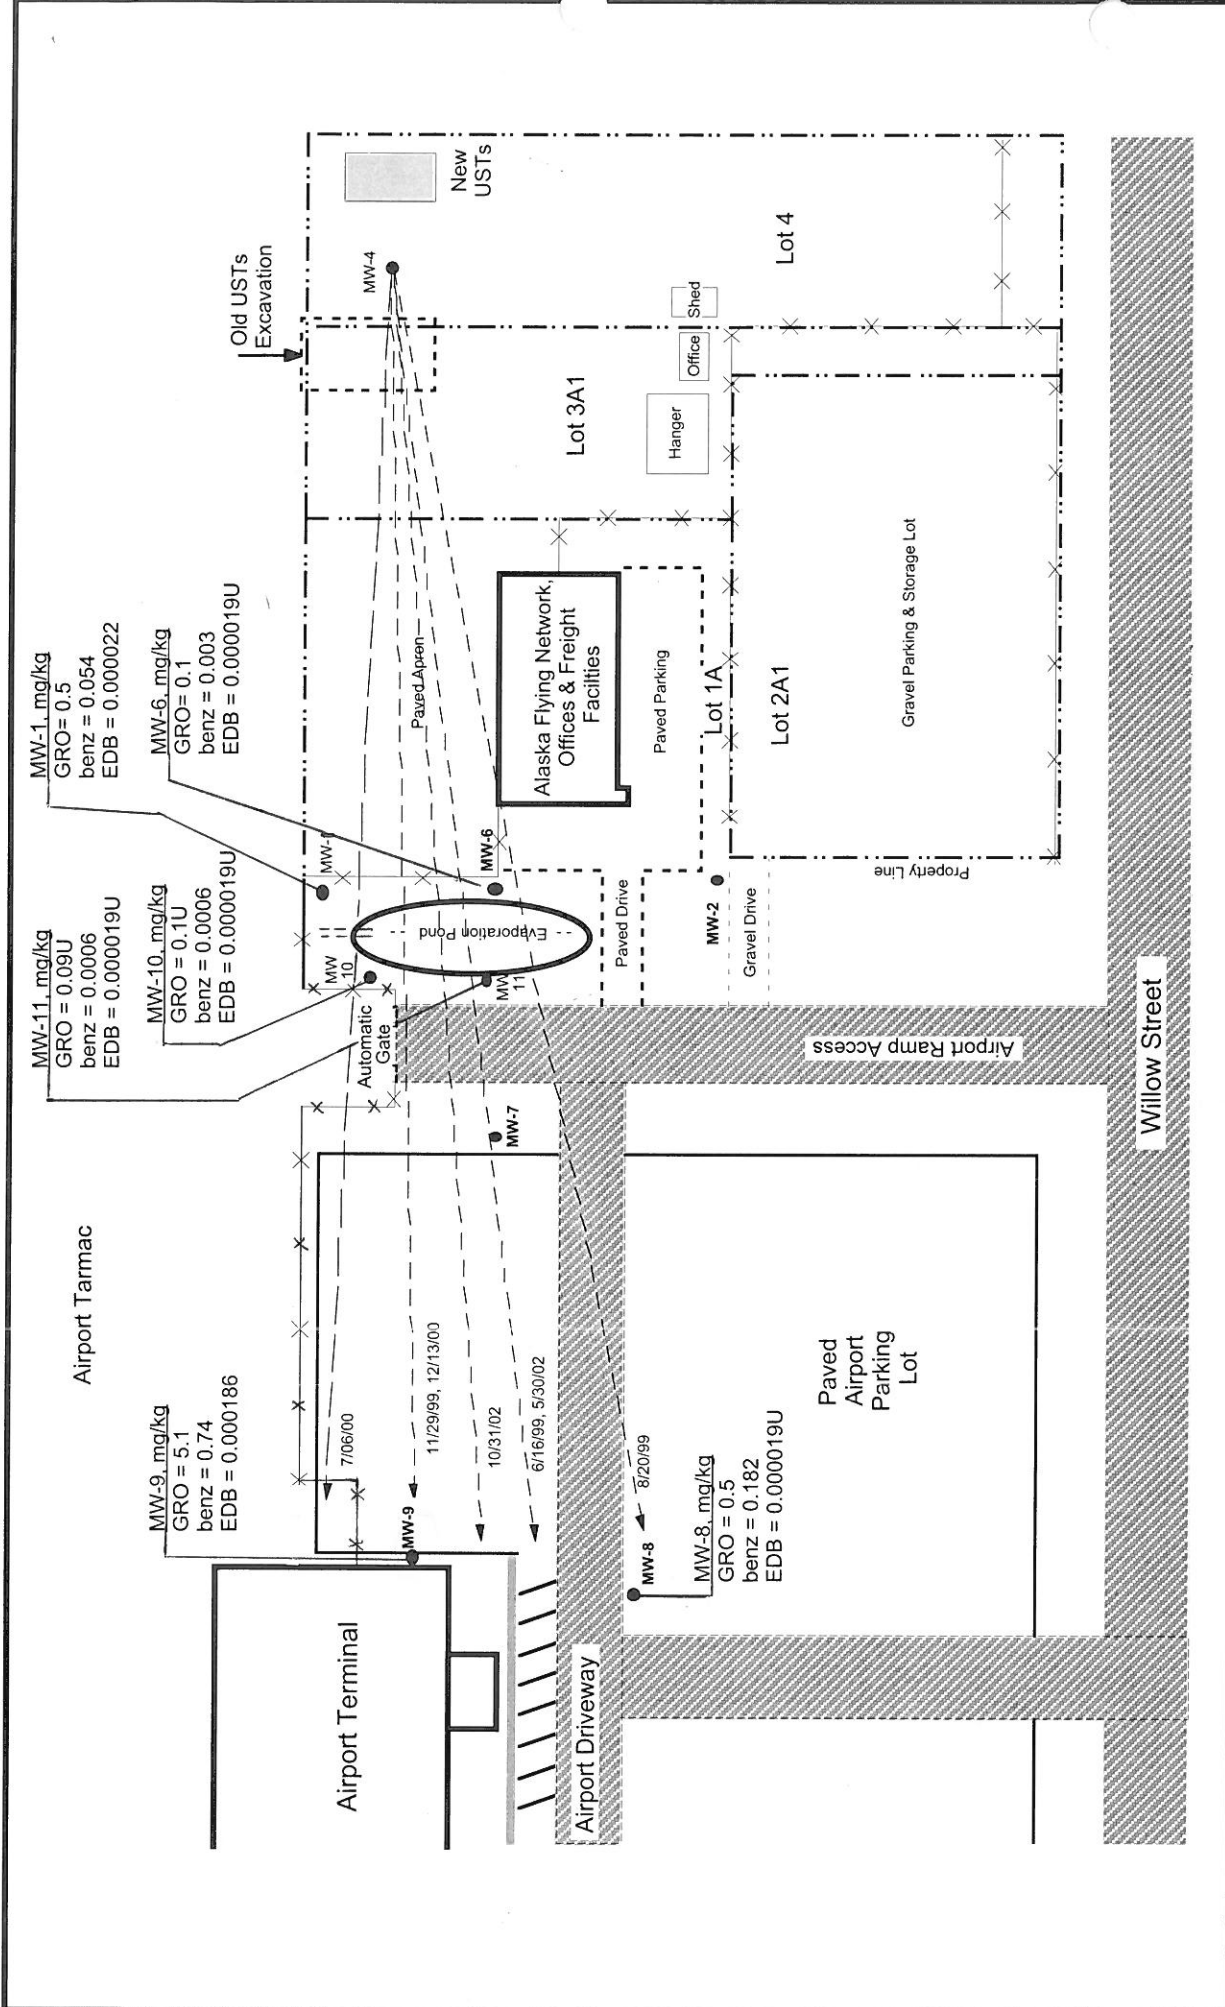
The groundwater flow during the last sample event was south to southeast (Figure 1), similar to the last five sample events. The flow direction has fluctuated a little but ~~has~~ generally has been toward the south-southeast. The gradient typically has been 0.0021 to 0.0025 ft/ft, but on October 31, 2002 the gradient was a little steeper (approximately 0.0030 ft/ft). The steeper gradient and higher water table are probably due to the unusually heavy rainfall that occurred during September and October 2002. Figure 2 shows approximate groundwater contours derived from the elevation survey conducted October 31, 2002. The contours reflect mounding of the groundwater in the vicinity of the evaporation pond. The mounding is probably due to a large discharge of water from the 30" culvert into the evaporation pond.

It appears the groundwater contamination south of the evaporation pond is being reduced by natural attenuation, probably due to the swale and evaporation pond north of the Ramp Access. However, contamination levels exceed cleanup levels at the two down-gradient monitor wells, MW-8 and MW-9, and the west and south (leading) edges of the plume from the KAFS UST site have not been adequately defined. A Point of Compliance monitor well needs to be installed down gradient of MW-9, near the southeast corner of the Main Terminal. Since the EDB levels are close to cleanup levels, in the future we recommend reducing the EDB analysis to three monitor wells: MW-1, MW-8, and MW-9. *Okay.*

The high contamination levels at MW-9 do not fit with the contamination pattern developed from earlier test results, and indicate another source may be contributing to the plume, especially at MW-9 and possibly at MW-8. The presence of another source between the Ramp Access gate and MW-9 should be investigated. Since spill records are not available, additional soil and groundwater sample points should be used to determine the source of contamination at MW-9.

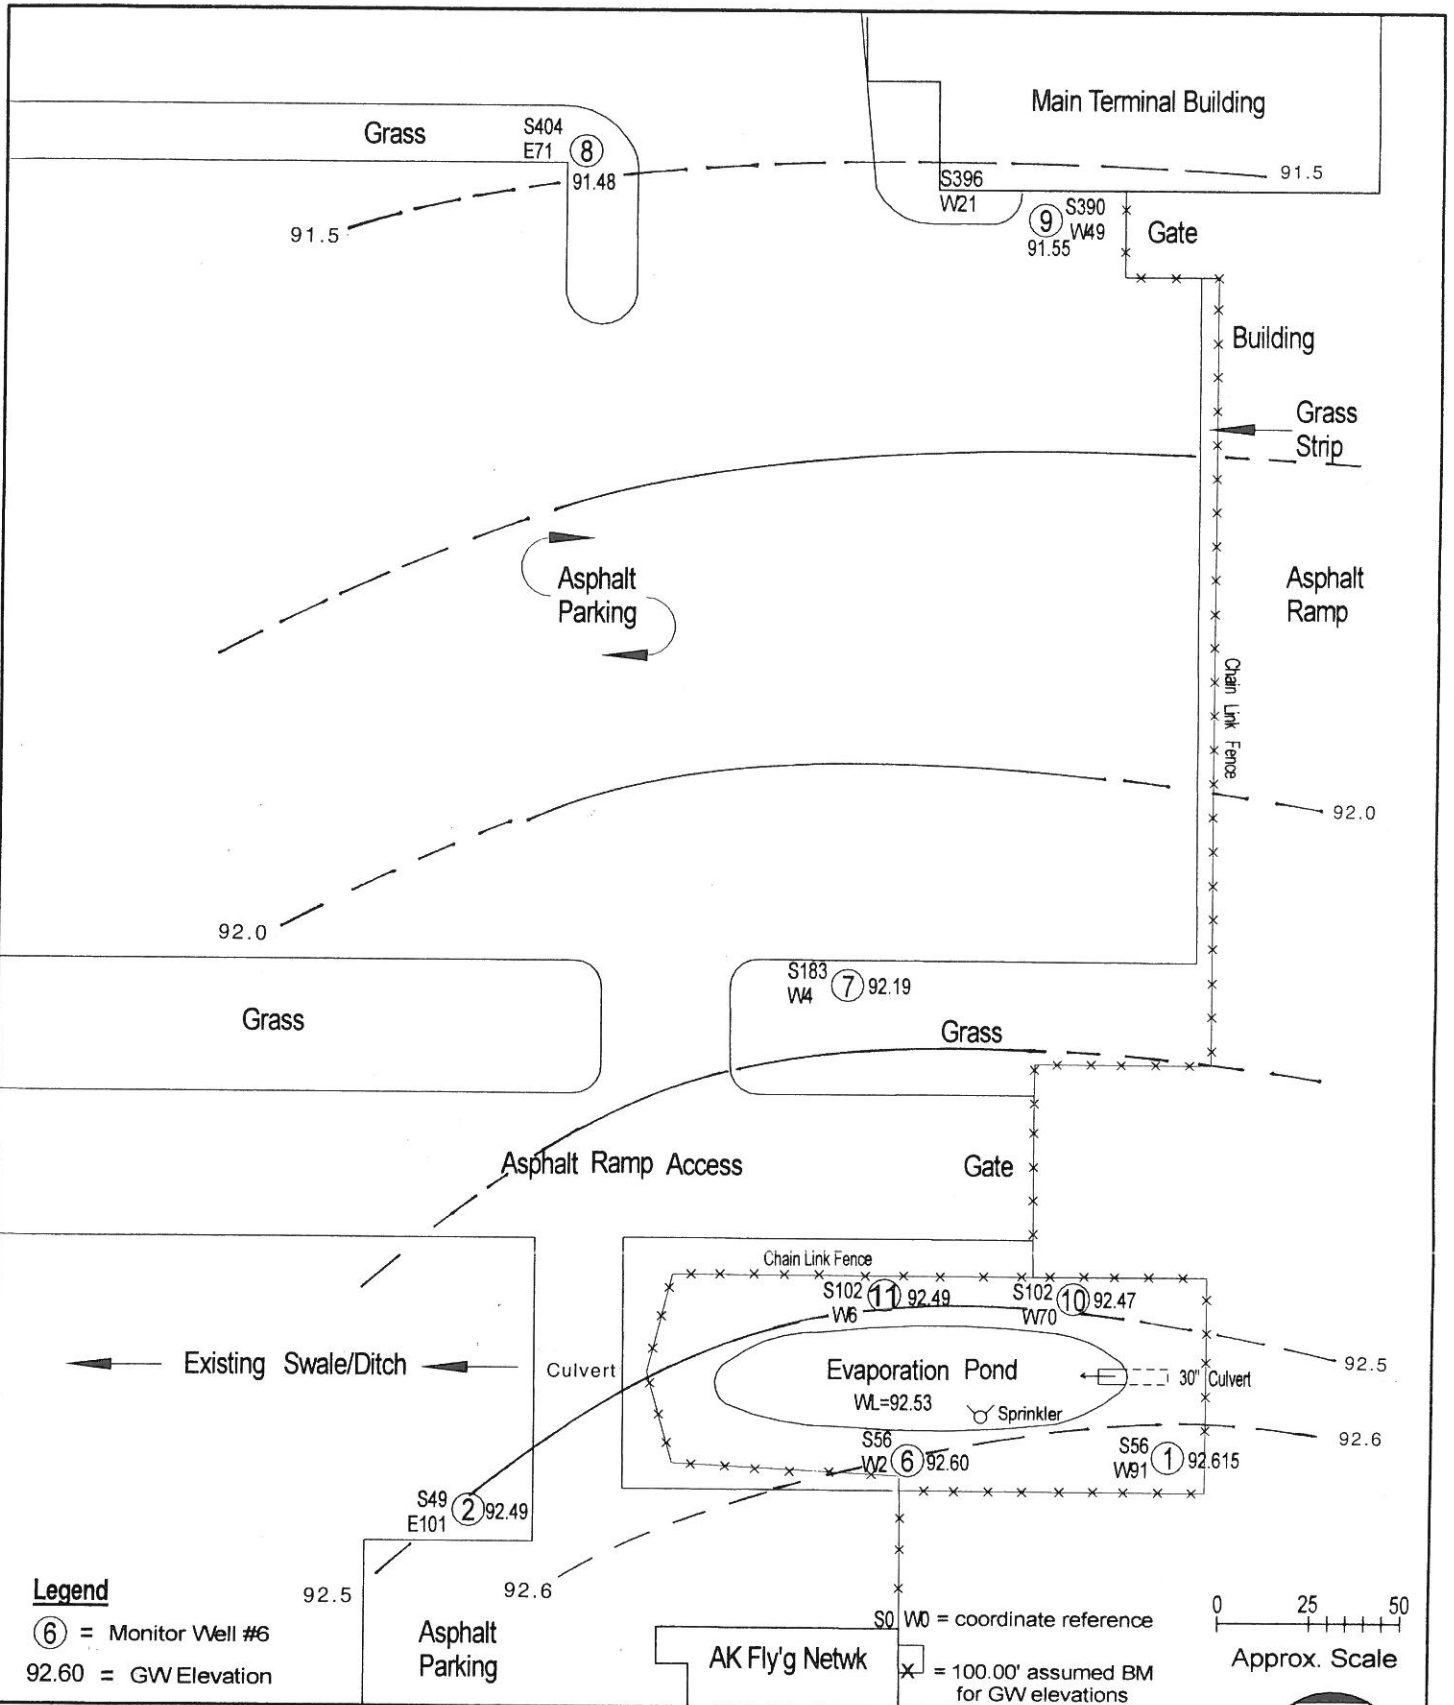
Figure 2

The survey showed the groundwater was about one foot higher than any of the previous surveys. The flow was toward the south-southeast, similar to many of the previous surveys, but the gradient was a little steeper. Groundwater contours in the vicinity of the evaporation pond reflected mounding, possibly due to a large discharge of water from the 30" culvert into the evaporation pond.

Groundwater elevations were determined by subtracting the SWL measurement from the PVC casing elevation. The groundwater elevations are shown on Figure 2, next to the monitor wells, and are included (rounded to the nearest 1/10th foot) on Tables 1-6. On the tables, "SWL" refers to the elevation, in feet, of the static water level at the monitor well. The elevations are relative to a temporary reference elevation of 100.00 feet on the northeast corner of the concrete sidewalk outside the southwest door of the Alaska Flying Network office. Groundwater elevations on October 31, 2002 were approximately one foot higher than any previous surveys.
