Subject: Kenai Airport Fuel Service, Spill #90230026801 at UST Facility ID #2187 June 2006 Groundwater Sampling Event

Remedial Action Report #3 Kenai Airport Fuel Service Kenai, Alaska

UST Facility ID #2187 Reckey #90230026801

June 2006

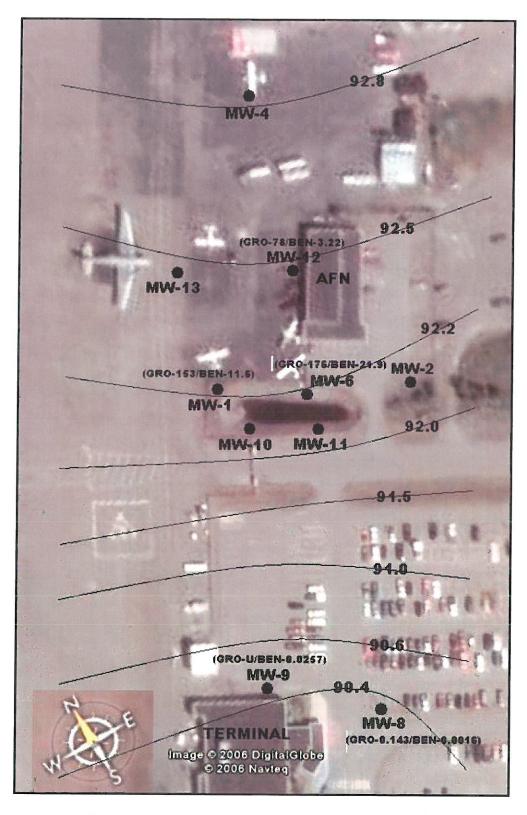
Figure 3-1. Groundwater flow contours for the KAFS site, June 2006.

Groundwater levels were measured in several other wells that were not sampled during this event. Groundwater elevations were also measured at MW-4 and MW-13. Measured elevations were 92.91 and 92.46, respectively. Elevations were used to generate a contour map of the site shown in Figure 3-1. Groundwater elevations measured as part of this sampling event were consistent with previous results. The direction of flow was south towards the Kenai Airport Terminal and the location of MW-8 and MW-9. This is also consistent with results from the last sampling event. The calculated gradient was 0.0016 ft/ft measured from MW-4 to MW-9 (659 foot distance).
