TAURIAINEN ENGINEERING & TESTING

DRAFT Well Closure Report

Date: 29 Jan 2021 20048

Subject: North Star Pit, 44485 Knight Drive Soldotna, Alaska
EPA File ID: AK122PS-30-13955
Consent Agreement, Docket No. SDWA-10-2021-0002
2 Pages + Attachments

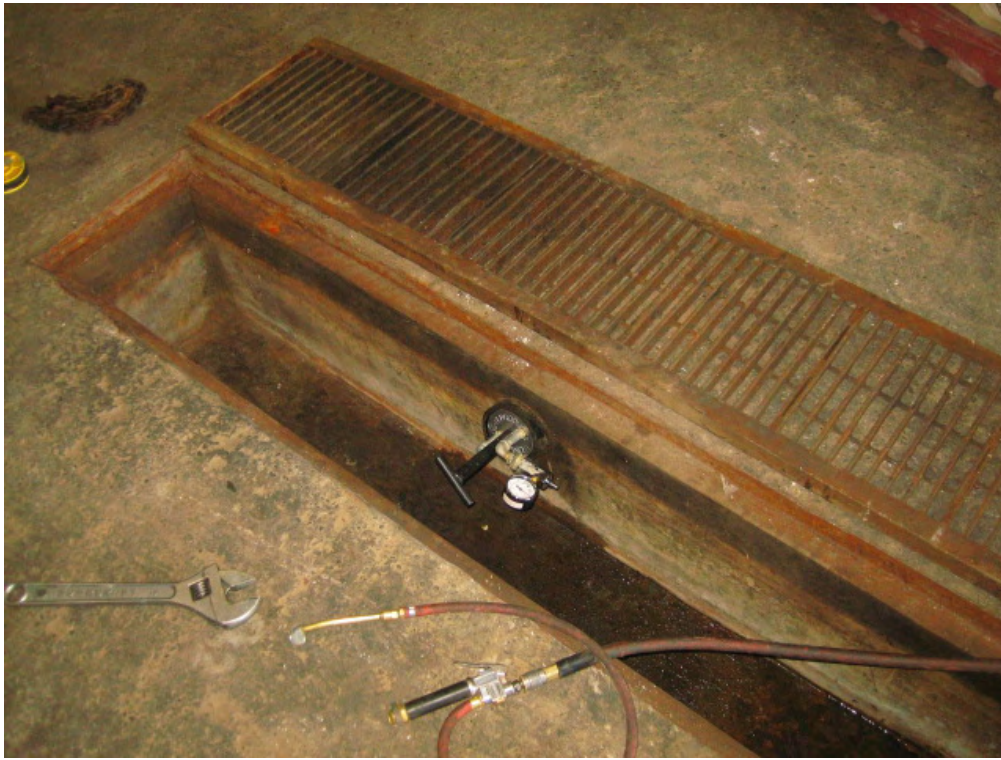
1. Pressure testing of the piping between the floor drain and oil/water separator, performed 14 Sep 2020, indicated 1) that the floor drain was connected solely to the oil/water separator tank, and 2) that the piping between the floor drain and oil/water separator tank was not leaking.

Photo 1: Pressure testing of piping between floor sump and oil/water separator tank

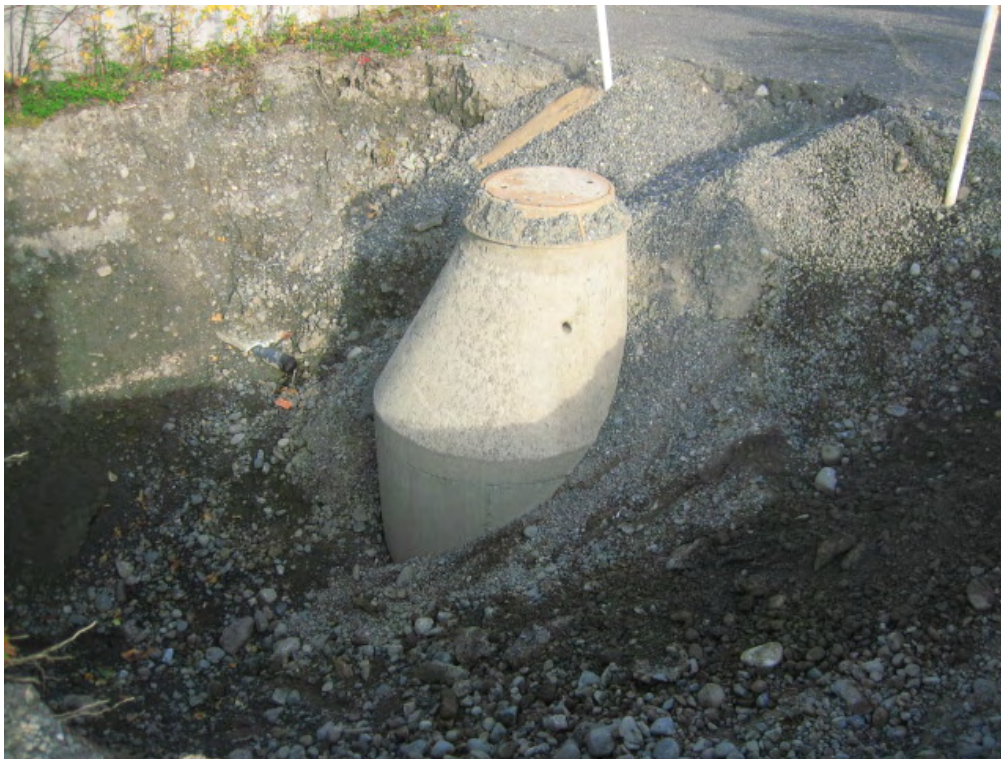
Photo 2: Beginning to excavate oil/water separator tank

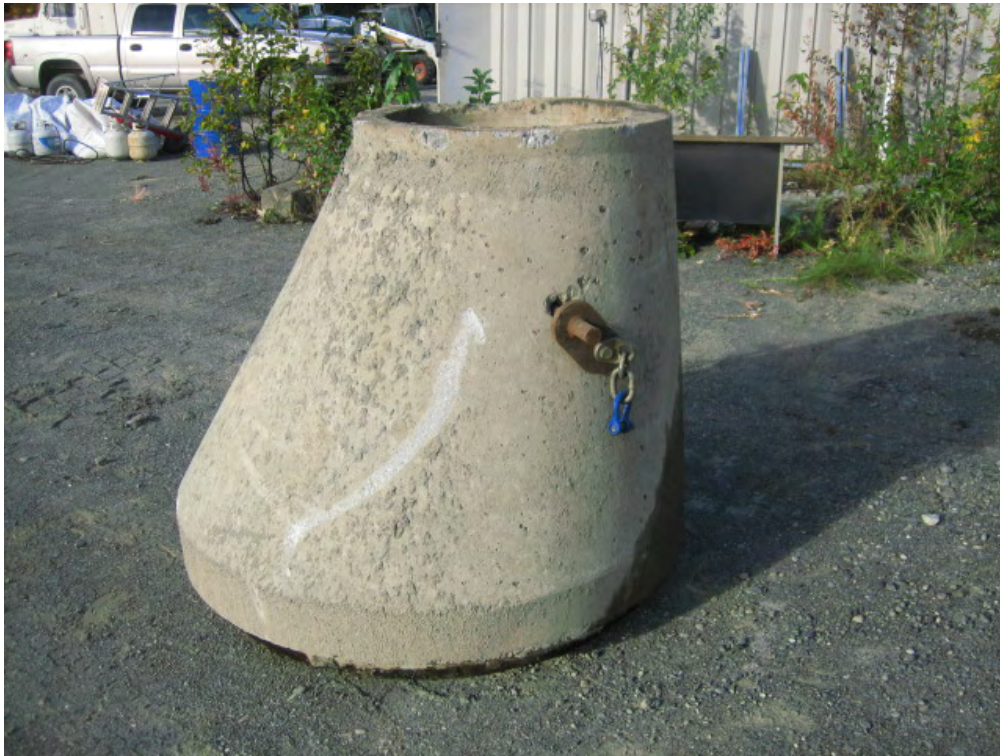
Photo 3: Top section of oil/water separator tank removed

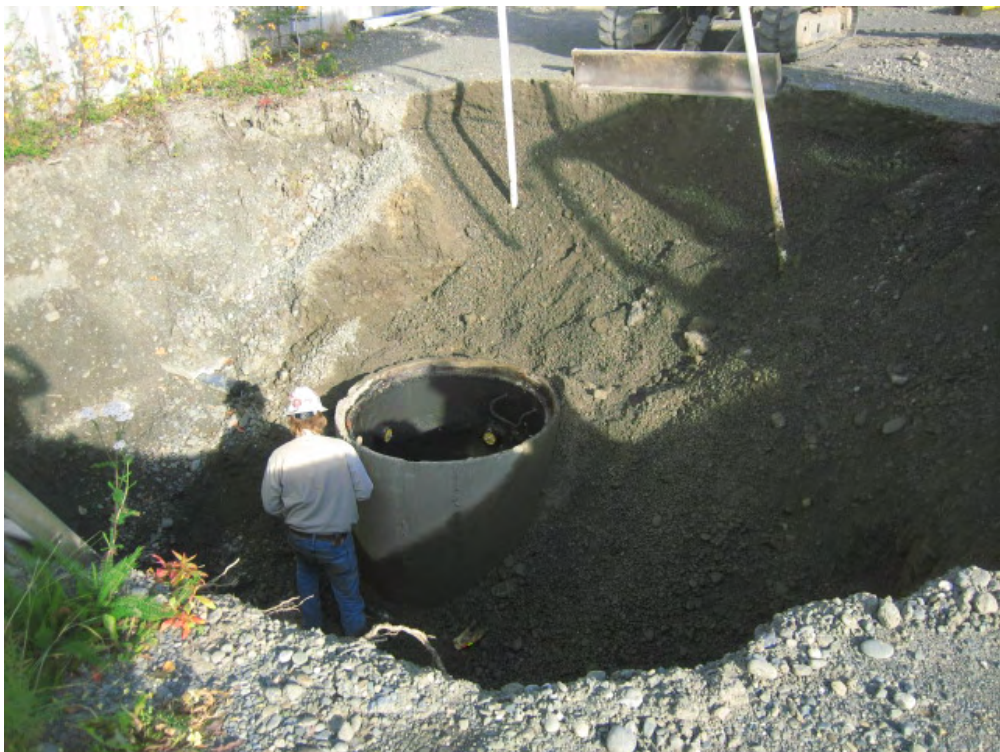
Photo 4: Preparing to excavate base section of oil/water separator tank

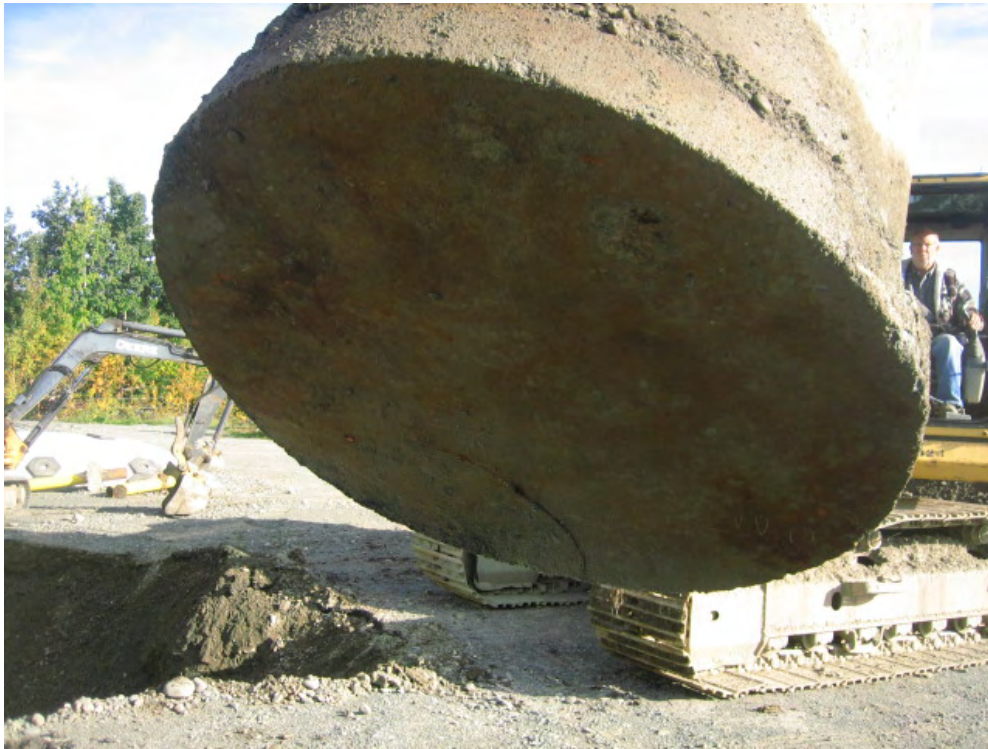
Photo 5: Lifting out base section of oil/water separator tank

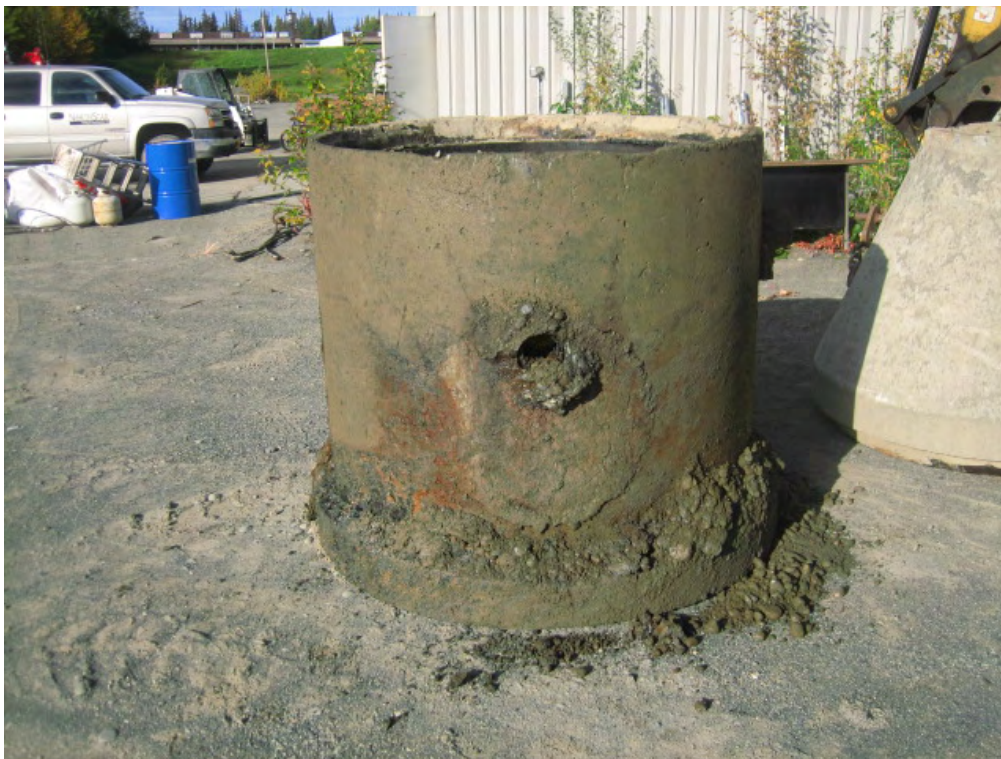
Photo 6: Base section of oil/water separator tank removed. Red and black staining on exterior below outlet invert for approximately $\frac{1}{4}$ of tank circumference.

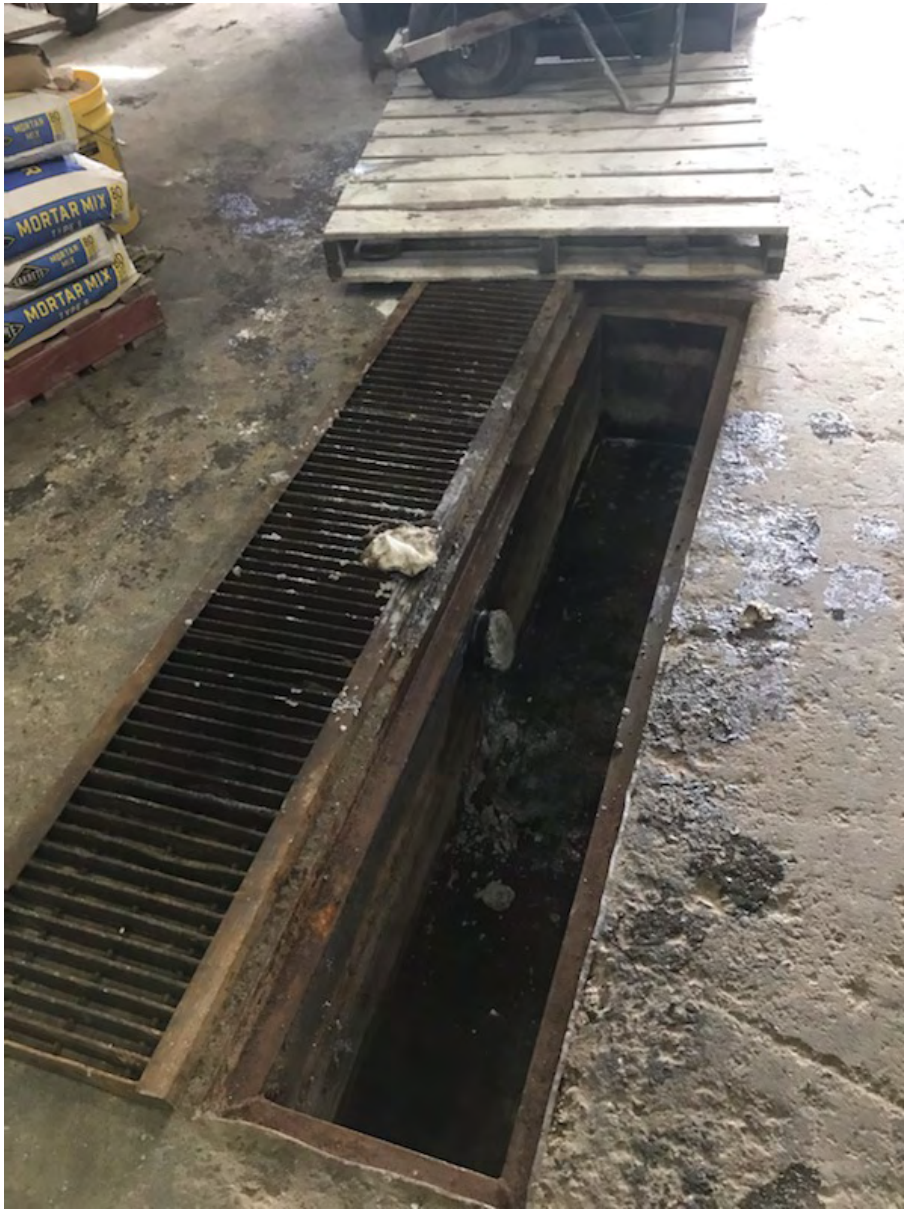
Photo 7: Bentonite slurry was pumped to completely fill piping between floor sump and oil/water separator's previous location (this photo shows piping exiting sump full of bentonite)

3. Piping was capped upstream of the oil/water separator tank. Piping between floor drain and capped end was then pumped full with bentonite slurry (to flush with sidewall of sump). The sump in the concrete slab remains (for future snow-melt catchment area), but bentonite slurry has filled all piping to prevent any future discharge from the sump.

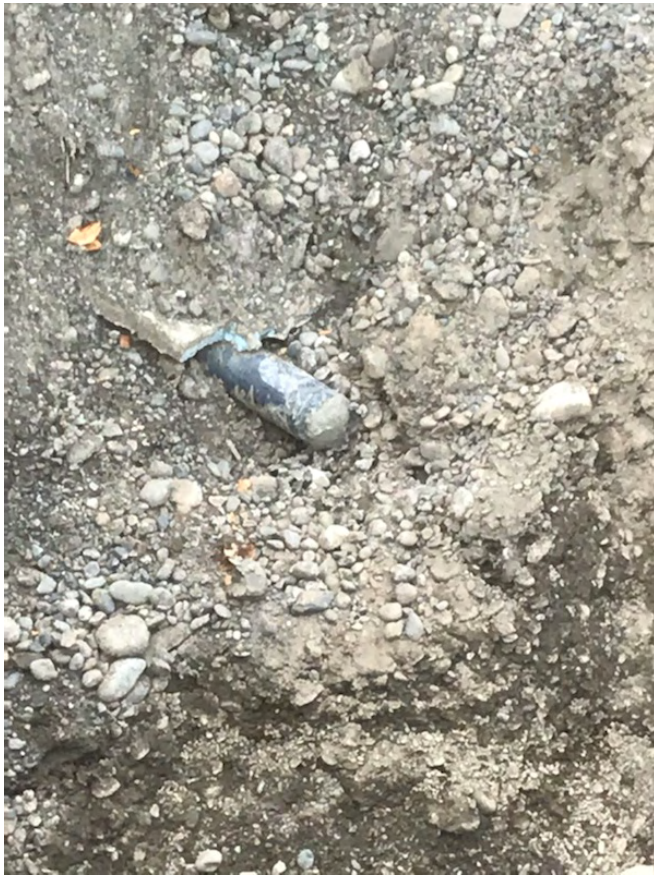
Photo 8: Bentonite slurry was pumped to completely fill piping between floor sump and oil/water separator's previous location (this photo shows exterior end of piping full of bentonite)

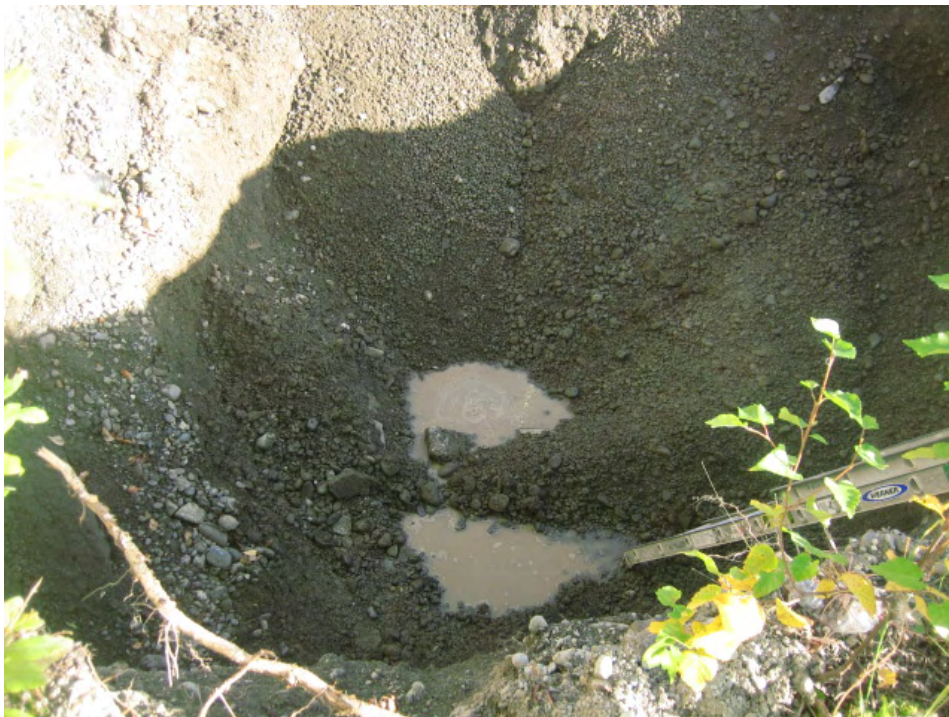
Photo 9: Groundwater observed at approximately 10' below grade

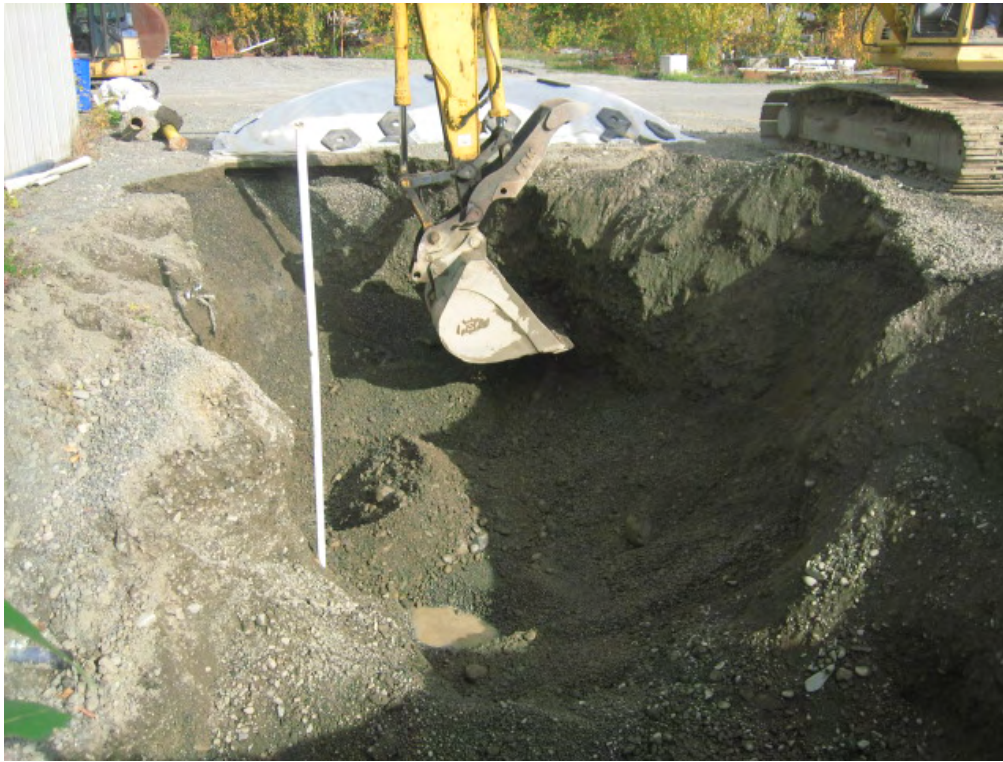
4. On 14 Sep 2020, the leachfield was excavated to remove all imported drain rock, perf pipe, and backfilled soils. Visual observation of soils directly beneath and adjacent to leachfield

showed no signs of staining and/or contamination. Excavation of the leachfield was simply a lateral expansion of the excavation performed for the oil/water separator tank; groundwater level in the excavation was approximately 10' below grade. On 14 Sep 2020, TriHydro performed soils analysis with a photo-ionization detector (PID) and facilitated lab soil analyses per the 5 Aug 2020 Closure Plan. (See attached TriHydro 18 Nov 2020 Report including soil and water field and lab analyses results.)

Photo 10: Excavating leachfield, looking north. Monitor Well #1 remains; Monitor Well #2 was removed and decommissioned.

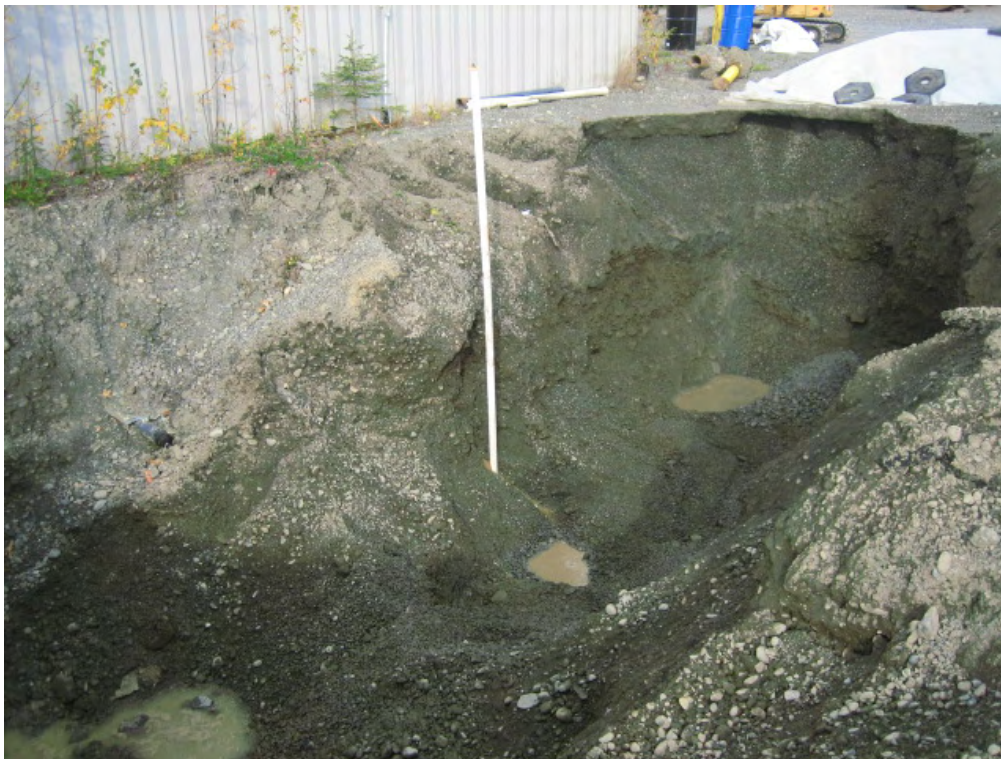
Photo 11: Groundwater observed at approximately 10' below grade. Note undermining of concrete pad near upper right hand corner of photo.

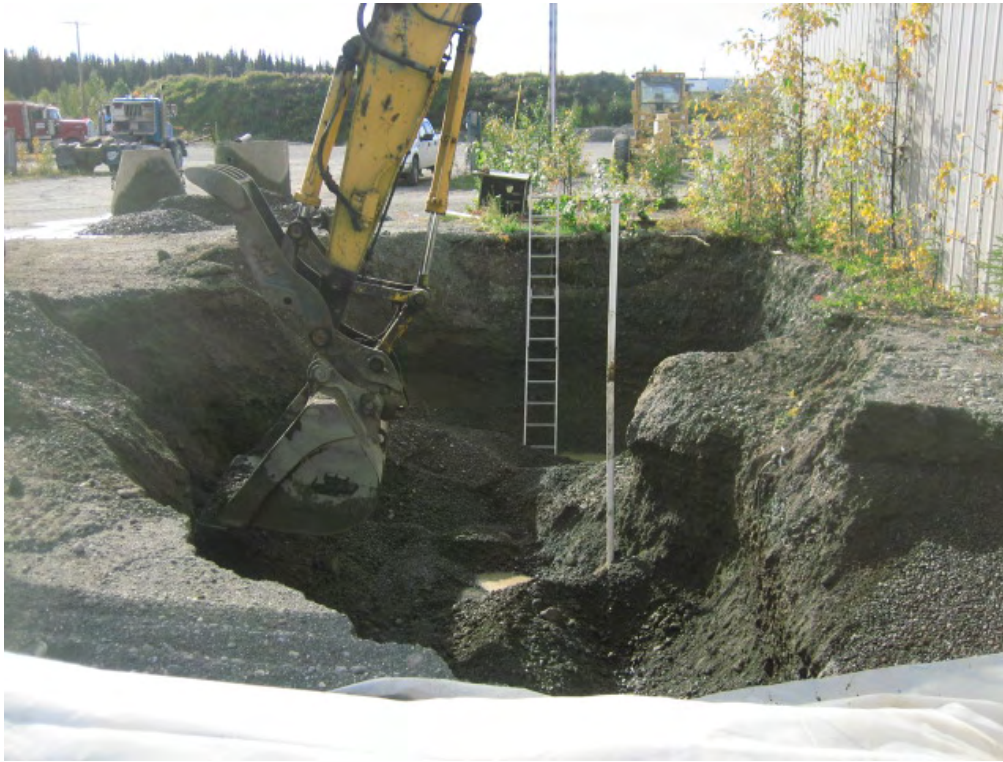
Photo 12: Excavating leachfield, looking south
