## SOIL REMEDIATION CONSTRUCTION COMPLETION REPORT FORMER COASTAL DRILLING SITE SOLDOTNA, ALASKA

ADEC FILE NO. 2333.38.013 EPA ID NO. AKD 982 820 235

Kenai Spur Investments, LLC.

June, 2016

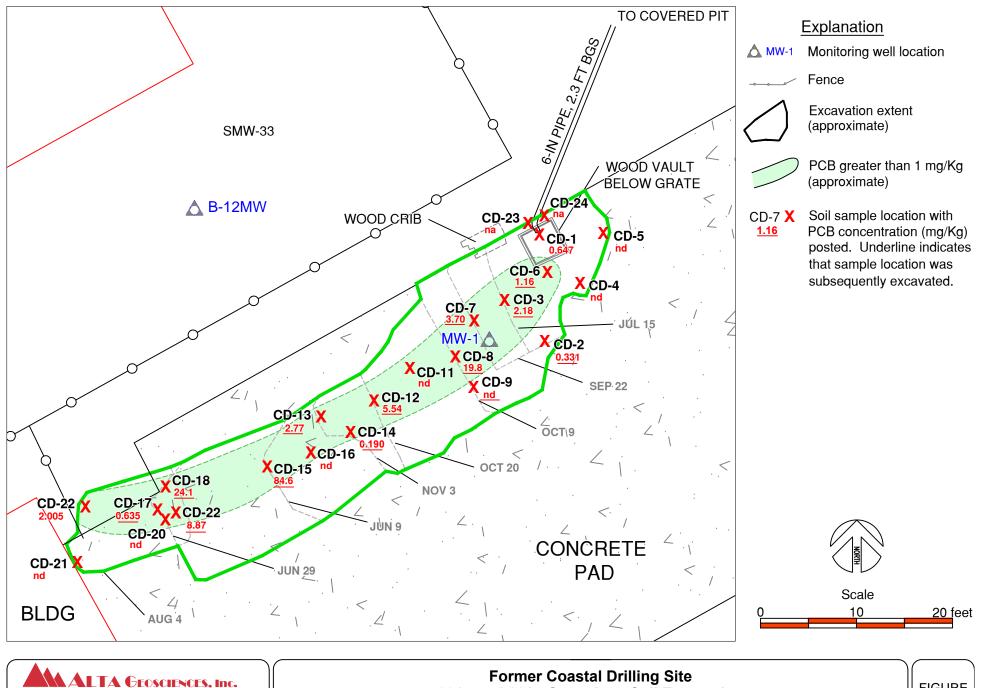
2014 and 2015 Grate Area Soil Excavation

Figure 4 shows the approximate grate area excavation limits as of August 4, 2015. Sample locations and PCB concentrations are also shown on Figure 4. Note that an underlined sample concentration indicates that the soil represented by the sample was subsequently excavated. All soil sample results are summarized in Table 1. Table 2 shows only PCB results for clarity. The excavation work proceeded as described below.

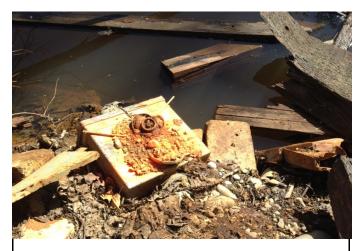
Photo 1. Open pit, recovered intact battery. 7/1/2014

Removal of the debris from the open pit began on July 2, 2014 and was completed on July 10, 2014. Recovered intact batteries, broken batteries and battery plates, and associated soil are described in Section 7.0. See Photos 1 through 4.

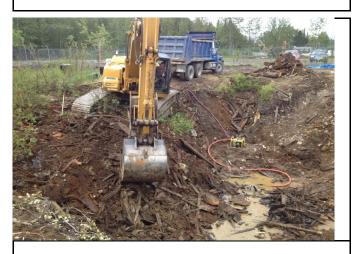
Photo 4. Open pit, debris removal. 7/7/2014

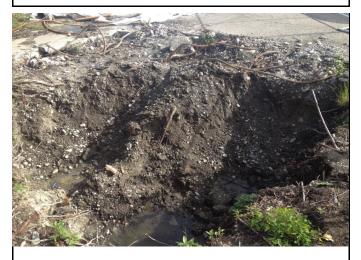
Photo 11. Continued excavation, 9/11/2014

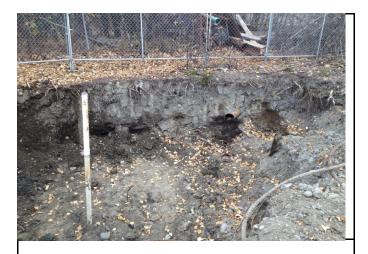
- October 9, 2014. The excavation was extended ~3 feet further west and south. Soil relationships observed at this point suggest that PCB-impacted material was deposited as fill at the site as opposed being contaminated in place. Two distinct zones of fill covering native silt was apparent on the west sidewall. A pit-run gravel layer predates gravel plus debris that appears to have been dumped in a shallow trench cut through the pit-run material into native silt. PID screening of the gravel plus debris material showed elevated head space readings of 35 to 120 parts per million (ppm), and sample CD-8 from the gravel and debris zone contained 19.8 mg/Kg PCBs and 23,000 mg/Kg DRO. In contrast, PID readings in the pit-run layer and native silt were 0.3 to 8.0 ppm, and sample CD-9 of the silt contained no detectable PCBs and 356 mg/Kg DRO.

Photo 13. Continued excavation. 10/9/2014

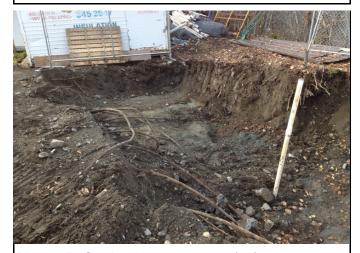
- October 20, 2014. The excavation was extended 10 feet further west following the PCB-impacted gravel plus debris zone. The depth of the zone decreased to the west from ~4 feet at sample location CD-8 to ~2 feet at location CD-12. Native silt immediately below the gravel plus debris material was characterized by bottom sample CD-11 which contained no detectable PCBs and 77 mg/Kg DRO. The gravel plus debris material on the west side wall (sample CD-12) contained 5.54 mg/Kg PCBs. A refrigerated connex unit blocked further excavation to the west at this time.

Photo 15. Continued excavation. 10/20/2014

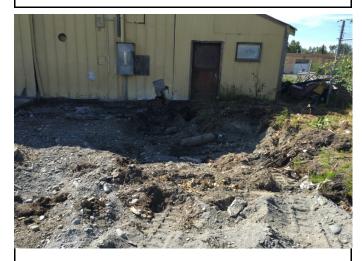
- August 4, 2015. The excavation was extended approximately 10 feet west to the edge of the warehouse building and was deepened on the east end to remove soil at sample location CD-19. The soil from this phase of excavation was segregated from the existing stockpile using plastic sheet as a separator. Bottom sample CD-20 was collected in native silt and did not contain detectable PCB indicating that impacted soil at location CD-19 was removed. West sidewall sample CD-21 collected adjacent to the building foundation did not contain detectable PCB. West sidewall sample CD-22 contained 2.005 mg/Kg PCB, and soil characterized by this sample remains in place.

Photo 17. Final excavation, 8/14/2015
