7/12 AMENDMENTS TO THE CLEANUP PLAN -
WRANGELL LUMBER MILL SITE

6.5-Mile Zimovia Highway
Wrangell, Alaska

Prepared by
Southeast Management Services
1061 Mendenhall Peninsula Road, Juneau, Alaska 99801

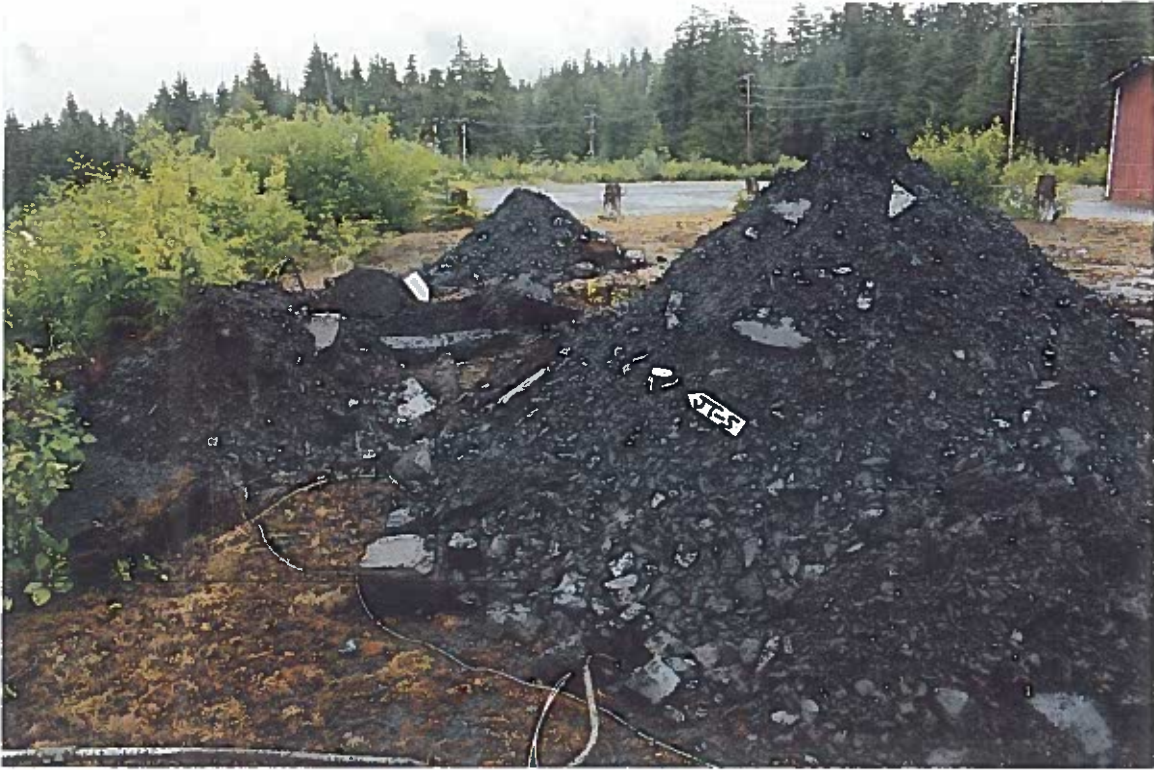
1. Jet-A fuel tank site (*Cleanup Area #1*). The Jet-A tank site near the Wrangell Lumber mill office was excavated on 7/1/12. Photos on page B2 show the 4.5'-deep excavation. A slight diesel odor was detected in about 2-3 c.y. of the excavated gray-colored soils, which were set aside and sampled to determine if cleanup criteria were met. A somewhat larger pile of discolored soil (about 5-6 c.y.) also was sampled, as was the final excavation.

Photo #1: 7/1/12 view looking north across the three piles of excavated soil from the Wrangell Lumber mill site's Jet-A Tank cleanup site, showing two of the 5 samples to confirm whether ADEC cleanup criteria have been met. The unmarked arrow shows the 4.5'-deep excavation site, see photo below.

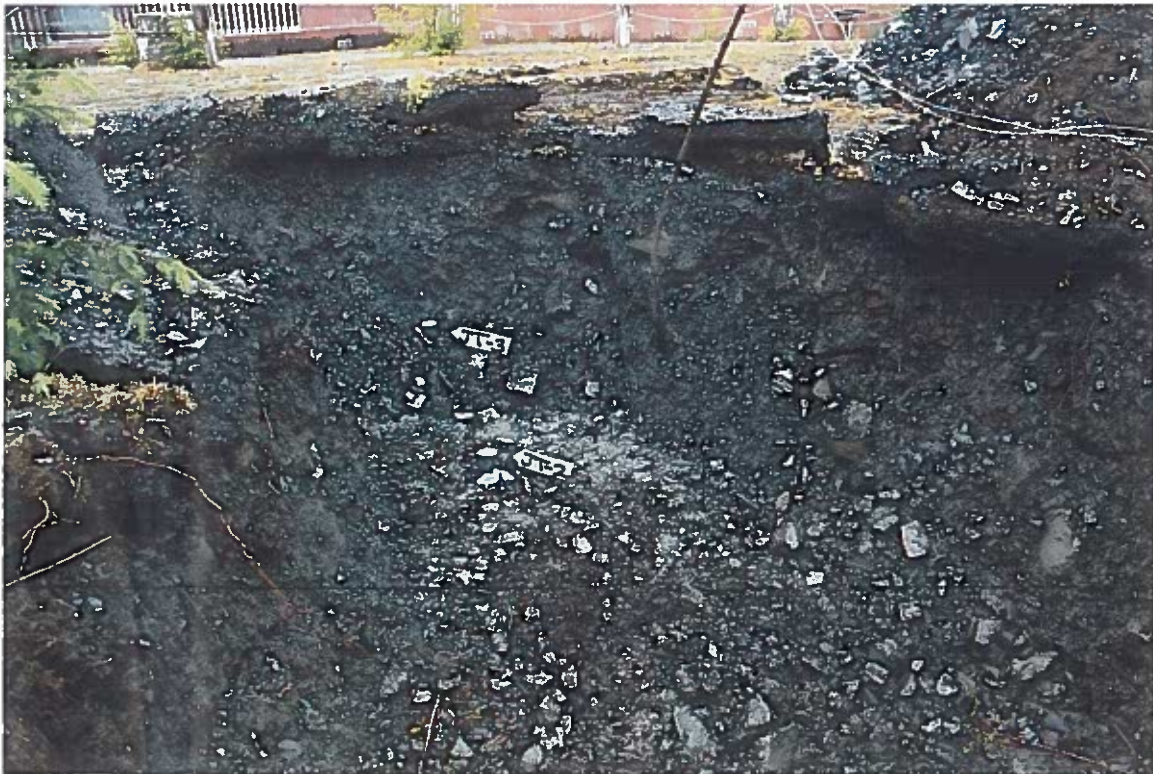
Photo #2: 7/1/12 view looking east towards the Wrangell Lumber mill office, showing the two confirmation sampling sites in the 4.5'-deep excavation of the former Jet-A Tank site.

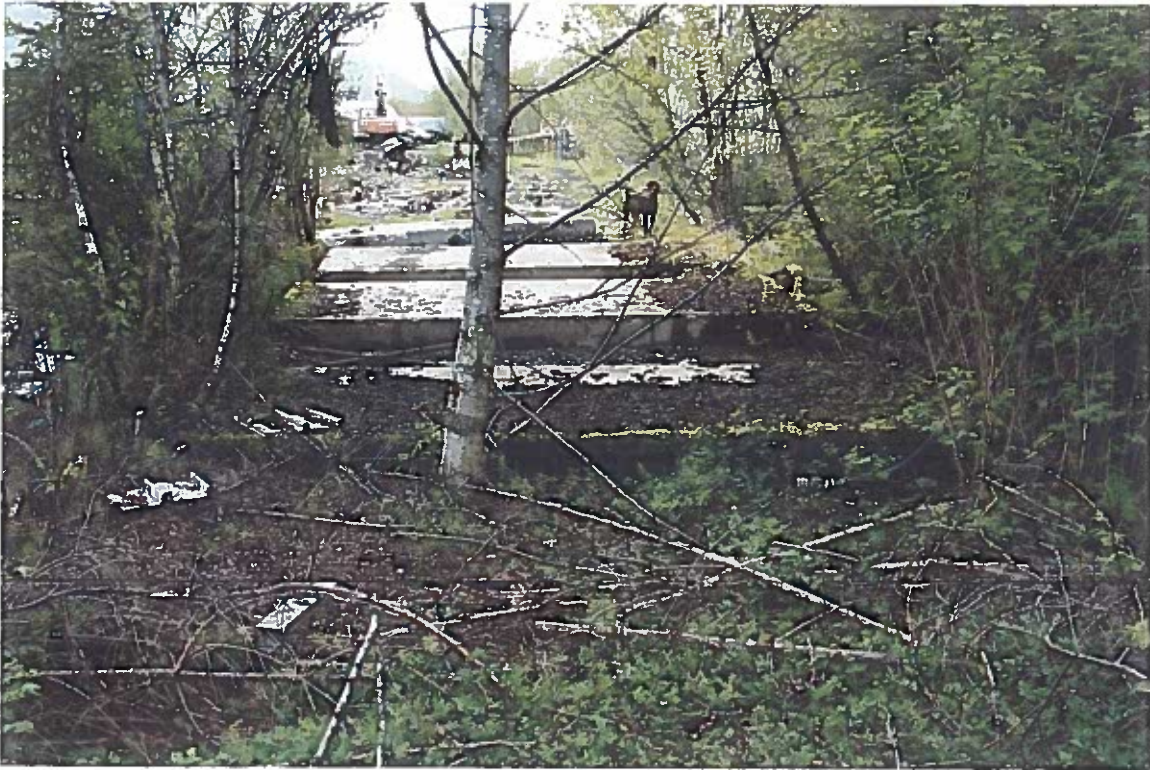
Photo #3: 5/17/12 view looking west across the former Wrangell Lumber Mill site's generator tank area, just before beginning excavations below where the tank's outlet pipe had been located (arrow).

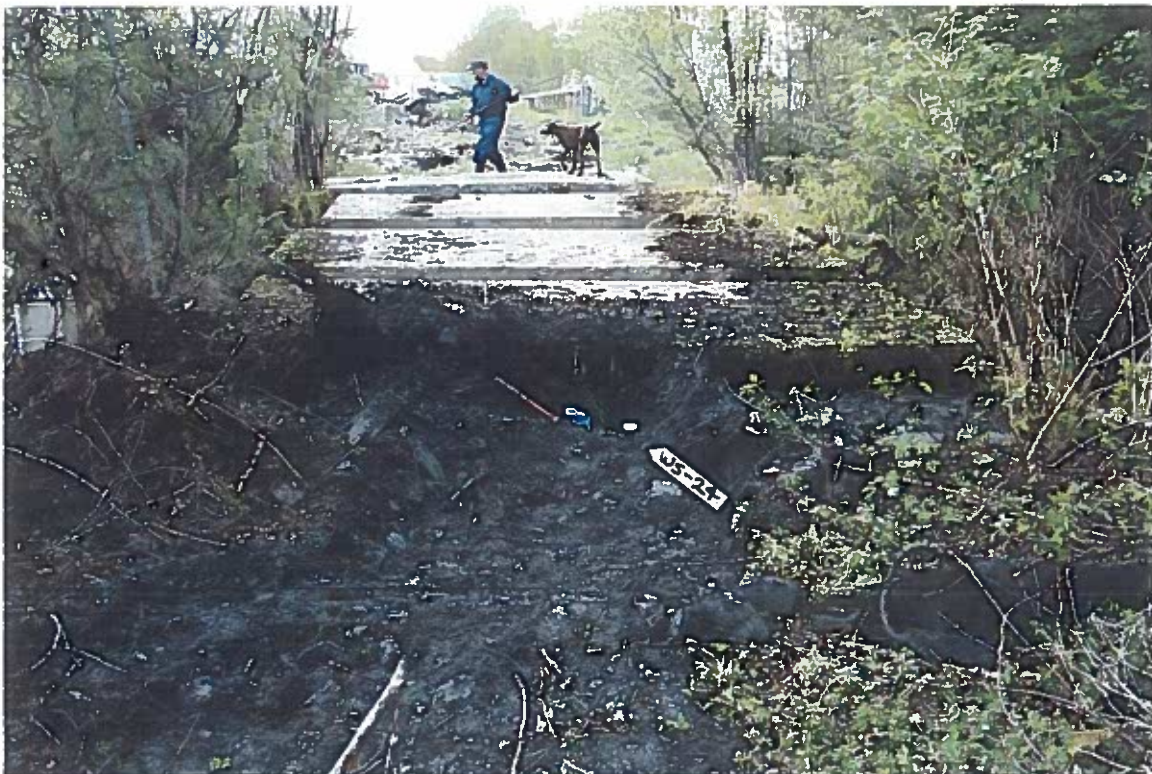
2. Generator fuel tank (*Cleanup Area #2*). The 14'-long block of concrete that had supported the electric generator fuel tank's east end was moved back 30" on 5/17/12. The area under where the tank's discharge pipe had been located was excavated to 12"-18", but there was very little indication of any contamination. Two samples were taken and had very low DRO and RRO levels of 160-180 mg/kg and 220-440 mg/kg. Consequently no soils were removed and the site was confirmed to meet cleanup criteria.

Photo #4: 5/17/12 view looking west across the Wrangell Lumber mill's electric generator tank site excavation. No soil was removed & the two confirmation samples easily met cleanup criteria (DRO = 160-180 mg/kg, RRO = 220-440 mg/kg).

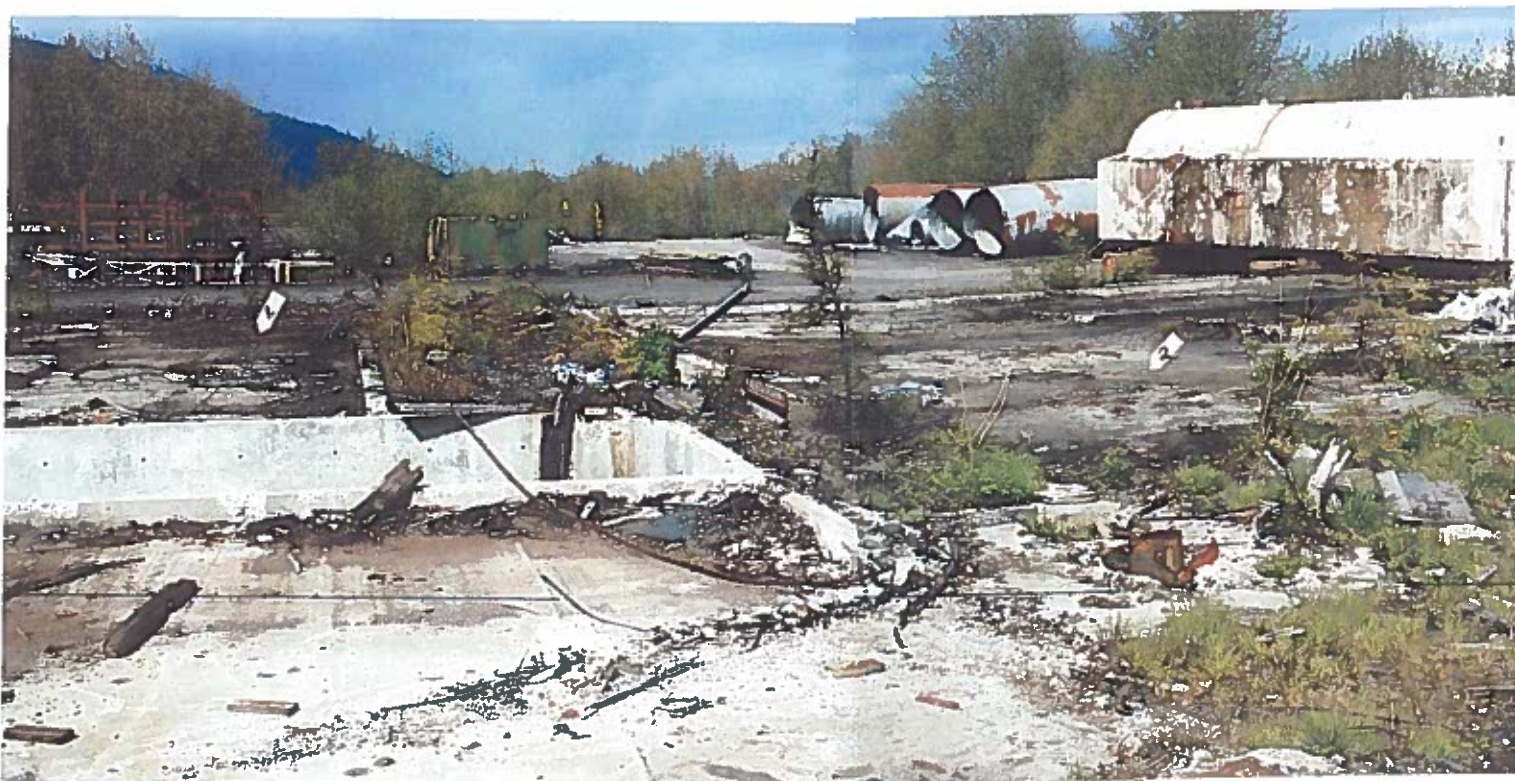
Photo #5: 5/15/12 view looking west-northwest across the Wrangell Lumber mill site's concrete transformer pad (1) and emergency generator pad (2) just prior to excavations.

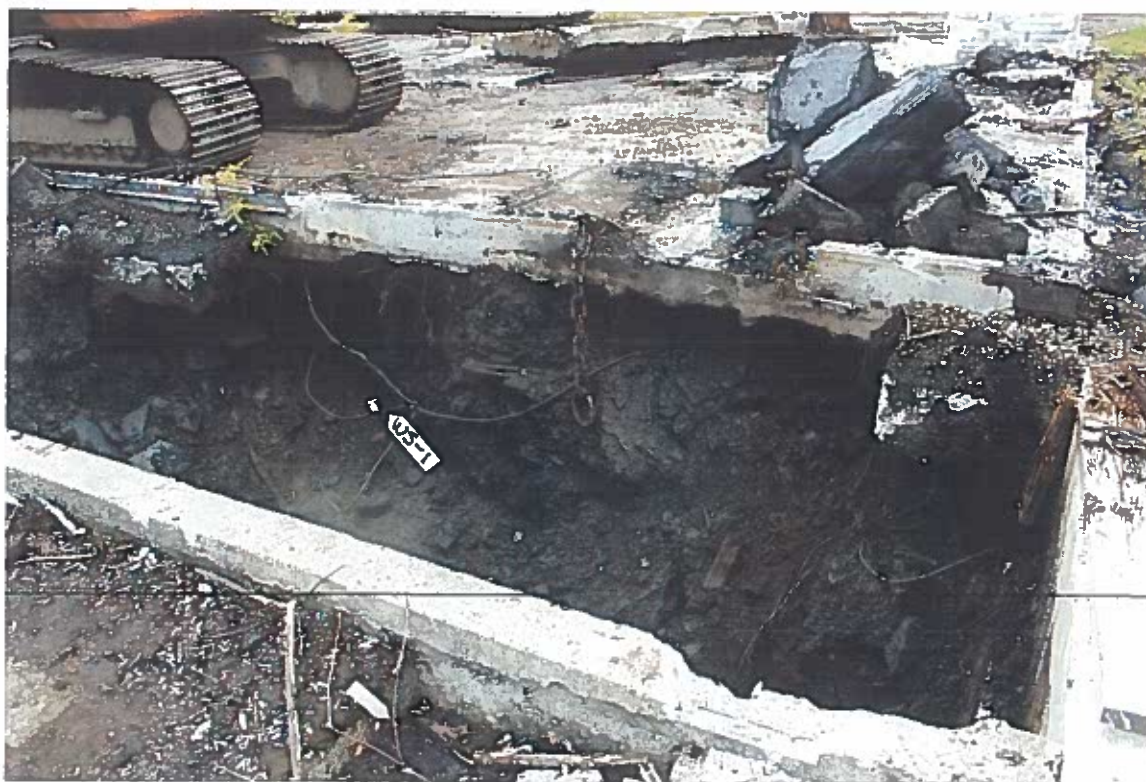
Photo #6: 5/17/12 view looking northwest at the 4'-deep characterization sample WS-1 under the generator pad, which had DRO and RRO levels of 17,000 mg/kg and 2,600 mg/kg. The arrow at the bottom of the photo shows the former drain sump for the transformer pad.

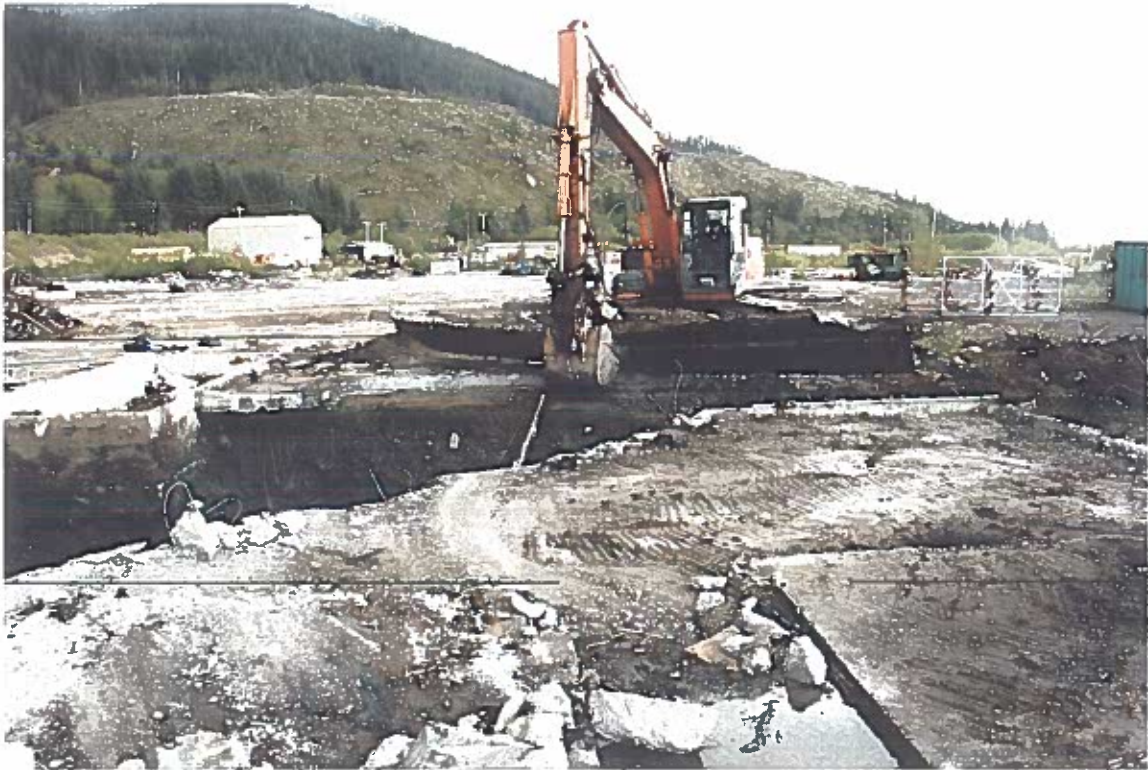
Photo #7: 5/15/12 late-afternoon view looking south at the removal of a long 10'-wide section of the former Wrangell Lumber mill's transformer pad.

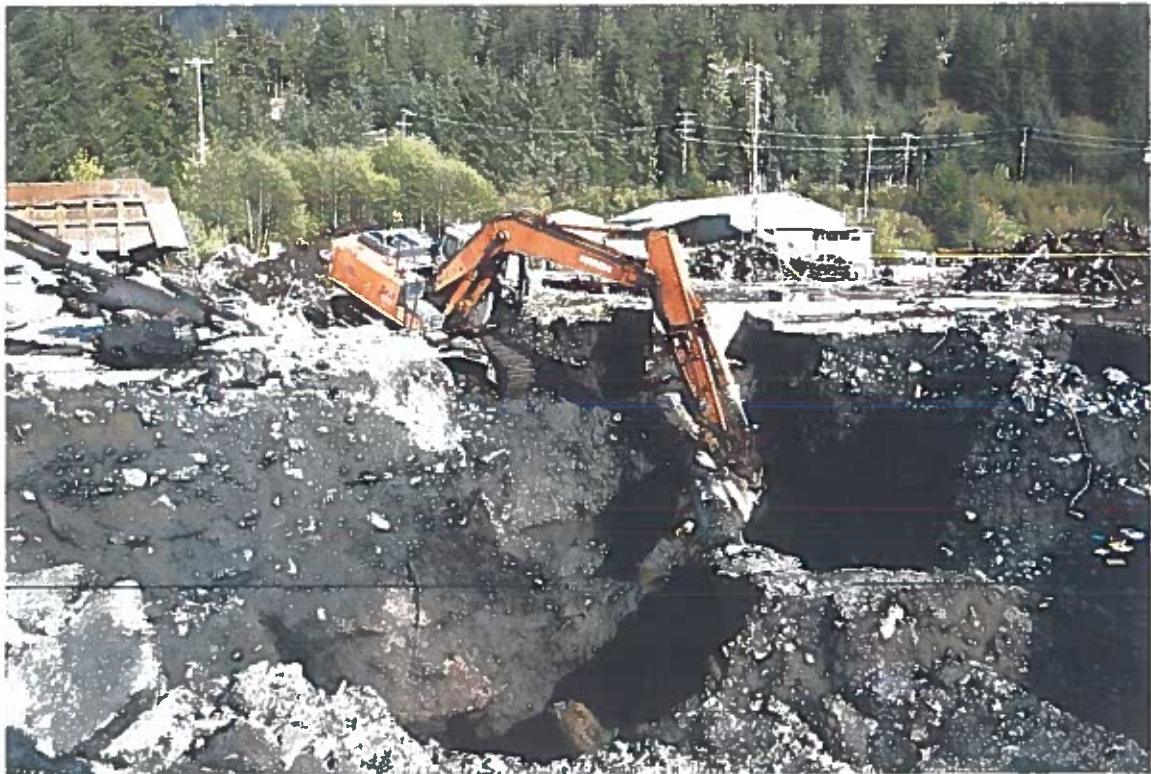
Photo #8: 5/17/12 view looking east at the backhoe removing remaining contaminated soil at an 11' depth from under a large drain pipe that exited from beneath the sawmill concrete pad.

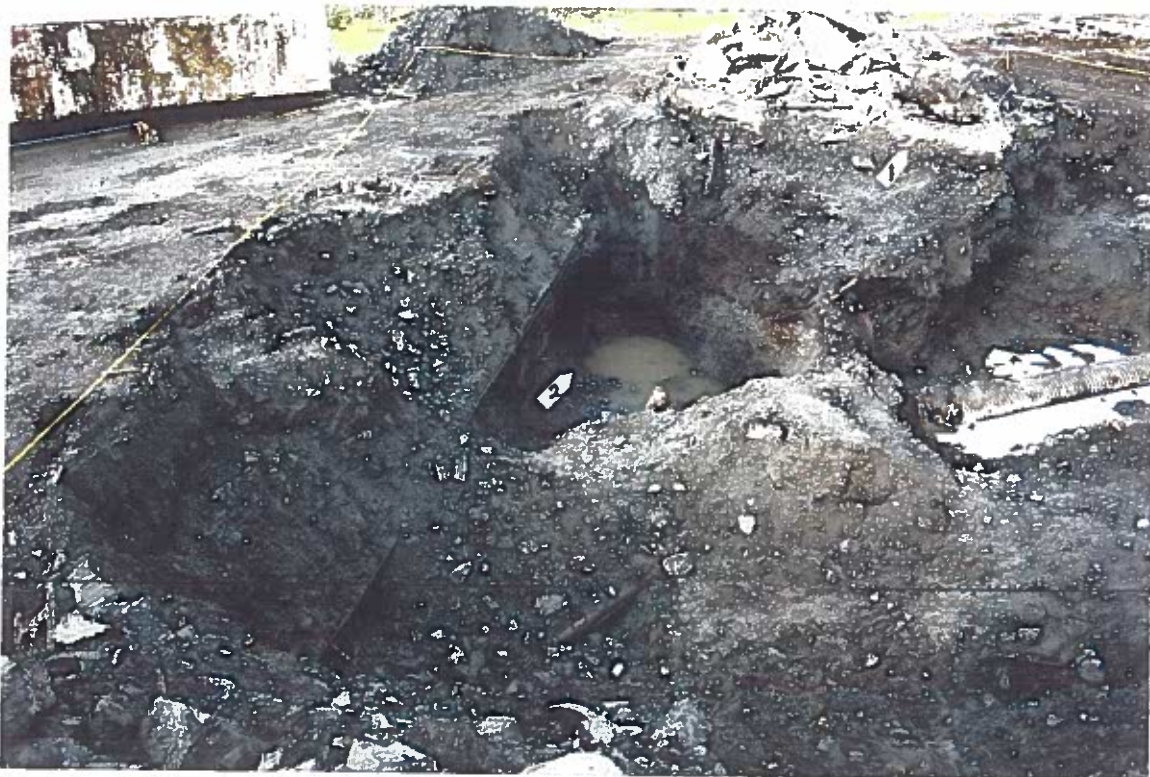
Photo #9: 5/17/12 view looking northeast across the greatly enlarged Wrangell Lumber mill site's transformer/generator pad excavation, showing (1) what little remained of the emergency generator pad, and (2) the 12'-13'-deep hole required to remove contaminated soil from what appears to have been a long-used open burn area.

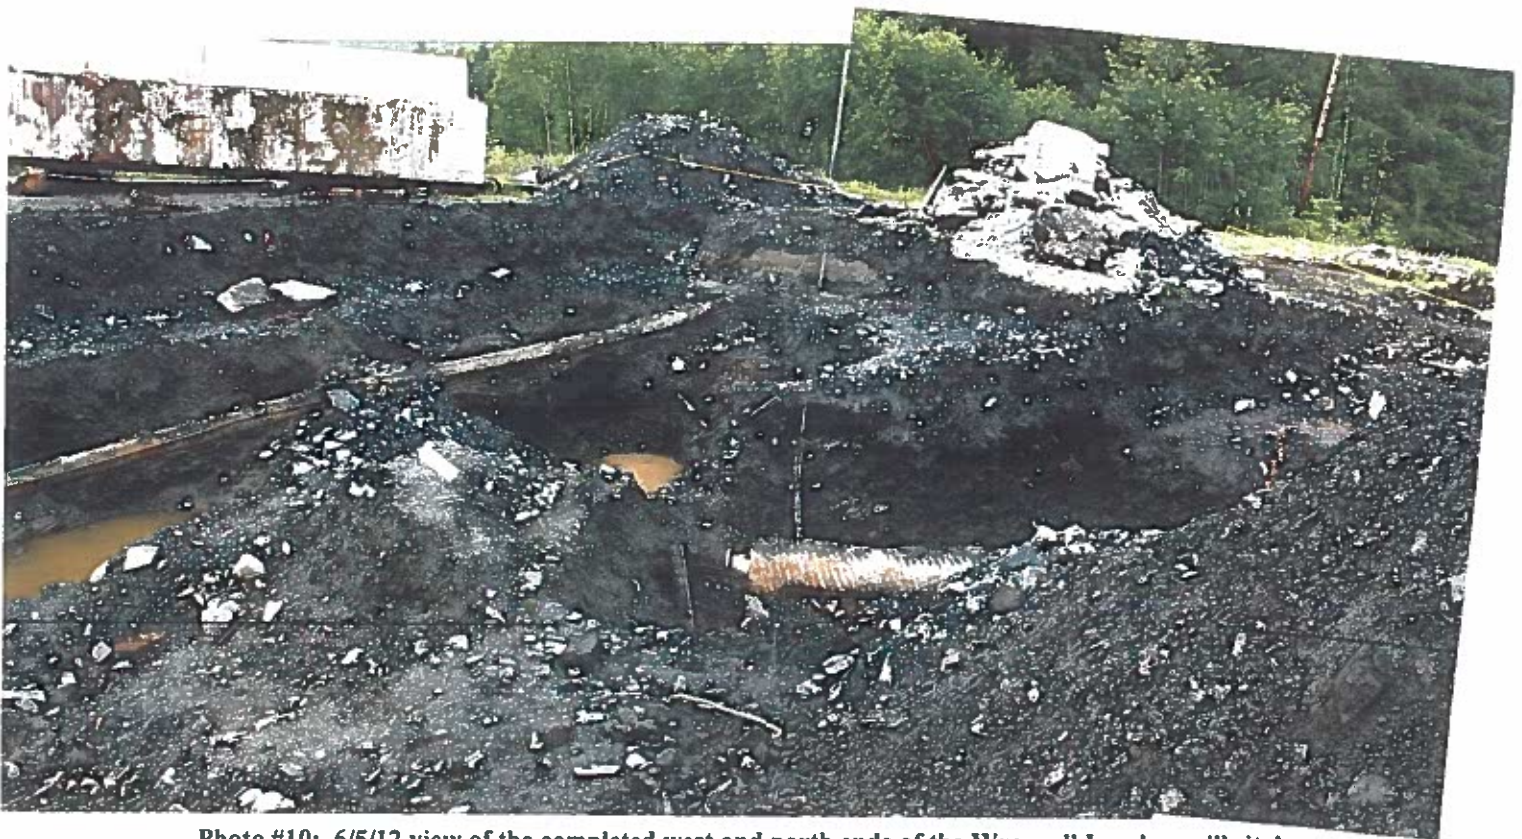
Photo #10: 6/5/12 view of the completed west and north ends of the Wrangell Lumber mill site's transformer/generator excavation. Note the completely exposed 10"-dia. former fire protection waterline along the left side of photo, where a rocked support was placed (arrow) after excavating its immediate vicinity to keep the pipe from collapsing as excavations were completed. Compare with previous photo.

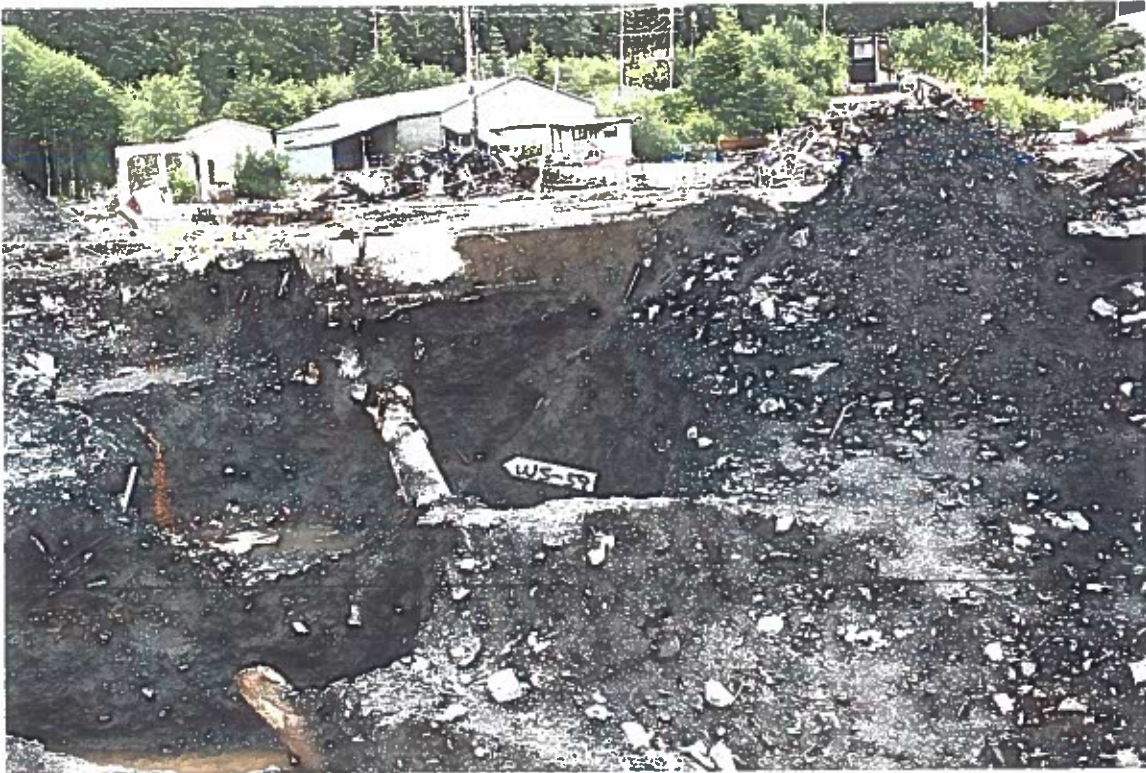
Photo #11: 6/29/12 view looking east at the final excavation 11.5' below the former Wrangell Lumber transformer drain sump site, where an earlier 5/17/12 sample had indicated that contaminated soil above the cleanup criteria still remained. However, none could be found in the re-excavation and two additional confirmation samples were taken.

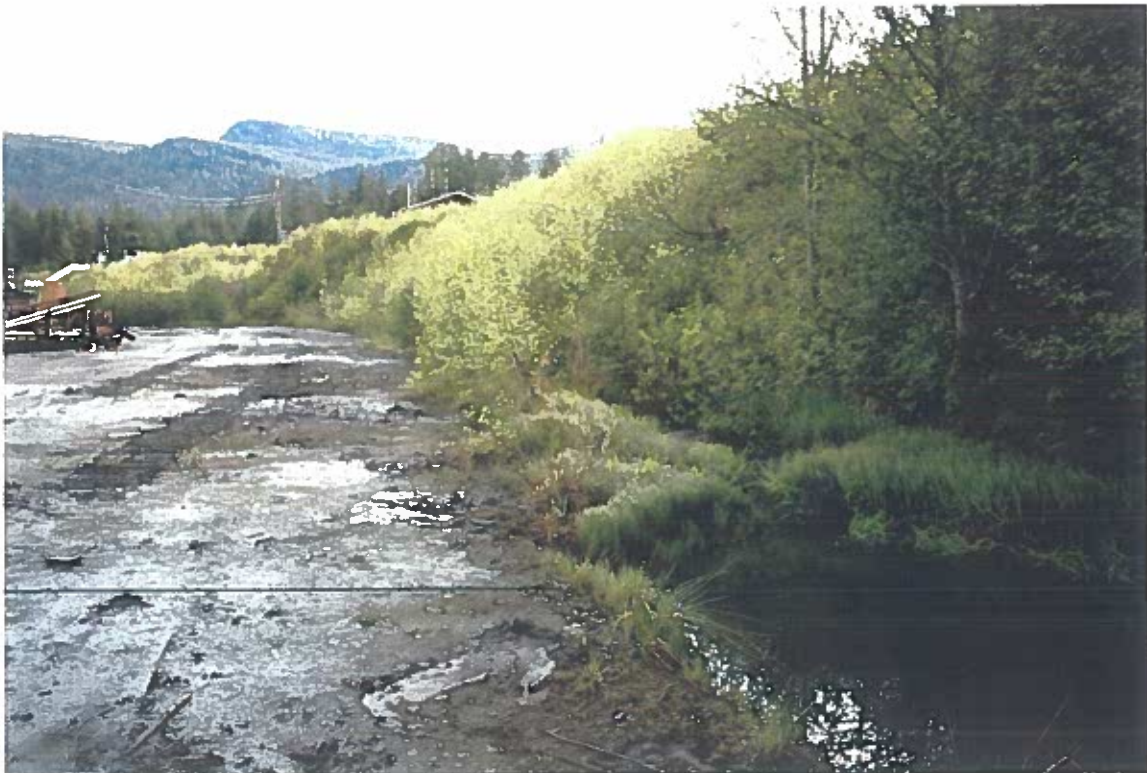
4. Shop ditch & sump (*Cleanup Area #4*). Excavations at the Wrangell Lumber mill's shop drainage ditch and sump (Photo #12, page B7) began soon after 5/19/12. The sump's sediment deposits were excavated to about a 2' depth. Contaminated soils also were removed throughout the 254'-long ditch line, including from along and under the edge of the adjacent asphalt (Photo #13, page B8).

Photo #12: 5/19/12 view looking north from the Wrangell Lumber mill site's shop ditchline sump, showing its grass-covered deposition area and the alder-lined ditch leading to behind the shop building that is just out of view in the upper left of the photo.

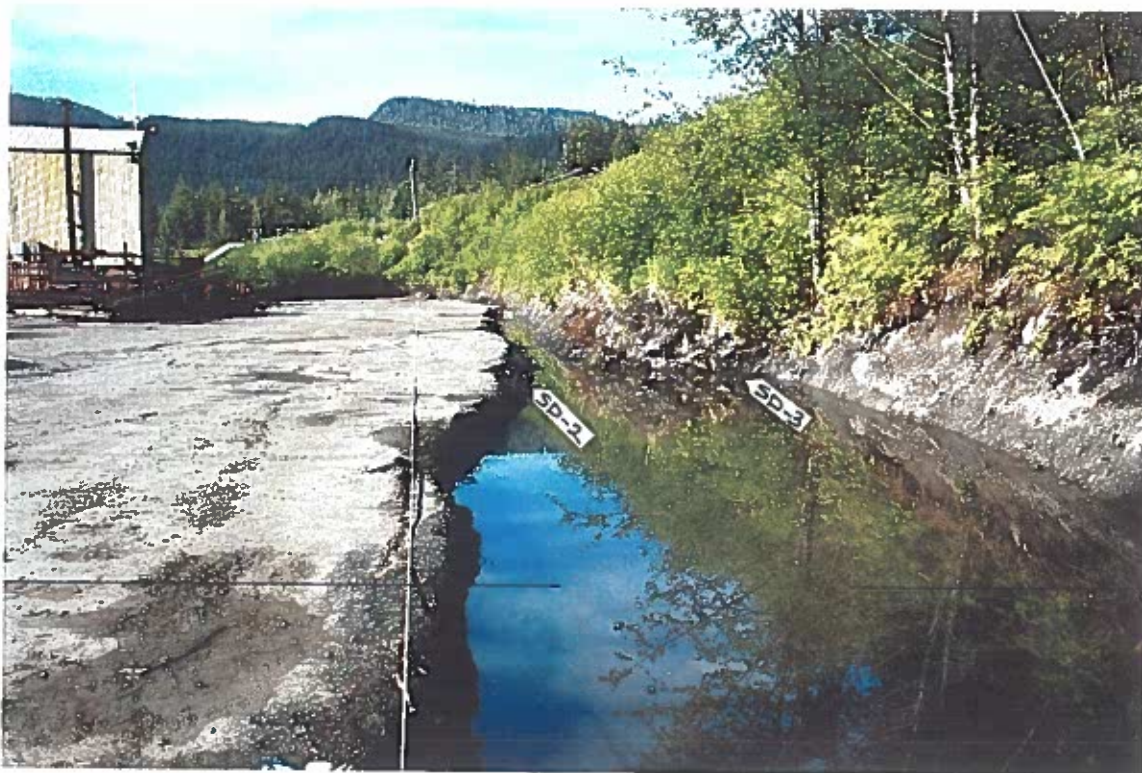
Photo #13: 6/4/12 view of the Wrangell Lumber mill site's shop drainage ditch and sump, now cleaned with vegetation removed. The sampling control line started from the former sump outlet, and crossed the shop ditchline 260' away where it turned behind the shop building.

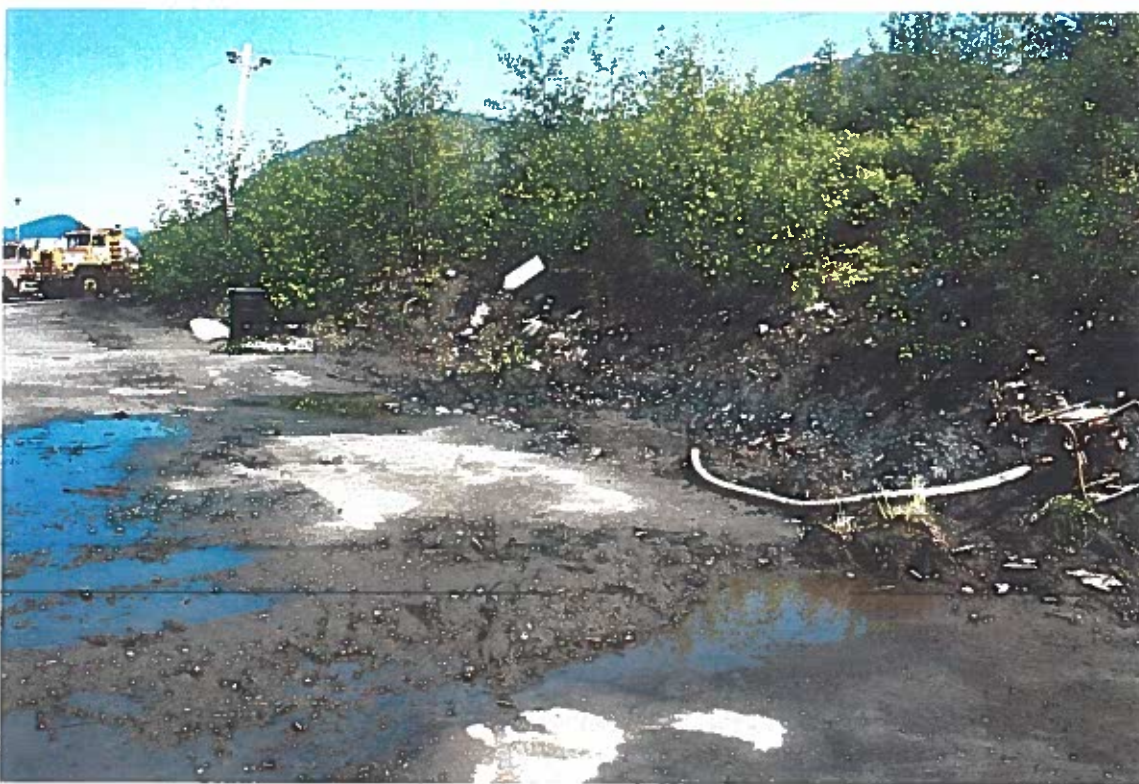
Photo #14: 6/4/12 view of the ditchline ponded area behind the Wrangell Lumber mill site's shop building, showing the initial excavations as well as the cleared-off embankment area (arrow) where some battery pieces were found and carefully removed. About 30 lbs of battery pieces and their adjacent soil were placed in the black drum for disposal as hazardous wastes.

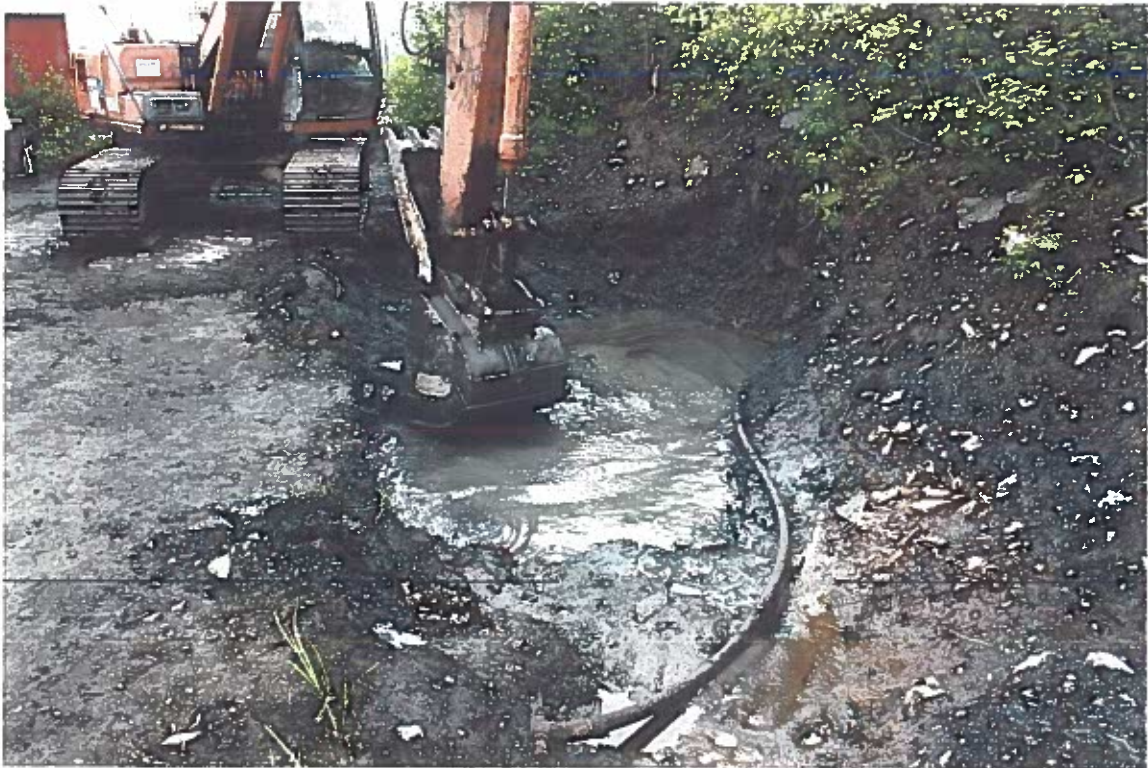
Photo #15: 6/30/12 view of the restarted contaminated soil excavations at the ponded ditchline area behind the Wrangell Lumber mill site's shop building.

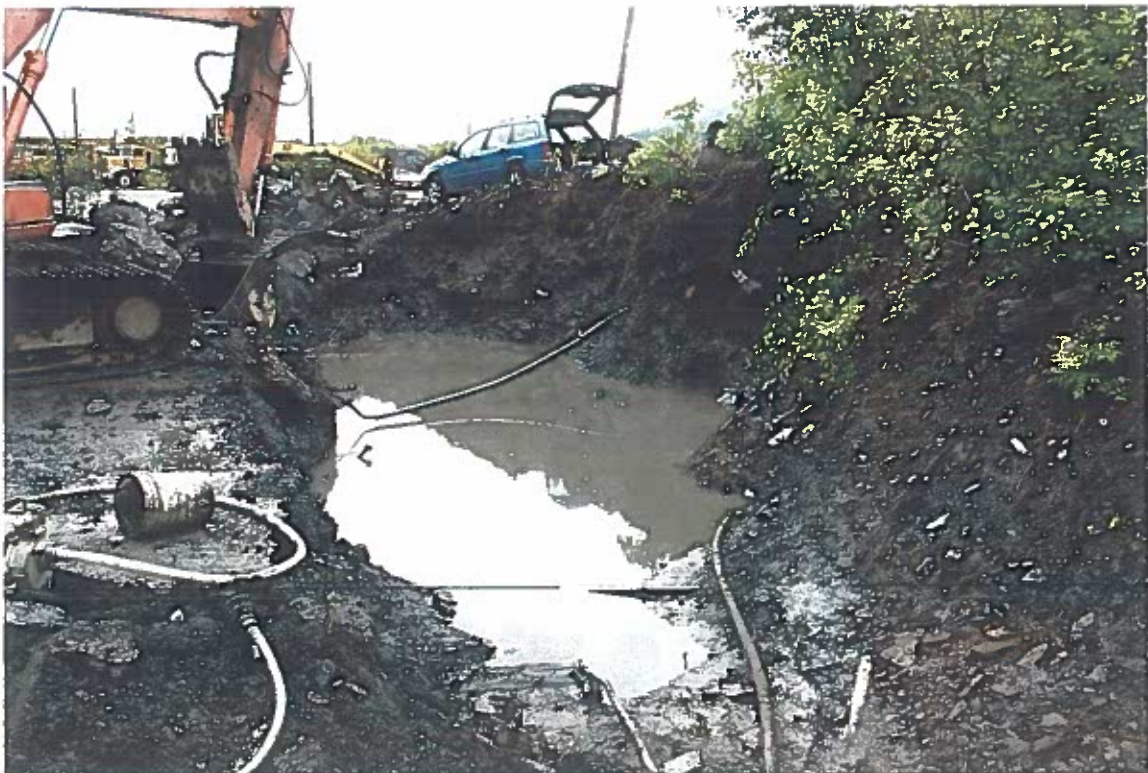
Confirmation sampling showed that the ditch line and sump area met the cleanup criteria. However, contaminated soil still remained at the end of the ditch behind the shop building (photos on page B9). It is expected that this last area will be completed in July.

Photo #16: 7/1/12 view of the excavation status of the ditchline ponded area behind the Wrangell Lumber mill shop building, where confirmation sampling was completed along its far northwestern end. Contaminated soil still remains along the pond's lower portion, and likely extends a foot or more beneath the asphalt pavement.

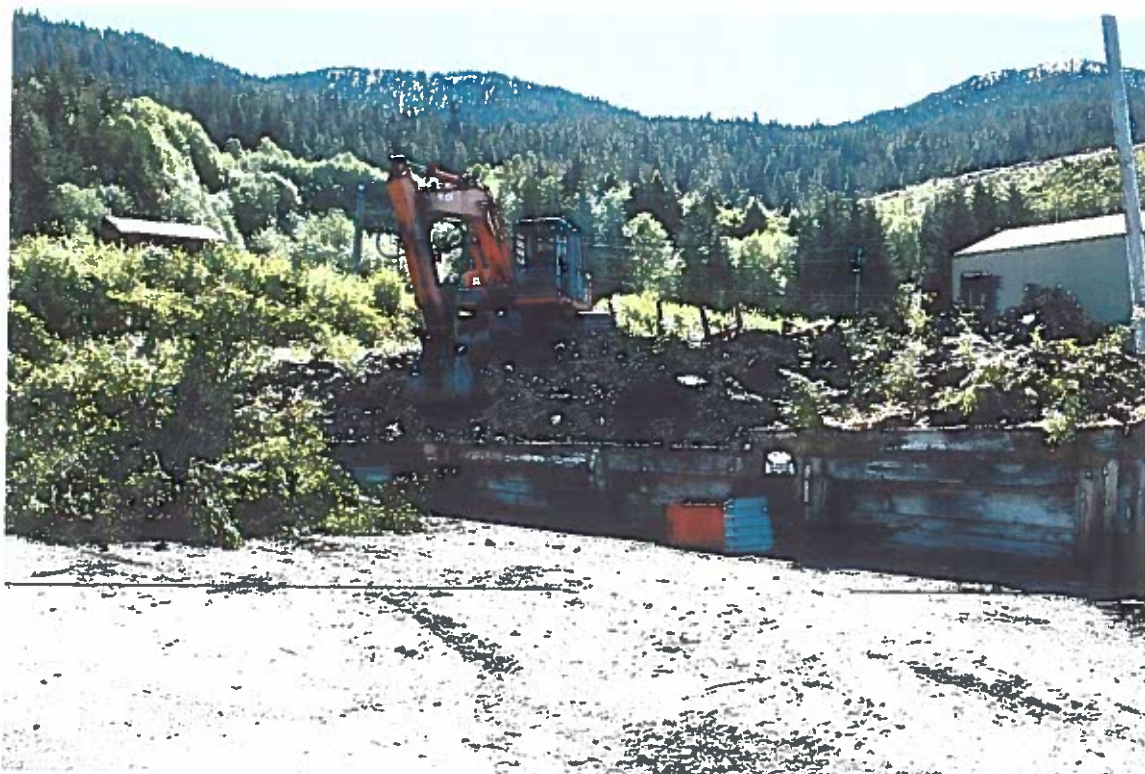
Photo #17: 6/4/12 view looking southeast at the initial excavation of the Wrangell Lumber mill site's fuel depot area, showing the bulkhead to still be in place.

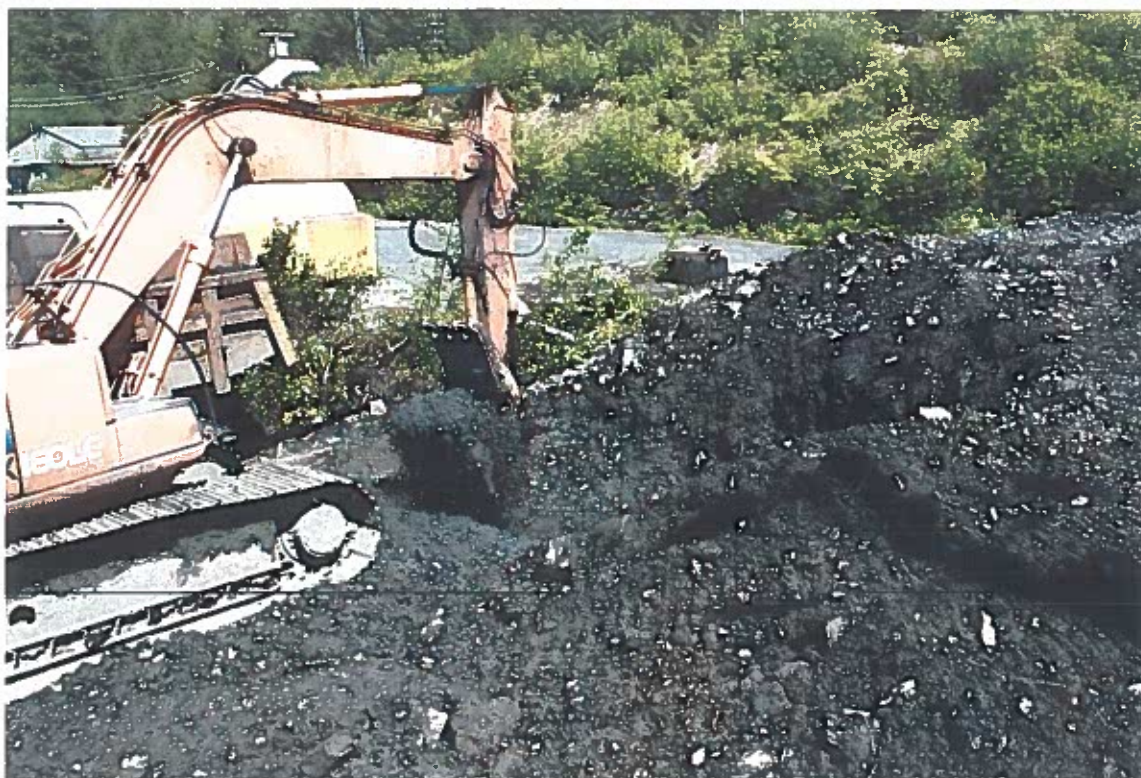
Photo #18: 6/4/12 view looking northeast at gray-colored contaminated soil being removed at about a 4' depth below the area where the diesel oil tank's discharge line had been located.

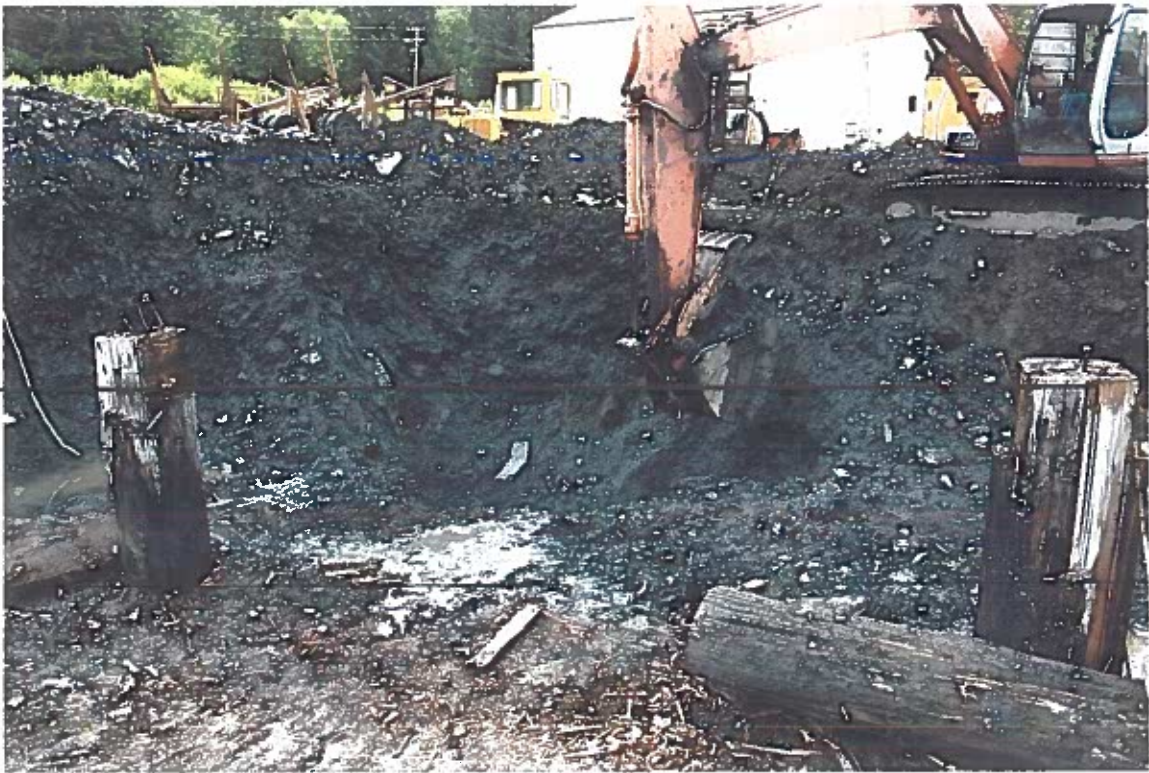
Photo #19: 6/5/12 view looking southeast at a 4'-deep excavation below the concrete surface and near the center line of the Wrangell Lumber mill's fuel tank site, where characterization sample FD-1 at a 3' depth had a high GRO level of 1,500 mg/kg which exceeded ADEC's Method-2 ingestion criteria of 1,400 mg/kg. The DRO and RRO levels were 6,800 mg/kg and 470 mg/kg.

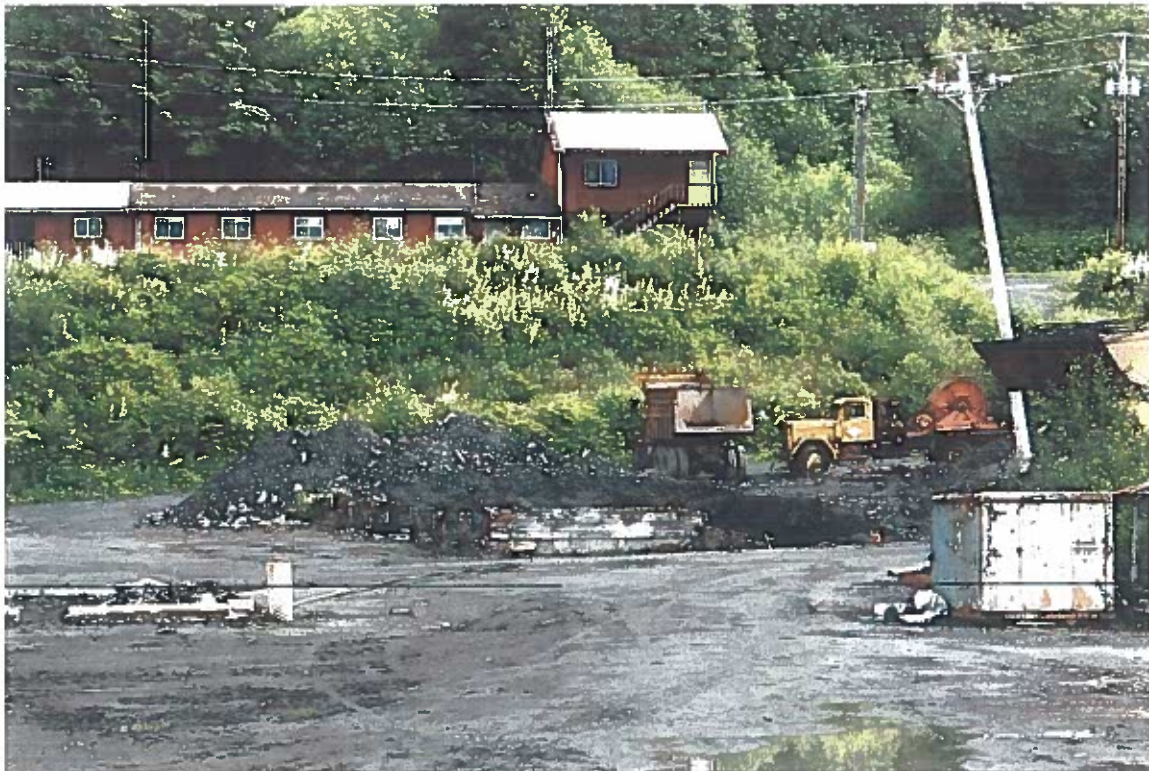
Photo #20: 6/30/12 view of the Wrangell Lumber mill's former fuel tank site excavation, showing the bulkhead to have been completely removed. See next photo.

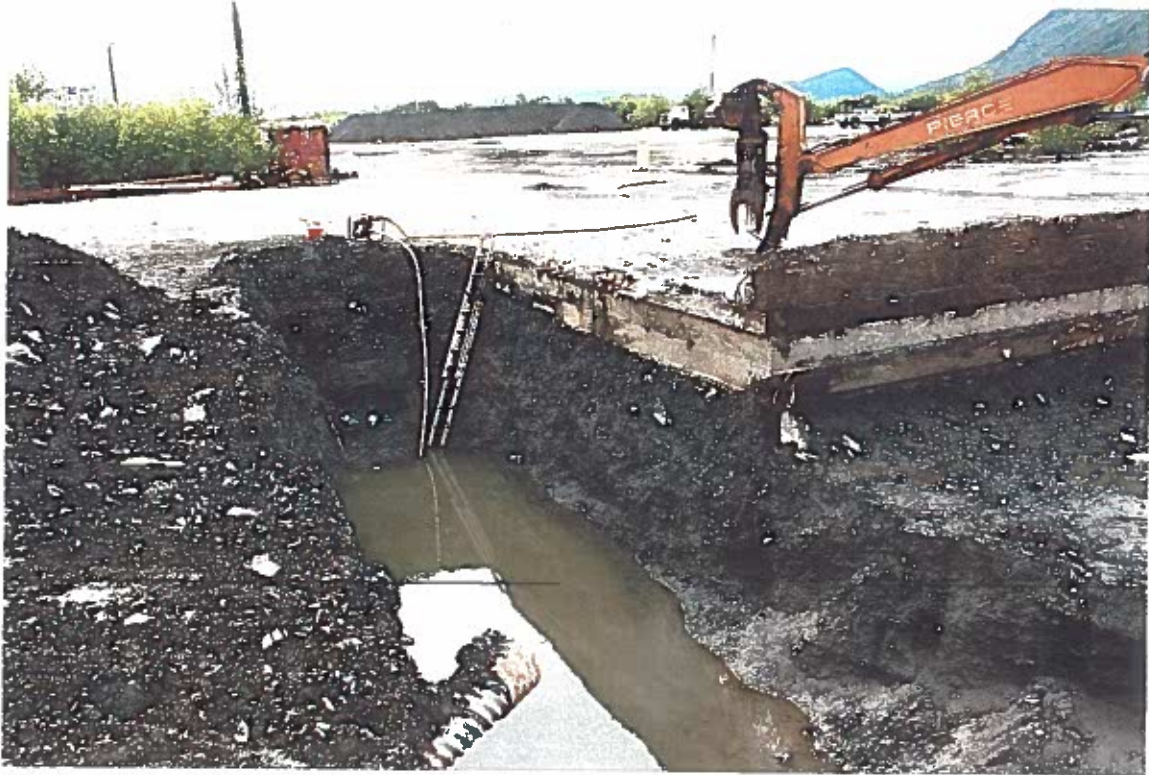
Photo #21: 6/29/12 view looking down the westward extension of the Wrangell Lumber mill's fuel depot excavation, where a 2' band of gaseous sand (PID levels of 100-300 ppm) remained starting at about a 6'-7' depth. Three characterization samples were taken within and at the assumed bottom of the gaseous layer.

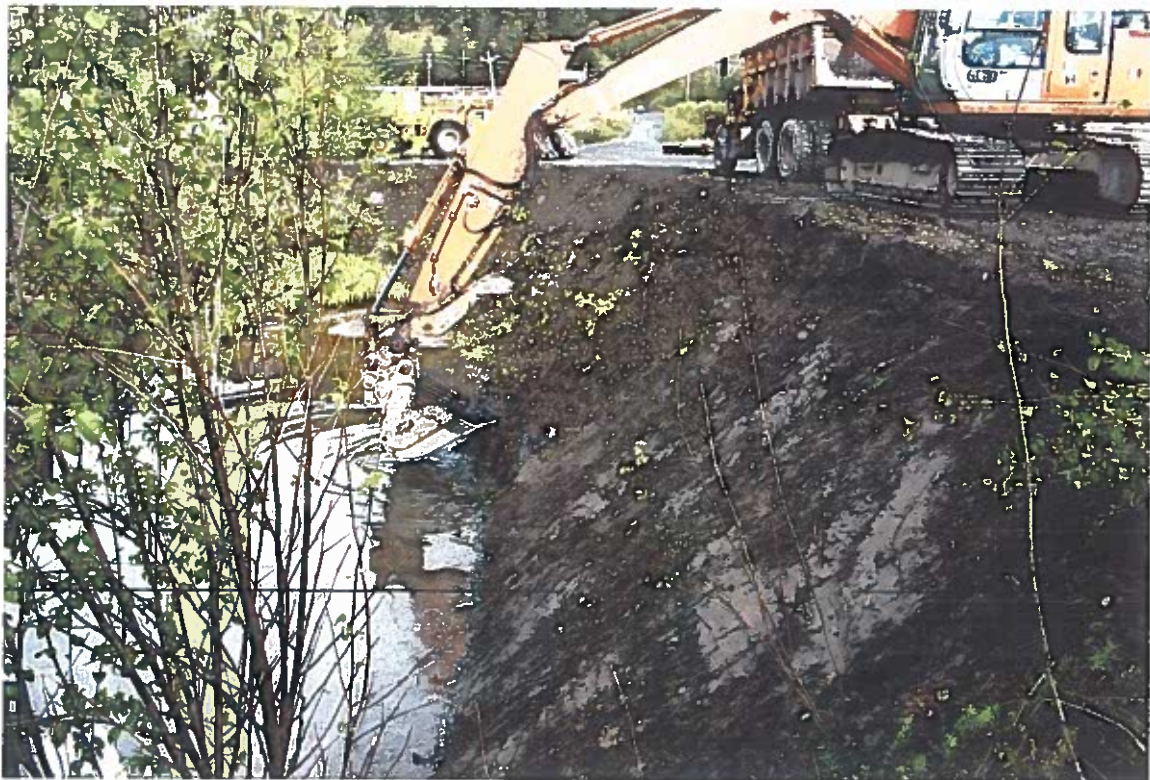
Photo #22: 5/18/12 view looking southeast across the Wrangell Lumber mill's oil/water separator pond after its alder growths had been removed, showing the steep south embankment being smoothed and contoured as its contaminated soil layer is being removed from along and below the waterline.

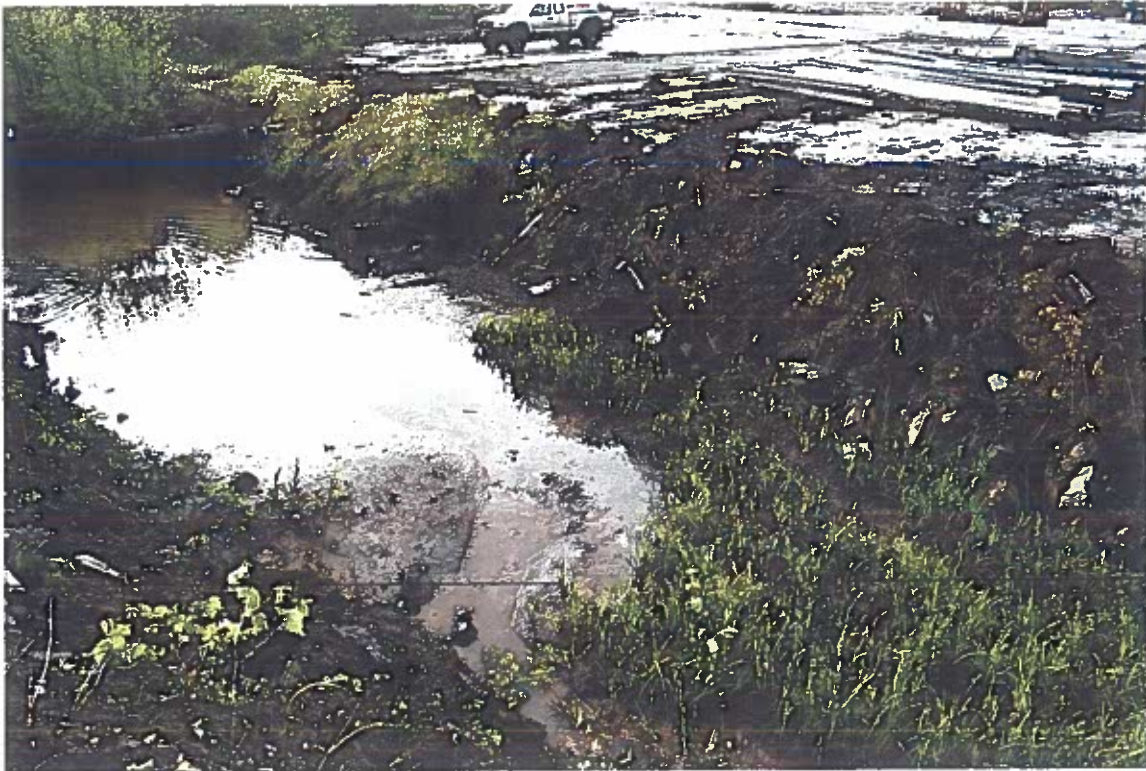
Photo #23: 5/18/12 view looking down on the Wrangell Lumber mill's oil/water separator pond sediment deposits, about to be excavated to a 1'-2' depth. See photo below.
