7/12 AMENDMENTS TO THE CLEANUP PLAN -
WRANGELL LUMBER MILL SITE

6.5-Mile Zimovia Highway
Wrangell, Alaska

Prepared by
Southeast Management Services
1061 Mendenhall Peninsula Road, Juneau, Alaska 99801

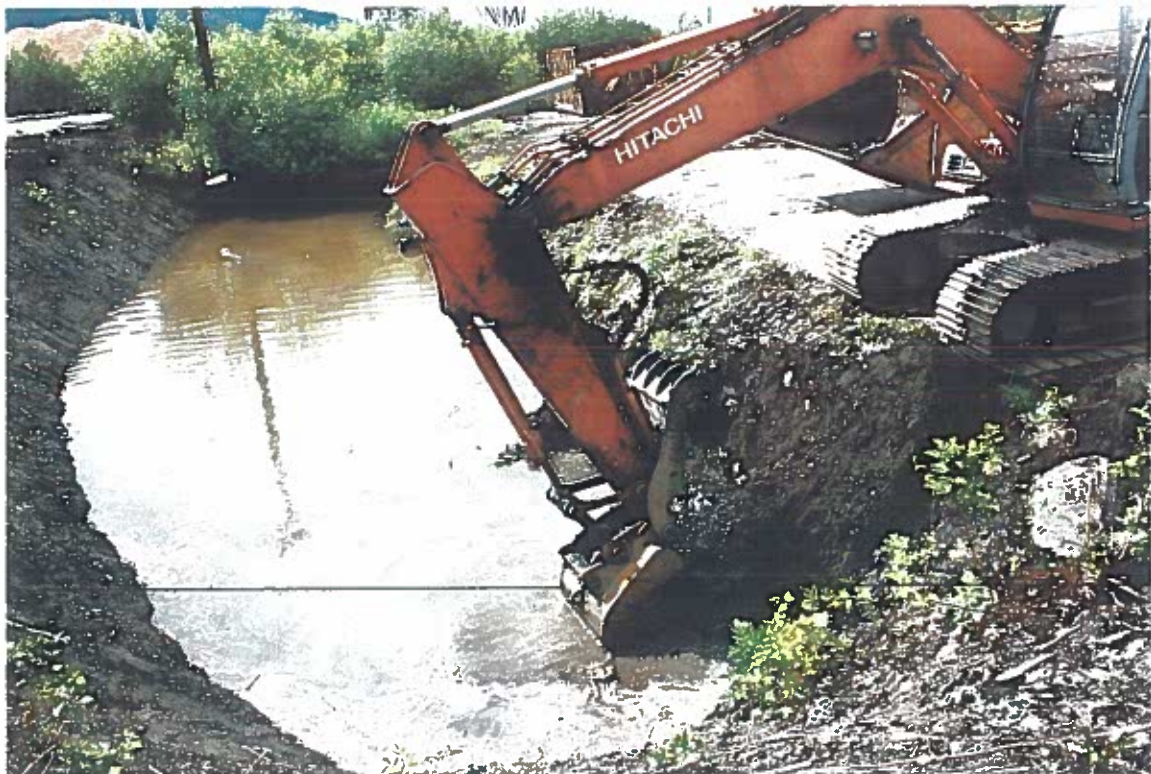
Photo #24: 5/18/12 continuing excavation of the oily deposits along the Wrangell Lumber mill's oil/water separator's north-side waterline, after the sediment deposits shown in the previous photo had been removed.

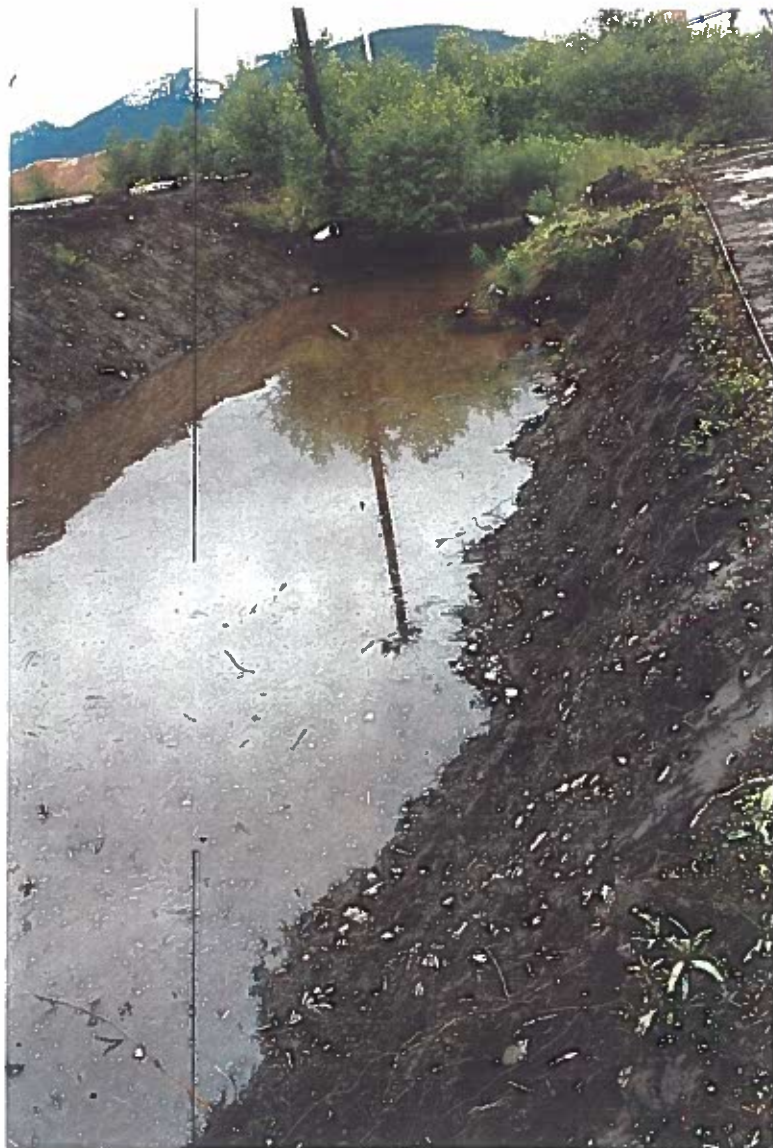
Photo #25: 6/30/12 sampling along the north side of the Wrangell Lumber mill site's oil/water separator pond, after excavations to remove additional oil contaminated soil along the waterline because 5/18/12 sampling exceeded cleanup criteria.

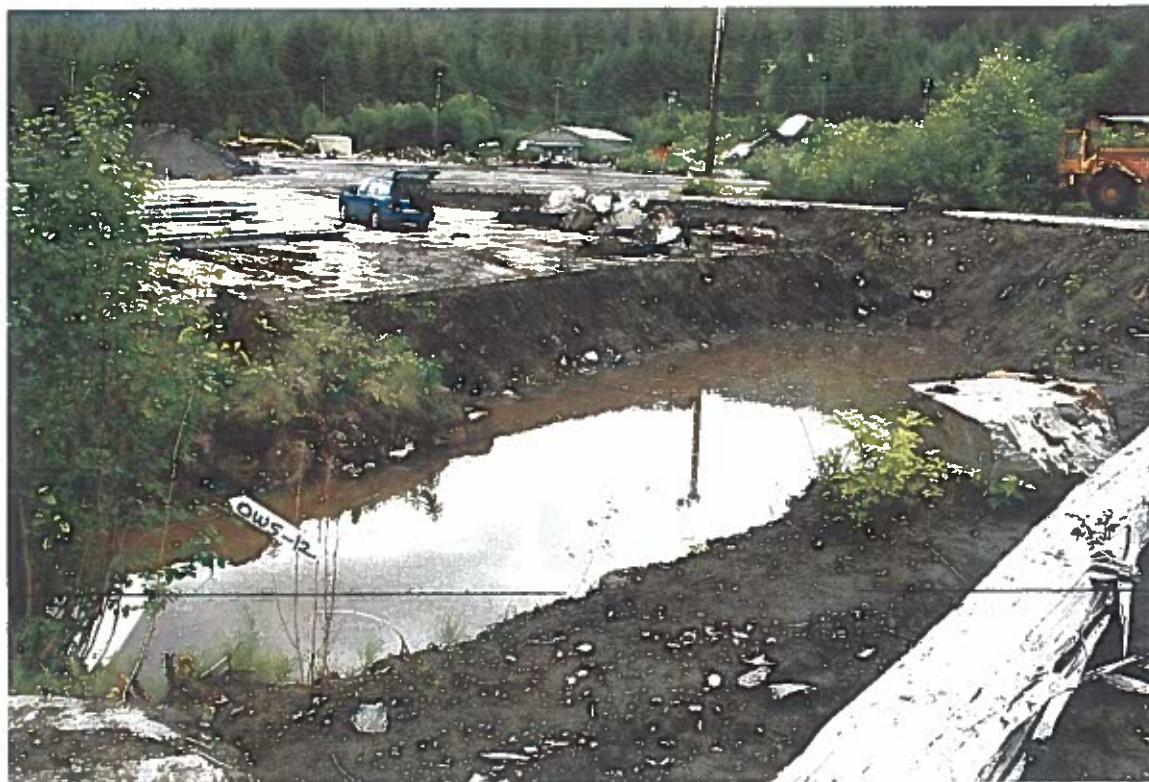
Photo #26: 6/30/12 view looking northeast across the Wrangell Lumber mill site's oil/water separator pond, showing one of the 5 sampling sites along the shoreline of the north side's completed re-excitation.

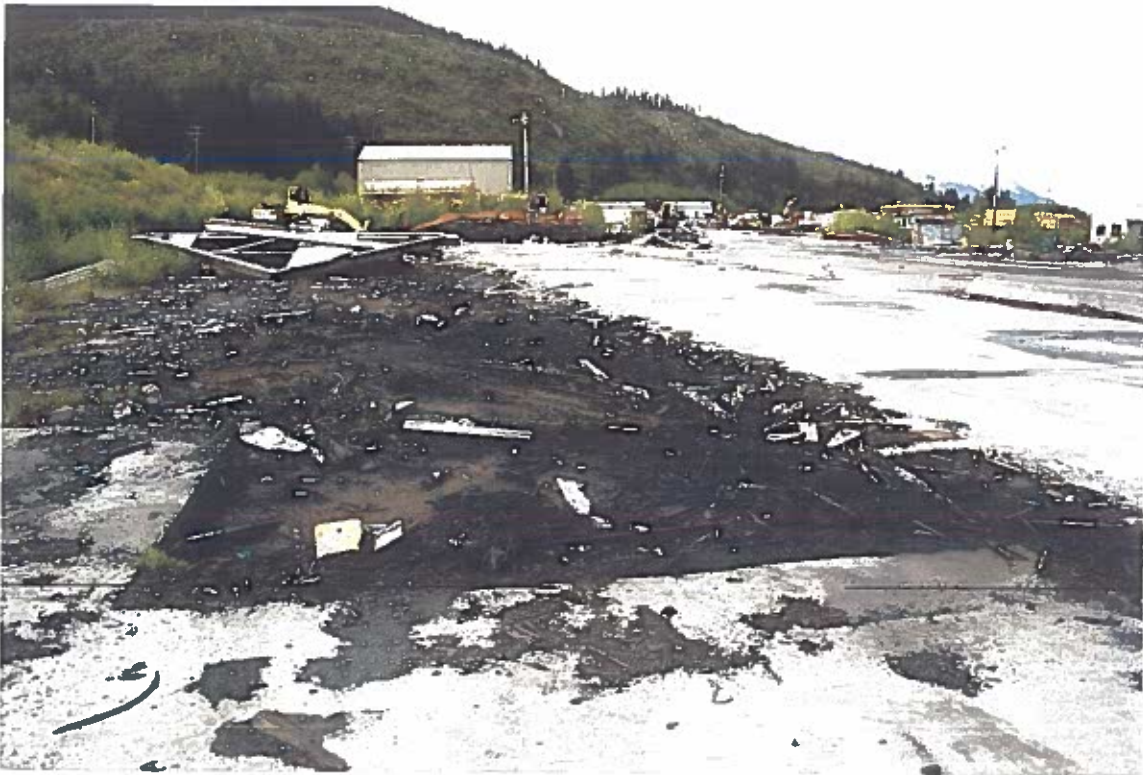
7. Green Chain Line (Cleanup Area #11). [Figure 4](#) (page A5) shows the green chain line area of the former Wrangell Lumber sawmill, where sawn lumber product exited the mill and was sorted/banded for export. Photo #27 (page B15) shows the area when it was inspected on 5/19/12 and found to have dark stained surface soil. Several shallow hand excavations confirmed the presence of oily contaminated soil, and two soil samples taken from a 2'-deep exploratory excavation on 6/5/12 (Photo #28) had high DRO levels of 5,500-11,000 mg/kg and RRO levels of 15,000-25,000 mg/kg.

Photo #27: 5/19/12 view looking south across the Wrangell Lumber mill's former green chain area, where dark-stained soils were found extending along the edge of the concrete foundation. Oil-contaminated soil was found in several shallow hand excavations.

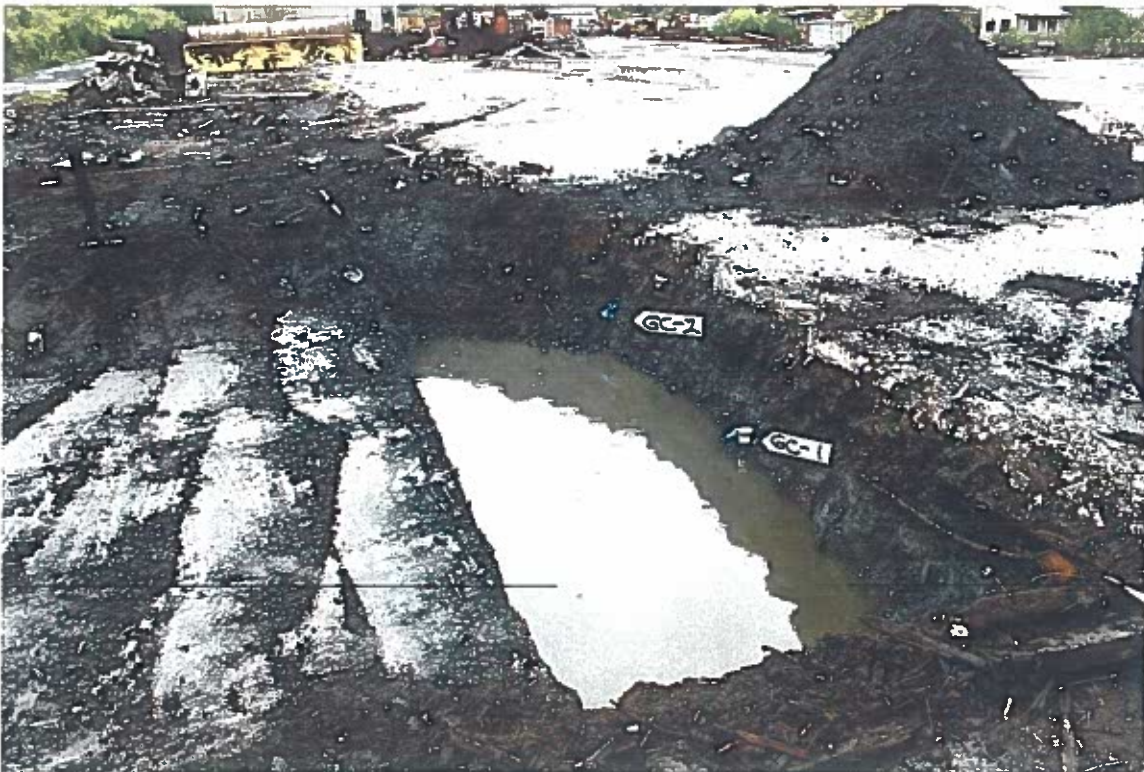
Photo #28: 6/5/12 view looking southwest across the 2'-deep exploratory excavation at the north end of the Wrangell Lumber mill's former green chain area. Sample GC1 had DRO/RRO levels of 5,500 & 15,000 mg/kg, and GC-2's levels were 11,000 & 25,000 mg/kg.

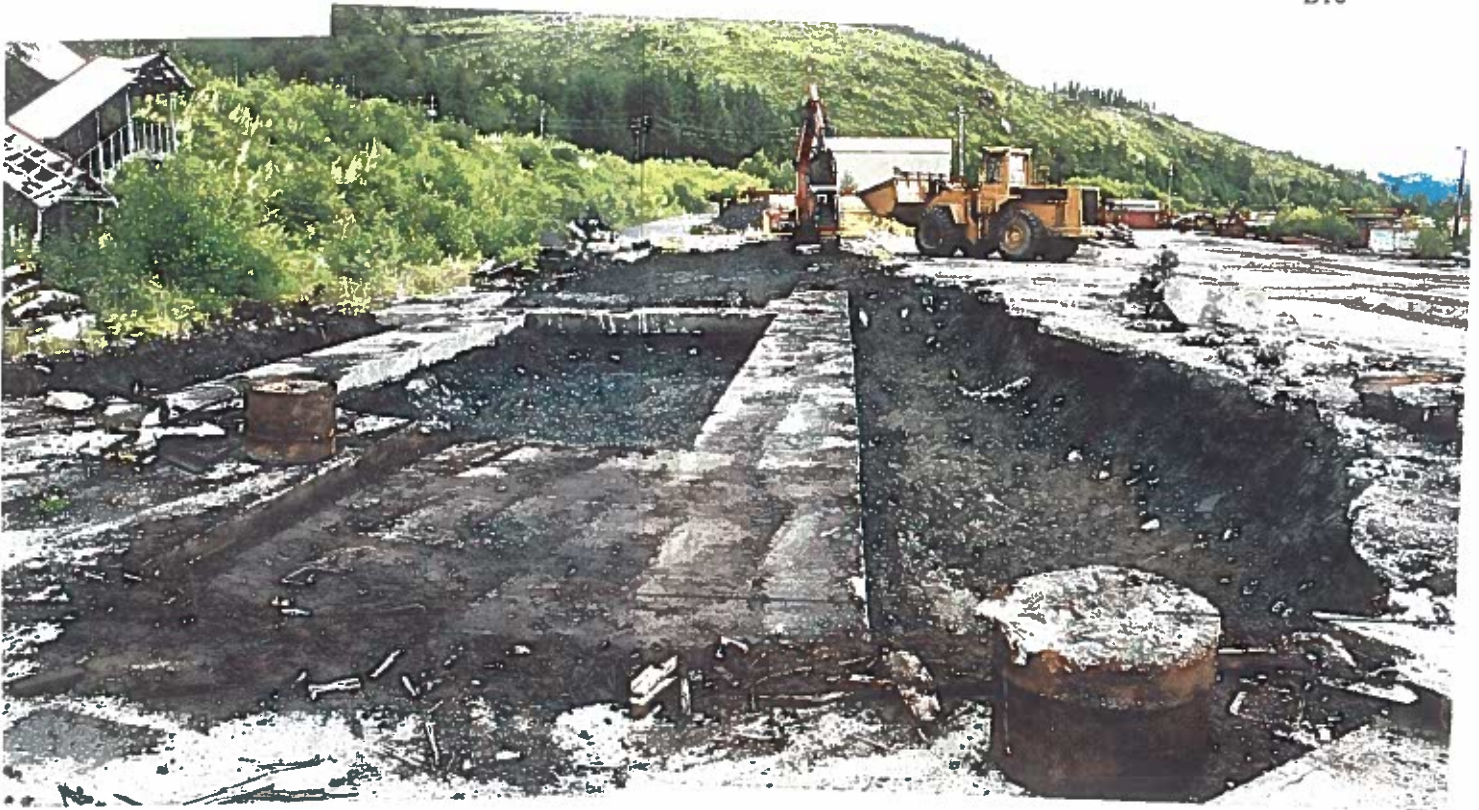
Photo #29: 6/29/12 view looking south across the Wrangell Lumber mill's former green line area, exposing 4'-wide foundations as the 1'-4' deep oil-contaminated soil was removed along much of the former sawmill foundation's east edge.

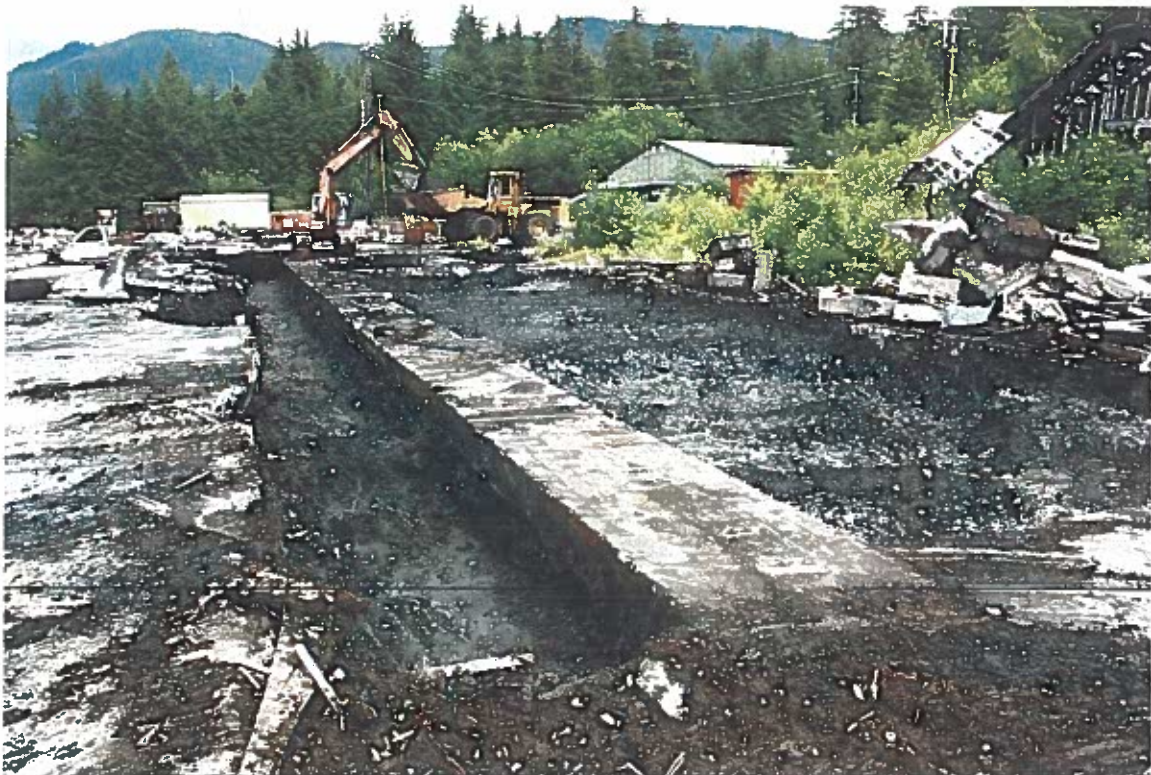
Photo #30: 6/30/12 view looking north across the continuing excavations in the Wrangell Lumber mill's green line area, now 154' long. Excavations along the north end went another 11' before ending later in the day, allowing confirmation sampling to take place on 7/1/12.

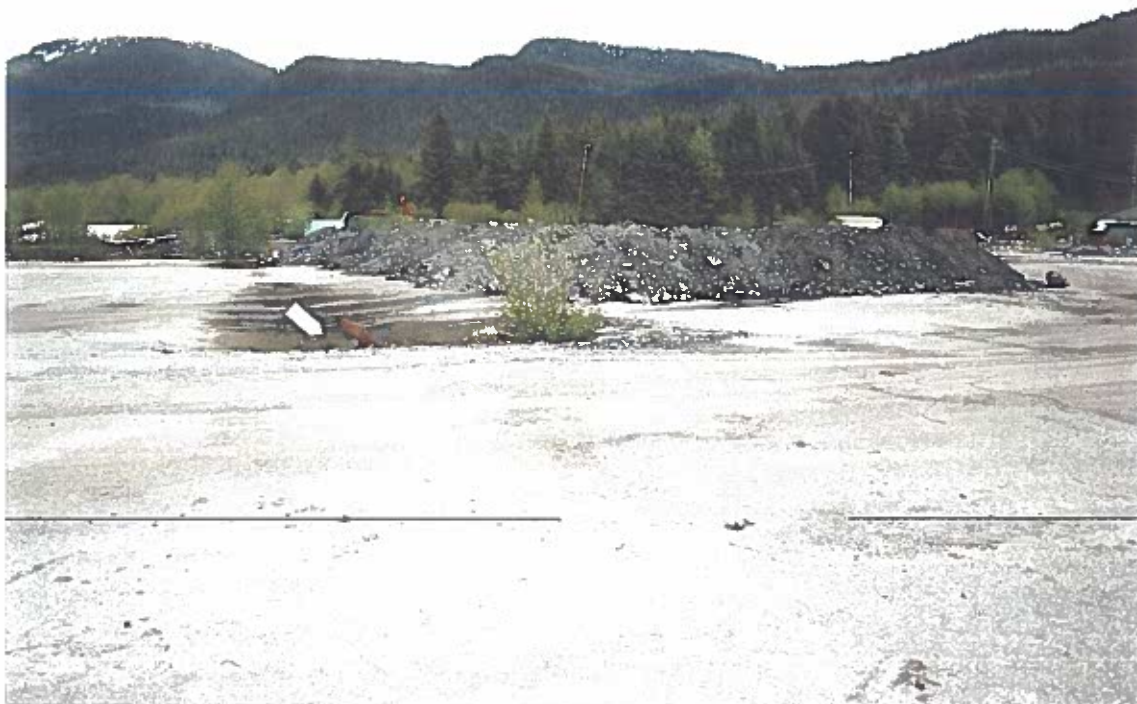
Photo #31: 5/19/12 view of the initial contaminated soil stockpile on the Wrangell Lumber mill's concreted area. Arrow points to a roadway culvert inlet, one of several that drained the area to the oil/water separator pond.

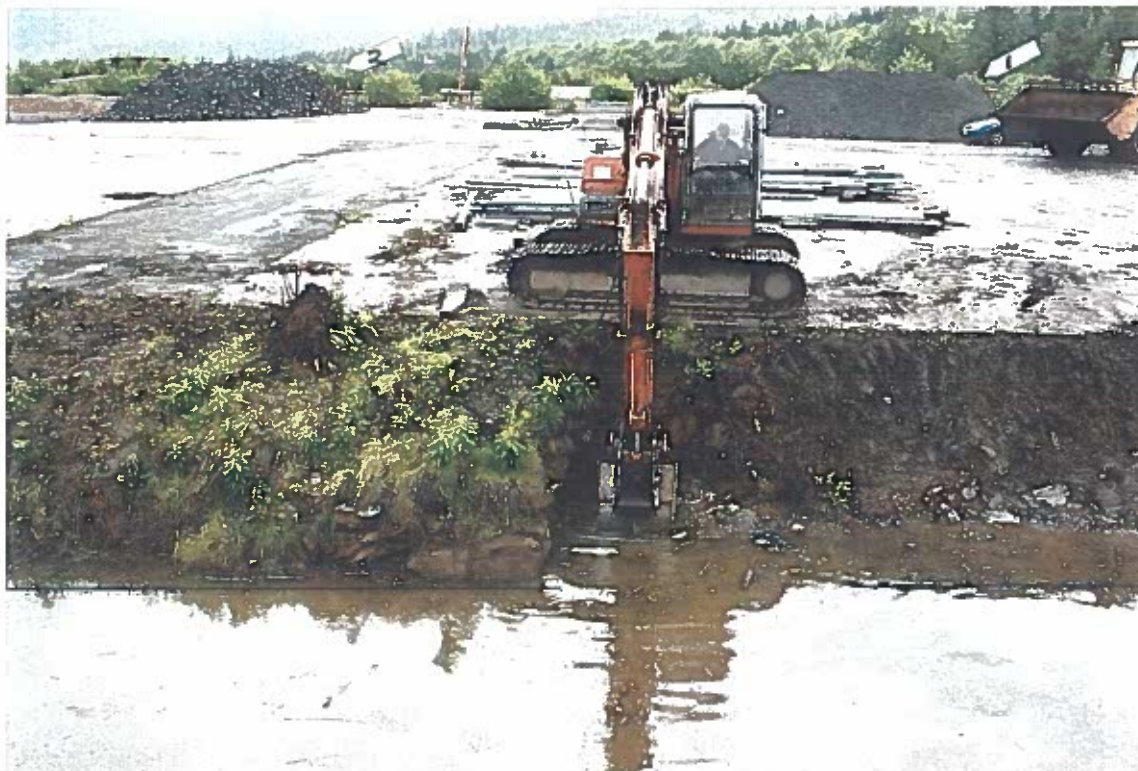
Photo #32: 6/30/12 view looking north from the ongoing cleanup of the oil/water separator pond, showing the 12'-13' high contaminated soil pile of about 2,000- c.y. that had been vibratory-screened to 2" minus (1), and the screened-out oversize rock pile of about 600 c.y. (2).

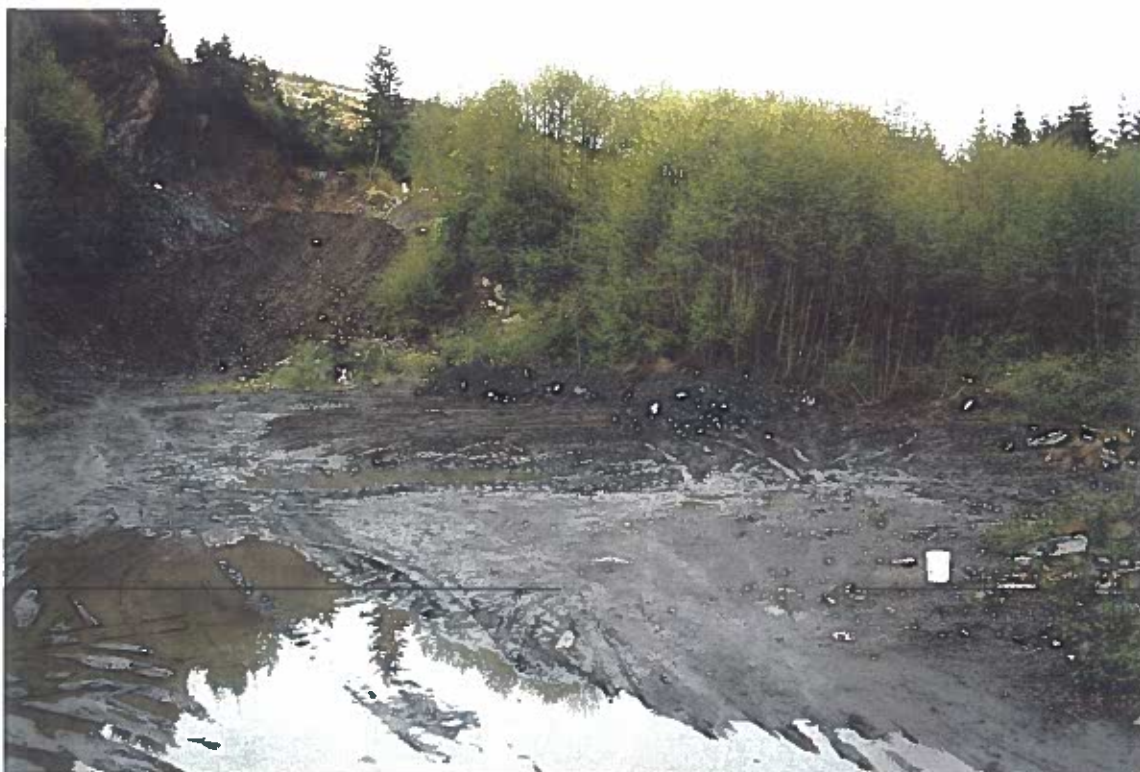
Photo #33: 5/19/12 view of the original contaminated-soil stockpile & bioremediation site in the Wrangell Lumber mill's rock quarry, where 7 truckloads of contaminated soil had been placed before it became apparent that a much larger site would be needed.

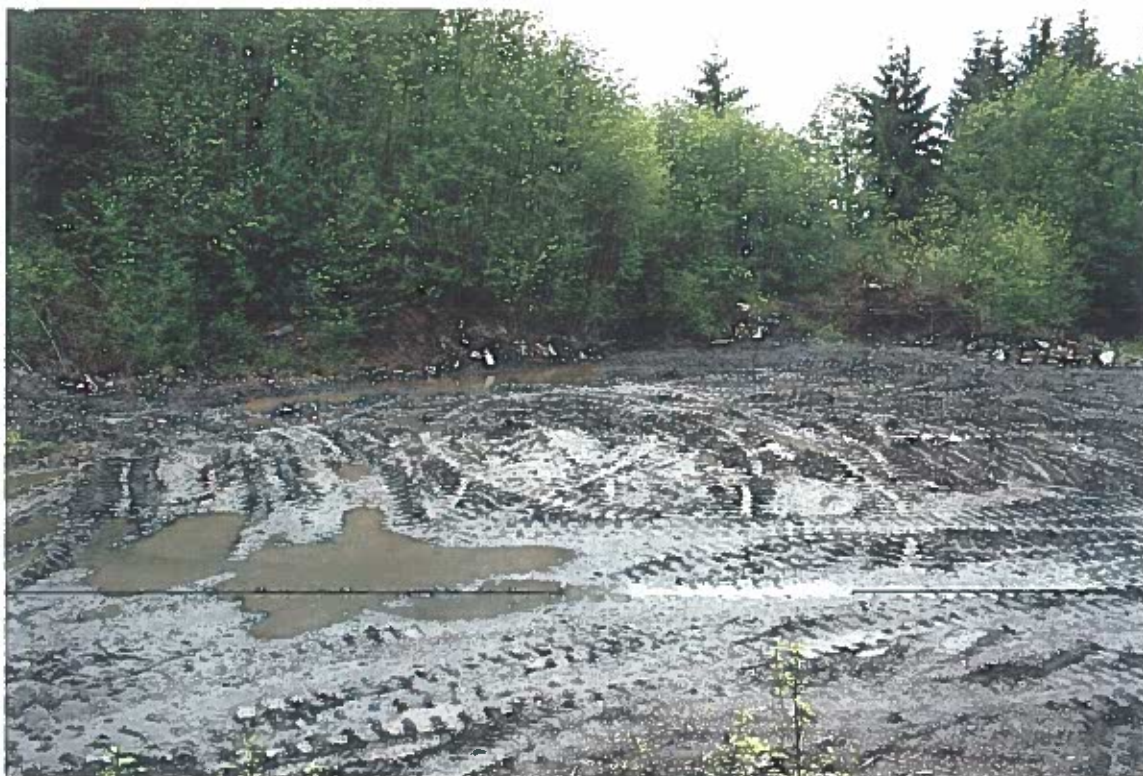
Photo #34: 6/5/12 view looking west across the Wrangell Lumber mill's rock quarry, showing that all of the originally stockpiled contaminated soil had been removed. DRO levels of the two soil samples taken where the 7 loads of soil had been placed were 110-280 mg/kg, and RRO levels were 910-1,400 mg/kg.
