Former Golovin Dumpsite

Environmental Audit and Inventory

Golovin, Alaska

By:
OASIS Environmental, Inc
January 28, 2008

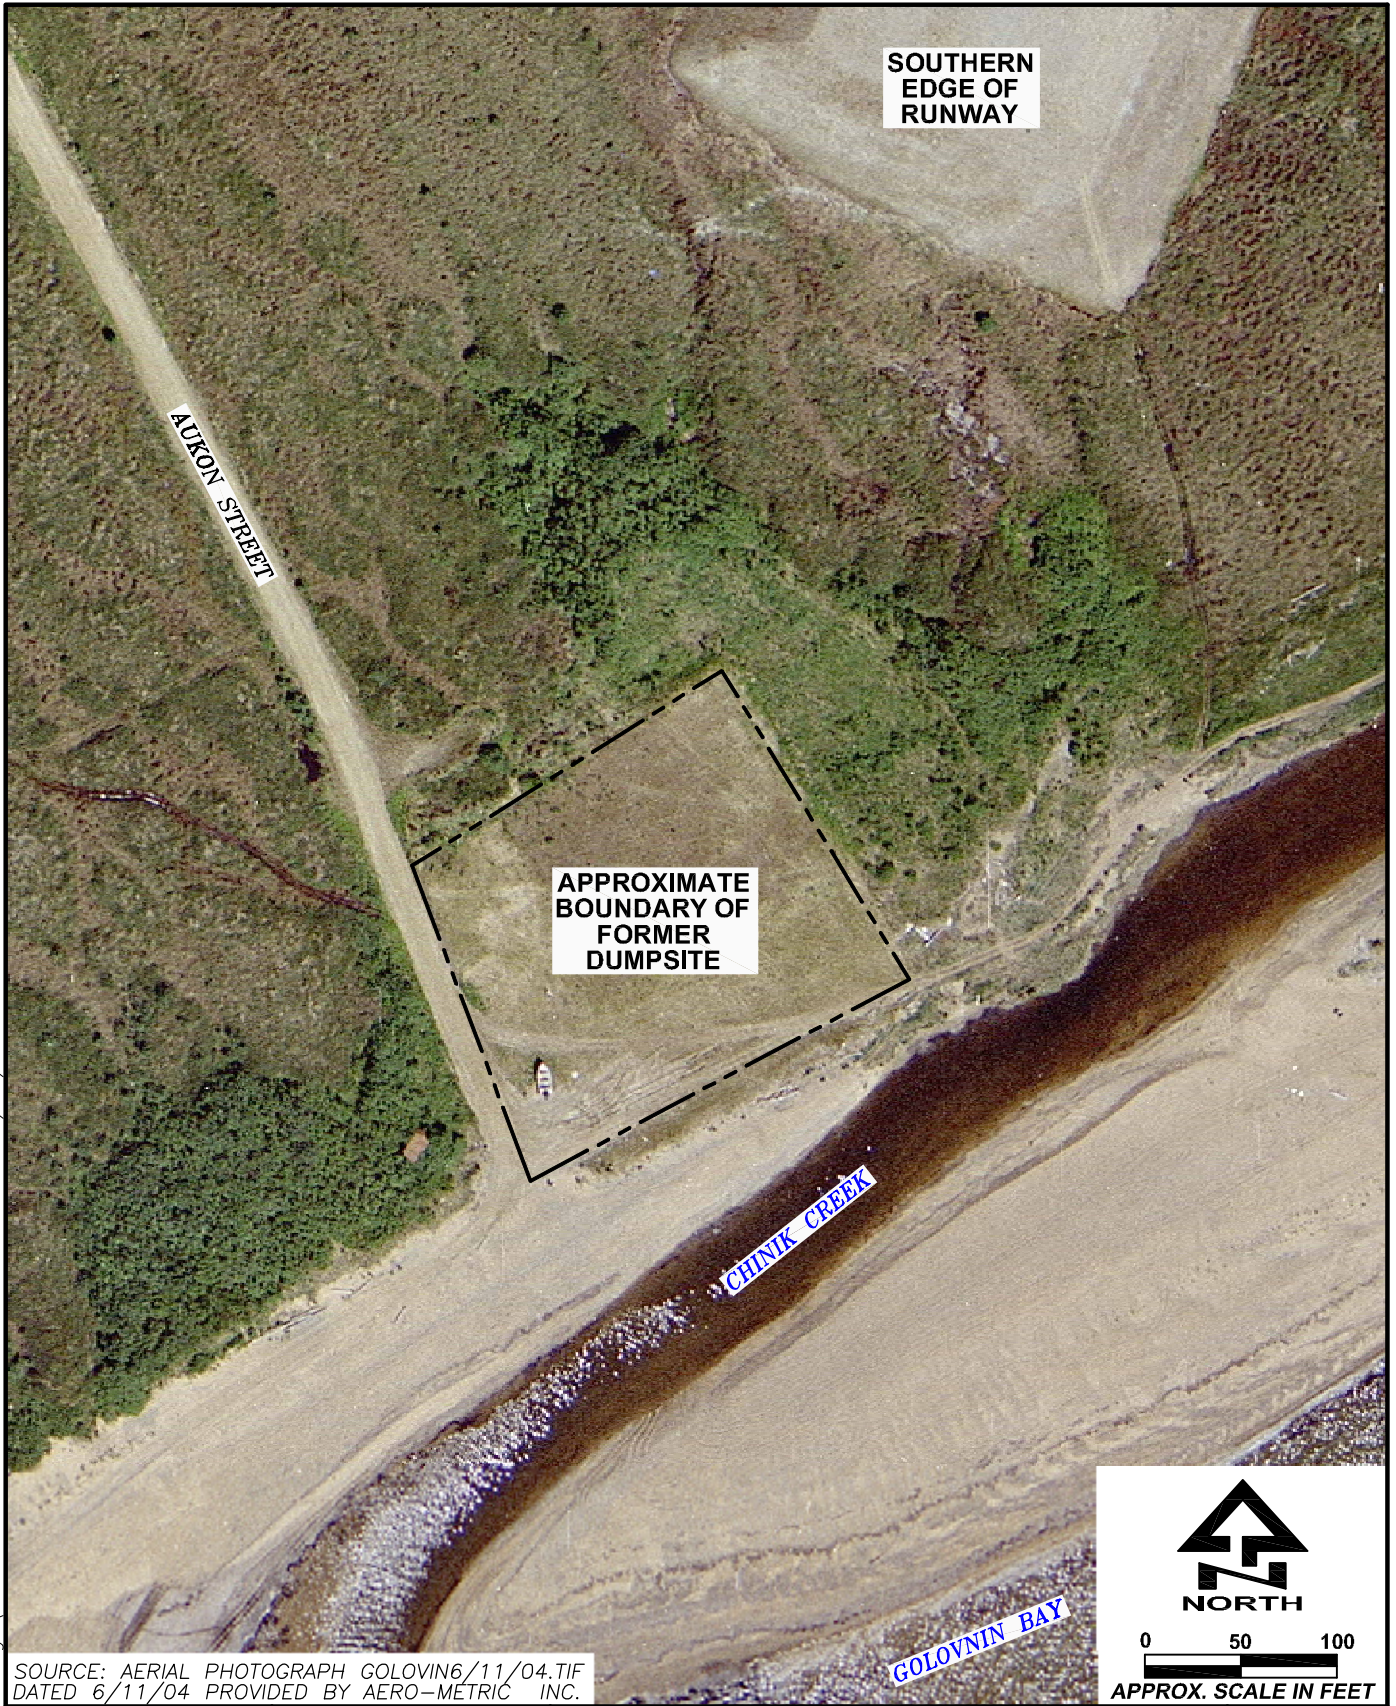
In the 2004 photo, the site appears very similar to its appearance during OASIS’ site visit, but with slightly less vegetation. The gravel pad is easily distinguishable and is approximately 1.0 acre in area. However, as noted in Section 2.2, the area encompassed by the buried dumpsite may be larger, as the southeastern edge of the gravel pad has likely eroded over time.

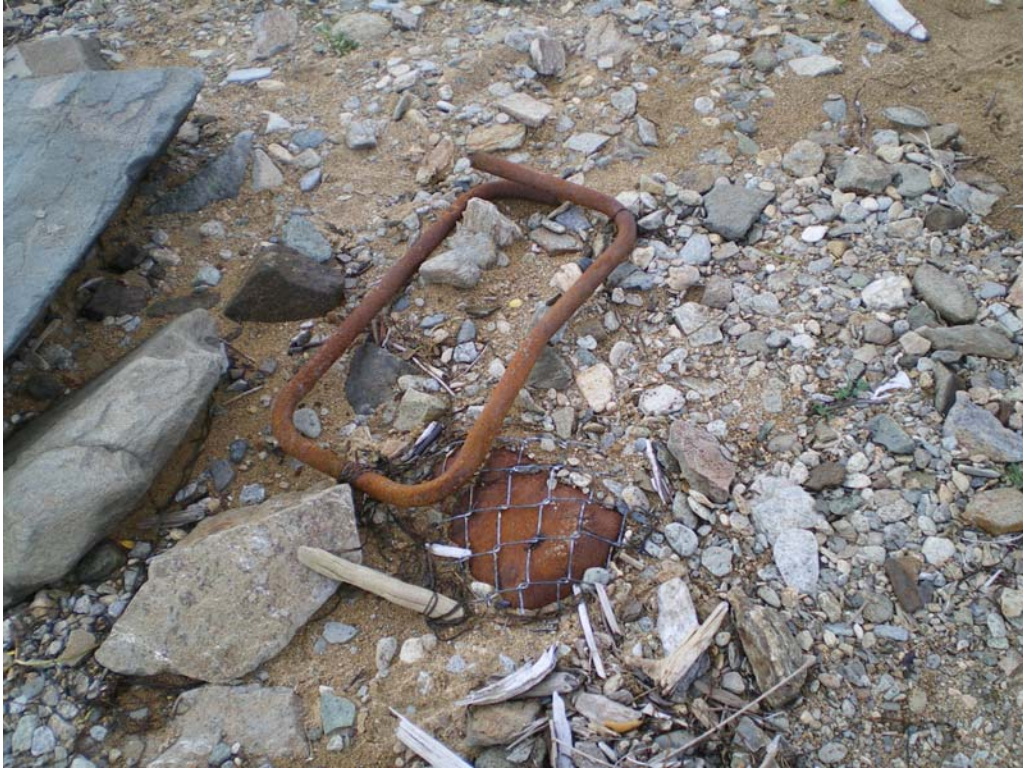
Figure A3. Metal debris exposed on surface of former dump site.

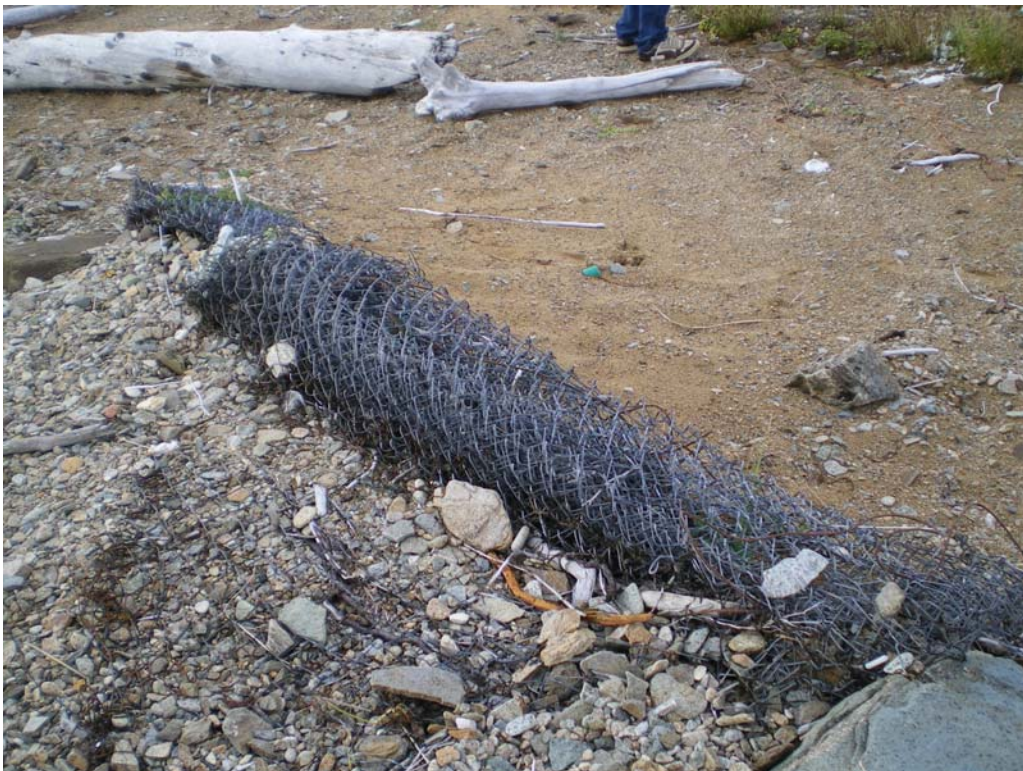
Figure A4. Rolled-up fencing that was erected around former dump site.

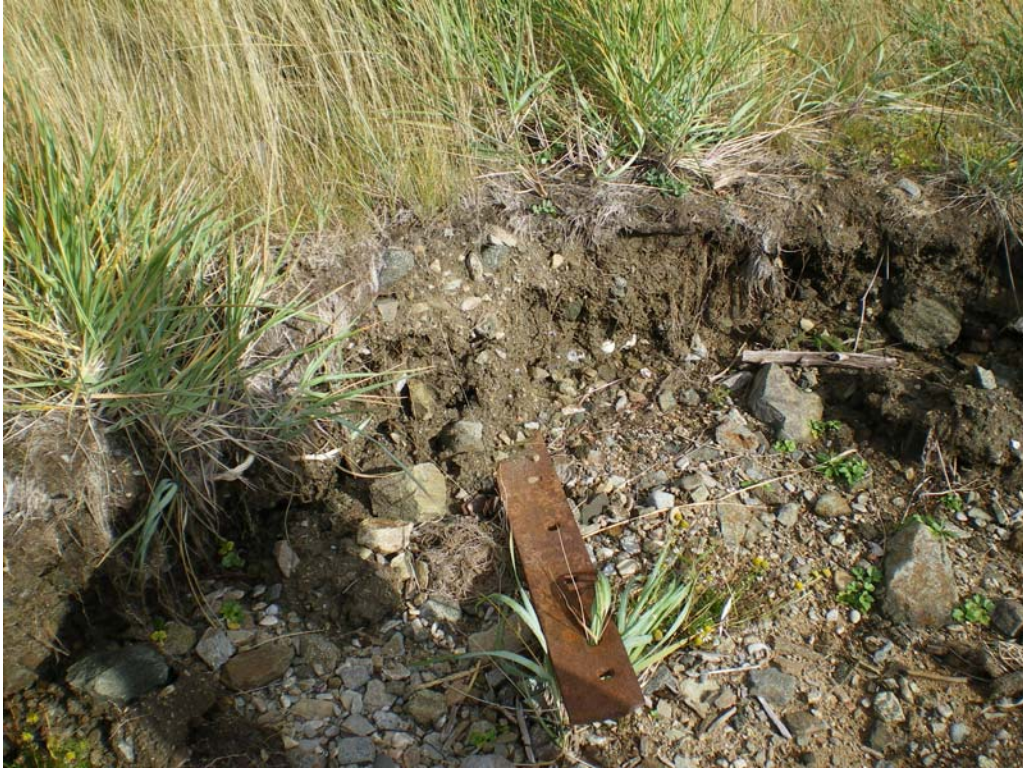
Figure A5. Metal protruding from southern edge of site.

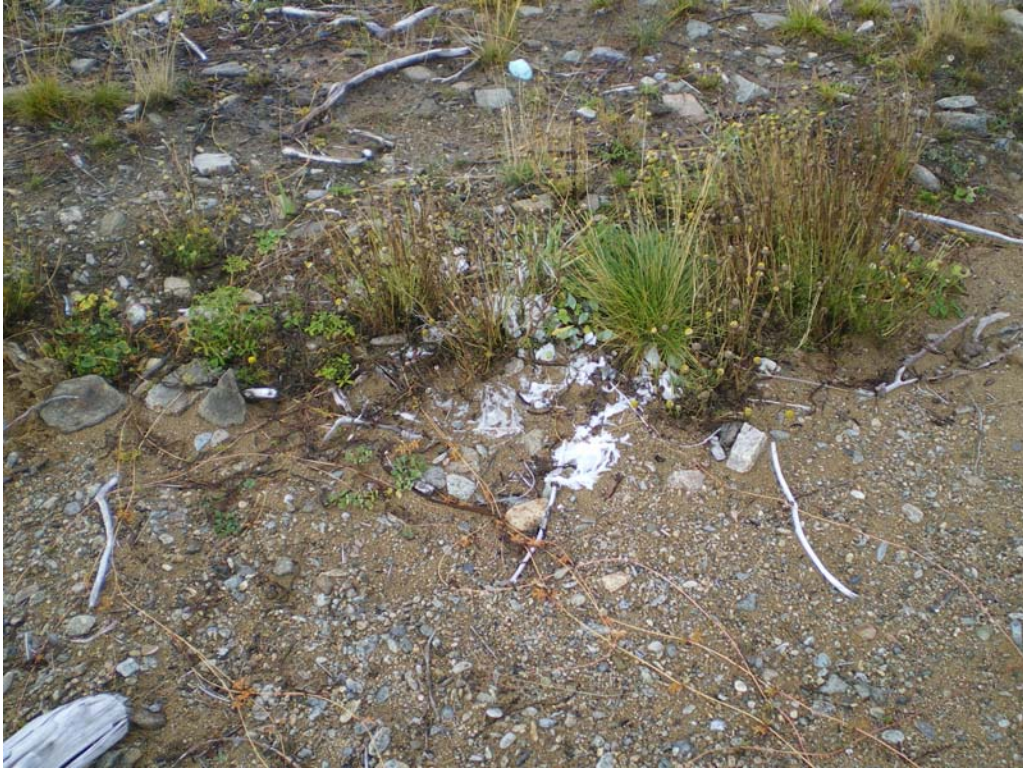
Photographs of the site are provided in Appendix A. The surface of the site is strewn with partially-exposed municipal and industrial waste and debris. Items observed included plastics, metal debris, and pieces of the fence that formerly surrounded the dumpsite (Figures A3 and A4). Metal debris was also observed protruding from the southern edge of the site (Figure A5). However, the majority of the site remains well-covered (Figures A1 and A6). Most of the observed waste was only slightly exposed (Figure A7). Tall grasses are growing over about half of the site.

Figure A7. Plastic exposed at surface of former dumpsite.

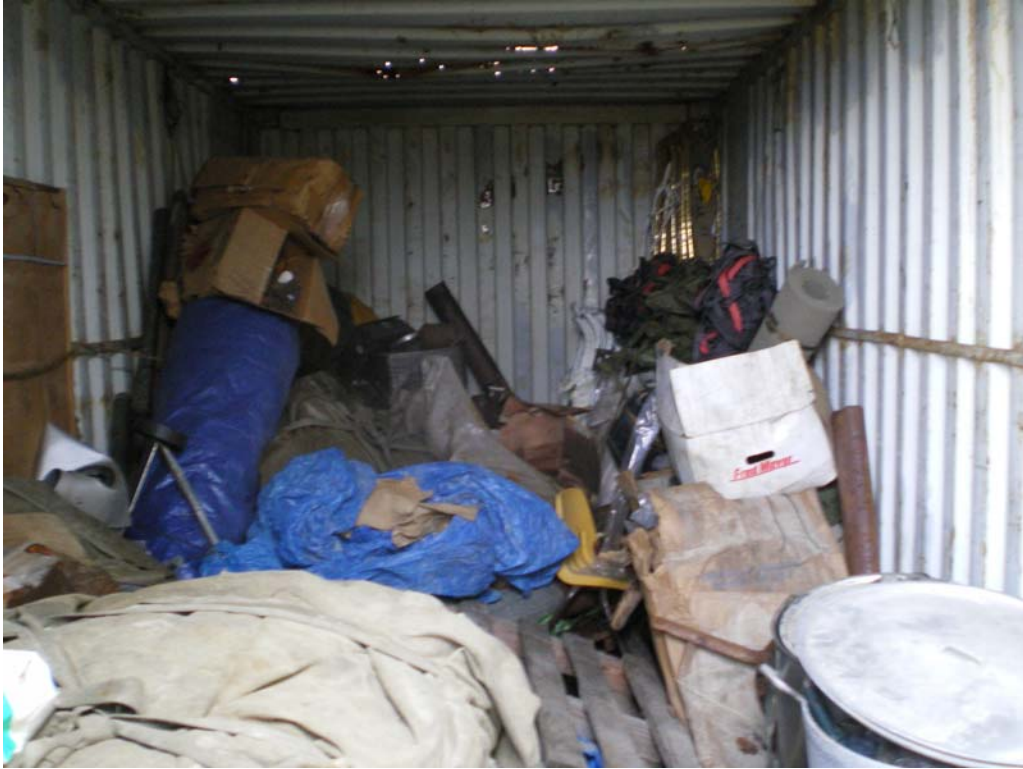
Figure A9. Inside of connex shown in Figure 2. Connex is used to store various debris and waste.

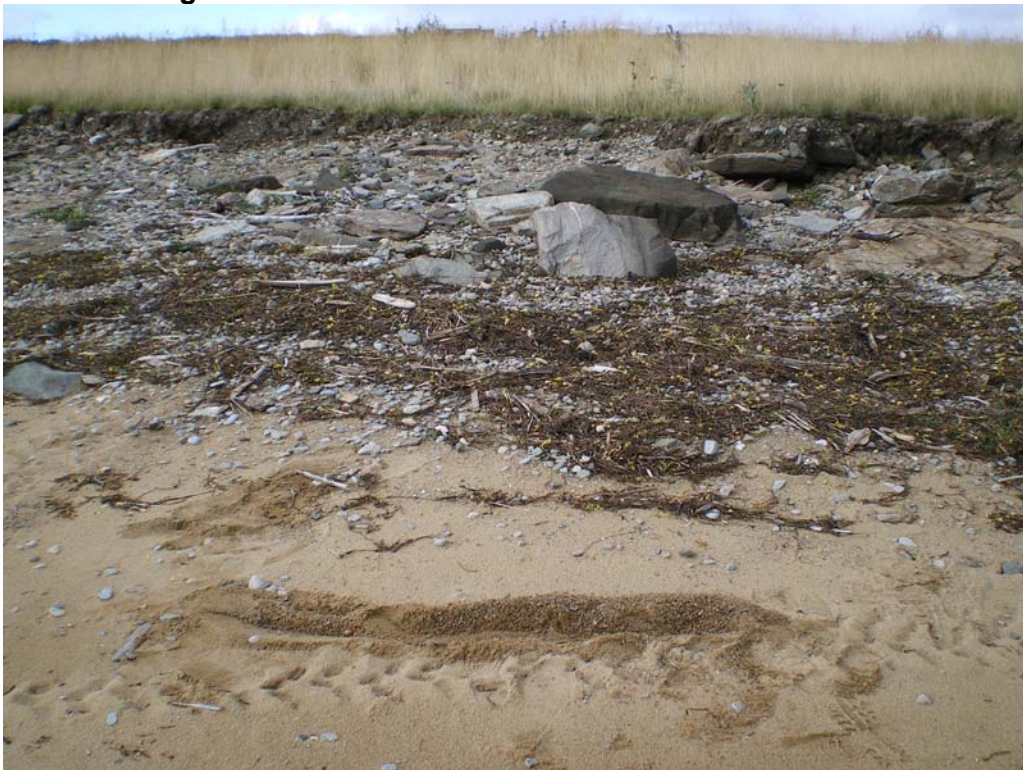
Figure A13. Looking north at site from Chinik Creek shore. Line in sand is Jack Fagerstrom's estimate of former dumpsite extent (prior to erosion).

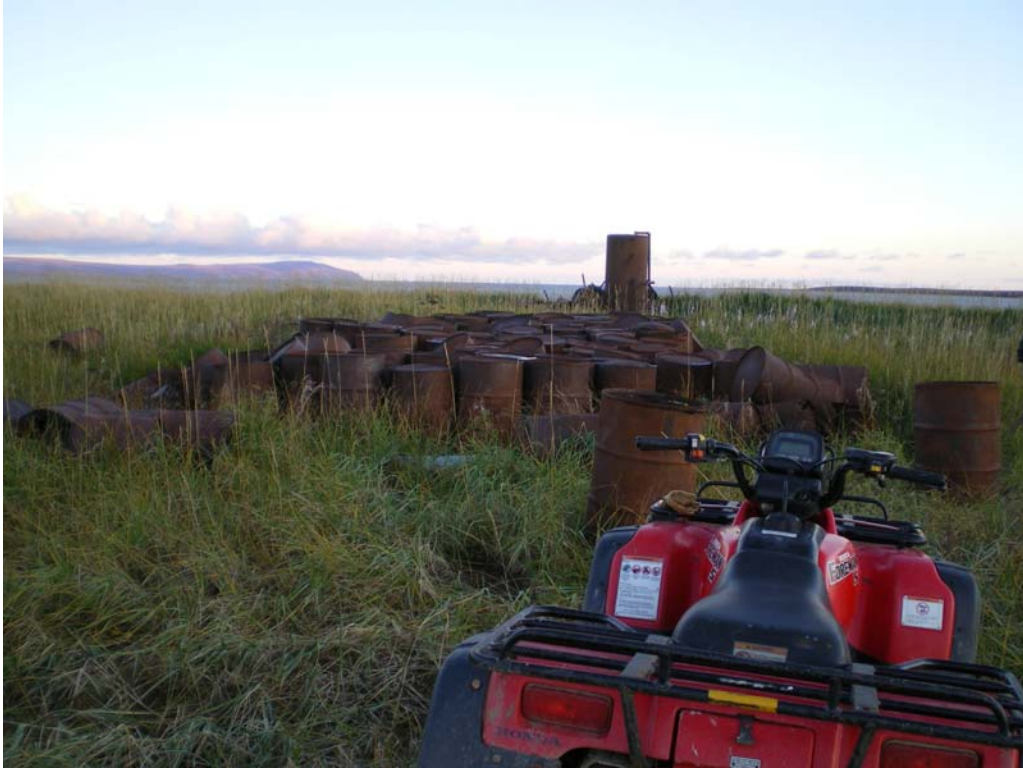
- *Drum cache* (Figures C1-C3): This area is also near the shore at the southwestern end of the village. At least fifty drums are stored here, all of which are heavily rusted. Some may be leaking. Many of the drums are at least partially filled with unknown contents; tar, water, or mixtures of the two are some possible contents.

Figure C1. Drum cache.

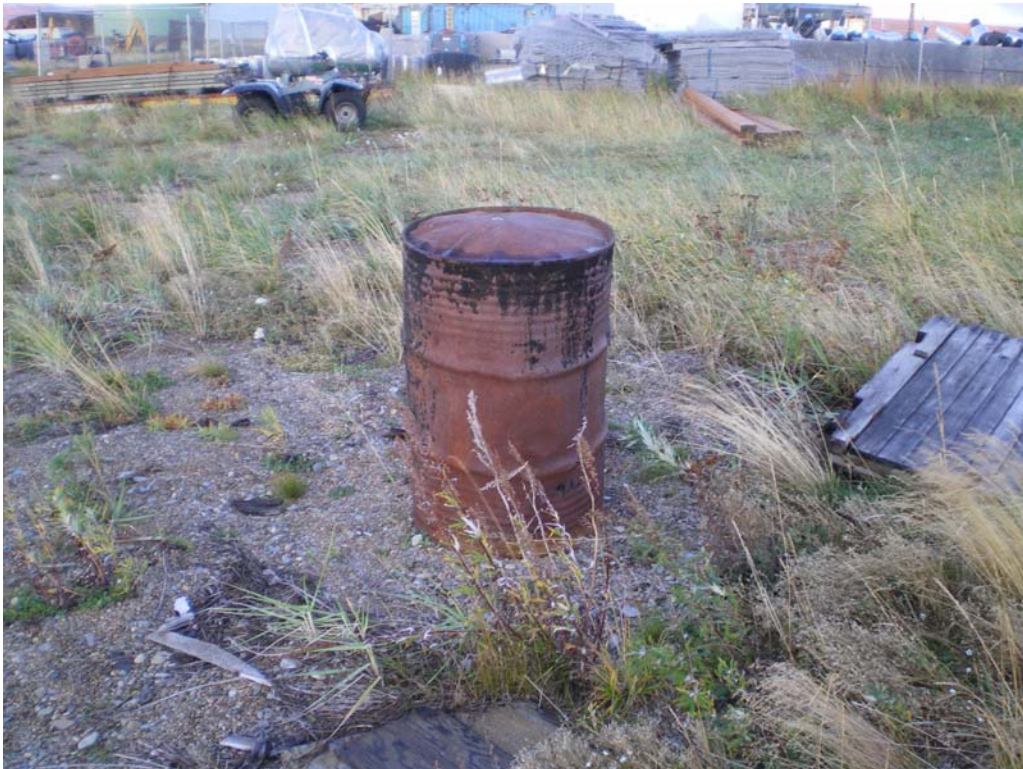
Figure C2. One of drums in drum cache. Note tar stains on exterior.

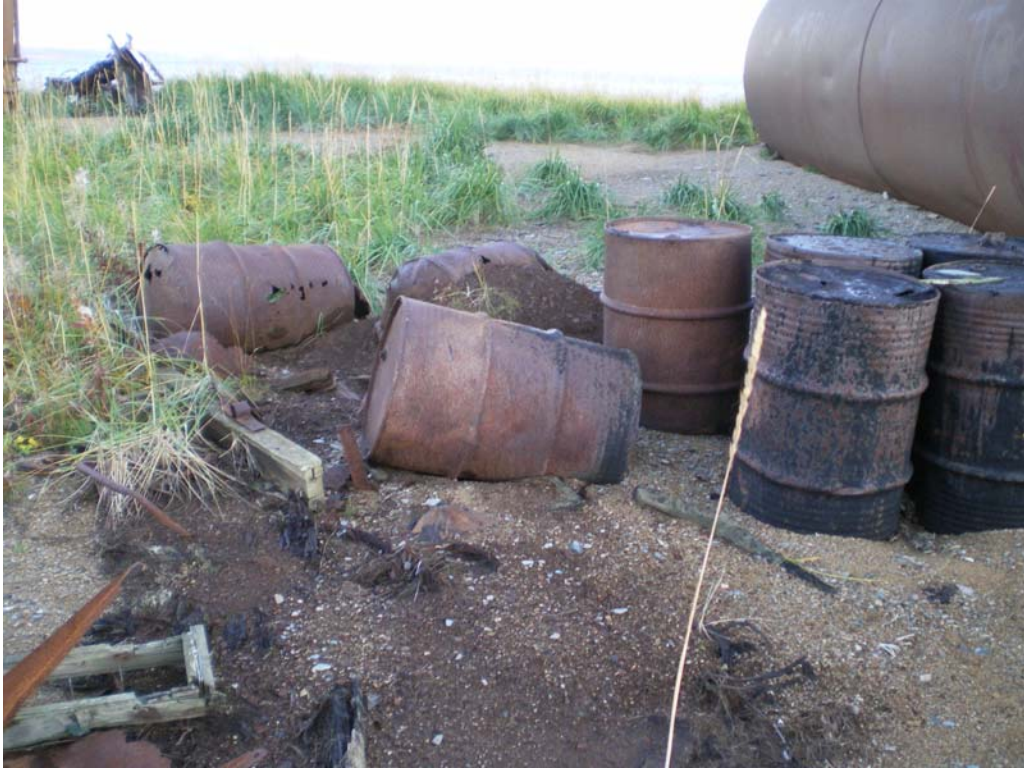
Figure C3. More drums in cache. Note punctures in some and fuel tank in background.

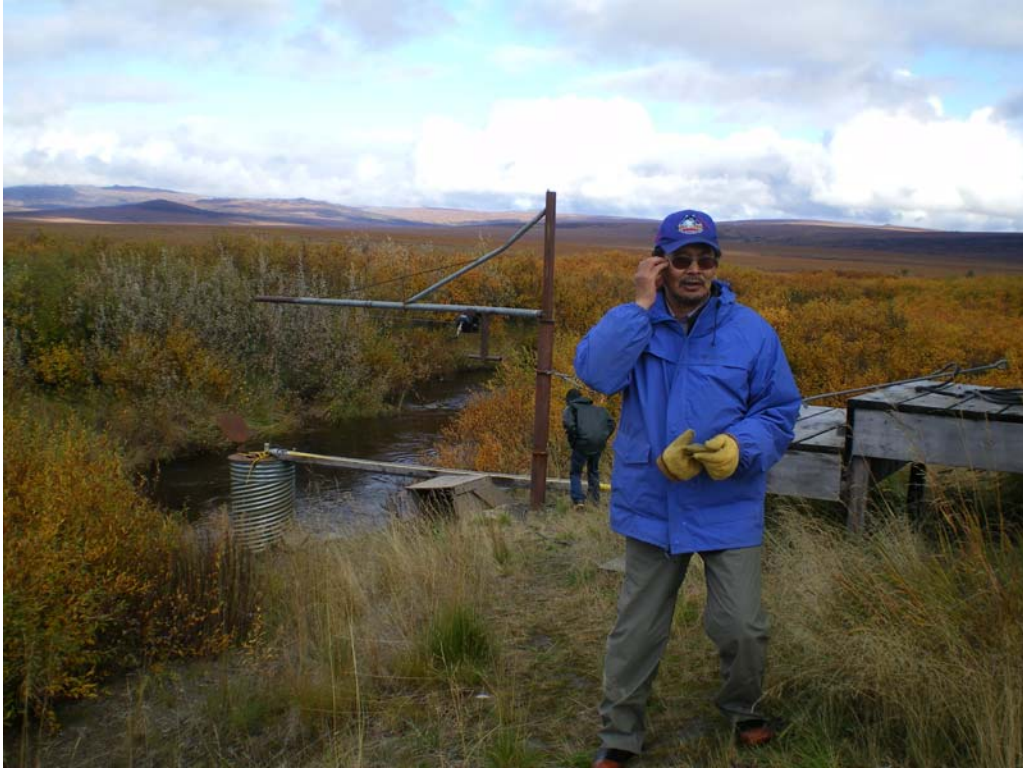
- *Drinking water supply intake*: The community's drinking water supply intake is located in Chinik Creek about 7,000 feet north of the former dumpsite (Figure C4). The community is concerned by high levels of salinity and lead recently found in drinking water samples. The source of the salinity and lead is unknown. During the site visit, Ms. Benson suggested that the high lead results are likely due to corrosion of the lead solder in the water-supply pipes rather than surface-water contamination.

Figure C4. Looking northeast at drinking water intake. Toby Anungazuk in foreground.

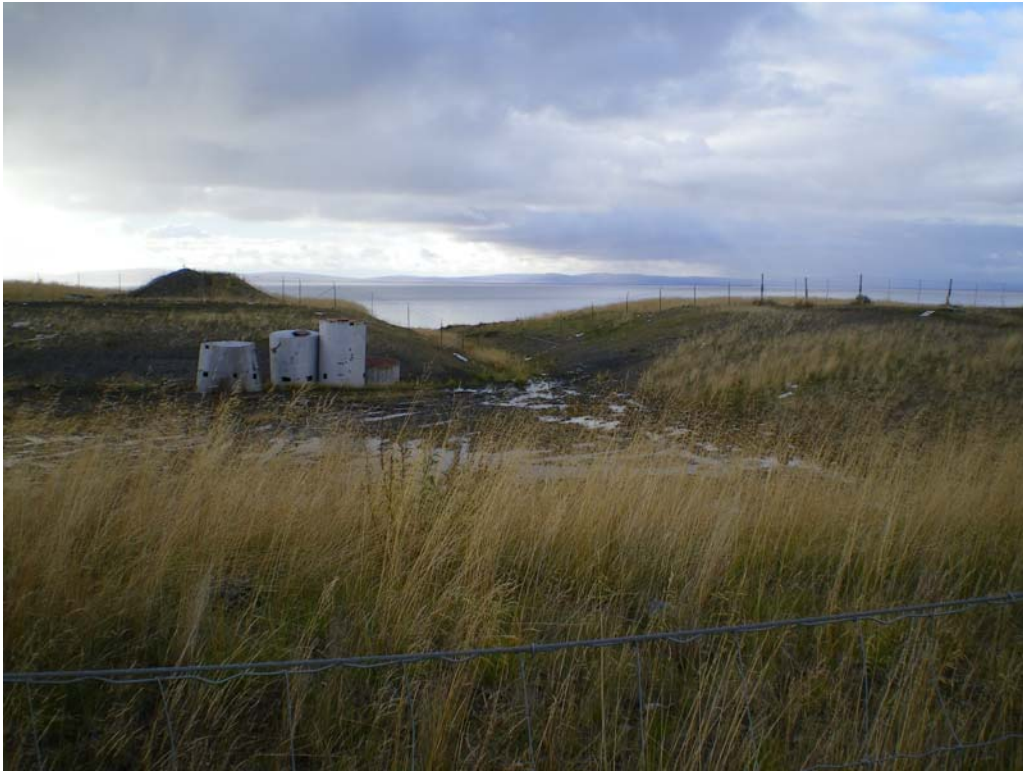
- *Current landfill*: The current city landfill appears to be in good condition (Figure C5). However, concern was expressed over the drainage outlet from the landfill (Figure C6). The drain channels runoff through the tundra and eventually to Golovnin

Figure C6. Looking west at drainage outlet of landfill.
