Re: 2822 Marsha Avenue, Spill #14119919601

2822 MARSHA
PLAN VIEW

FIGURE
1

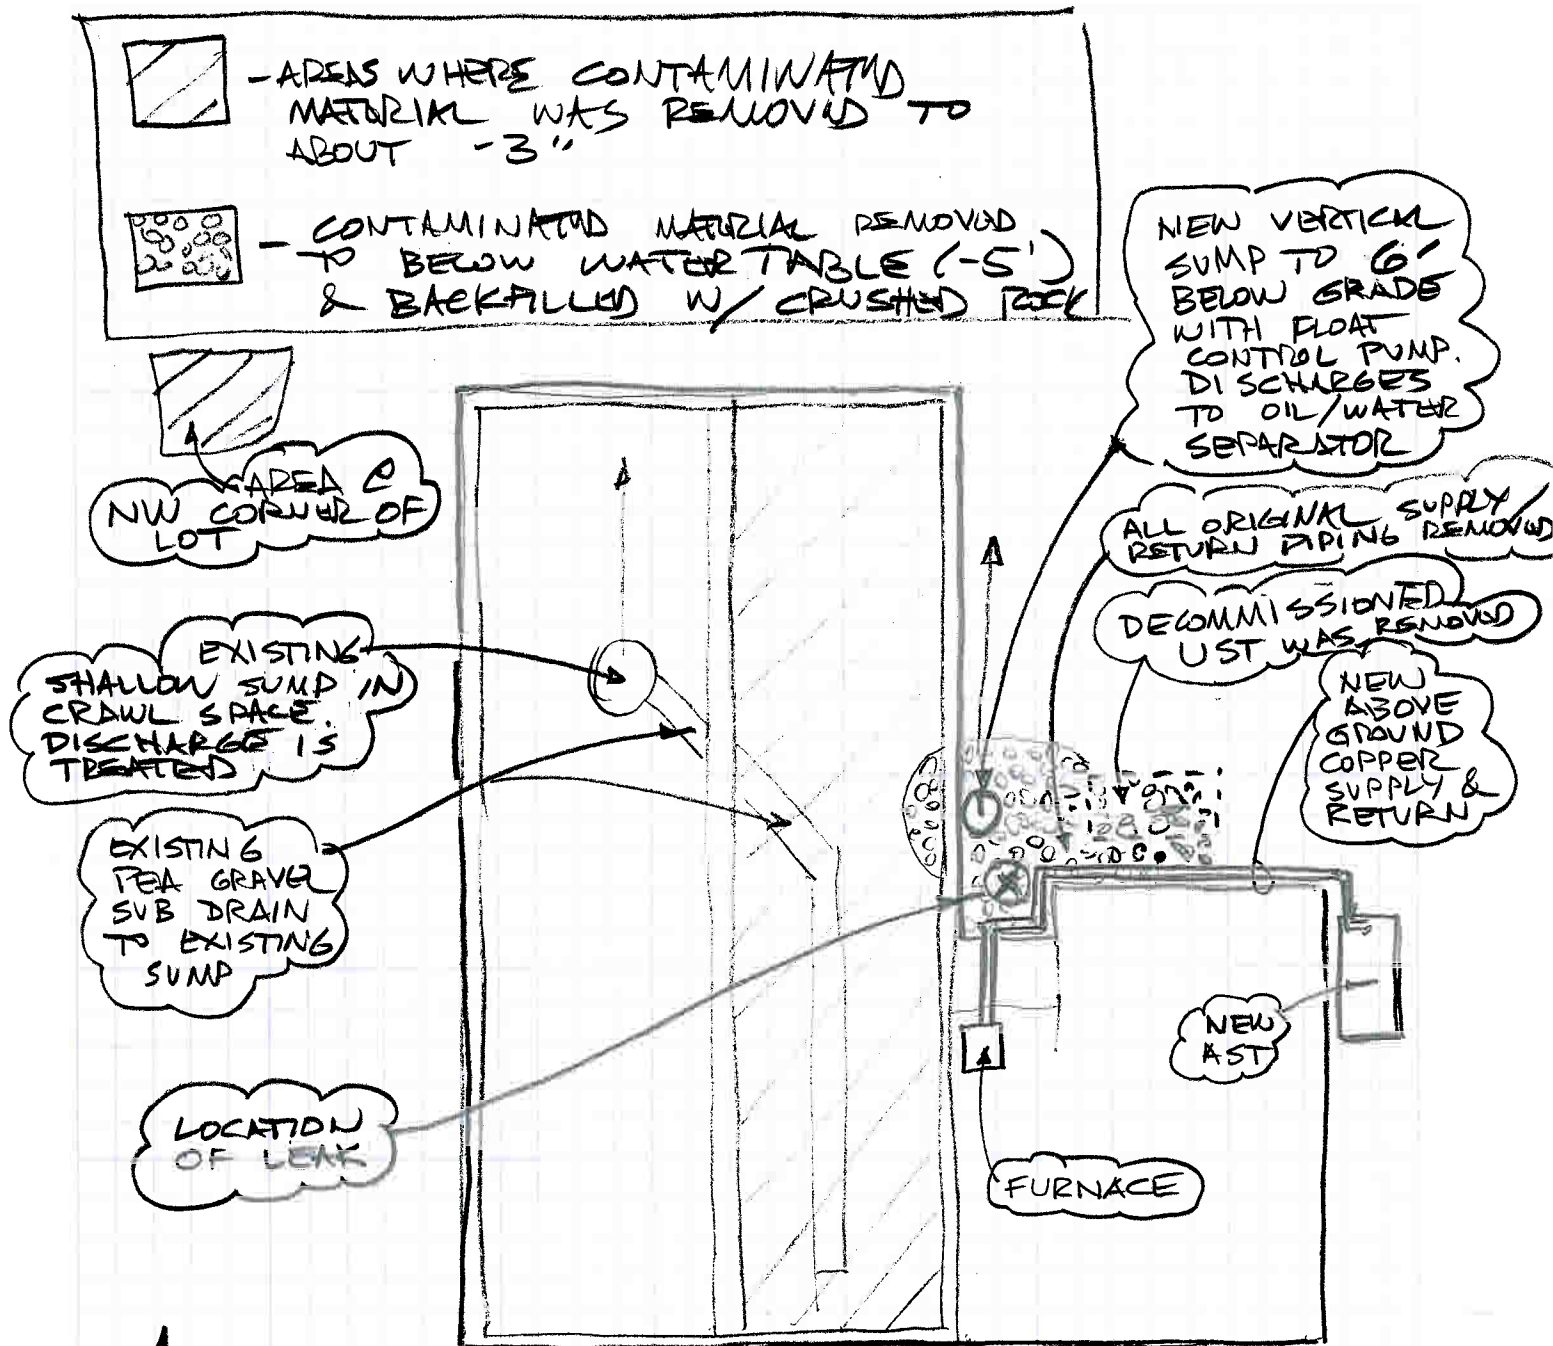
In May 2013, as a pre-condition to for the DeWees's to buy the house, the existing UST was decommissioned and a new AST was installed to replace it. The new supply/return piping for the new AST was connected to the existing underground supply/return piping that had served the UST. Subsequent to that work, there was a failure either in the existing old piping or at the fittings where it connected to the new piping, and a spill of 250 gallons, plus or minus, resulted. It wasn't until the end of 2013 that a rising water table brought fuel into the crawl space and forced the DeWees family to move out because of fuel odors inside the house.

NOTE: ORIGINAL SPILL OCCURRED AFTER NEW AST WAS INSTALLED. A LEAK OCCURRED WHERE NEW SUPPLY/RETURN PIPES CONNECTED TO ORIGINAL SUPPLY/RETURN PIPES.

Also on Tuesday, Andrea decided to have Cheeseman remove and dispose of the old UST. As a result, the excavated area was expanded and deepened to about 5.5' below grade (about 1.5' below water table). The resulting overall excavation was then backfilled with approximately 10 yards of 2" crushed rock. As part of the backfill effort, a 12" vertical sump was installed complete with a float-controlled sump pump that discharges through an oily water separator and then through the ADEC filtration barrel before ultimate discharge to the CBJ storm drain system. The sump pump in the crawl space also discharges through the ADEC filtration barrel. A small amount of contaminated soil was also removed from the NW corner of the parcel where the crawl space sump pump had discharged before the ADEC filtration barrel was installed.

Figure 1, attached herewith, illustrates what has been accomplished.
