**Department of Environmental
Conservation**

DIVISION OF SPILL PREVENTION AND RESPONSE
Contaminated Sites Program

Re: Decision Document: Crowley Tank Farm Iliamna Airport
Cleanup Complete Determination

Crowley Tank Farm Iliamna Airport
Lot 2A, Block 1200 Iliamna Airport
Iliamna, AK 99606

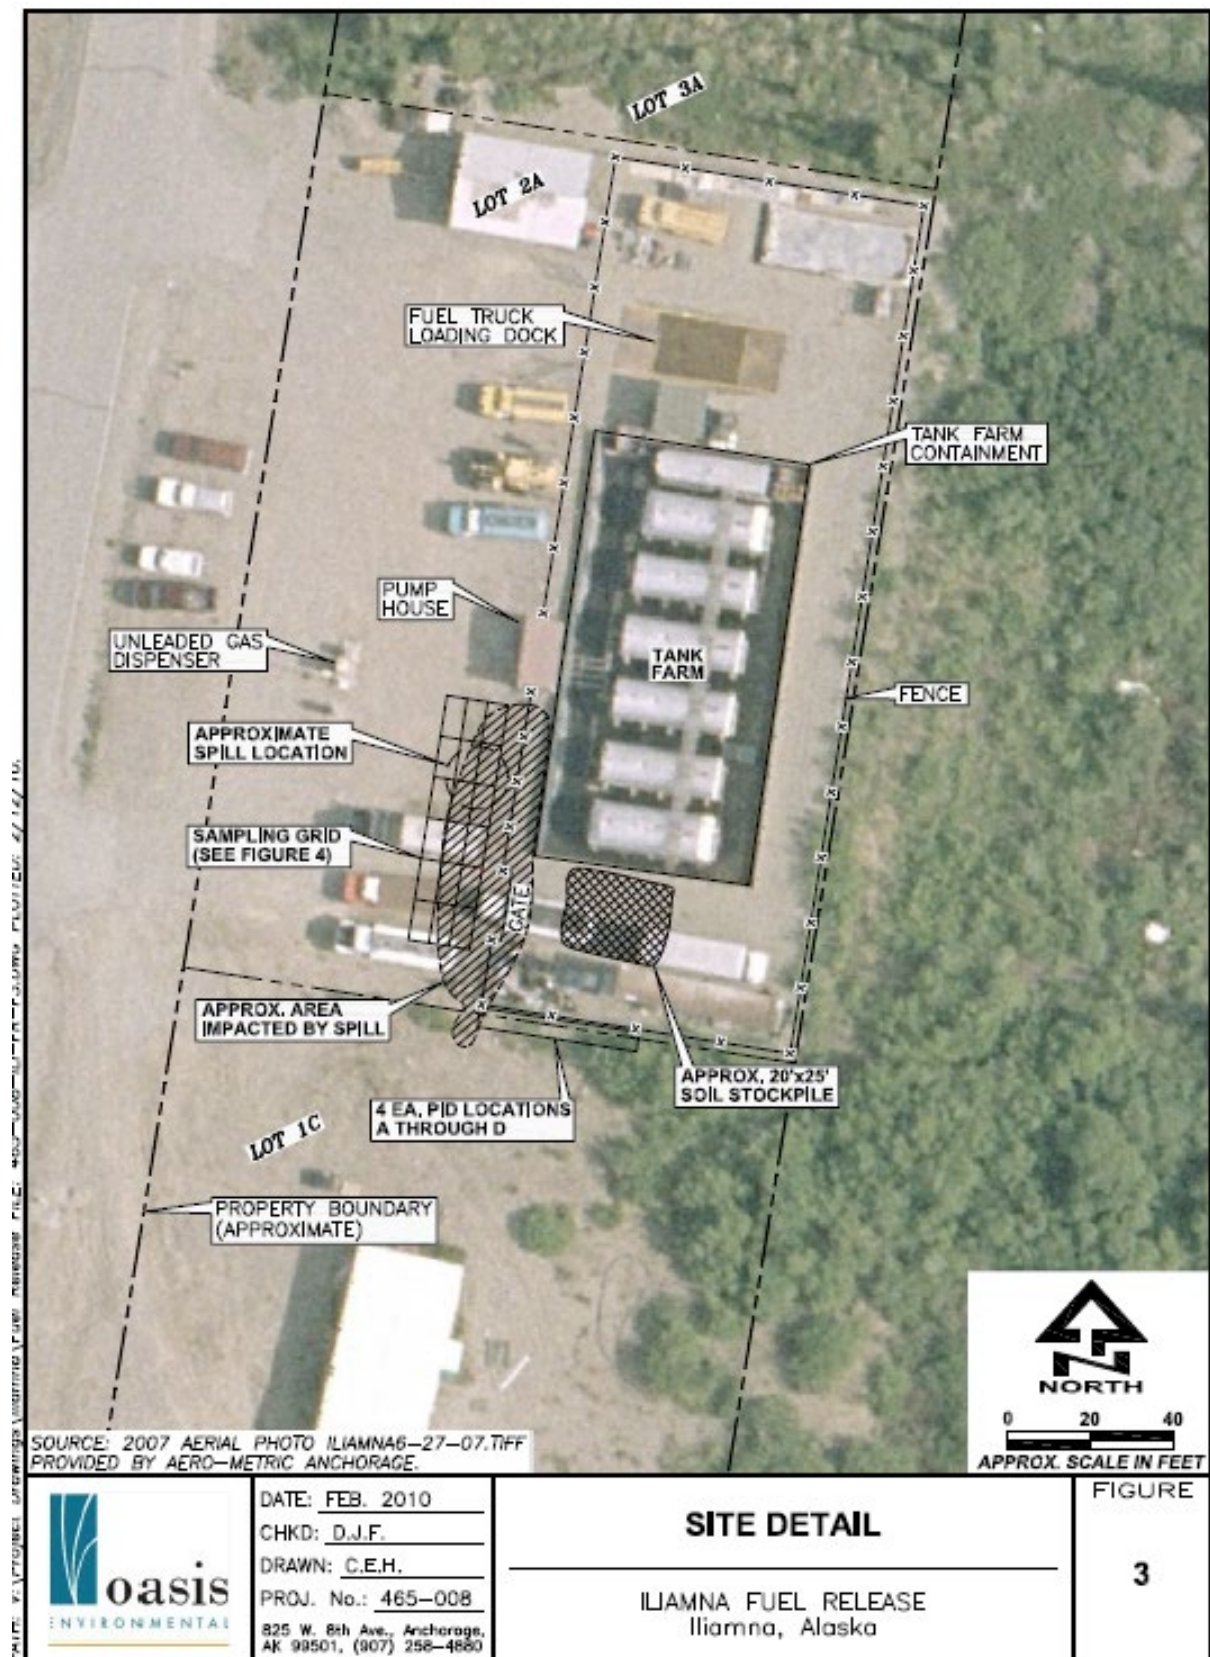
Figure 1: Site detail.

The DEC Prevention Preparedness and Response Program (PPRP) was notified that an aviation gas spill occurred from a fuel tanker truck parked at the Crowley tank farm (Figure 1) at the Iliamna airport in Iliamna, Alaska (the Site) between November 18, 2009 and December 15, 2009. The tanker truck was identified as carrying 1,507 gallons of aviation fuel of which the entire contents was released to the ground.

On December 14, 2009 the spill occurred on the western side of Crowley's tank farm located east of the Iliamna airport (Figure 1). The spill occurred on the loading dock and was immediately contained. The leak was due to a broken fuel line elbow on the truck at the bottom of the tanker's tank. Contaminated soil was removed on December 29, 2009 by OASIS to the extent practicable at the Iliamna Airport property. Sixty-

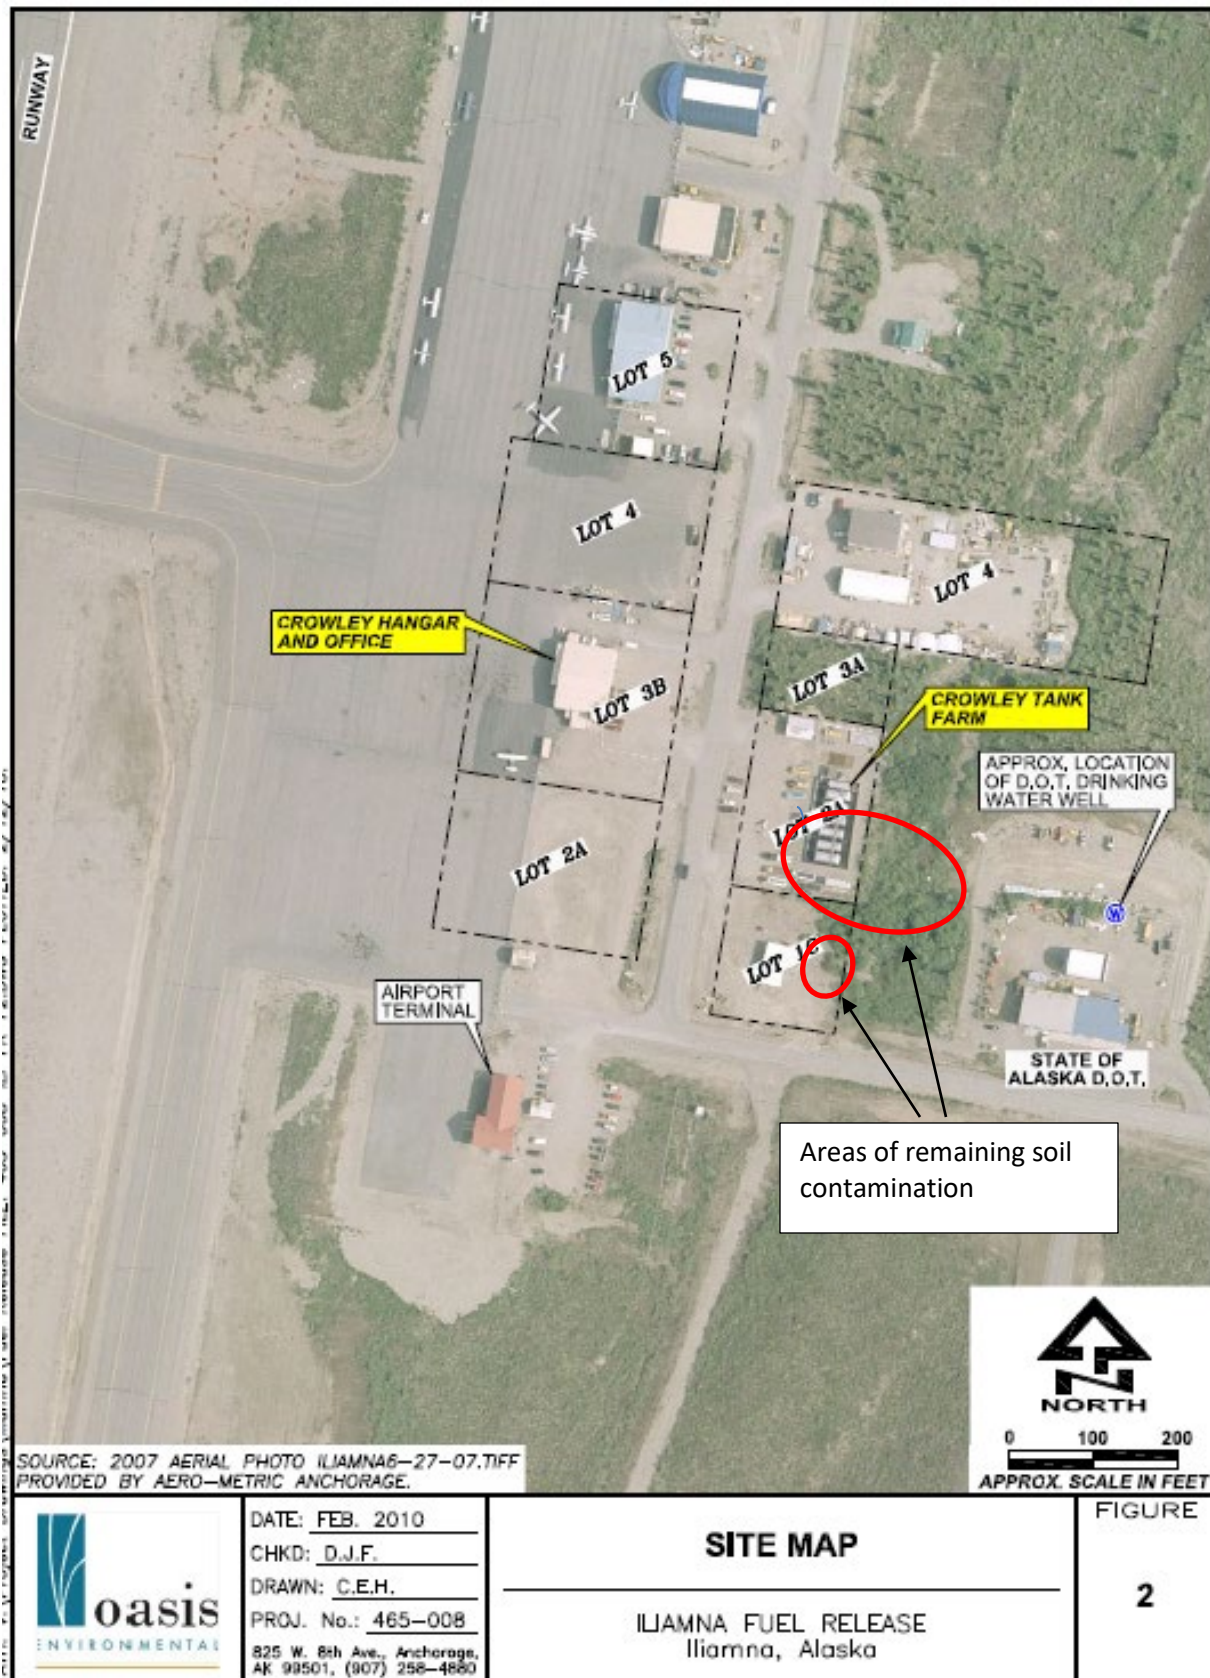
Figure 2: Area where soil contamination may remain (figure revised by DEC).

On October 13, 2021, DNA Environmental Consultants conducted re-sampling at the location where the GRO concentration exceeded the maximum allowable concentration criteria in 2009 and at the location where the benzene concentration exceeded the Table B1 human health cleanup level in 2010. The laboratory reported all GRO and BTEX results as not detected. A review of the soil data indicates that at various times DRO, GRO, benzene, and toluene were present throughout the site at depths primarily between 5 and 8 ft bgs.

Soil contamination at the site has been cleaned up to concentrations suitable for residential land use and groundwater contamination is no longer present. DRO and other petroleum compounds may remain in subsurface soil, which is mostly expected to be between 5 to 8 ft bgs. This site will receive a “Cleanup Complete” designation on the Contaminated Sites Database, subject to the following standard conditions.
