September 29, 2016

Rescon Alaska LLC (Rescon) has developed this Site Assessment Report on behalf of our client, to detail environmental assessment activities and sampling at the property located at 1407 East 30th Avenue in Fairbanks, Alaska. Please note that due to the very limited budget for this work, all ADEC sampling protocols were not followed in the sampling and reporting at this site. Instead, the monies available were used to collect as much data as possible to help determine the exposure pathway risks at the site.

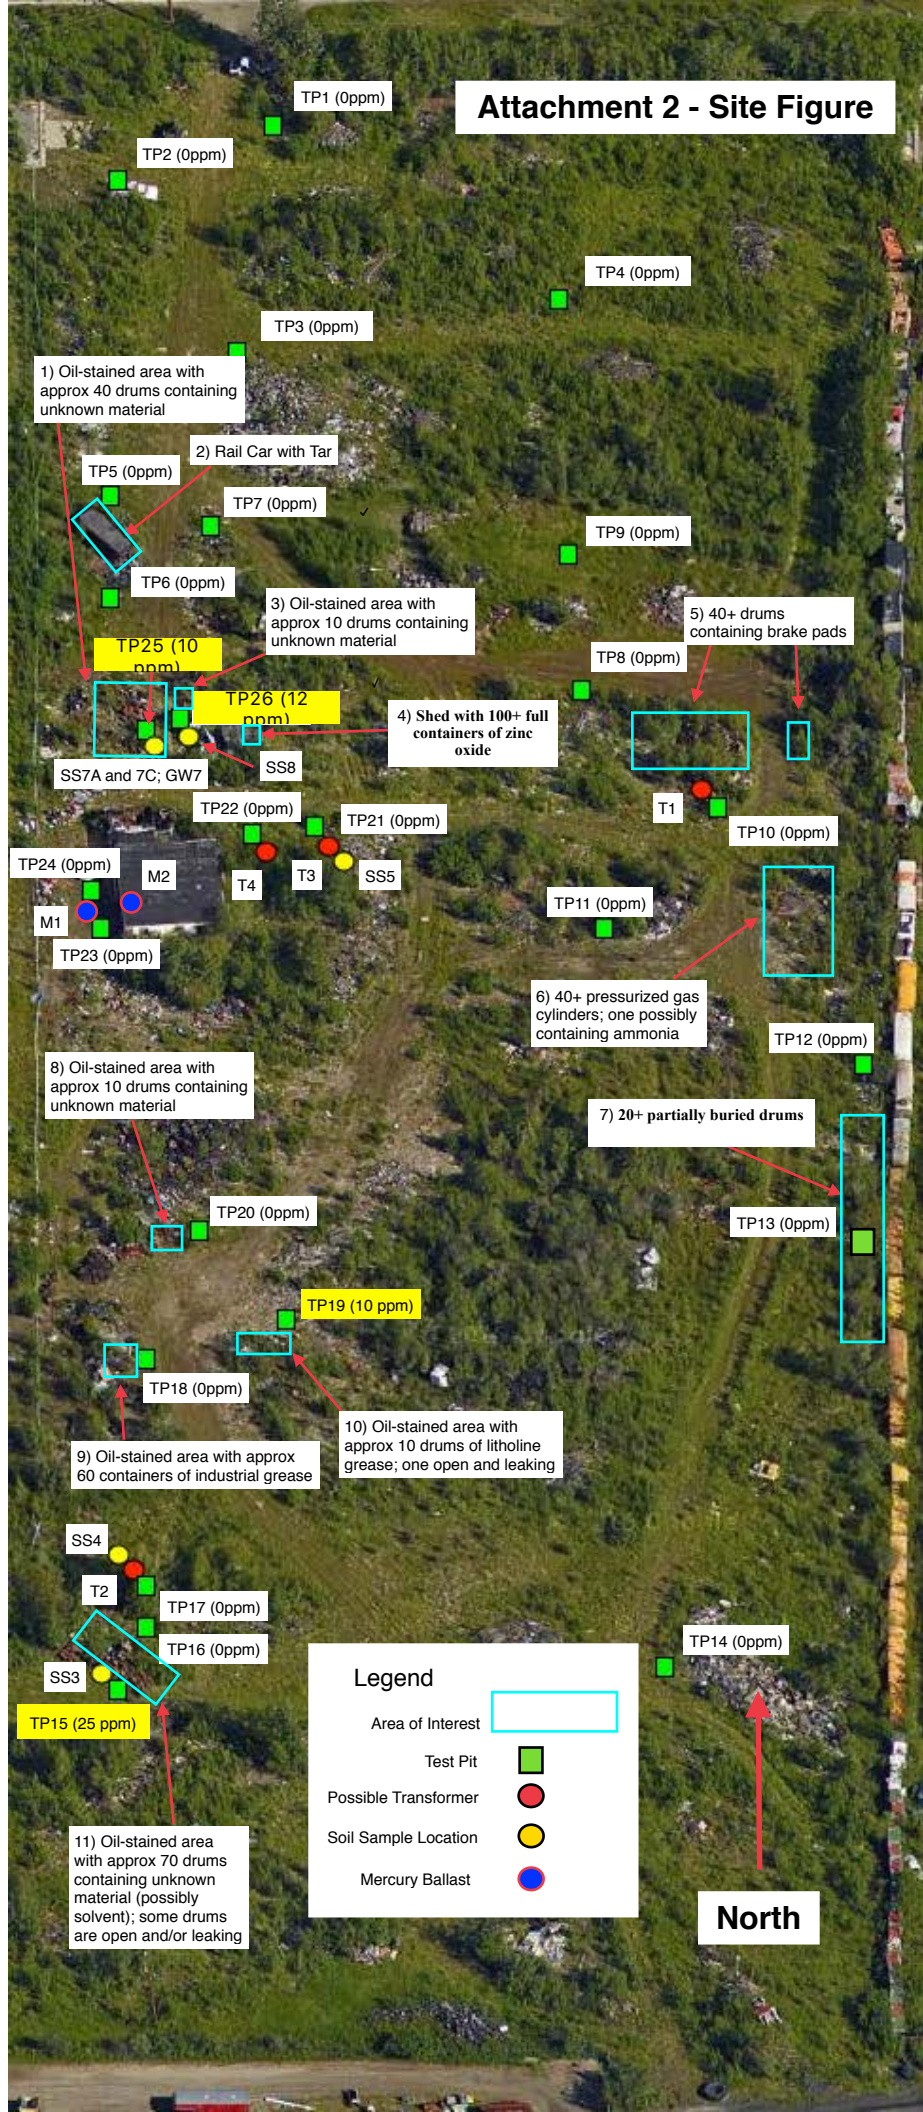
Attachment 2 - Site Figure

1) Oil-stained area with approx 40 drums containing unknown material

2) Rail Car with Tar

3) Oil-stained area with approx 10 drums containing unknown material

5) 40+ drums containing brake pads

4) Shed with 100+ full containers of zinc oxide

6) 40+ pressurized gas cylinders; one possibly containing ammonia

8) Oil-stained area with approx 10 drums containing unknown material

7) 20+ partially buried drums

9) Oil-stained area with approx 60 containers of industrial grease

10) Oil-stained area with approx 10 drums of litholine grease; one open and leaking

11) Oil-stained area with approx 70 drums containing unknown material (possibly solvent); some drums are open and/or leaking

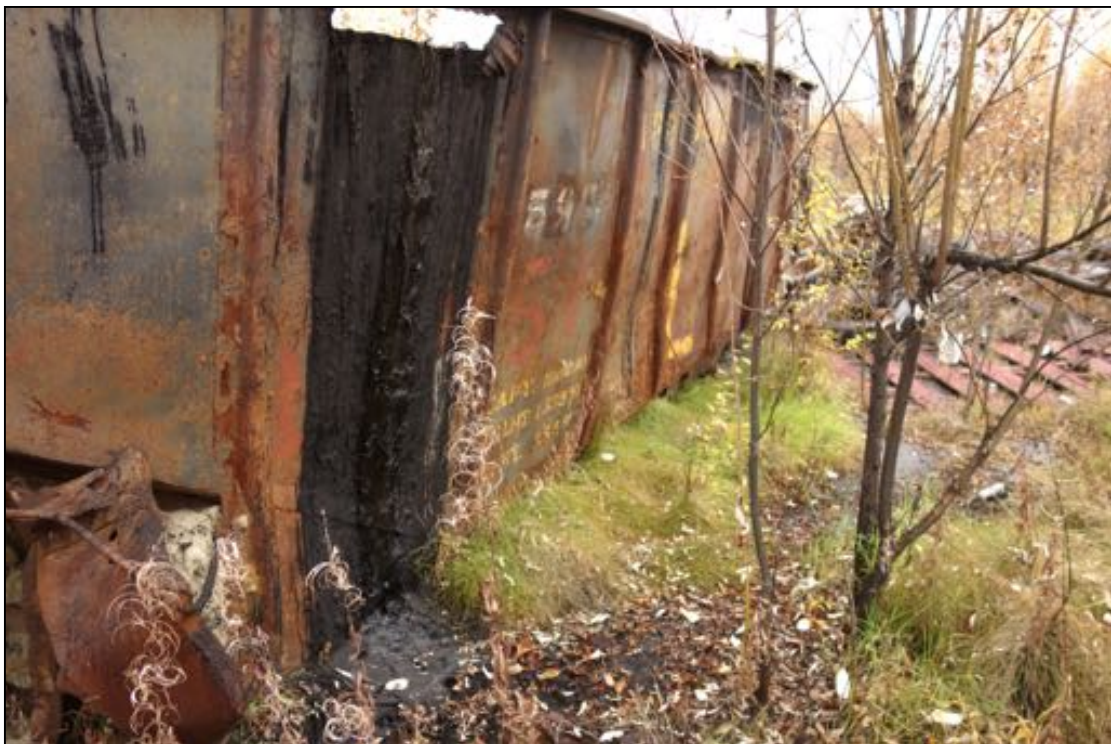
- 2) An approximately 20ft long by 8ft wide by 8ft high rail car filled with tar is located in the northwestern portion of the site. Tar has leaked from the south side of the rail car and accumulated in an approximately 20ft by 20ft area. Tires have been stacked on top of the leaked tar. Two test pits (TP-5 and TP-6) were excavated to 2ft bgs to the north and south of the rail car. No elevated PID results were recorded. No petroleum hydrocarbon odors were observed, and no soil sample was collected in this area. See photos 2 - 6 in photograph log.

PHOTOGRAPH 2: RAIL CAR WITH TAR ON NORTHWEST PORTION OF PROPERTY (SEE FIGURE - AREA OF INTEREST #2); LOOKING SOUTHEAST. 9/22/2016.

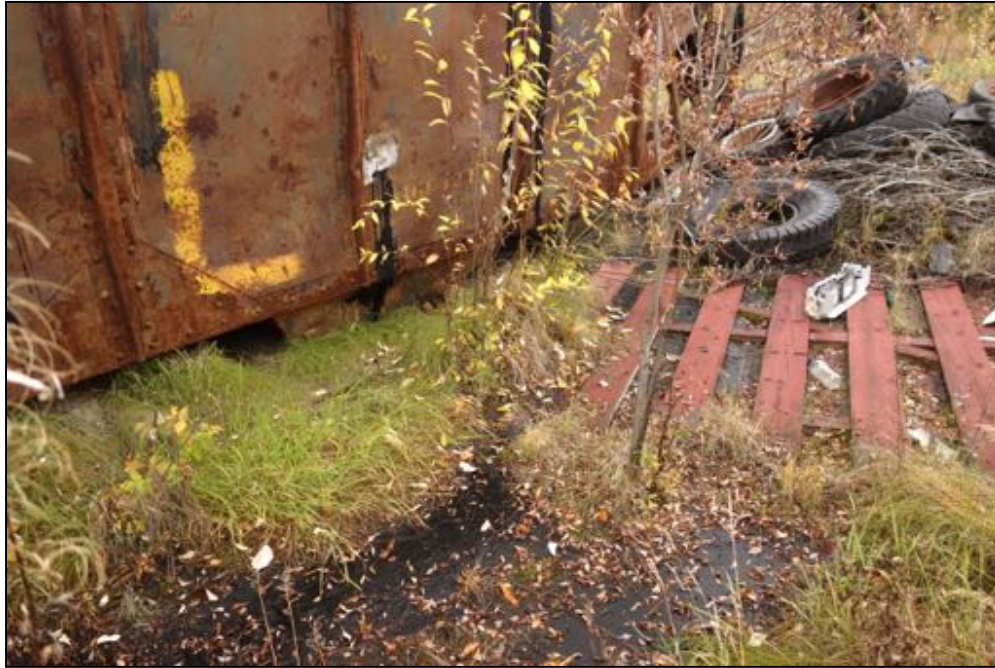
PHOTOGRAPH 3: TAR THAT HAS LEAKED AND POOLED ON SOUTH SIDE OF RAIL CAR (SEE FIGURE - AREA OF INTEREST #2); LOOKING EAST. 9/22/2016.

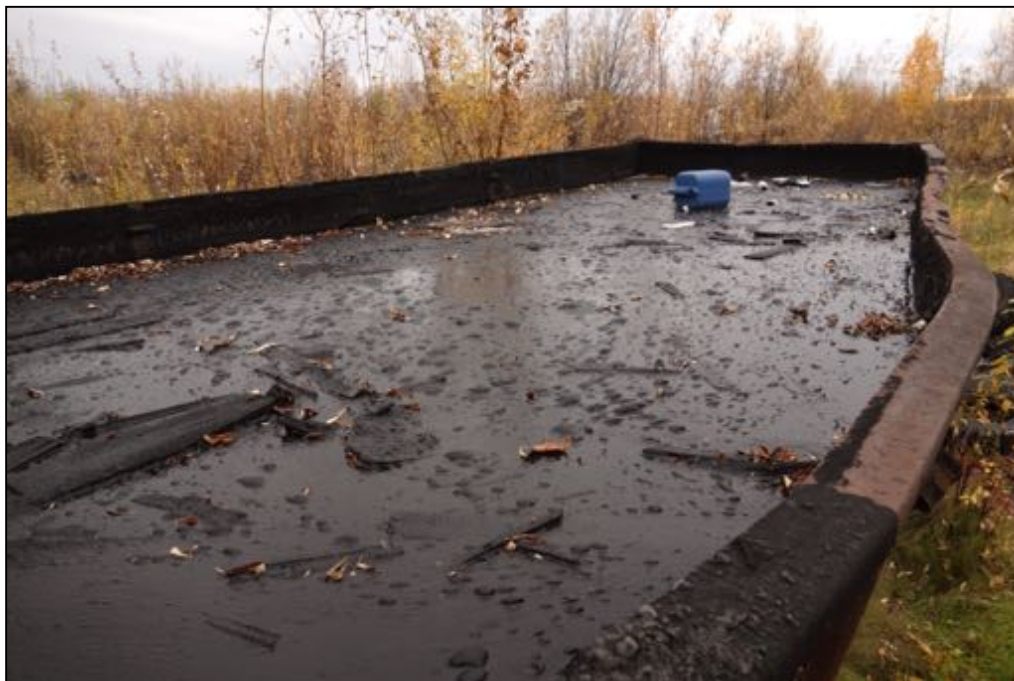
PHOTOGRAPH 4: RAIL CAR FILLED WITH TAR (SEE FIGURE - AREA OF INTEREST #2); LOOKING SOUTHEAST. 9/22/2016.

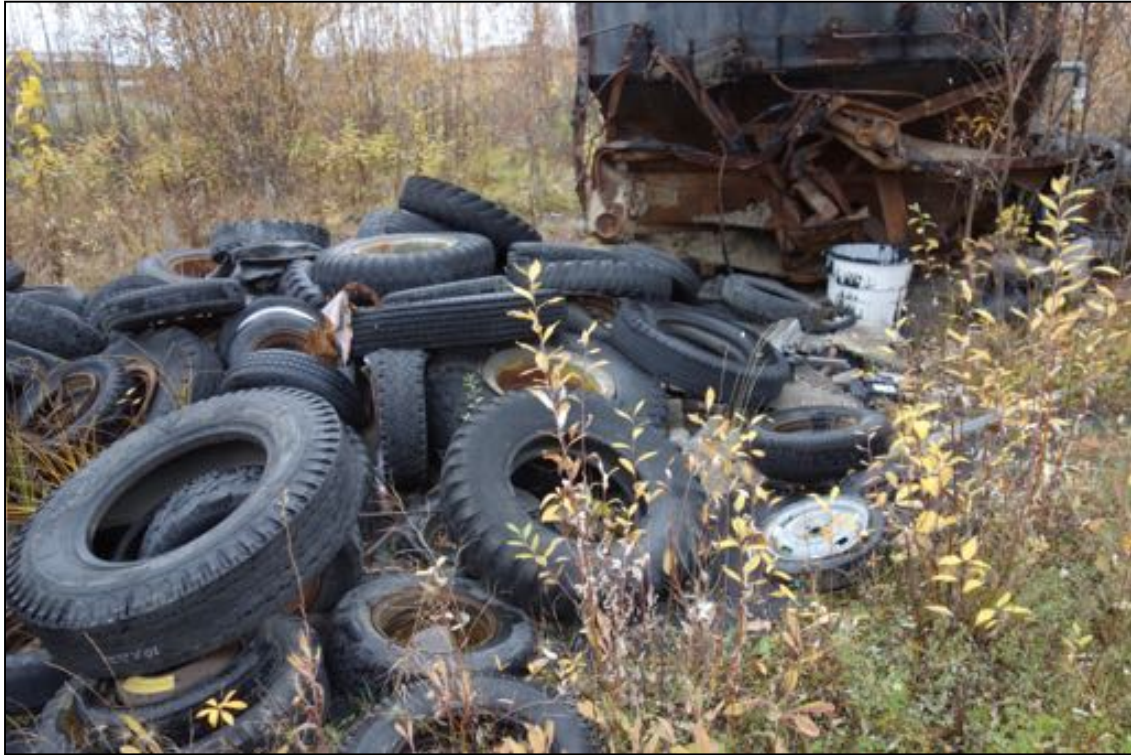
PHOTOGRAPH 5: LEAKED AND POOLED TAR ON SOUTH SIDE OF RAIL CAR; COVERED WITH TIRES (SEE FIGURE - AREA OF INTEREST #2); LOOKING NORTHWEST. 9/22/2016

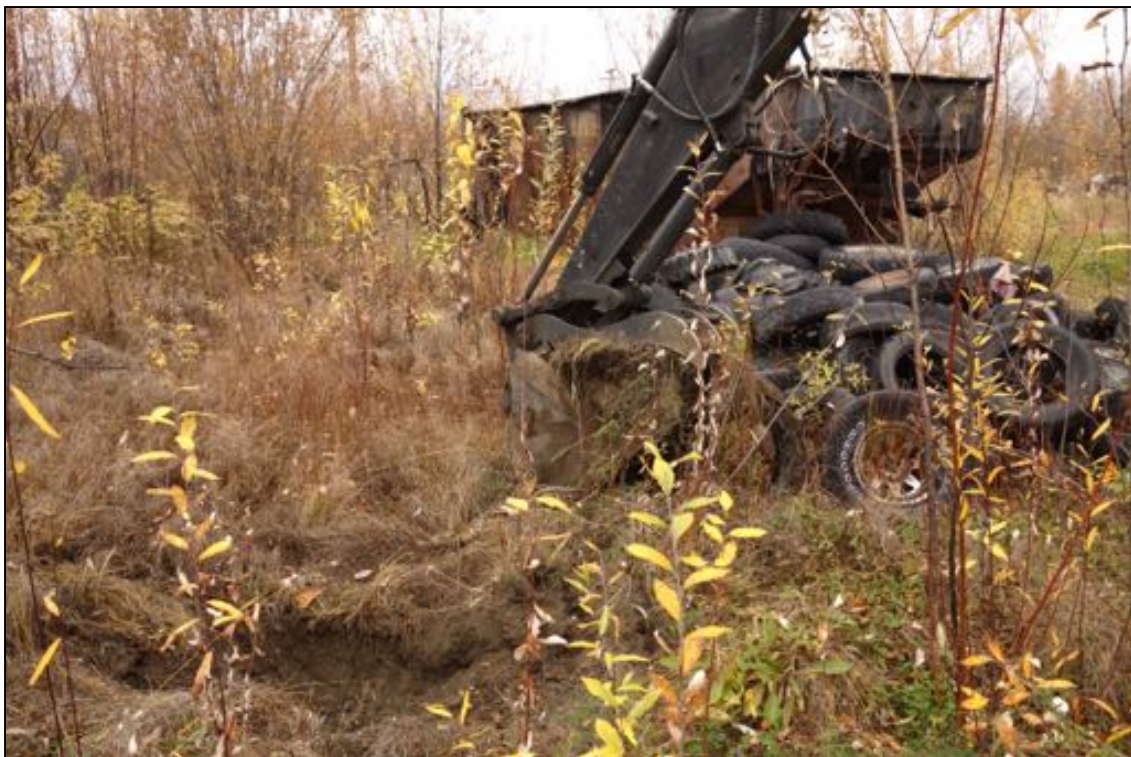
PHOTOGRAPH 6: DIGGING TEST PIT (TP-6) NEAR POOLED TAR; LOOKING NORTHWEST. 9/22/2016.

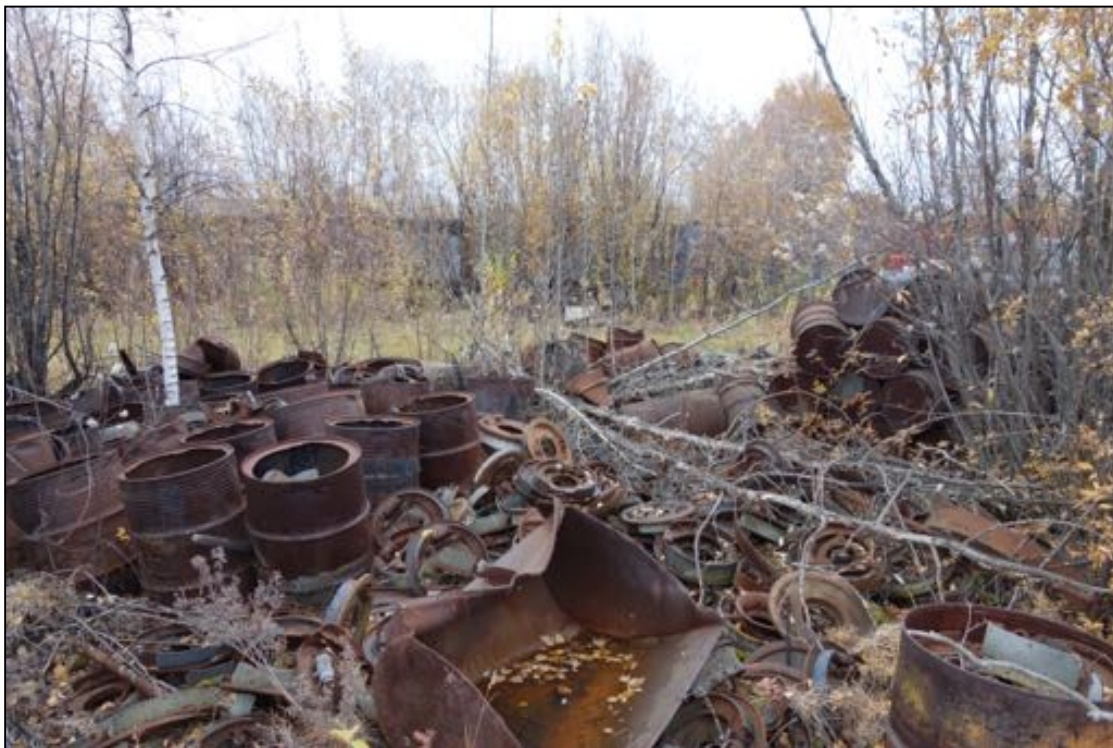
- 5) This area contains 40-to-50, 50-gal drums used to store brake pads. This is an area of interest, as brake pads can contain asbestos and may require special disposal procedures. No odors were observed. No test pit was excavated, and no soil sample was collected in this area. See photos 8 and 9 in photograph log.

PHOTOGRAPH 8: 55-GAL DRUMS CONTAINING USED BRAKE PADS (SEE FIGURE – AREA OF INTEREST #5); LOOKING NORTHWEST. 9/22/16.

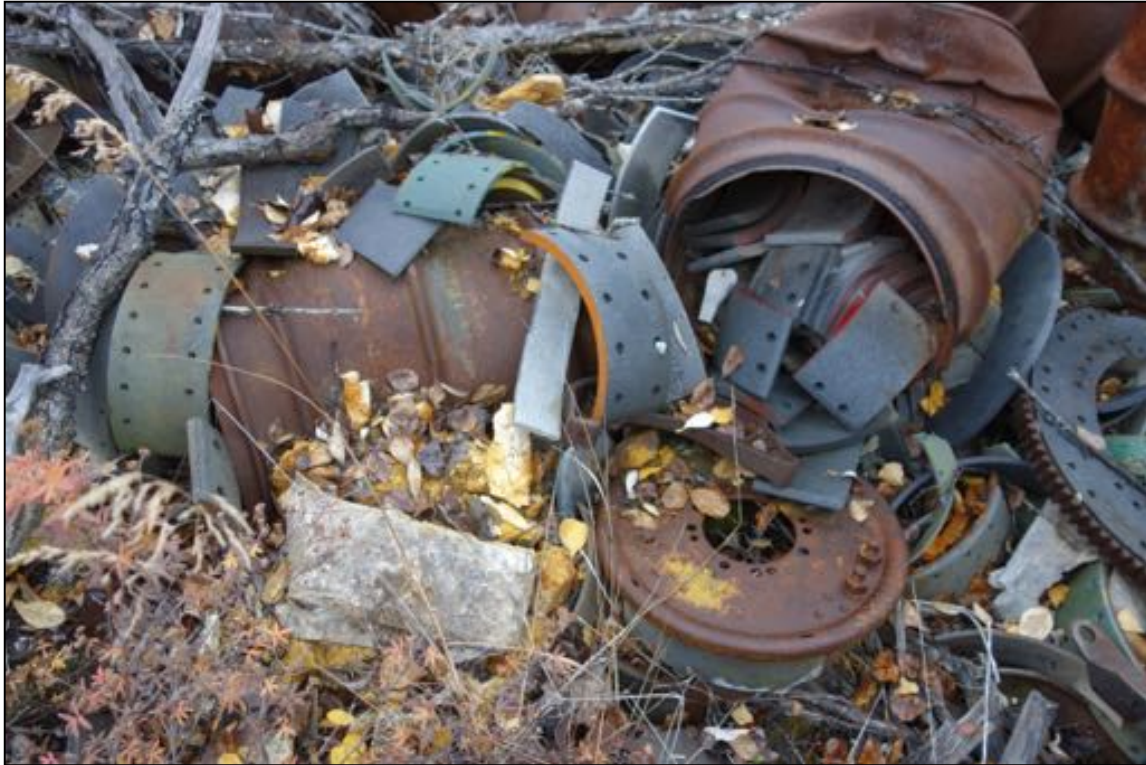
PHOTOGRAPH 9: 55-GAL DRUMS CONTAINING USED BRAKE PADS (SEE FIGURE – AREA OF INTEREST #5); LOOKING WEST. 9/22/16.

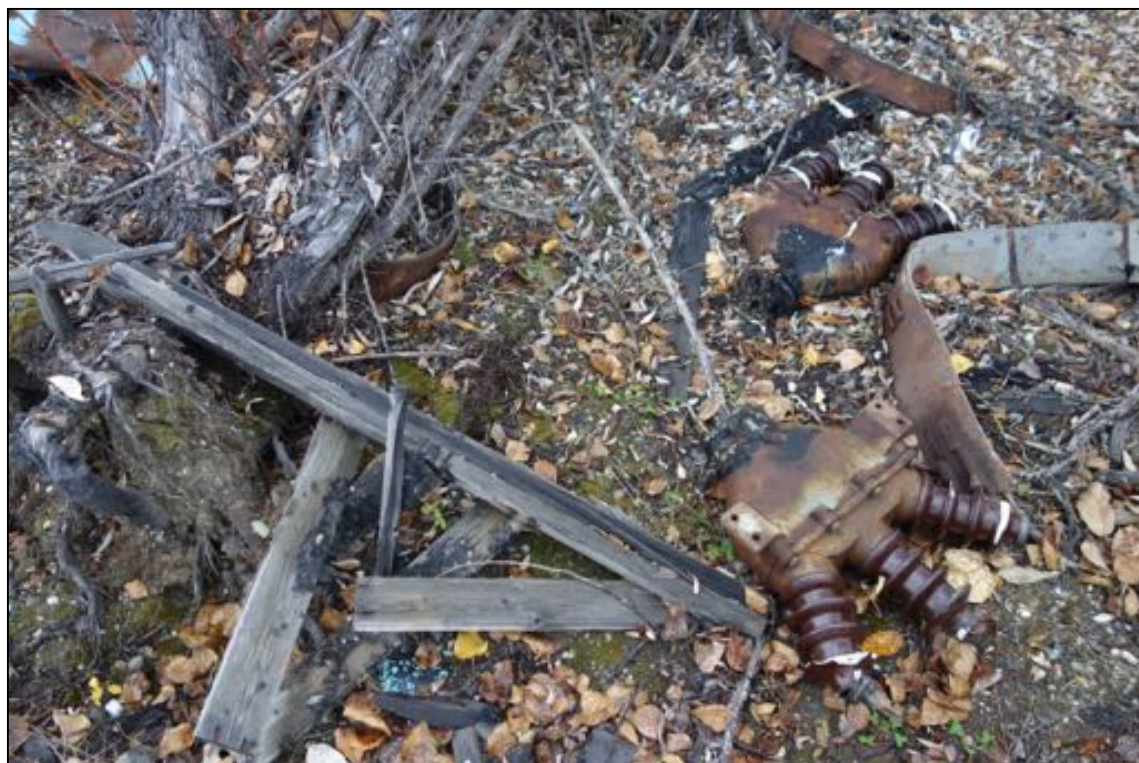
T-1) Possible transformer parts were identified on the eastern portion of the site south of the Area of Interest #5. A soil sample was not collected from this location, as a transformer cylinder (which would possibly contain PCB oil) was not observed. See photo 10 in photograph log.

PHOTOGRAPH 10: POSSIBLE TRANSFORMER PARTS AT LOCATION T-1 (SEE FIGURE). 9/22/16.

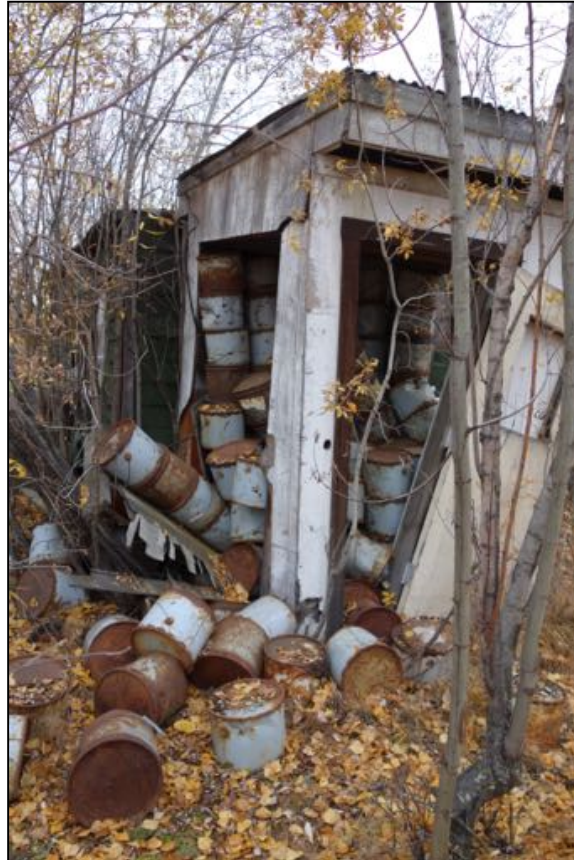
- 4) This area contains a shed with approximately 100 (or more) 73lb containers of zinc filler. No odors were observed. No test pit was excavated, and no soil sample was collected in this area. See photos 11 and 12 in photograph log.

PHOTOGRAPH 11. SHED CONTAINING APPROXIMATELY 100, 73LB CONTAINERS OF CARBOLINE ZINC FILLER (SEE FIGURE – AREA OF INTEREST #4); LOOKING SOUTH. 9/22/16.

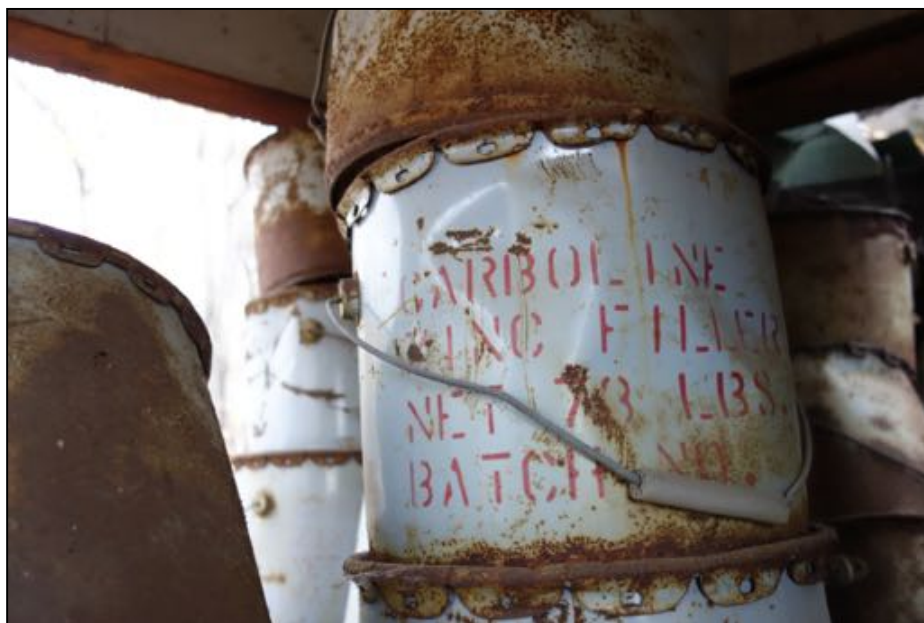
PHOTOGRAPH 12: SHED CONTAINING APPROXIMATELY 100, 73LB CONTAINERS OF CARBOLINE ZINC FILLER (SEE FIGURE – AREA OF INTEREST #4); LOOKING SOUTH. 9/22/16.

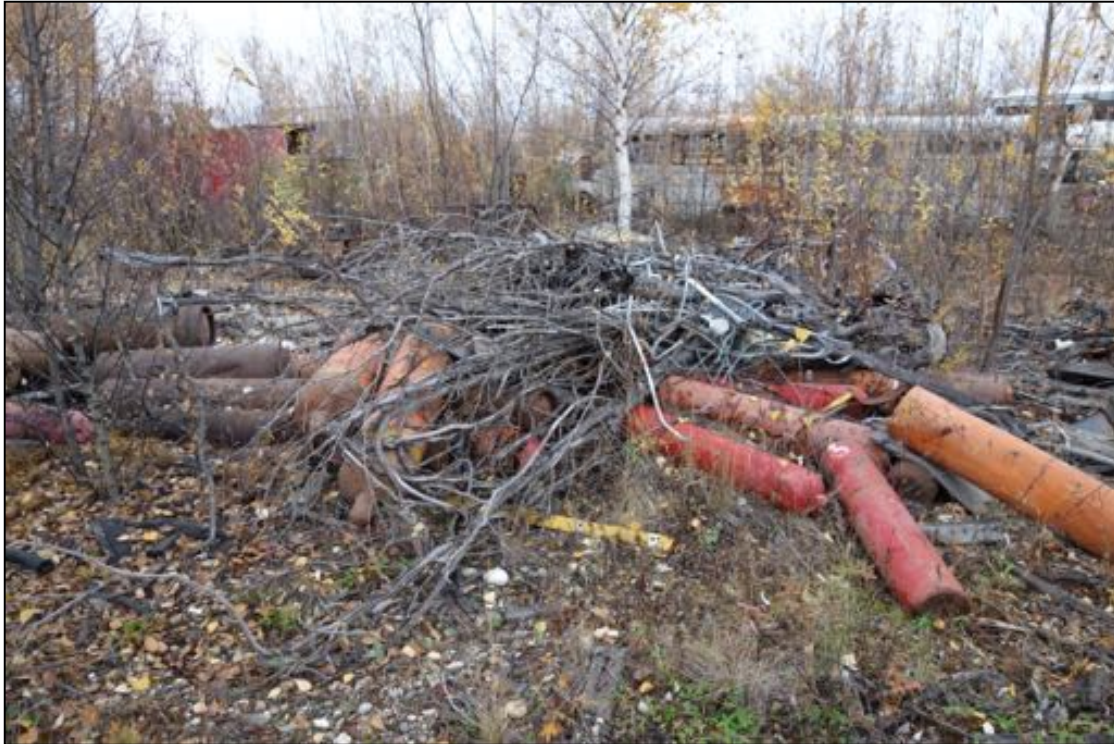
- 6) This area contains approximately 40 used compressed gas cylinders. This is an area of interest, as one of the cylinders reads "Ammonia", which may require special disposal procedures. No odors were observed. No test pit was excavated, and no soil sample was collected in this area. See photos 13 and 14 in photograph log.

PHOTOGRAPH 13: PILE OF APPROX 40 USED COMPRESSED GAS CYLINDERS ON EAST SIDE OF SITE (SEE FIGURE – AREA OF INTEREST #6); LOOKING EAST. 9/22/16.

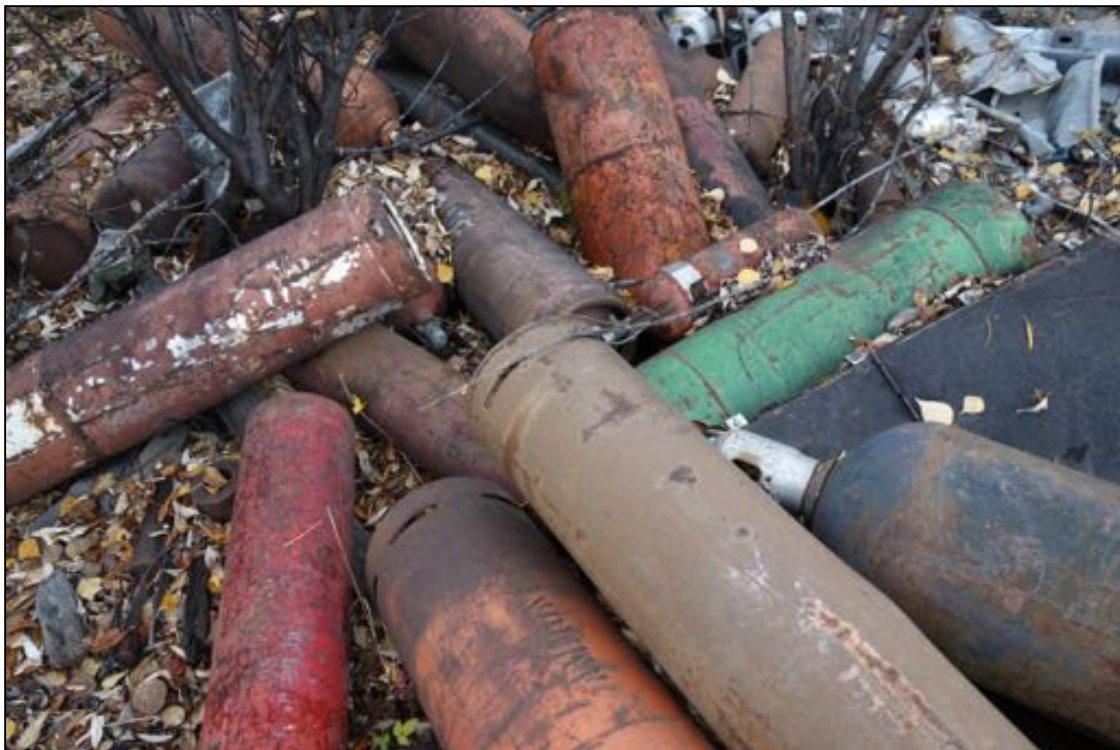
PHOTOGRAPH 14: ORANGE CANISTER IN FOREGROUND READS AMMONIA (SEE FIGURE – AREA OF INTEREST #6). 9/22/16.

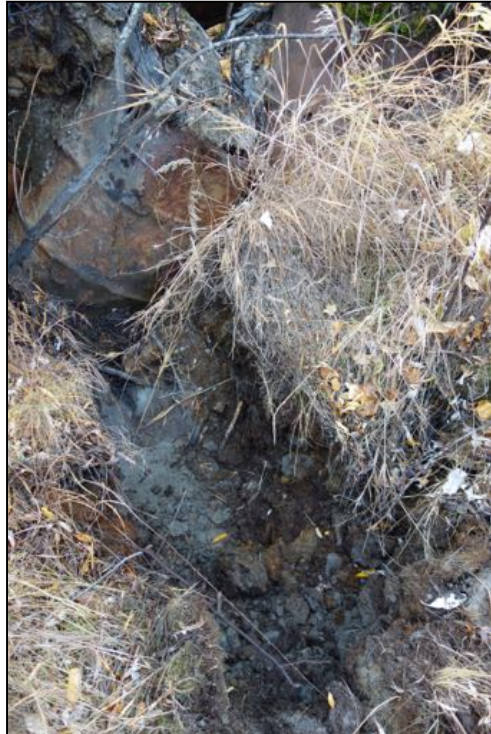
- 7) This area contains approximately 20 partially buried drums that may have contained petroleum (or other) contents at the time of disposal. A test pit (TP-13) was excavated to 2ft bgs in this area. No elevated PID results were recorded. No odors were observed, and no soil sample was collected. See photos 15 and 16 in photograph log.

PHOTOGRAPH 15: DRUM IN AREA ALONG EAST BORDER OF SITE CONTAINING APPROX 20 PARTIALLY BURIED DRUMS (SEE FIGURE – AREA OF INTEREST #7); LOOKING EAST. 9/22/16.

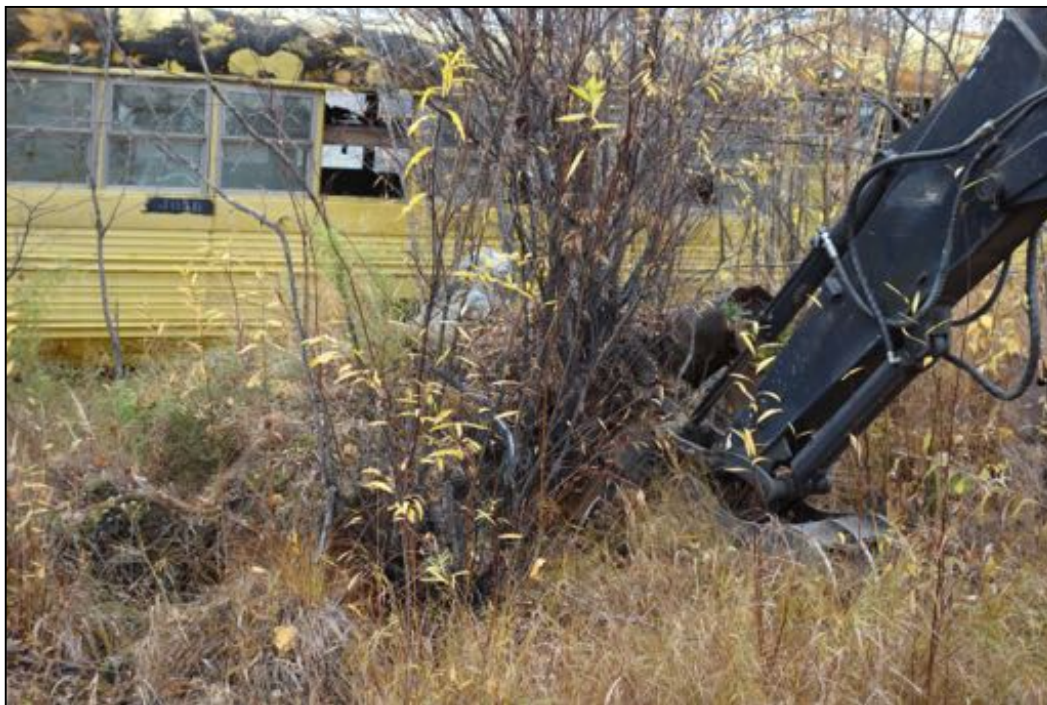
PHOTOGRAPH 16: DIGGING TEST PIT (TP-13) IN AREA ALONG EAST BORDER OF SITE CONTAINING APPROX 20 PARTIALLY BURIED DRUMS (SEE FIGURE – AREA OF INTEREST #7); LOOKING EAST. 9/22/16.

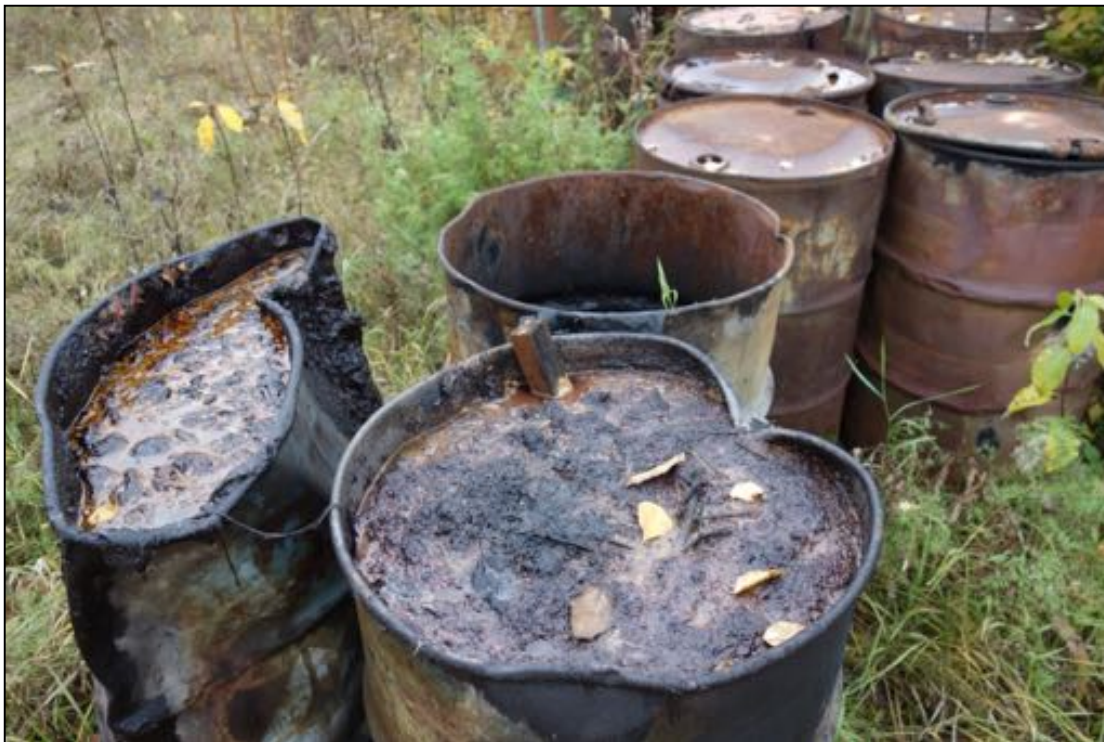
- 11) This area contains approximately 70, 55-gal drums with unknown contents and six cases of bearing grease. Some of the containers appear to be unopened, while some appear to have been reused as storage containers (spray painted "waste oil" and "clean sol."). Multiple drums appear to be leaking. There is an area of black surface staining near a few of the leaking drums, which is likely some sort of petroleum hydrocarbon product. There is a slight petroleum hydrocarbon odor in this location. A test pit (TP-15) was excavated to approximately 1ft bgs in the stained area. A PID reading of 25 ppm was indicated at 0.5 ft bgs. A soil sample (SS-3) was collected from 0.5ft bgs and submitted to ALS for VOC and RCRA 8 metals analyses. See photos 17 - 21 in photograph log.

PHOTOGRAPH 17: OPEN DRUMS WITH OILY CONTENT ON WEST SIDE OF SITE IN AREA OF APPROX 70 DRUMS (SEE FIGURE – AREA OF INTEREST #11); LOOKING NORTH. 9/22/16.

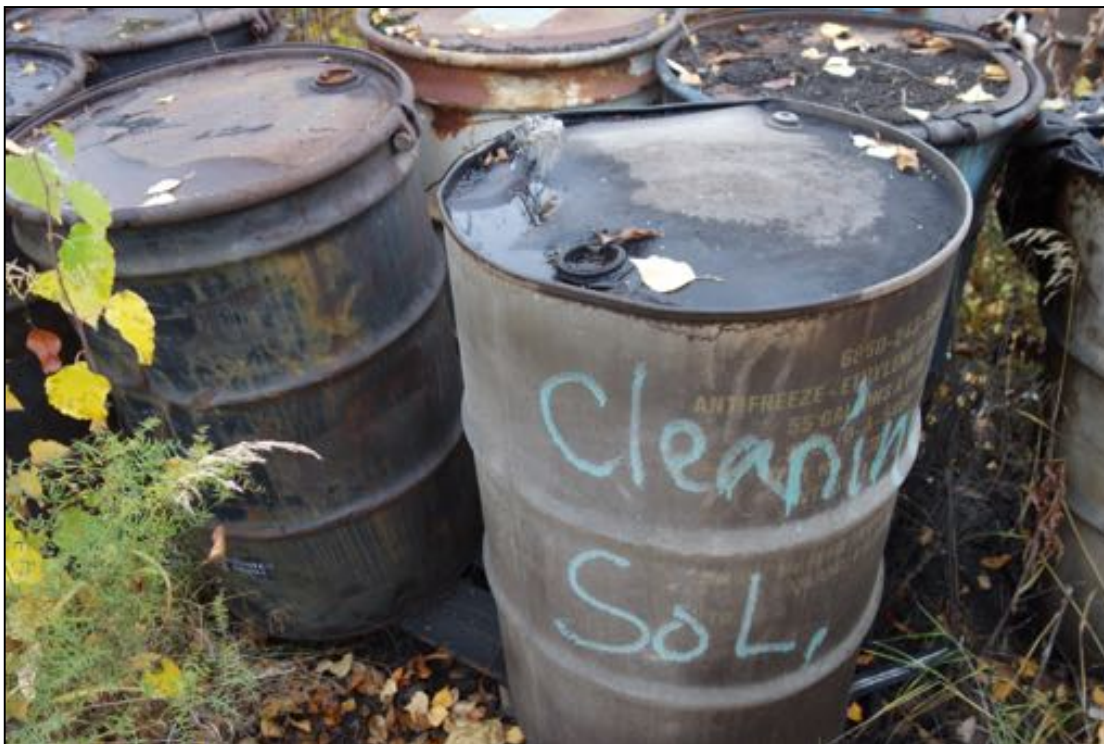
PHOTOGRAPH 18: DRUM CONTAINING POSSIBLE CLEANING SOLVENT IN AREA OF APPROX 70 DRUMS (SEE FIGURE – AREA OF INTEREST #11); LOOKING EAST. 9/22/16.

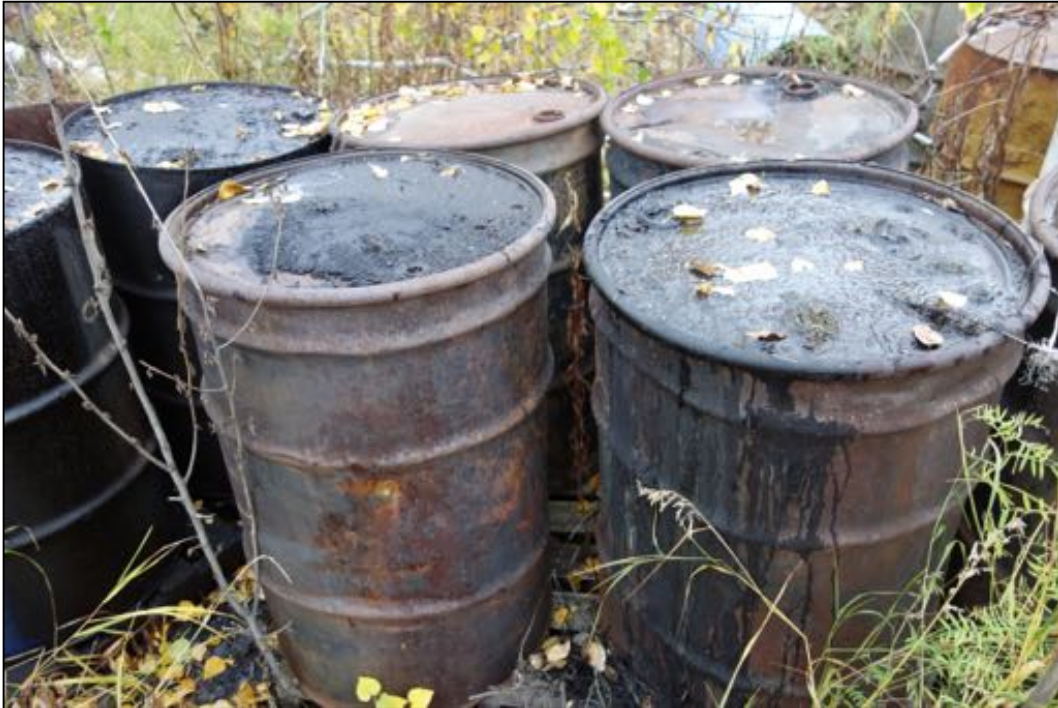
PHOTOGRAPH 19: LEAKING DRUMS CONTAINING POSSIBLE WASTE OIL IN AREA OF APPROX 70 DRUMS (SEE FIGURE – AREA OF INTEREST #11); LOOKING EAST. 9/22/16.

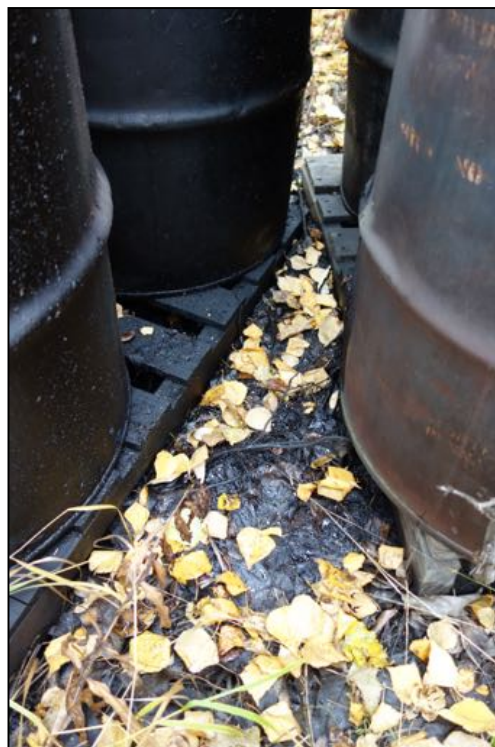
TP-15) This test pit was excavated to 1ft bgs in a stained location in Area of Concern #11. The PID result was 25 ppm. A soil sample (SS-3) was collected from this location at 0.5ft bgs.

PHOTOGRAPH 20: OIL-STAINED AREA NEAR LEAKING DRUMS; PID READING OF 25 PPM; SOIL SAMPLE (SS-3) COLLECTED FOR VOCs AND METALS ANALYSES (SEE FIGURE – AREA OF INTEREST #11). 9/22/16.

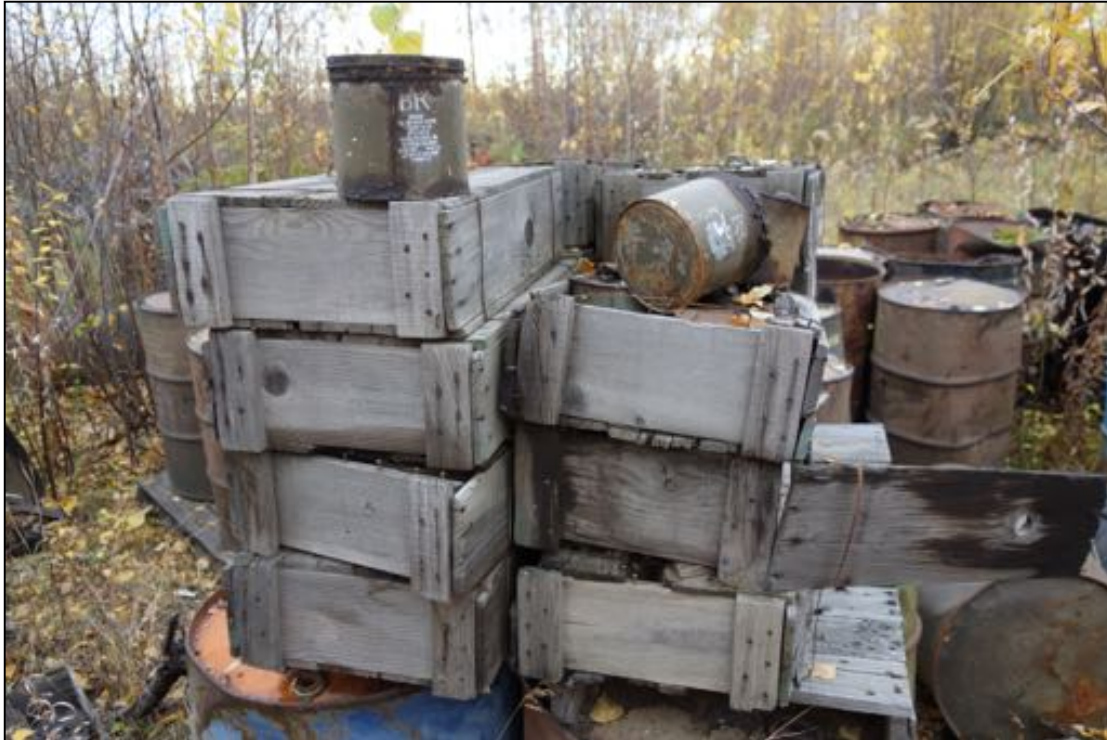
PHOTOGRAPH 21: 16 CASES OF BEARING GREASE IN AREA OF APPROX 70 DRUMS (SEE FIGURE – AREA OF INTEREST #11); LOOKING SOUTHEAST. 9/22/16.

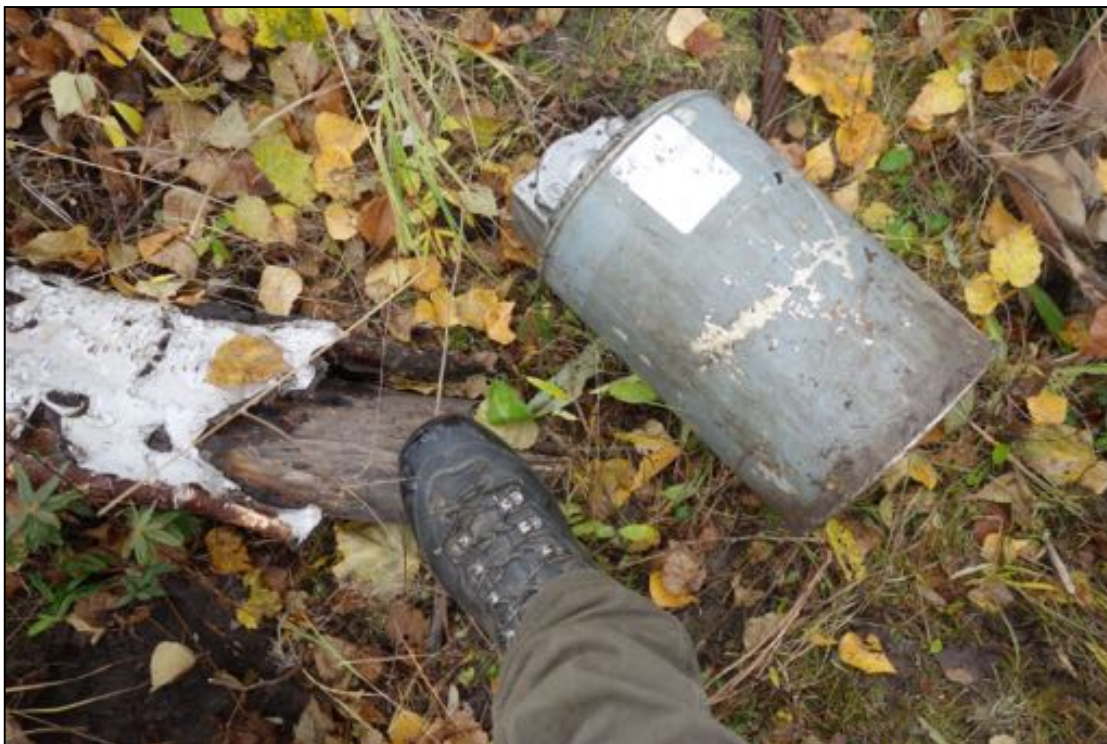
T-2) A small, cylinder-style transformer was observed on the western portion of the site north of the Area of Interest #11. A soil sample (SS-4) was collected from 0.5ft bgs at this location and submitted to ALS for PCB analysis. See photo 27 in photograph log.

PHOTOGRAPH 22: TRANSFORMER (T-2) LOCATED IN SOUTHWESTERN PORTION OF SITE; SOIL SAMPLE (SS-4) COLLECTED FOR PCB ANALYSIS. 9/22/16.

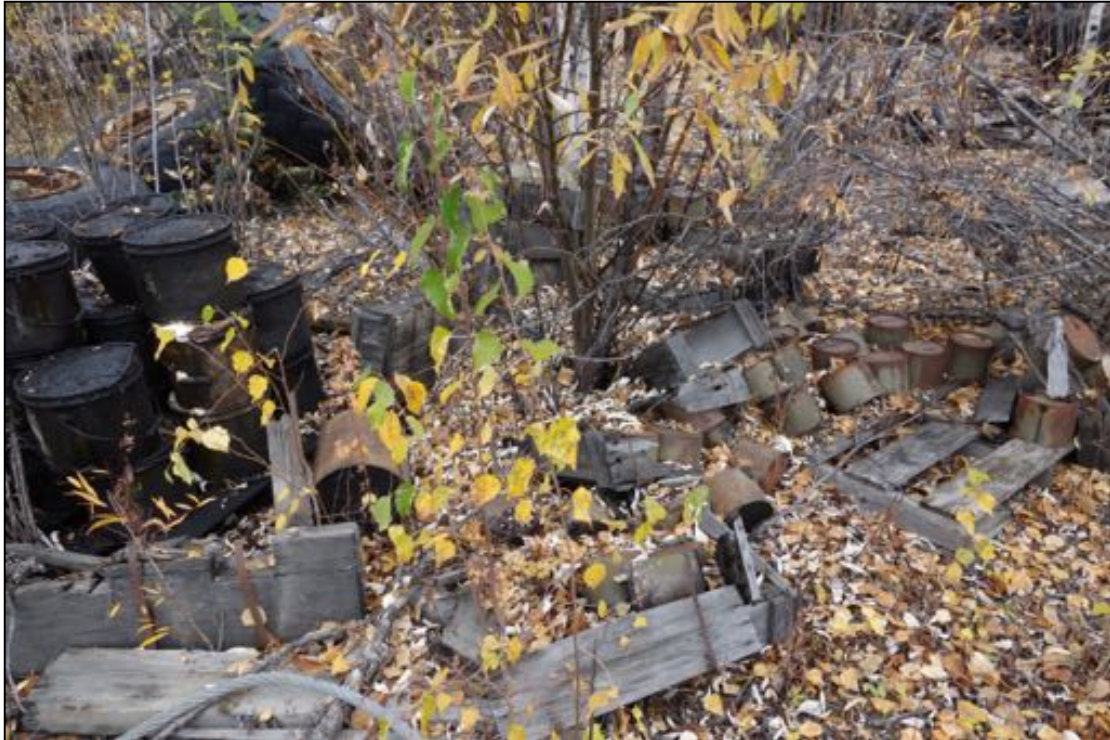
- 9) This area contains a combination of approximately 60, 1-gal and 5-gal containers of industrial grease. The 5-gal containers are visibly leaking, with some accumulation on the ground surface. A test pit (TP-18) was excavated to 2ft bgs. No elevated PID results were recorded. No odors were observed, and no soil sample was collected. See photo 23 in photograph log.

PHOTOGRAPH 23: PILE OF APPROX 60 CONTAINERS OF INDUSTRIAL GREASE LOCATED IN WESTERN PORTION OF SITE (SEE FIGURE – AREA OF INTEREST #9); LOOKING WEST. 9/22/16.

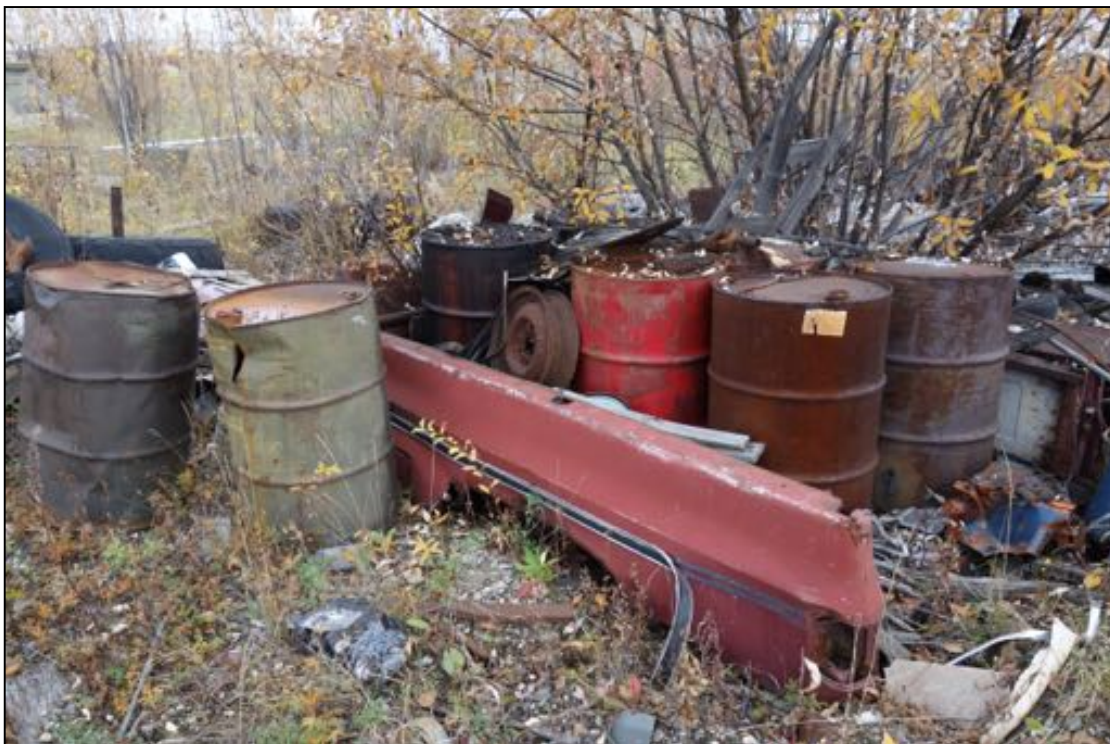
- 8) This area contains 10, 55-gal drums with unknown contents. A test pit (TP-20) was excavated to 2ft bgs. No elevated PID results were recorded. No staining or odors were observed, and no soil sample was collected. See photo 24 in photograph log.

PHOTOGRAPH 24: APPROX 10 DRUMS WITH UNKNOWN CONTENTS LOCATED IN WESTERN PORTION OF SITE (SEE FIGURE – AREA OF INTEREST #8); LOOKING WEST. 9/22/16.

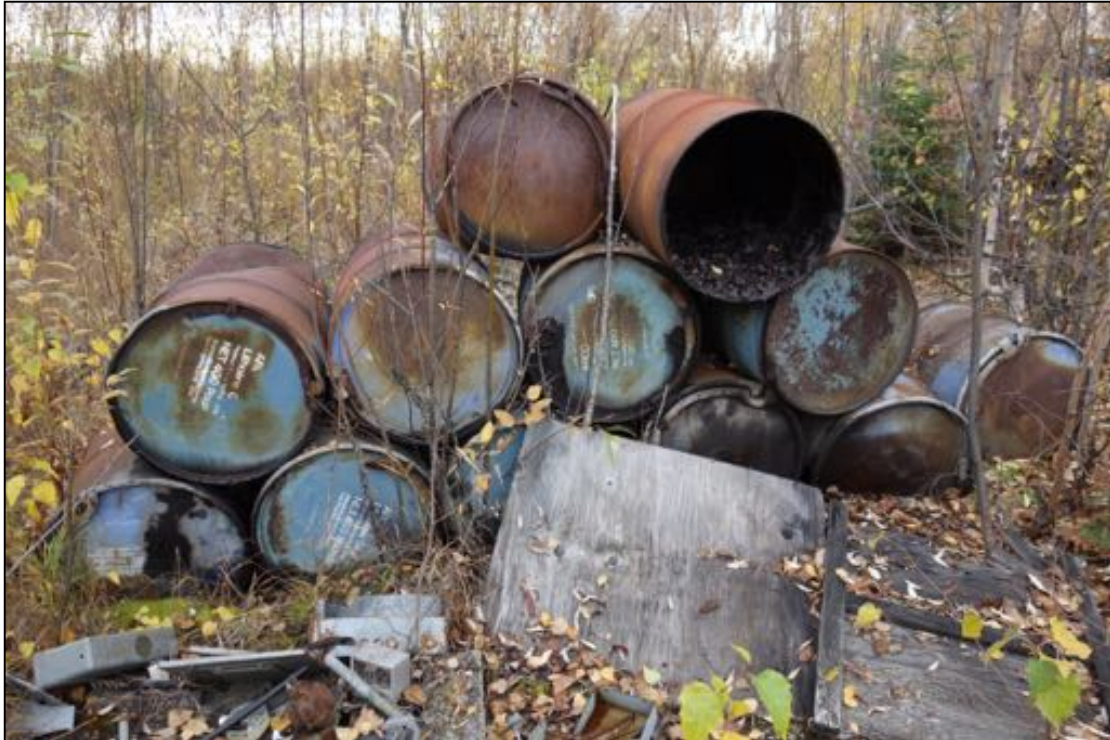
- 10) This area contains 12, 55-gal drums of litholine onyx (lithium grease) stacked on their sides. Some of the drums are leaking onto the ground surface and staining the immediate area. One of the drums is open. A test pit (TP-19) was excavated to 1ft bgs in this area, and a PID reading of 10 ppm was recorded. A slight petroleum hydrocarbon odor was observed. No soil sample was collected. See photos 25 and 26 in photograph log.

PHOTOGRAPH 25: PILE OF 12 DRUMS CONTAINING LITHIUM GREASE LOCATED IN WESTERN PORTION OF SITE (SEE FIGURE – AREA OF INTEREST #10); LOOKING SOUTH. 9/22/16.

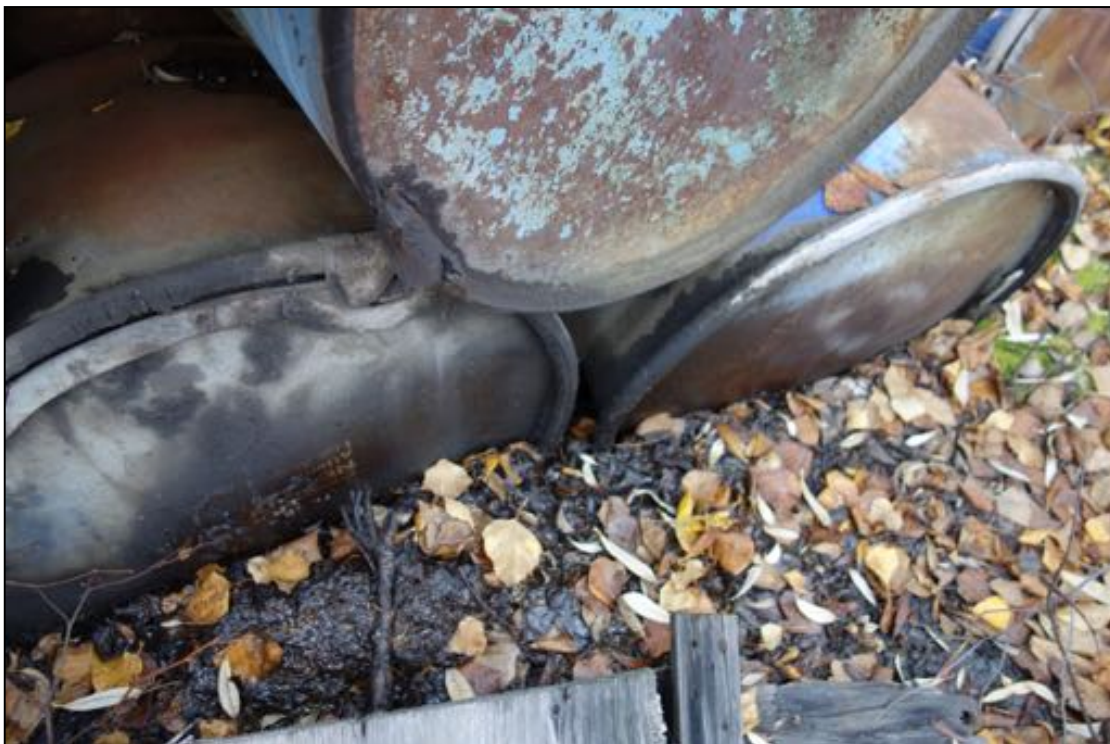
TP-19) This test pit was excavated to 2ft bgs in a stained location in area of concern #10. The PID result was 10 ppm.

PHOTOGRAPH 26: LEAKING DRUMS CONTAINING LITHIUM GREASE LOCATED IN WESTERN PORTION OF SITE PID READING OF 10 PPM; (SEE FIGURE – AREA OF INTEREST #10). 9/22/16.
