September 29, 2016

Rescon Alaska LLC (Rescon) has developed this Site Assessment Report on behalf of our client, to detail environmental assessment activities and sampling at the property located at 1407 East 30th Avenue in Fairbanks, Alaska. Please note that due to the very limited budget for this work, all ADEC sampling protocols were not followed in the sampling and reporting at this site. Instead, the monies available were used to collect as much data as possible to help determine the exposure pathway risks at the site.

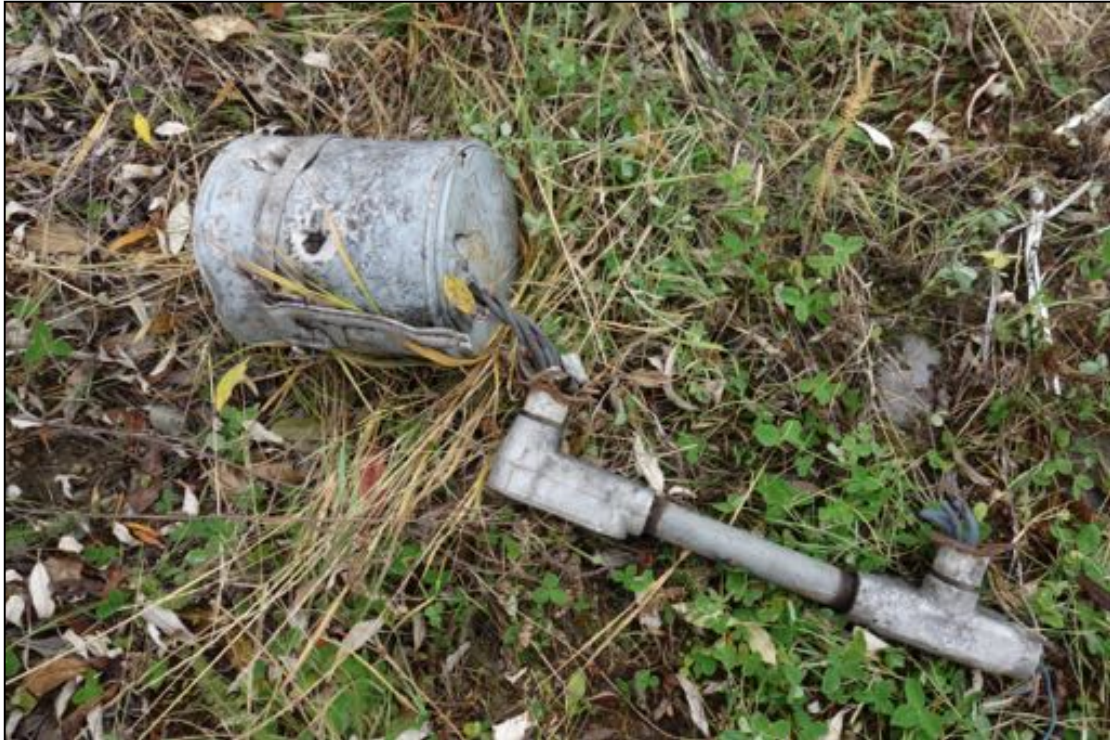
T-3) A small, cylinder style transformer was also observed on the western portion of the site and east of the shop. A soil sample (SS-5) was collected from 0.5ft bgs at this location and submitted to ALS for PCB analysis.

PHOTOGRAPH 27: POSSIBLE TRANSFORMER (T-3) SOIL SAMPLE (SS-5) COLLECTED FOR PCB ANALYSIS. 9/22/16.

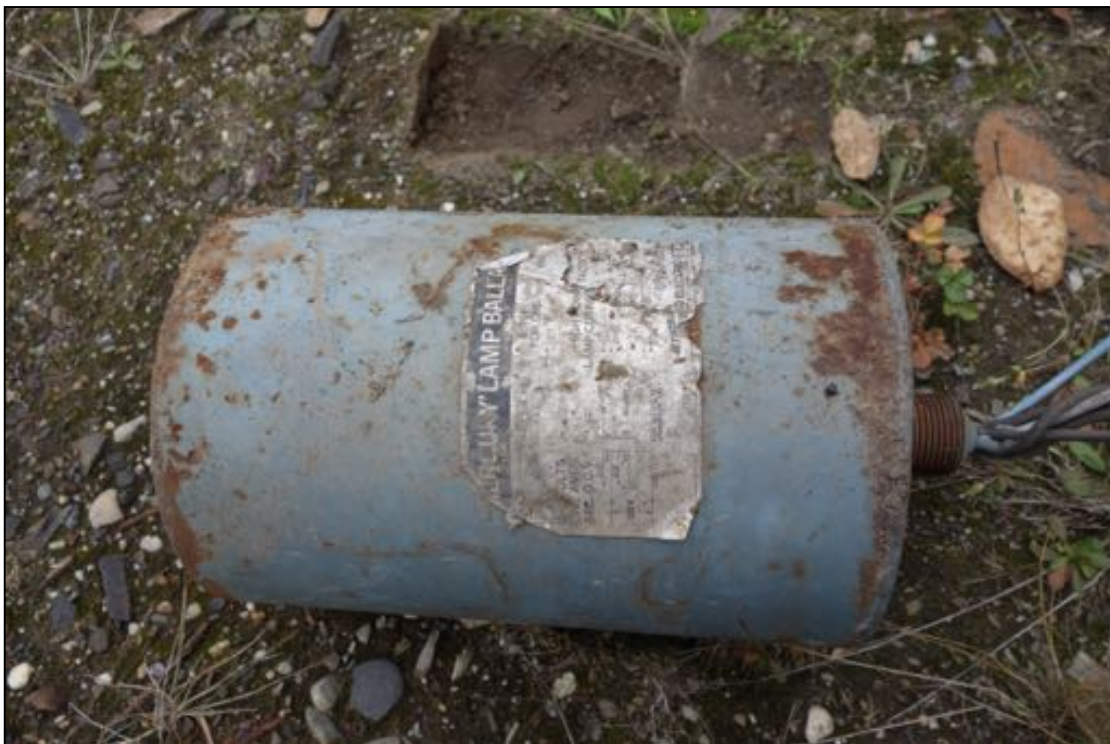
M-1) One mercury ballast was identified near the west entrance of the onsite shop. See photo 28 in photograph log.

PHOTOGRAPH 28: MERCURY LIGHT BALLAST (M-1) LOCATED WEST OF THE ONSITE SHOP. 9/22/16.

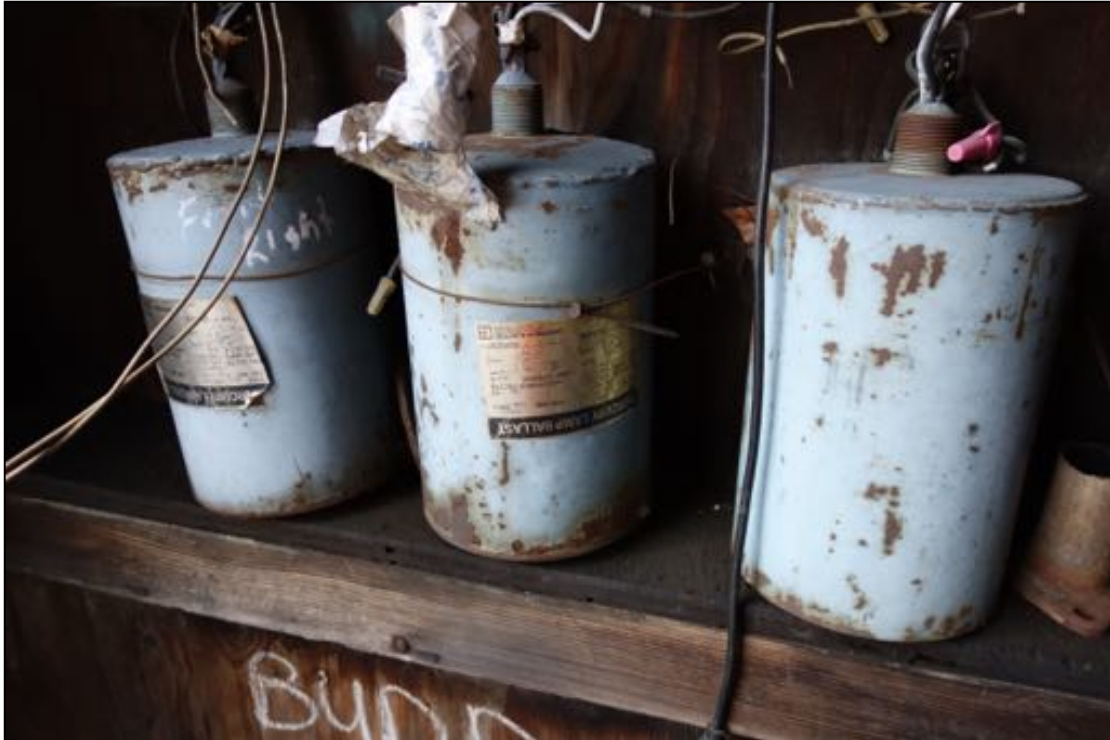
M-2) Three mercury ballasts were attached to the north wall of the onsite shop in the main bay, near the entrance. See photo 29 in photograph log.

**PHOTOGRAPH 29: THREE MERCURY LIGHT BALLASTS (M-2) LOCATED INSIDE ONSITE SHOP.
9/22/16.**

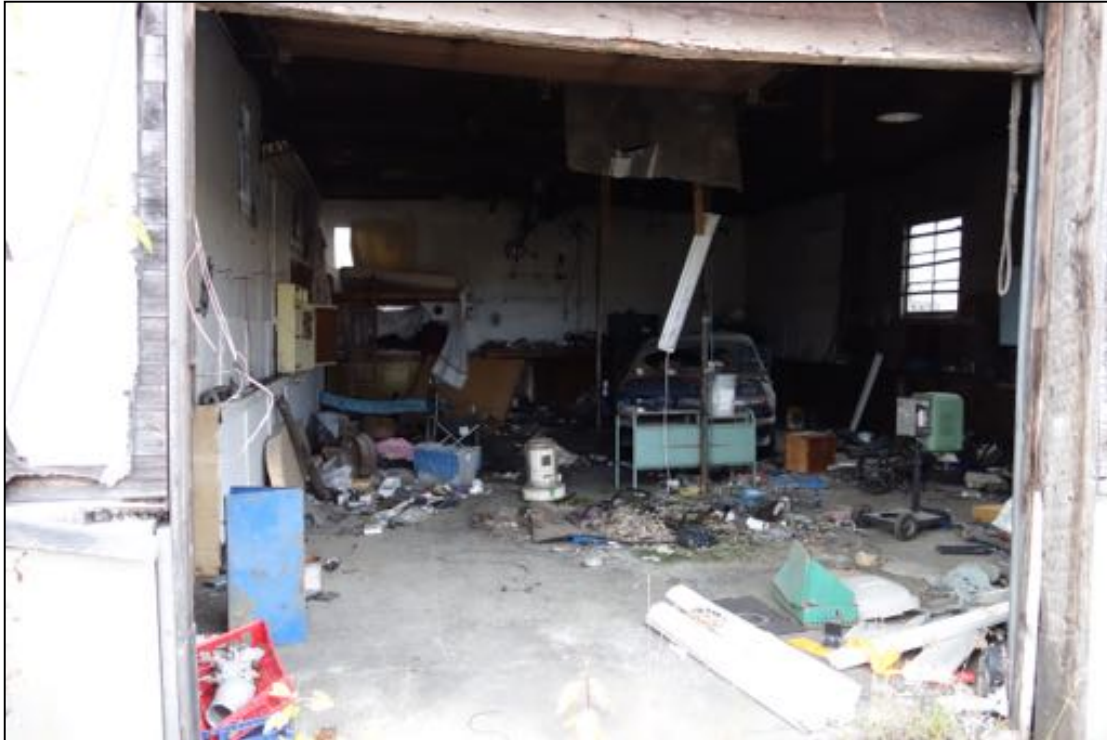
**PHOTOGRAPH 31: INSIDE OF SHOP; FLOOR DRAIN LOCATED BENEATH CAR; LOOKING EAST.
9/22/16.**

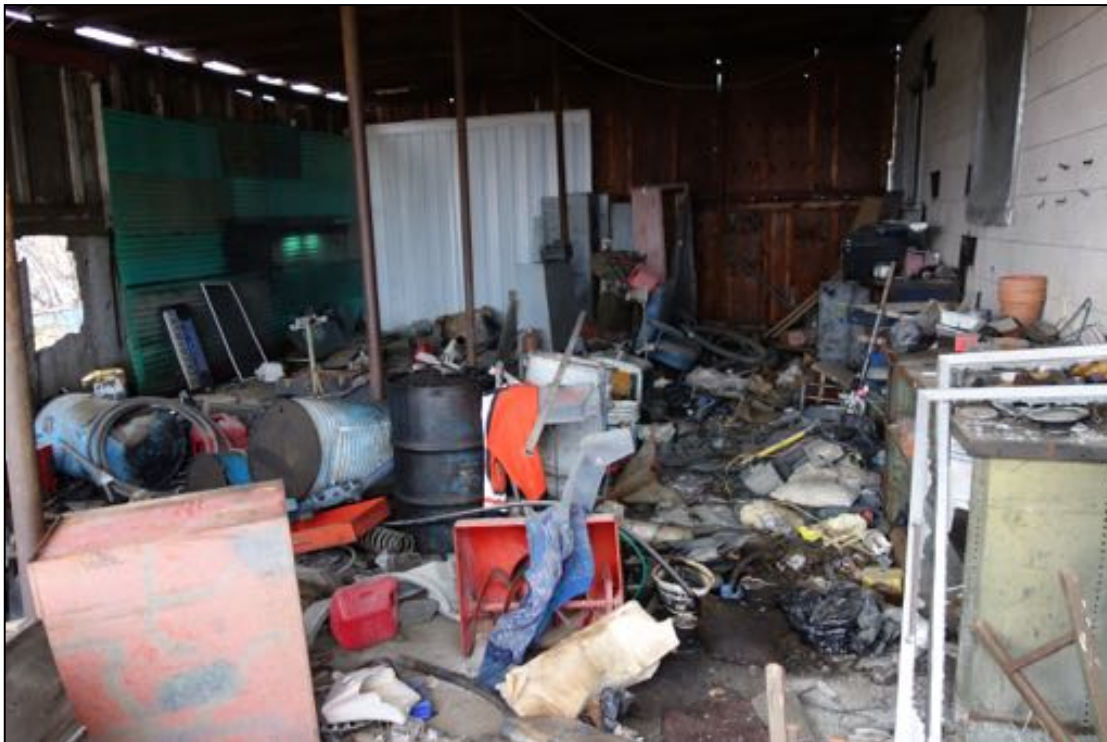
**PHOTOGRAPH 32: NORTHERN HALF OF SHOP; DRUMS WITH UNKNOWN CONTENTS OBSERVED;
OIL STAINING ON FLOOR; LOOKING WEST. 9/22/16.**

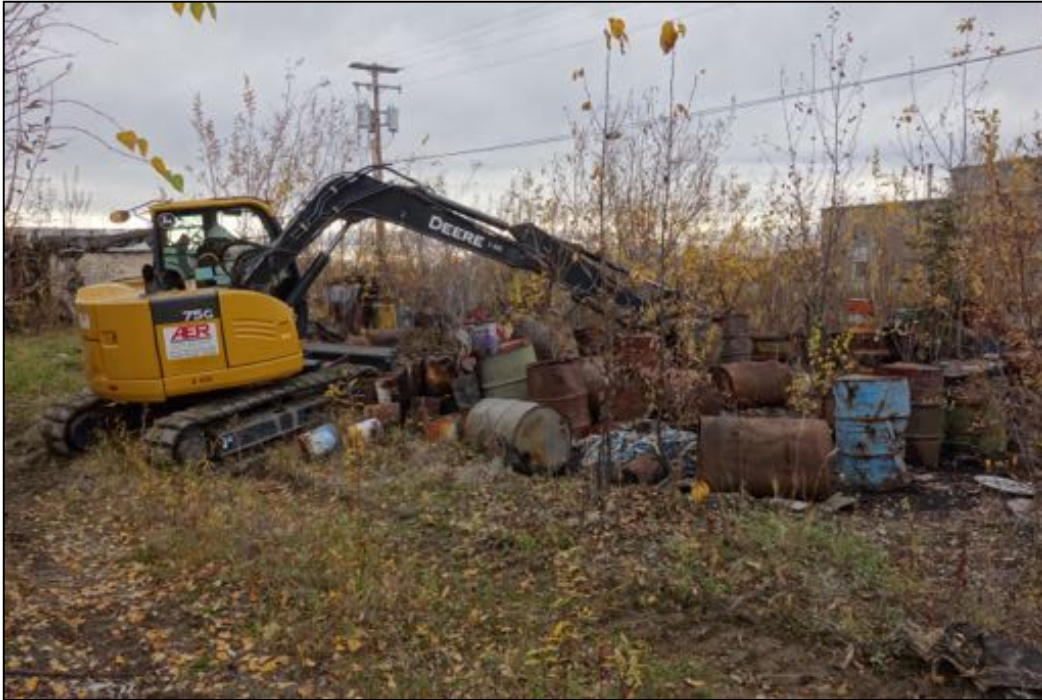
- 1) This area contains a combination of approximately 50, 55-gallon (gal) drums and 5-gal containers of unknown contents. Some of the containers appear to be unopened, while some appear to have been reused (spray painted “waste oil” and “gas”). There is an approximately 40 feet (ft) by 40ft area of black staining, which is possibly some sort of petroleum hydrocarbon product. There is a strong petroleum hydrocarbon odor in this location. A test pit (TP-25) was excavated to approximately 6.5ft below ground surface (bgs) in the stained area. An in-situ photo-

PHOTOGRAPH 33: AREA WITH APPROX 40 DRUMS WITH UNKNOWN CONTENTS (POSSIBLY GAS AND/OR WASTE OIL); OIL STAINING OBSERVED ON GROUND (SEE FIGURE – AREA OF INTEREST #1); LOOKING SOUTHWEST. 9/22/16.

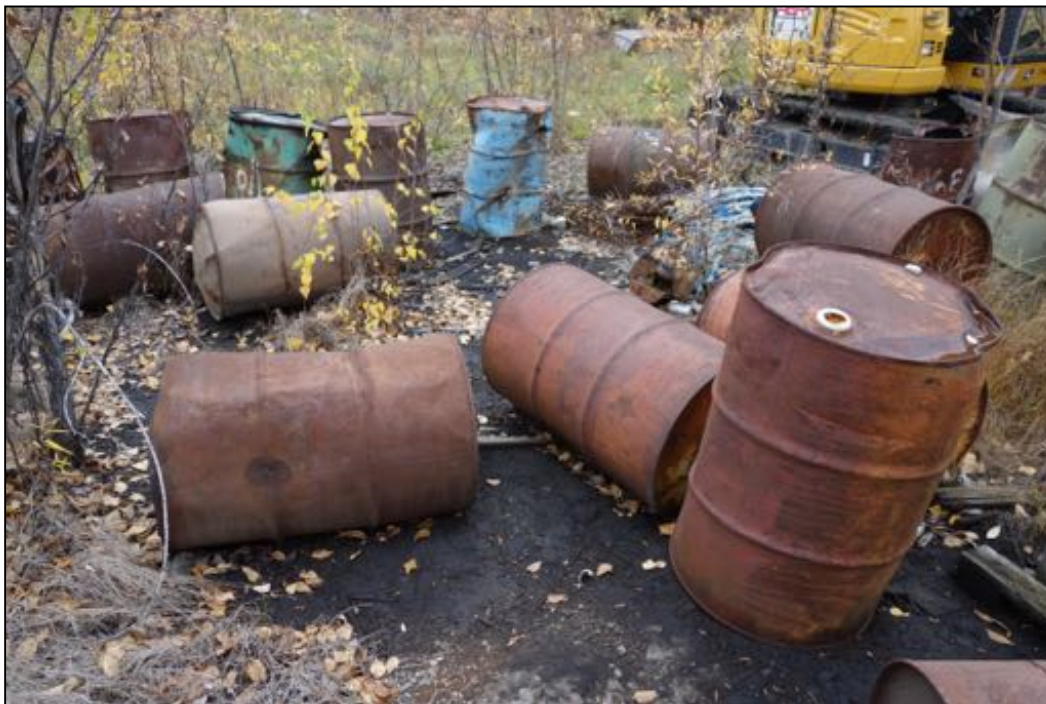
PHOTOGRAPH 33: AREA WITH APPROX 40 DRUMS WITH UNKNOWN CONTENTS (POSSIBLY GAS AND/OR WASTE OIL); OIL STAINING OBSERVED ON GROUND (SEE FIGURE – AREA OF INTEREST #1); LOOKING EAST. 9/22/16.

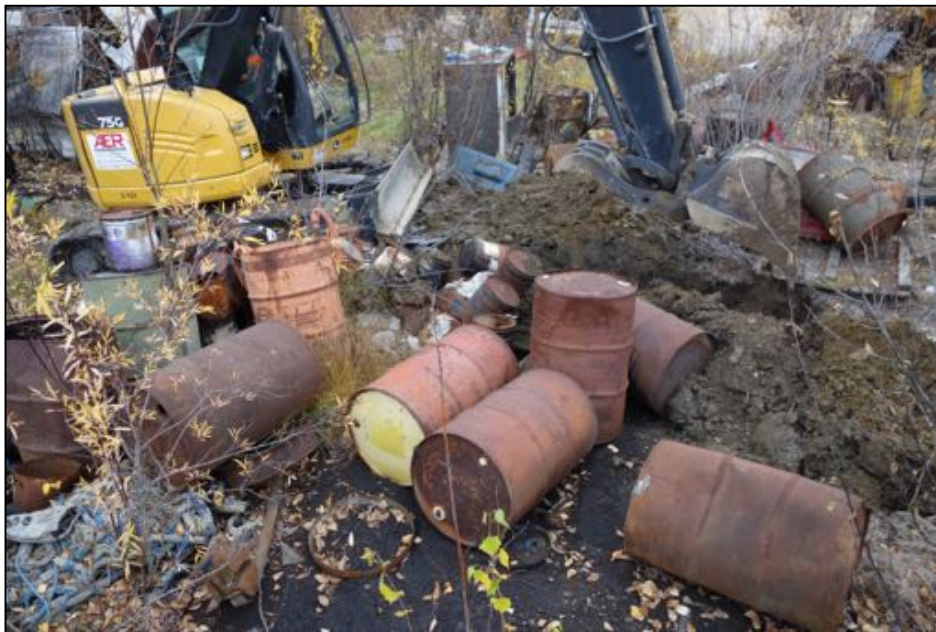
ionization detector (PID) reading of 10 parts per million (ppm) was indicated at 0.5 to 1ft bgs. Additionally, a slight petroleum hydrocarbon odor was observed in soil from 6.5ft bgs, at the depth of groundwater. Soil samples (SS-7A and SS-7C) were collected from 1ft and 6.5ft bgs, respectively, and were submitted to ALS Environmental Laboratory (ALS) for volatile organic compound (VOC), Resource Conservation and Recovery Act (RCRA) 8 metals, and polychlorinated biphenyl (PCB) analyses. Groundwater began to accumulate in the bottom of the test pit during excavation, and a slight sheen was observed. A groundwater sample (GW-7) was collected and submitted for VOC and RCRA 8 metals analyses. See photos 33 – 38 in photograph log.

**PHOTOGRAPH 35: DIG PIT (TP-25) IN STAINED AREA OF INTEREST #1; PID READING OF 10 PPM;
COLLECT SOIL SAMPLES (SS-7A AND 7C) AT 1FT AND 6.5FT BGS FOR VOCS AND METALS
ANALYSES; LOOKING SOUTH. 9/22/16.**

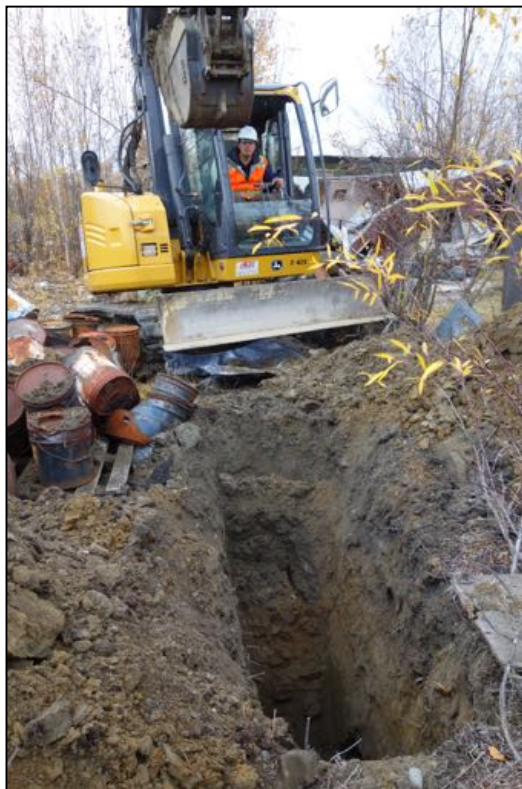
TP-25) This test pit was excavated to 6.5ft bgs in a stained location in Area of Concern #1. The PID result was 10 ppm near the ground surface; however, a moderate to slight petroleum hydrocarbon odor persisted to the groundwater depth of 6.5ft bgs. Soil samples (SS-7A and SS-7C) were collected from this location at 1ft and 6.5ft bgs, respectively. A groundwater sample (GW-7) was also collected from this location at 6.5ft bgs. See photos 36 – 38 in photograph log.

**PHOTOGRAPH 36: DIG PIT (TP-25) IN STAINED AREA OF INTEREST #1; PID READING OF 10 PPM;
COLLECT SOIL SAMPLES (SS-7A AND 7C) AT 1FT AND 6.5FT BGS FOR VOCS AND METALS
ANALYSES; LOOKING EAST. 9/22/16.**

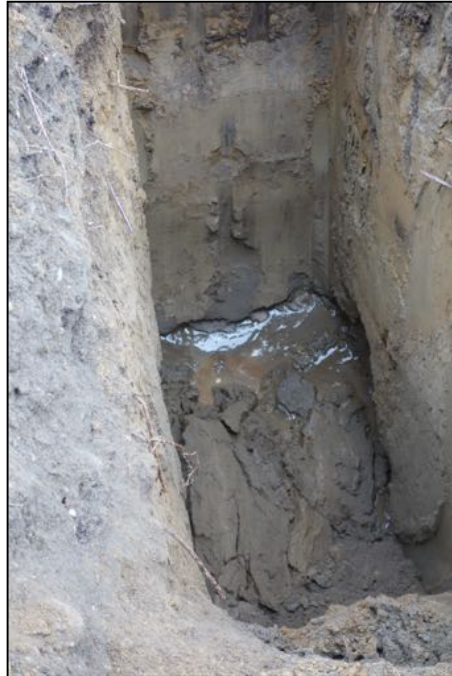
PHOTOGRAPH 37: TEST PIT (TP-25) IN AREA OF INTEREST #1 IS EXCAVATED TO GROUNDWATER DEPTH OF 6.5FT BGS; COLLECT GROUNDWATER SAMPLE (GW-7) FOR VOCS AND METALS ANALYSES. 9/22/16.

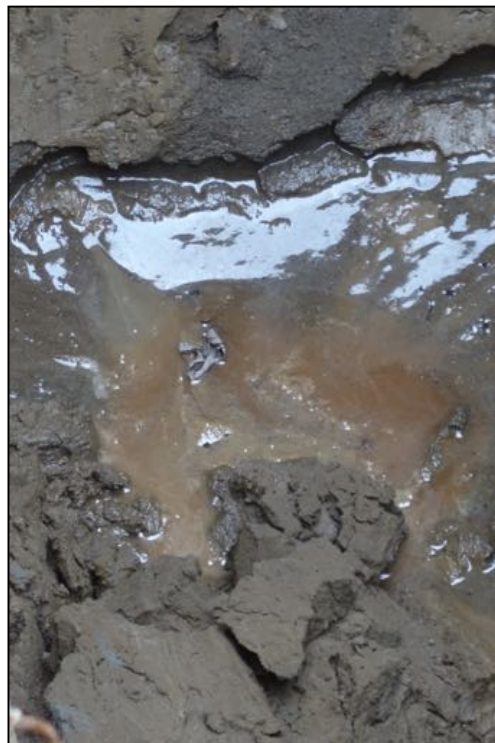
PHOTOGRAPH 38: TEST PIT (TP-25) IN AREA OF INTEREST #1 IS EXCAVATED TO GROUNDWATER DEPTH OF 6.5FT BGS; POSSIBLE SHEENING OBSERVED ON WATER SURFACE. 9/22/16.

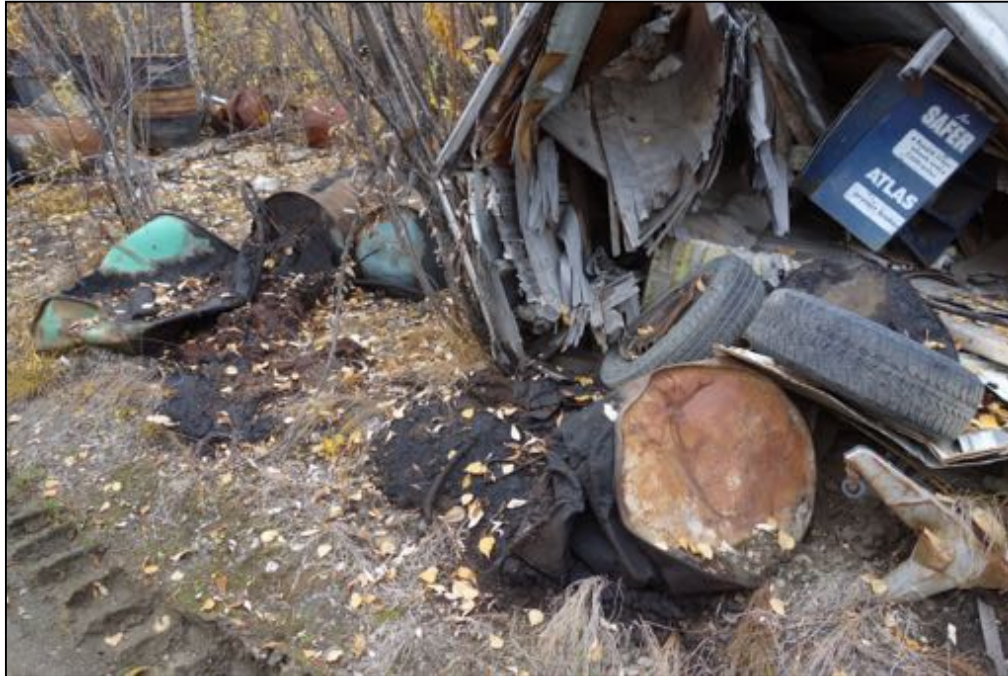
- 3) This area contains six drums with unknown contents lying on their sides. Some of the drums are crushed, while others are leaking their contents. A test pit (TP-26) was excavated to 2ft bgs in a stained area adjacent to these drums. A moderate petroleum hydrocarbon odor was observed in this area, and a PID reading of 12 ppm was recorded. A soil sample (SS-8) was collected in this area from 1ft bgs and was submitted to ALS for VOC and RCRA 8 metals analyses. See photos 39 and 40 in photograph log.

PHOTOGRAPH 39: AREA OF CRUSHED/LEAKING DRUMS AND OIL STAINING ON GROUND SURFACE (SEE FIGURE – AREA OF INTEREST #3); LOOKING NORTHWEST. 9/22/16.

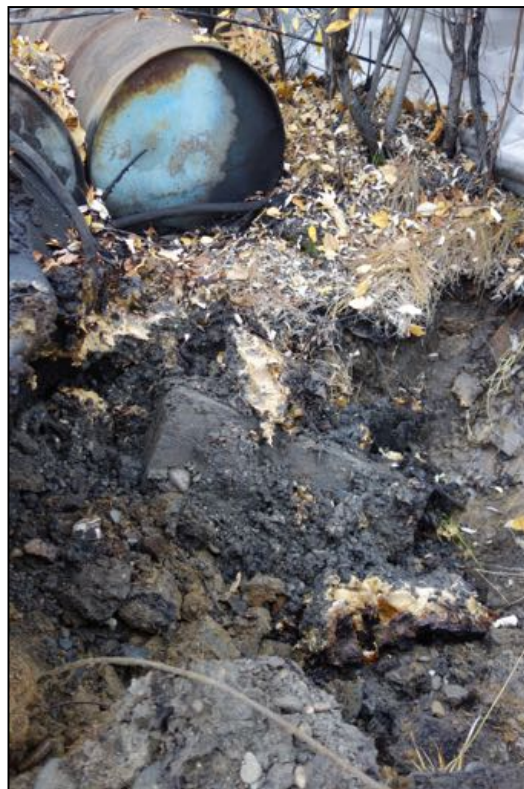
TP-26) This test pit was excavated to 2ft bgs in a stained location in Area of Concern #3. The PID result was 12 ppm. A soil sample (SS-8) was collected from this location at 1ft bgs. See photo 40 in photograph log.

PHOTOGRAPH 40: DIG PIT (TP-26) IN STAINED AREA OF INTEREST #3; PID READING OF 12 PPM; COLLECT SOIL SAMPLE (SS-8) FOR VOC AND METALS ANALYSES; LOOKING NORTH. 9/22/16.
