**Summary Site Assessment Report
Port of Anchorage Area
Anchorage, Alaska**

July, 1992

**Petroleum Users Group
Port of Anchorage
2000 Anchorage Port Road
Anchorage, Alaska 99501**

SHANNON & WILSON, INC.

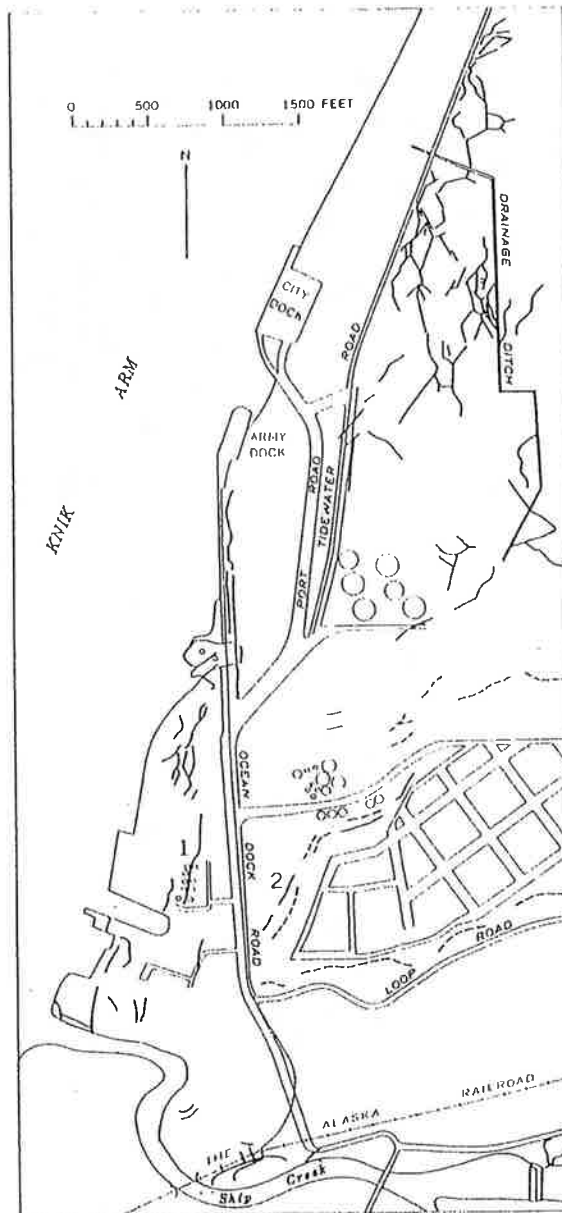
GROUND CRACKS FROM 1964 EARTHQUAKE

The City of Anchorage was struck by five major landslides in the downtown and residential areas which together accounted for a substantial portion of the total earthquake inflicted damage. Within the POA-PUG area, however, the majority of the damage induced by the quake was caused by ground displacement along fractures. Except for the Government Hill Slide, no major slides along the north bluff of Ship Creek were reported. Several small landslides occurred at locations, however, where fill material had been placed at the top of the slope along the bluff during former development (Shannon & Wilson, Aug. 1964). In addition, ground cracks developed in areas of the port, as shown in Figure 4, with the highest concentrations occurring in the northern portion within those parcels currently leased by Tote, Lonestar Cement No.1 and Sea Land and along Knik Arm within the parcels currently leased by MAPI, Lonestar Cement No. 2 and Chugach Electric (Varnes, 1969). The entire port area reportedly subsided in a non-uniform manner from 1 to 2-1/2 feet (Varnes, 1969).

Ground cracks caused by the March 27, 1964, earthquake (solid lines) and scarps of old landslides (dashed lines), port of Anchorage and vicinity.
