RE: FREE PRODUCT RECOVERY ASSESSMENT, FORMER MARKAIR FACILITY, KING SALMON, ALASKA; ADEC HAZARD ID: 1879

This letter report presents the results of Shannon & Wilson, Inc.'s (Shannon & Wilson) free product recovery assessment conducted at the Former MarkAir Facility in King Salmon, Alaska in June 2013. The project purpose was to recover free product from select monitoring wells at the site, evaluate the product recharge rate, and provide recommendations for recovering the free product.

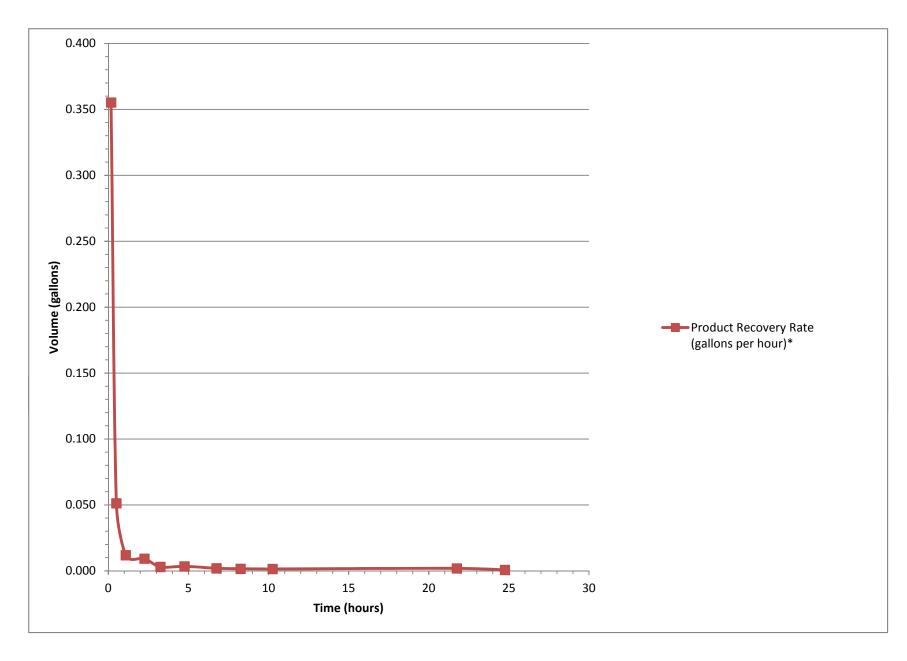
As shown on Graph 1 the rate of product entering the well dropped off significantly after ten minutes of monitoring. Due to the purging method and drawdown induced in the well, the initial recharge rate of 0.355 gallons per hour (gph) is likely higher than would be observed for a passive product recovery system. If a combined groundwater suppression/product recovery system is installed this would likely be the initial recovery rate. It is unknown how long this rate might be sustained.

The longer term recharge rate dropped below 0.01 gallons per hour [(0.58 milliliters per minute (mL/m)] after two hours and continued to decrease as the monitoring continued. Some of the measured decrease in the recharge rate is likely due to reaching static site conditions. With a continuous passive recovery system, it is estimated that a recovery rate of approximately 0.04 gph may be achievable for a limited amount of time.

While a combined groundwater suppression/product recovery system may increase product recovery rates it will also generate large quantities of water that will require treatment. We recommend installing 2 to 3 recovery wells in the vicinity of Monitoring Well B9MW. The recovery wells should be completed as six-inch diameter wells with stainless steel wire-wound screens. These screens allow product to enter the well more easily and generally minimize magnification effects opposed to slotted polyvinyl chloride wells. The use of a hydrophobic filter pack should also be evaluated.
