Re: **Hilcorp Trading Bay Piping Leak, Hazard ID: 27671**
Request for Work Plan

HILCORP TRADING BAY PRODUCTION FACILITY

ADEC FILE #: 2337.38.007, HAZARD ID: 1263

Date:	4/14/2023
Revision:	0
Project:	Trading Bay Production Facility
To:	Pete Campbell, ADEC
From:	Drew Anderson, Hilcorp
Attachments:	Attachment 1 – Figure Attachment 2 – Hydrographs Attachment 3 – LNAPL Thickness Graphs

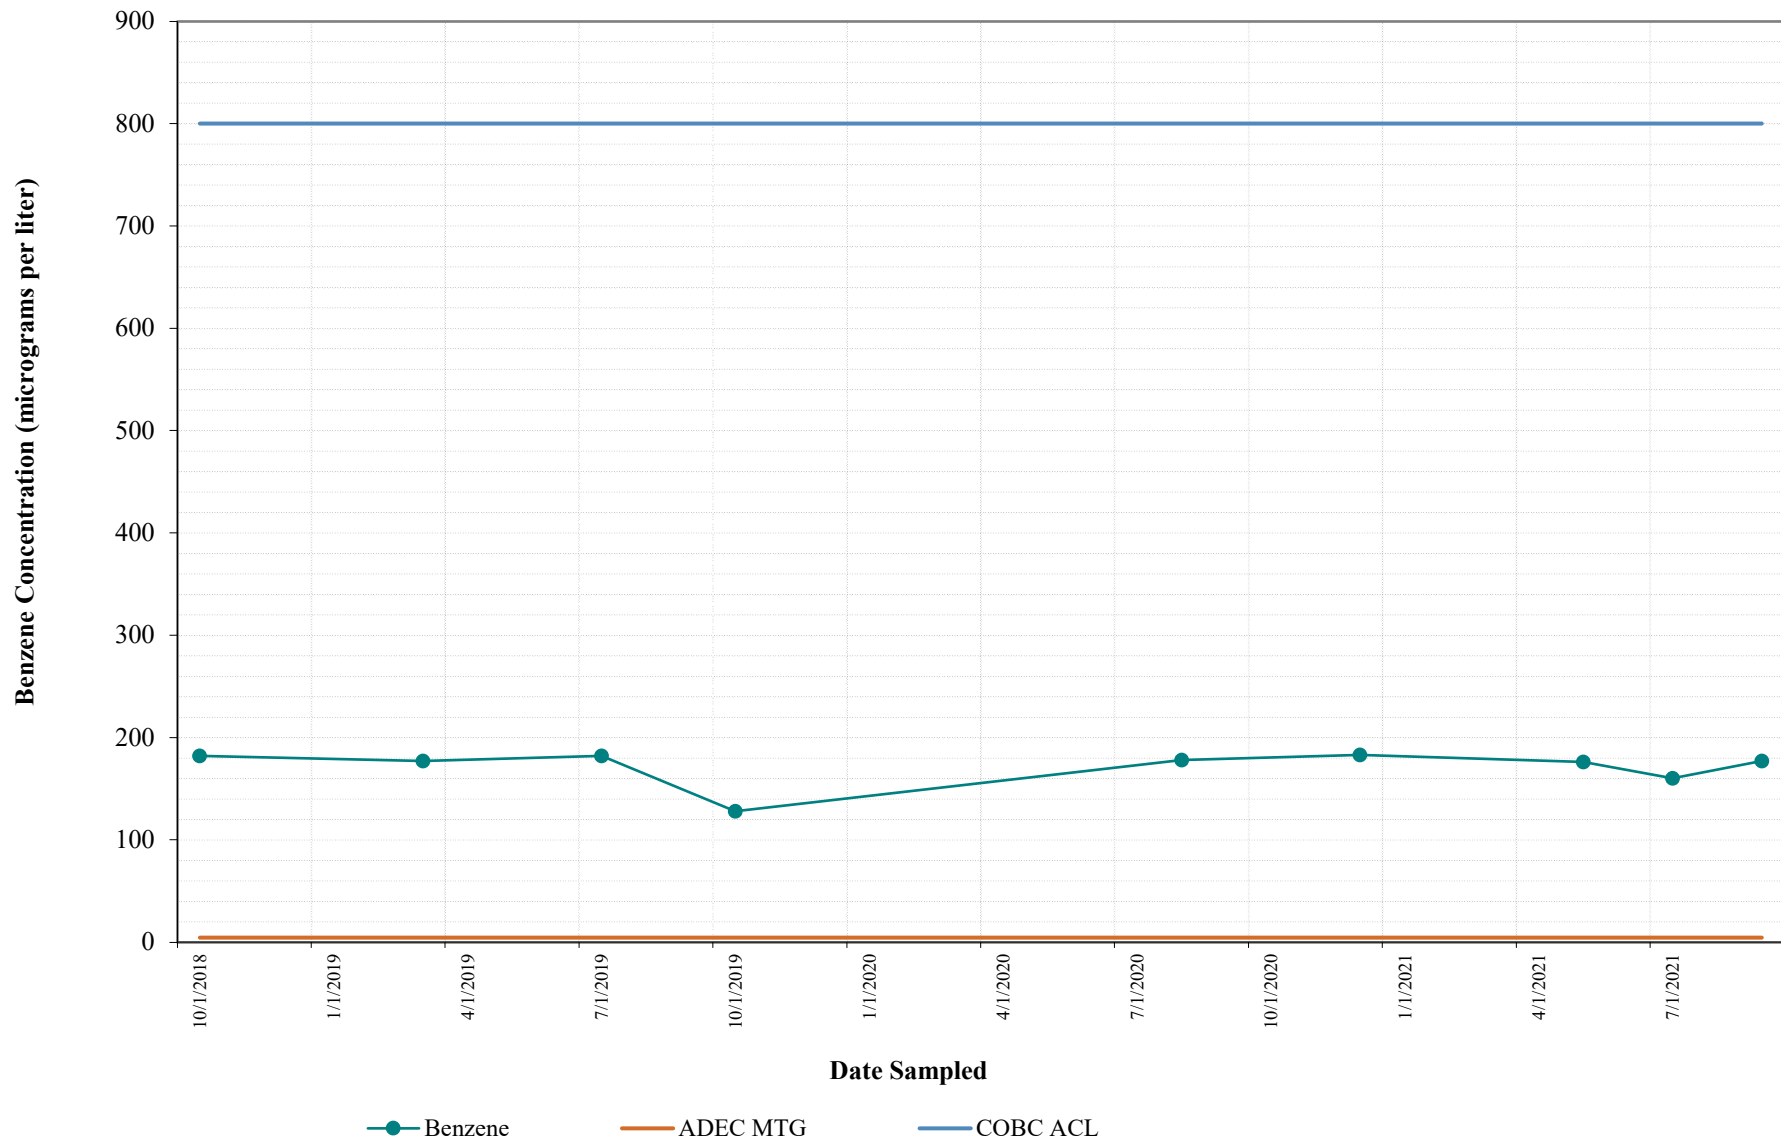
**RW-6
Benzene Concentrations
Trading Bay Production Facility
Cook Inlet, Alaska**

Hydrographs were generated for benzene concentrations in recovery wells RW-6 and RW-7, located downgradient of this spill, and are presented in Attachment 2. The hydrograph for RW-6 shows a steady concentration of benzene well below the COBC ACL. Although there is a spike of benzene in RW-7 in April 2021, after the conclusion of response activities for this spill, concentrations dropped to well below the COBC ACL in the next two sampling events.

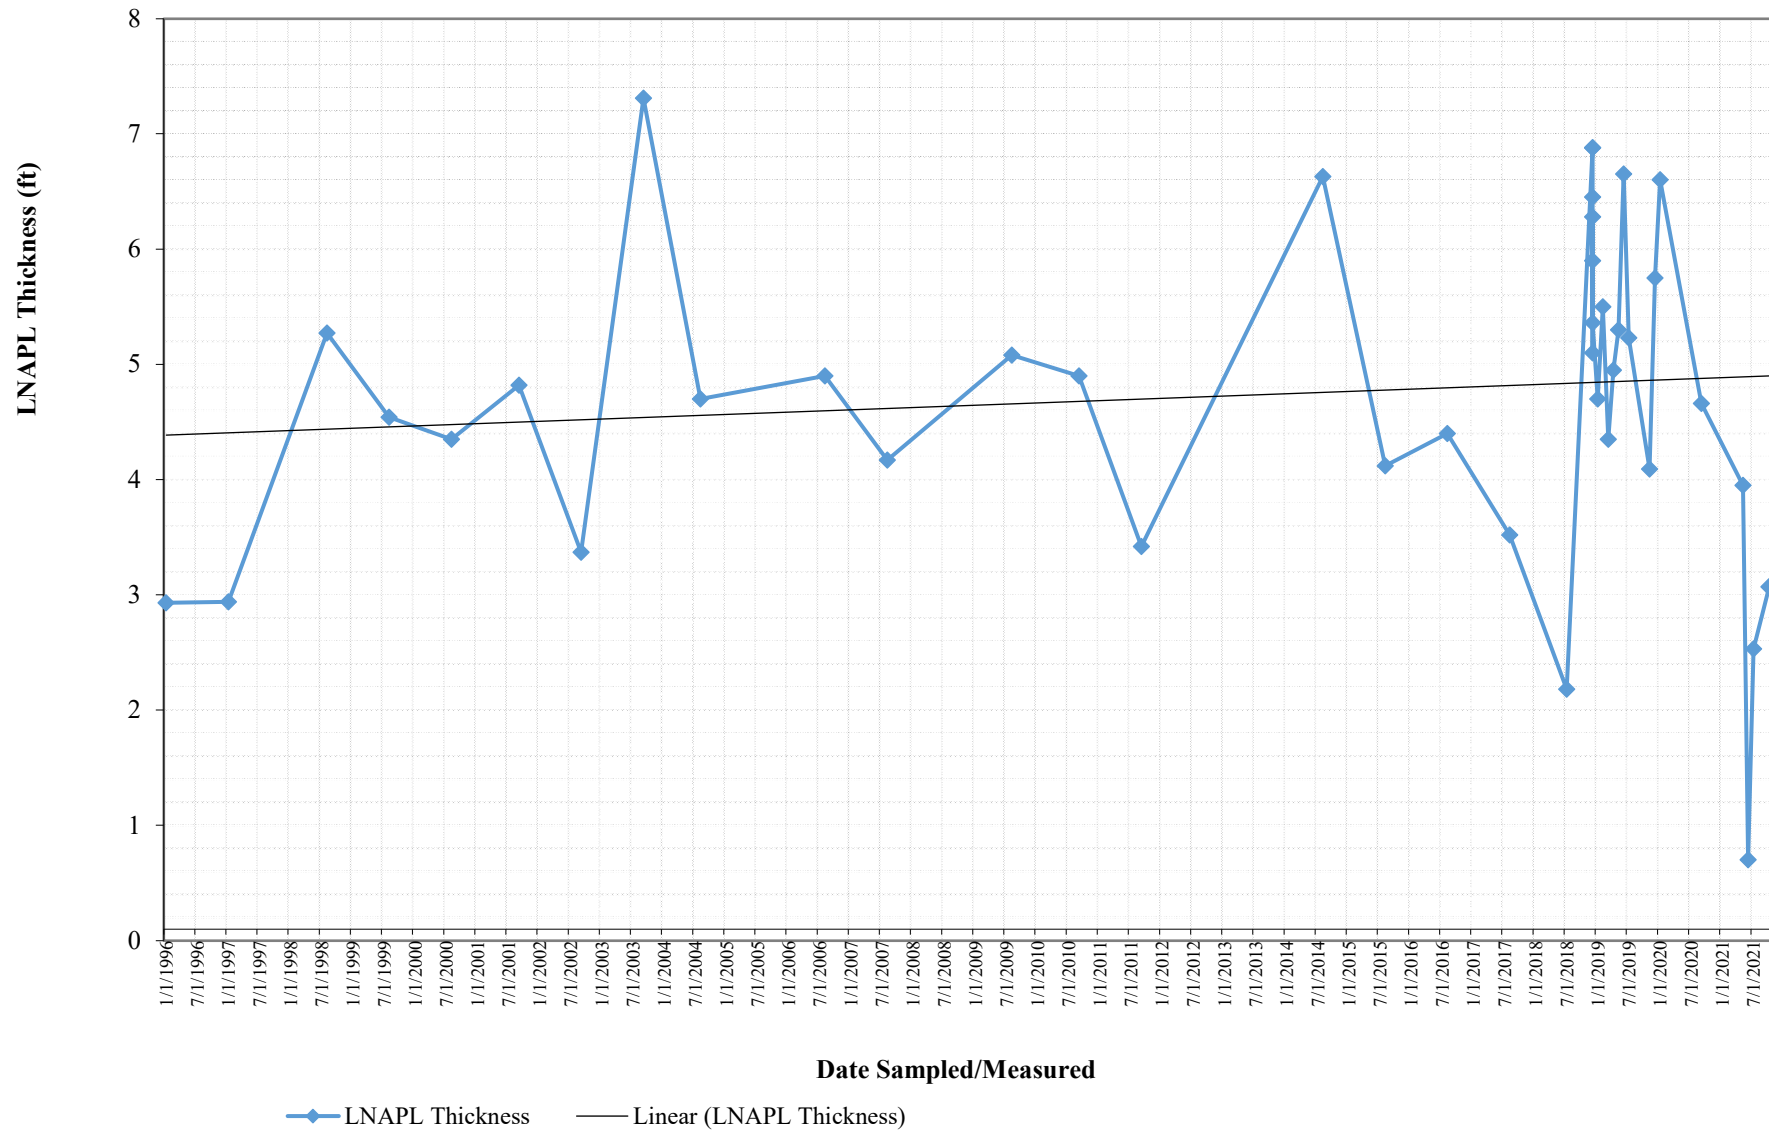
M-102D
LNAPL Thickness
Trading Bay Production Facility
Cook Inlet, Alaska

In addition to the hydrographs of benzene concentrations, linear graphs of measured NAPL thickness in wells M-111, RW-2 and M-102D were generated to illustrate NAPL thickness and variation over time (Attachment 3). Both M-111 and RW-2 show a linear trendline that is decreasing. Although the linear trendline for M-102D indicates a slightly increasing trend, all measurements collected since September 2020 have been below the overall average NAPL thickness for the well.
