**FINAL 2022 FIVE-YEAR REVIEW FOR  
SITE SS001 AT  
BETHEL RADIO RELAY SITE (RRS), ALASKA**

**Prepared By:  
Ahtna Solutions, LLC  
110 West 38<sup>th</sup> Avenue, Suite 200L  
Anchorage, Alaska 99503**

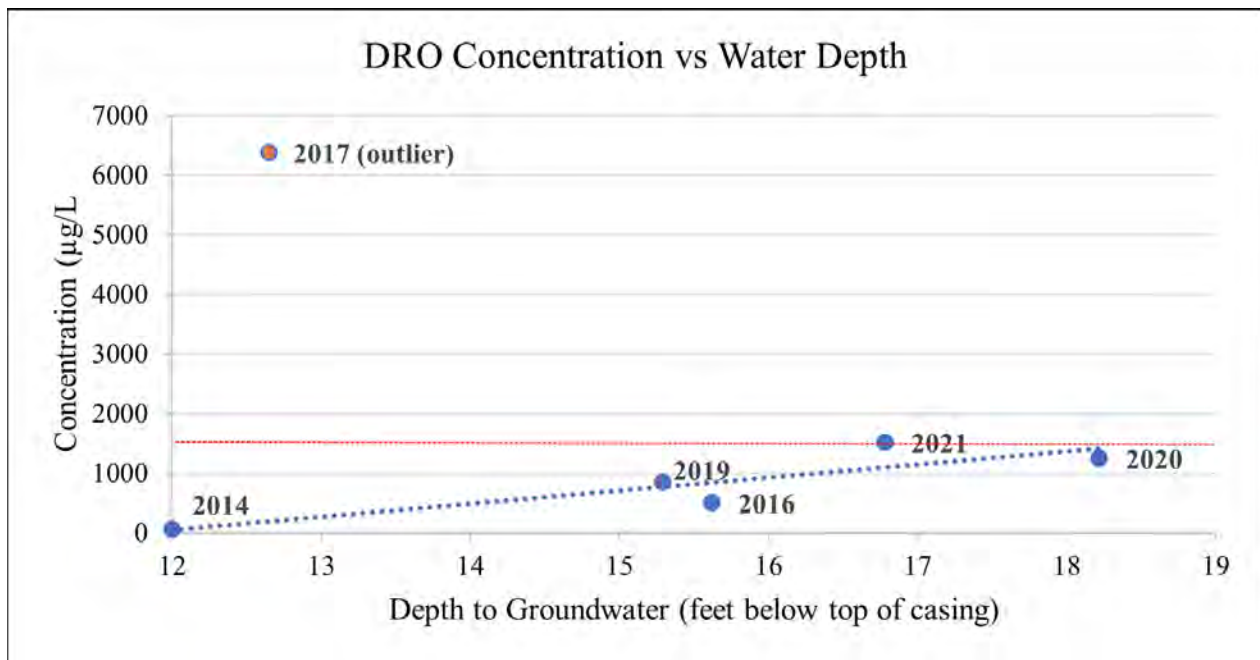
**GRAPH 1: DRO CONCENTRATIONS VS WATER DEPTH**

A Mann-Kendall trend analysis was performed utilizing data from the six historical sampling events. The results of the Mann-Kendall analysis show the DRO concentration is likely increasing in well MW-19RRS-R with a Confidence Factor of 93.36 percent (USAF, 2022). If the 2017 concentration is considered an outlier, there may be a correlation between DRO concentrations and water depth at the time of sampling,  $r^2 = .76$ ; however there still appears to be an increase in concentration over time (Graph 1).

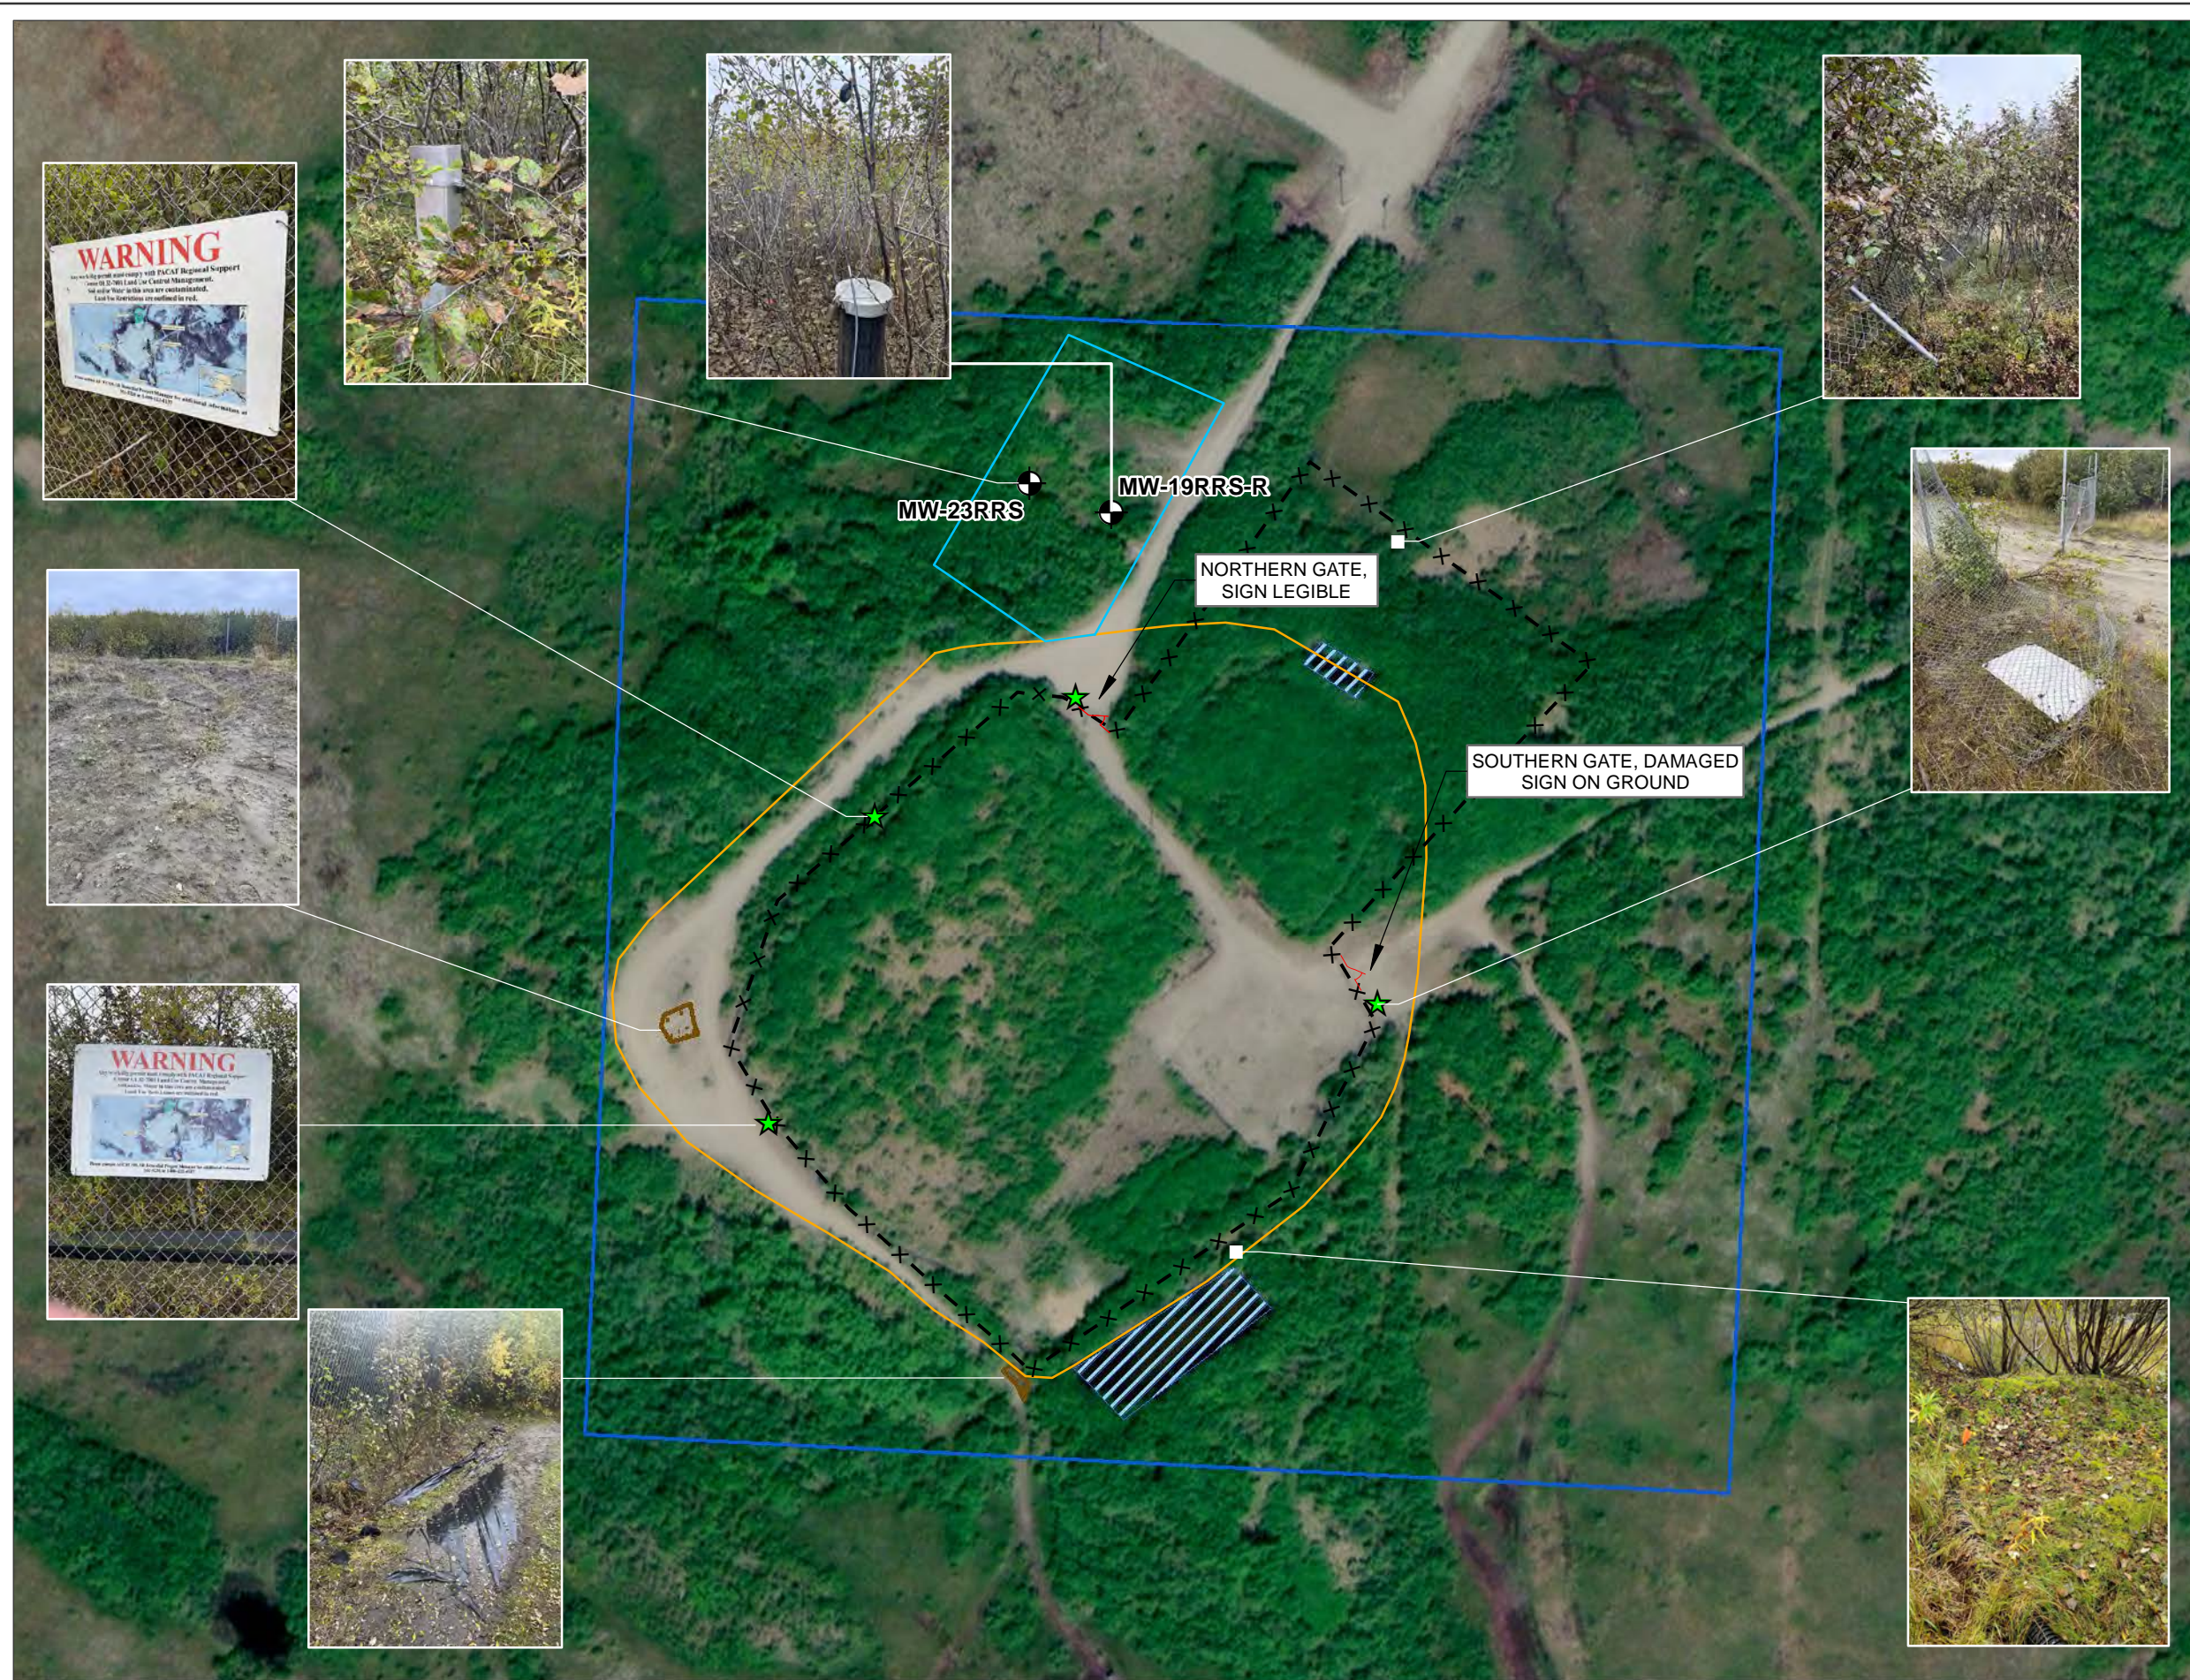
originating from the cap area within the fence. Consistent with past LUC inspections, erosion was also noted outside the exclusion fence in the western section of the SS001 boundary where fresh ATV and dog tracks were visible in the unvegetated silty gravel and along the ATV trail (Figure 2).

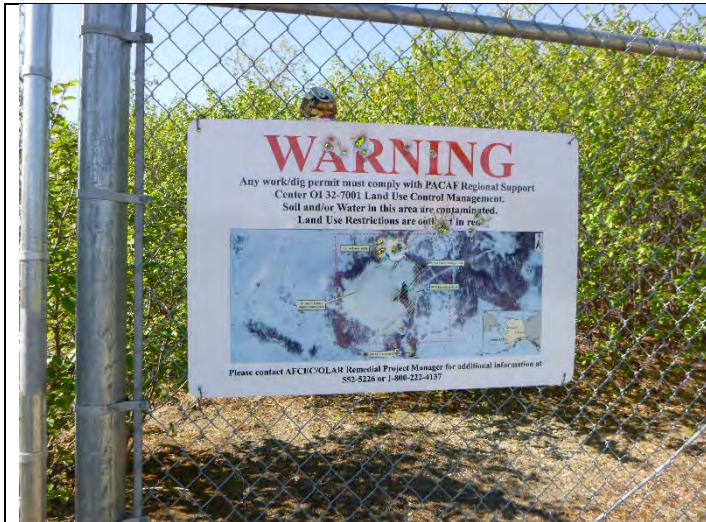
**PHOTO 1:** Signage at northern gate. Note bullet hole damage but mostly legible.

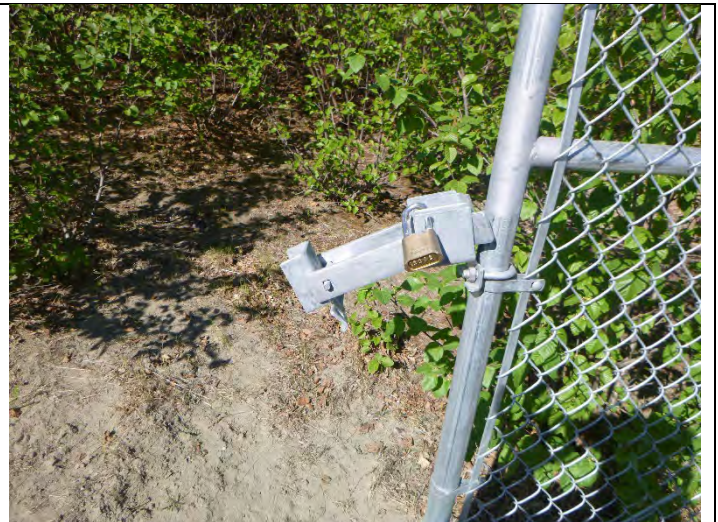
**PHOTO 2:** Northern gate latch was removed to allow trespassing.

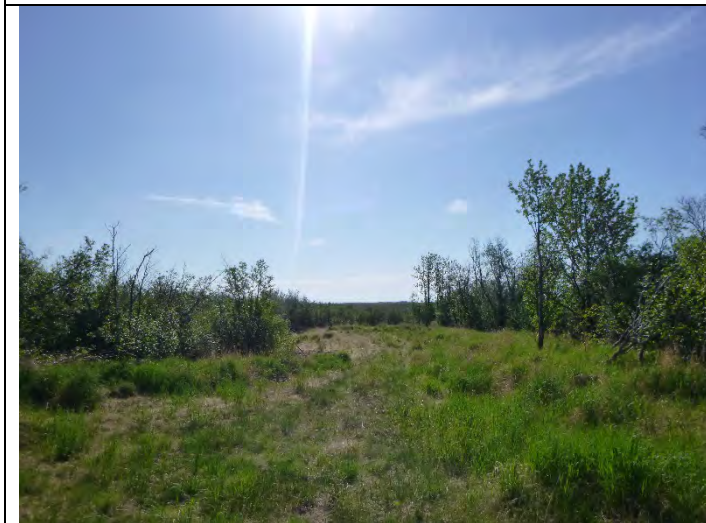
**PHOTO 3:** Photo of clearing in northeast quadrant of site.

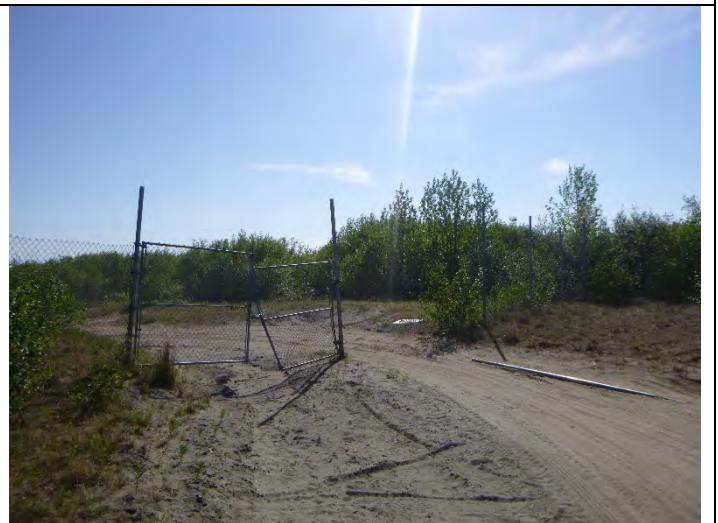
**PHOTO 4:** Southern gate has been extensively vandalized to allow for trespassing by vehicles. Note signage present on ground, but otherwise in good condition.

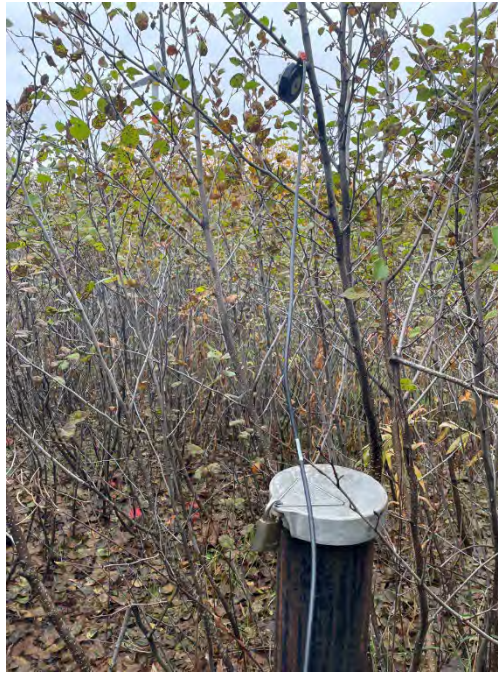
Photo ID: BE004. View north. MW-19RRS-R secured with lock, tall alders encroaching. GPS antenna hanging above well in the alder.

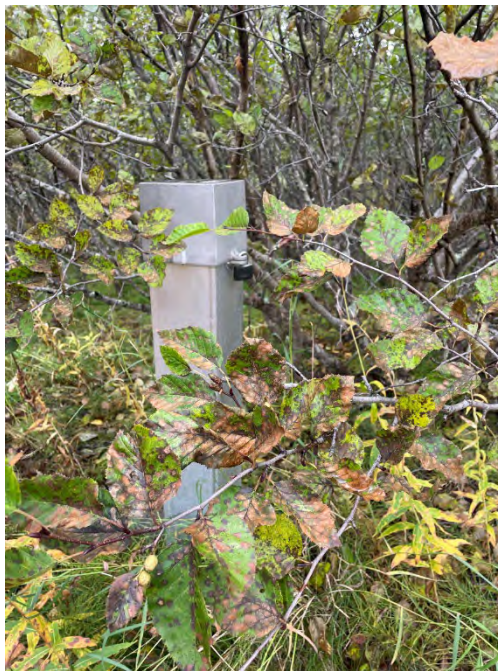
Photo ID: BE005. View northwest. MW-23RRS secured with lock, surrounded by dense alders.

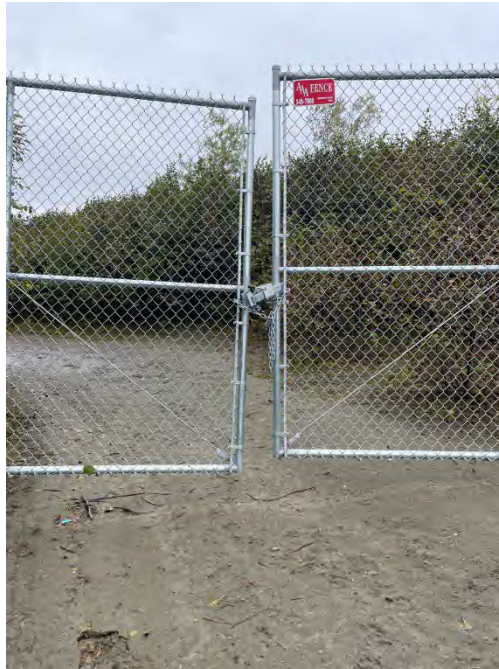
Photo ID: BE002. View south. Northern gate secured with locked chain. Prevents vehicles/ATVs access but not trespassers on foot.

Site SS001	<b>Issue Category:</b> Site Access/Security			
	<b>Issue:</b> The exclusion fence continues to be vandalized and breached by trespassers			
	<b>Recommendation:</b> The USAF, in cooperation with ADEC and as programming allows, should develop a plan to remove the fence while ensuring protectiveness of the remedy. Regulatory requirements, including final thickness of the soil cap, and any post-ROD changes to the remedy should be documented in an ESD. Community outreach to raise awareness of site contaminants and the importance of maintaining the soil cap integrity should be performed.			
<b>Affect Current Protectiveness</b>	<b>Affect Future Protectiveness</b>	<b>Party Responsible</b>	<b>Oversight Party</b>	<b>Milestone Date</b>
No	Yes	Other (AFCEC)	State	2024

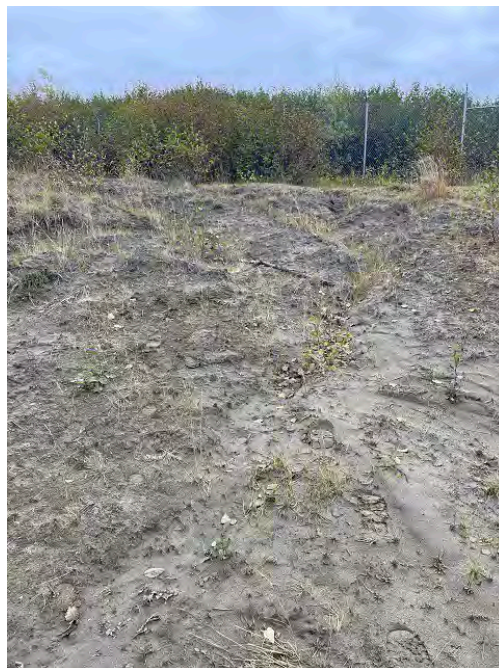
Photo ID: BE007. View northeast. Erosion area outside of exclusion fence in the western portion of SS001 LUC boundary. Evidence of ATV, foot, and dog traffic. Does not affect protectiveness because the cap is protected by a berm and lined drainage channel.

Site SS001	<b>Issue Category:</b> Operations and Maintenance			
	<b>Issue:</b> Erosion has been noted around the perimeter of the western fence and the southern gate.			
	<b>Recommendation:</b> Apply native grass seed to the southern gate area and northwestern erosion area outside the exclusion fence. Repair the southwestern erosion area along the ATV trail to cover the exposed liner.			
<b>Affect Current Protectiveness</b>	<b>Affect Future Protectiveness</b>	<b>Party Responsible</b>	<b>Oversight Party</b>	<b>Milestone Date</b>
No	Yes	Other (AFCEC)	State	2024

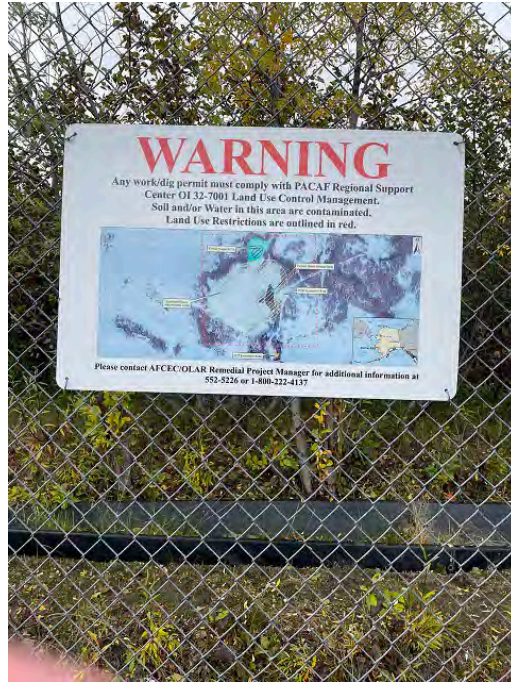
Photo ID: BE009. View northeast. LUC sign along southwestern exclusion fence in good condition. Lined drainage channel surrounding soil cap area shown beyond fence in lower portion of photo.

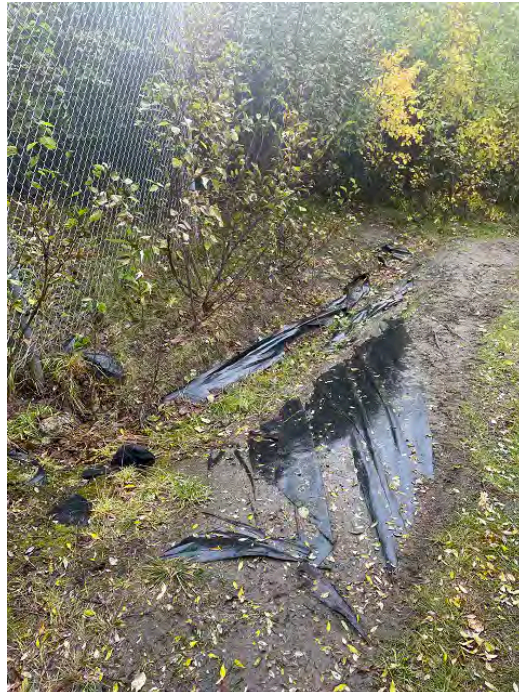
Photo ID: BE010. View southeast. Erosion and exposed liner along ATV trail at the southern corner of exclusion fence. Does not affect protectiveness as the cap is protected by a berm and lined drainage channel. See photo ID: Index 12, below.

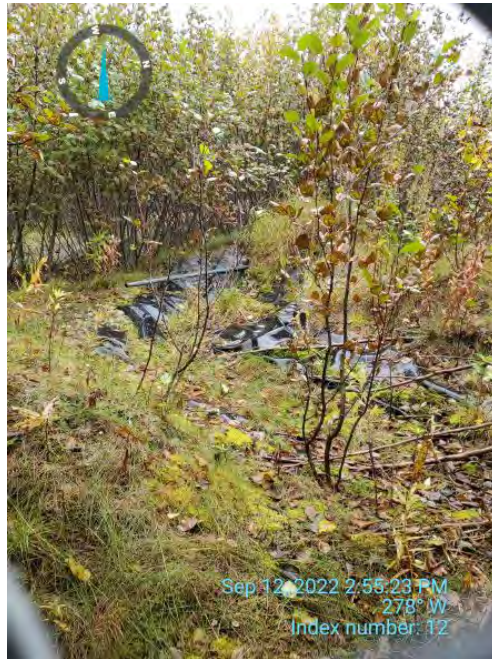
Photo ID: Index 12. View west. Lined drainage channel within exclusion fence at south corner adjacent to ATV trail. No sign of breaching contributing to ATV trail erosion.

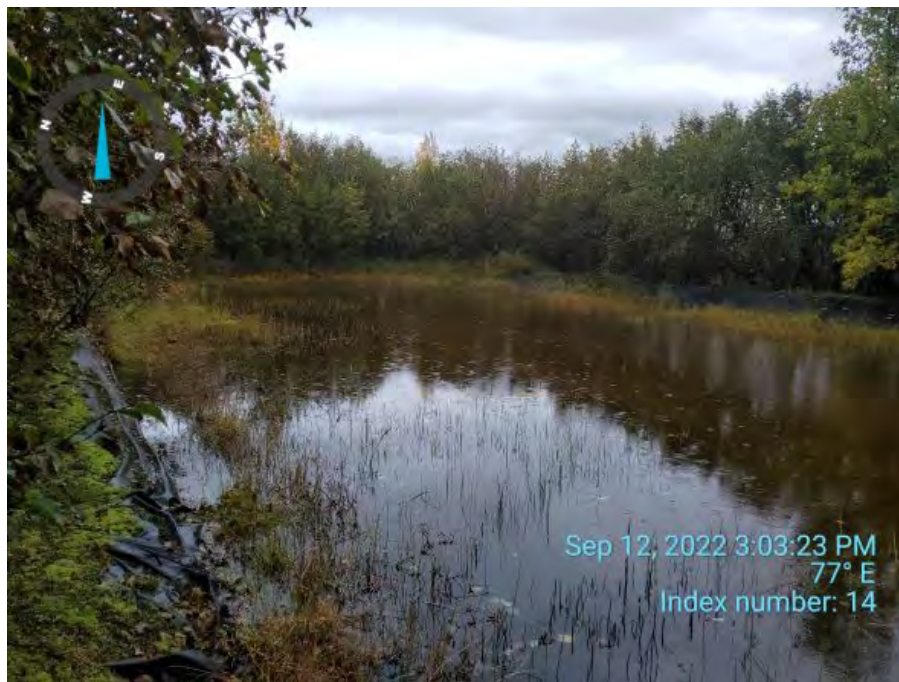
Photo ID: Index 14. View east. Lined holding pond south of exclusion fence.

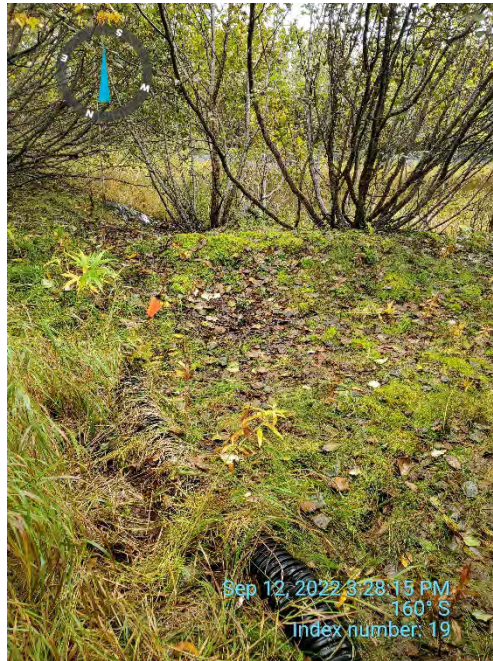
Photo ID: Index 19. View south. Black corrugated drain pipe protruding from southeast exclusion fence towards southern holding pond. Pipe terminates just before holding pond (orange flagging).

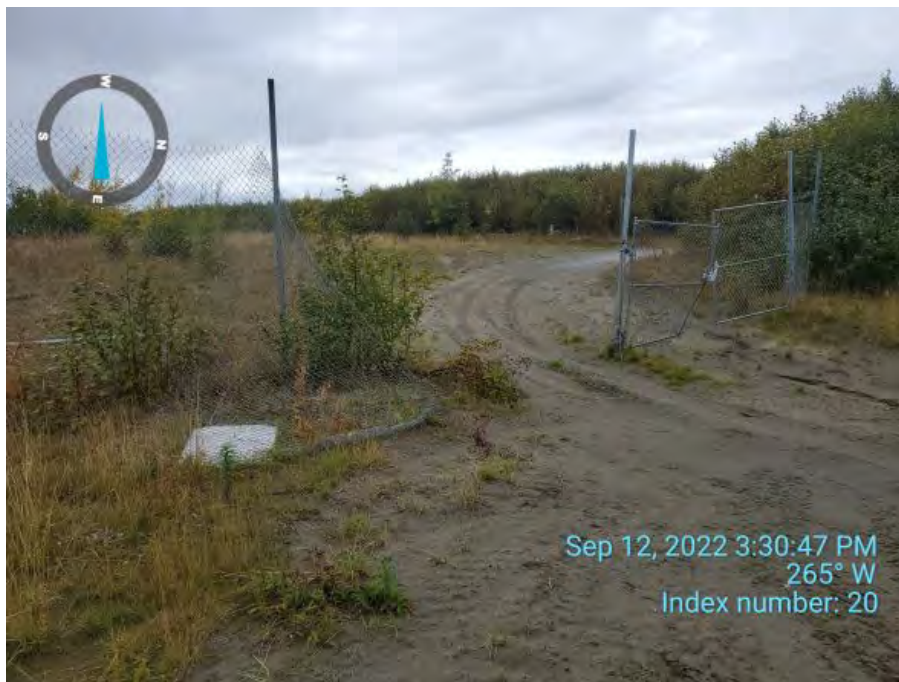
Photo ID: Index 20. View west. Southern gate with exclusion fence torn down. LUC sign on the ground but in good condition. ATV tracks and road erosion at photo right.

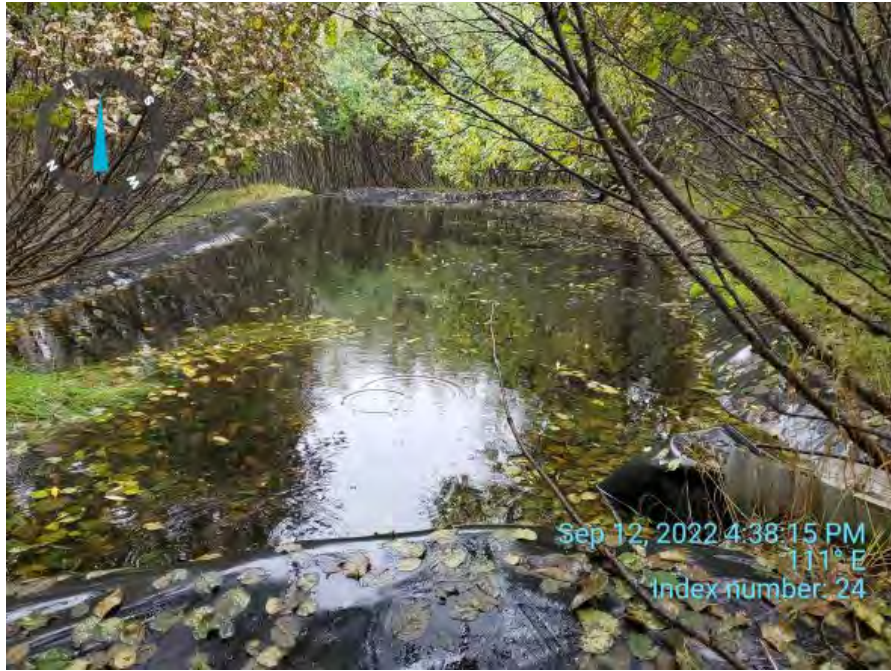
Photo ID: Index 24. View southeast. Eastern holding pond within exclusion fencing. Two functioning drainage culverts at west corners of pond liner.

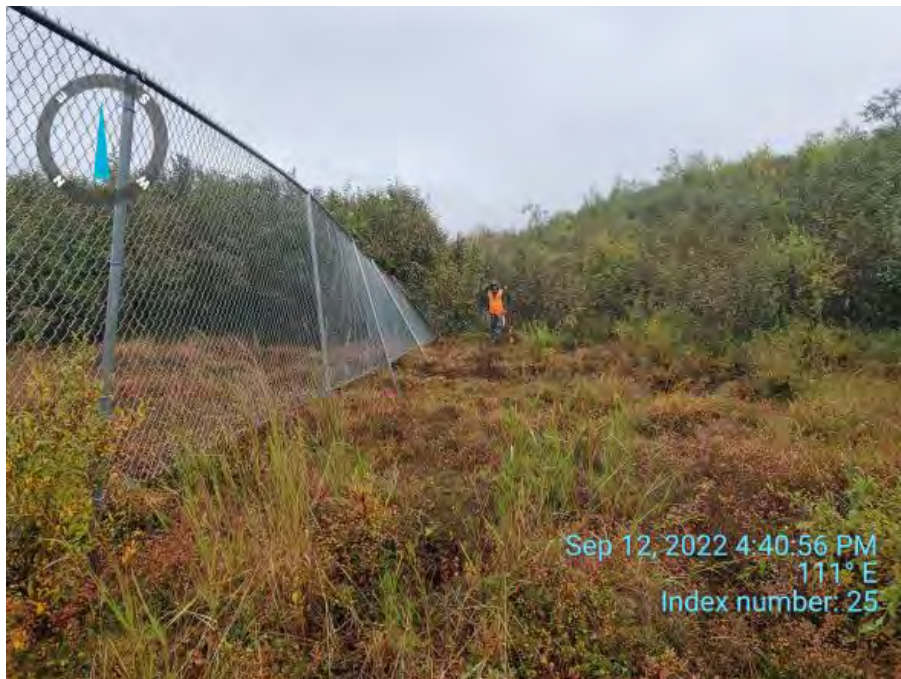
Photo ID: Index 25. View southeast. Eastern exclusion fence with post frost-jacked and leaning at 45-degree angle. Alders entwined in fence.

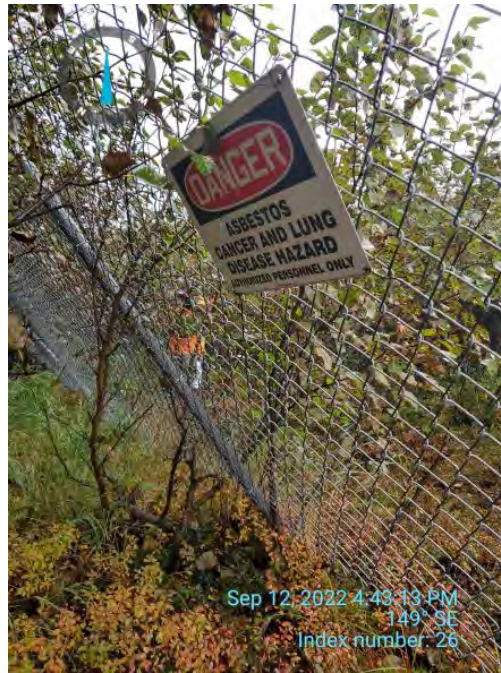
Photo ID: Index 26. View southeast. Asbestos warning sign hung on eastern exclusion fence. Fence leaning at 45-degree angle.

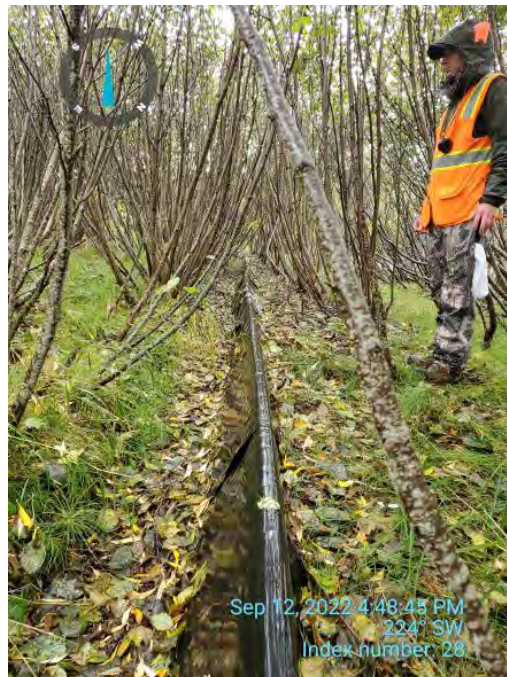
Photo ID: Index 28. View southwest. Lined drainage channel within eastern exclusion fence area, in good condition. Photo shows dense, tall alder growth characteristic of eastern and western cap areas.

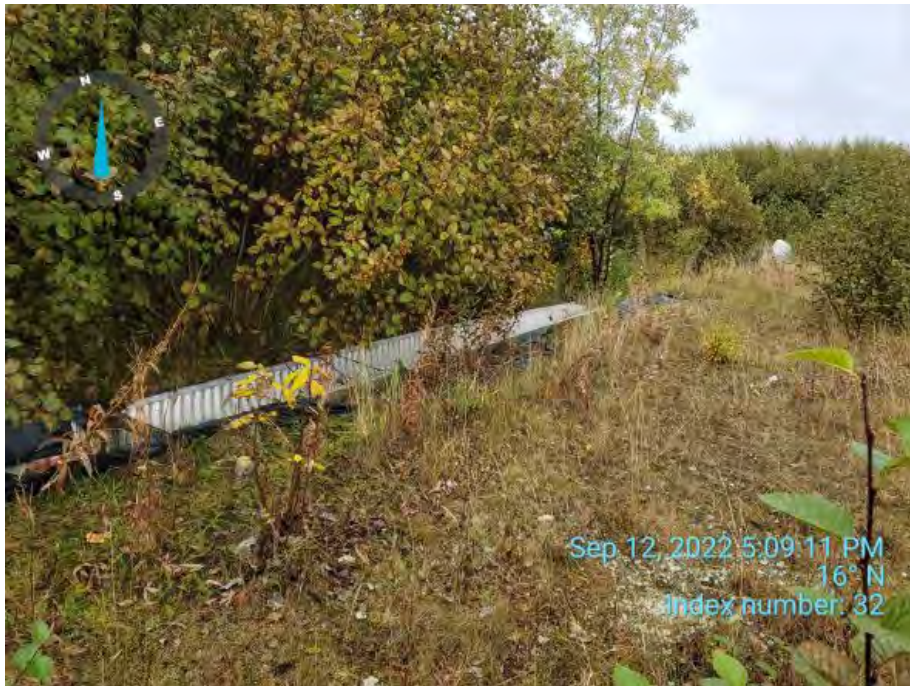
Photo ID: Index 32. View north. Drainage culvert along southern boundary of primary soil cap area.  
Corner of culvert shown protruding at photo right.

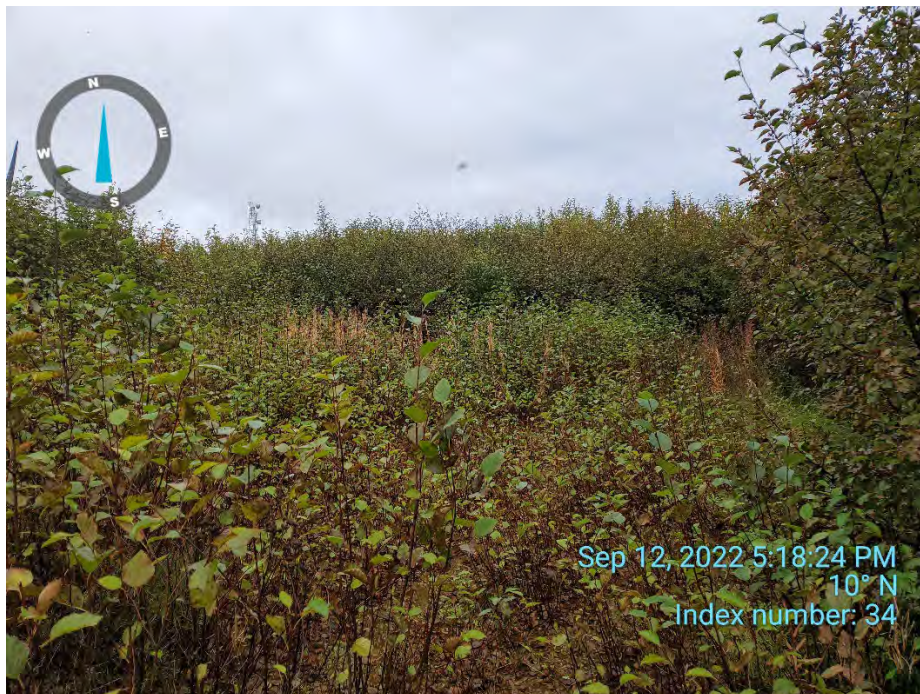
Photo ID: Index 34. View north. 2016 soil cap repair area showing native vegetation re-establishing.
