October 18, 2011

**Re: North Star Terminal #2
Chlorinated Solvent Site – Well Search and Indoor Air Survey
Fairbanks, Alaska**

Report **NORTH STAR TERMINAL #2
CHLORINATED SOLVENT SITE - WELL SEARCH AND
INDOOR AIR SURVEY**

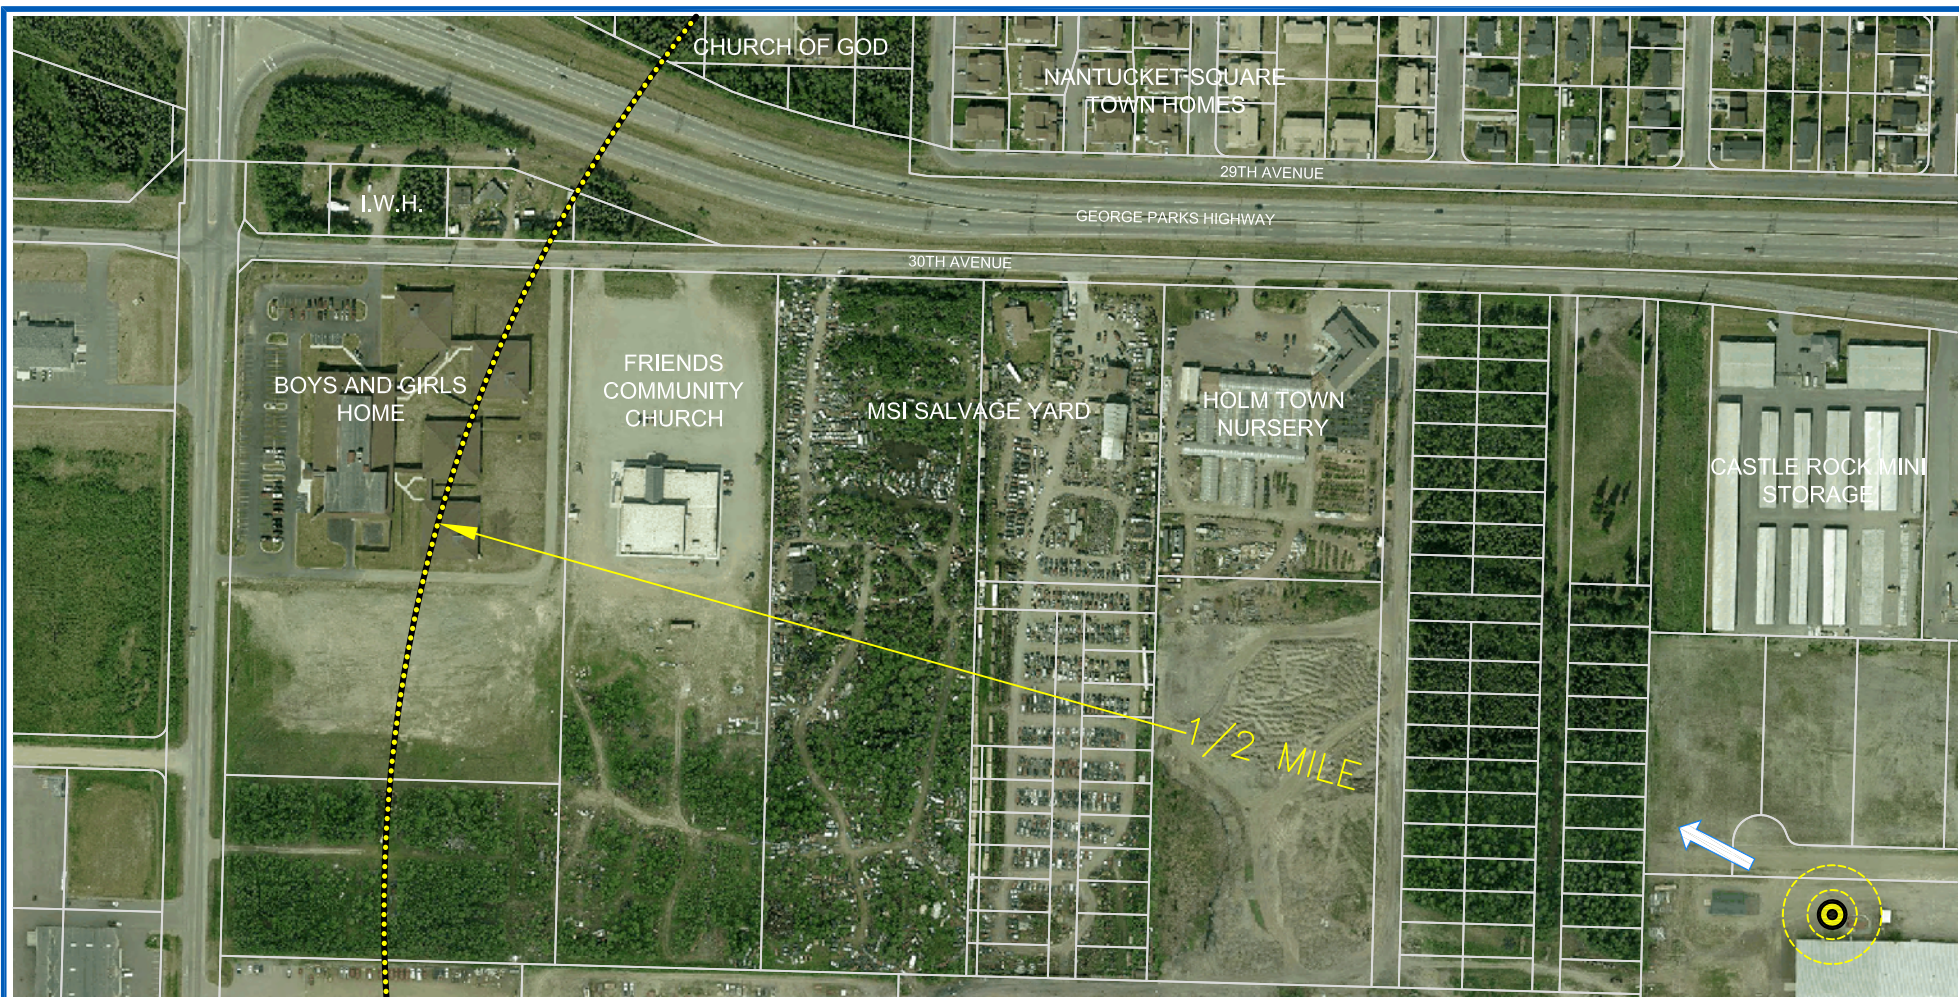
FIGURE 2 – WELL SEARCH PROPERTY MAP

SLR reviewed the Fairbanks North Star Borough online Property Database in order to identify landowners within a ½-mile radius down-gradient of the BESS facility (Figure 2) based on historic groundwater flow direction (SLR, 2010). Utility Services of Alaska was contacted to document whether those properties are connected to public utilities (Attachment 3). Developed properties were then contacted to inquire whether a domestic groundwater well is located on site. Of the eight developed properties identified, one is not connected to the public water system and uses a domestic well exclusively (MSI Auto Parts and Salvage), and one property uses a domestic well in addition to the public system (Holm Town Nursery). SLR contacted Holm Town Nursery on August 2 and left an additional message on August 3, but was unable to get information on the use of their domestic well.

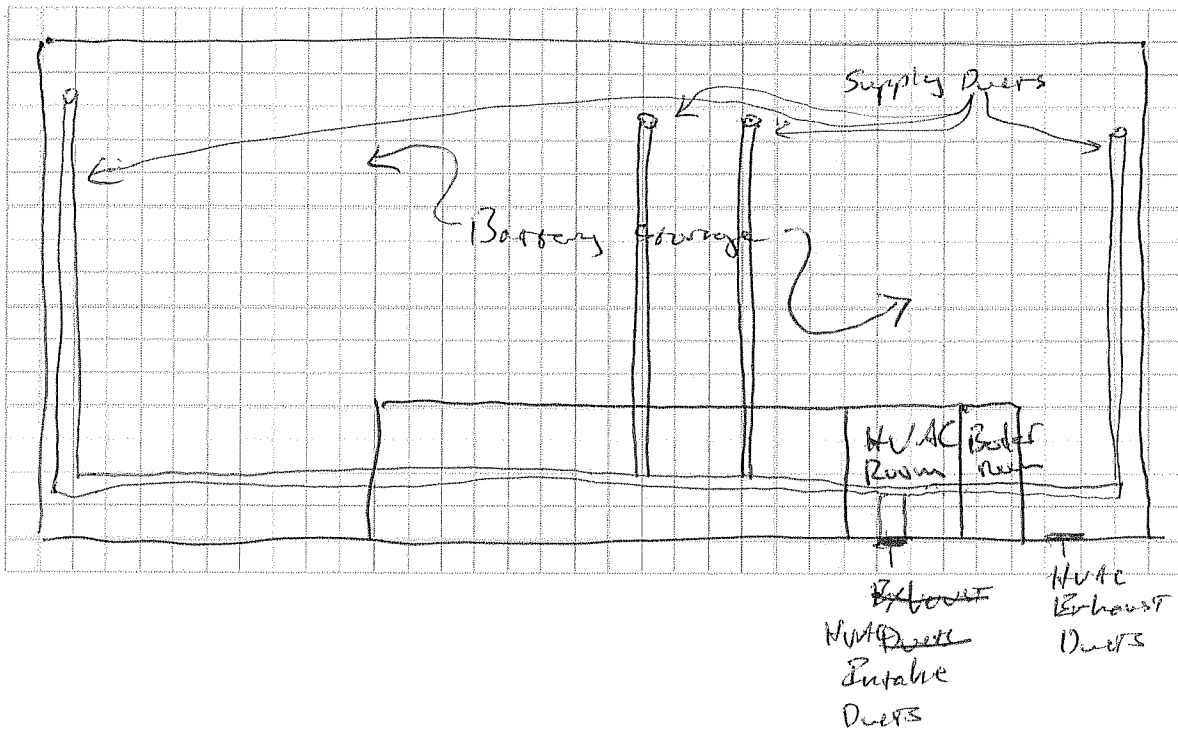
First Floor:

Expansion joints, minor cracking - all covered with epoxy paint on floor

Good condition, supply ducts on east and west
ends of bldg, two supply ducts in central area
All ^{supply} ducts originate on SE side of building
