**Company: Hilcorp**

**Date: 10/20/23**

**Project No.:  
105.00874.23018**

**RE: Field Report for Trench Excavation, Kenai Gas Field 41-7 Facility**

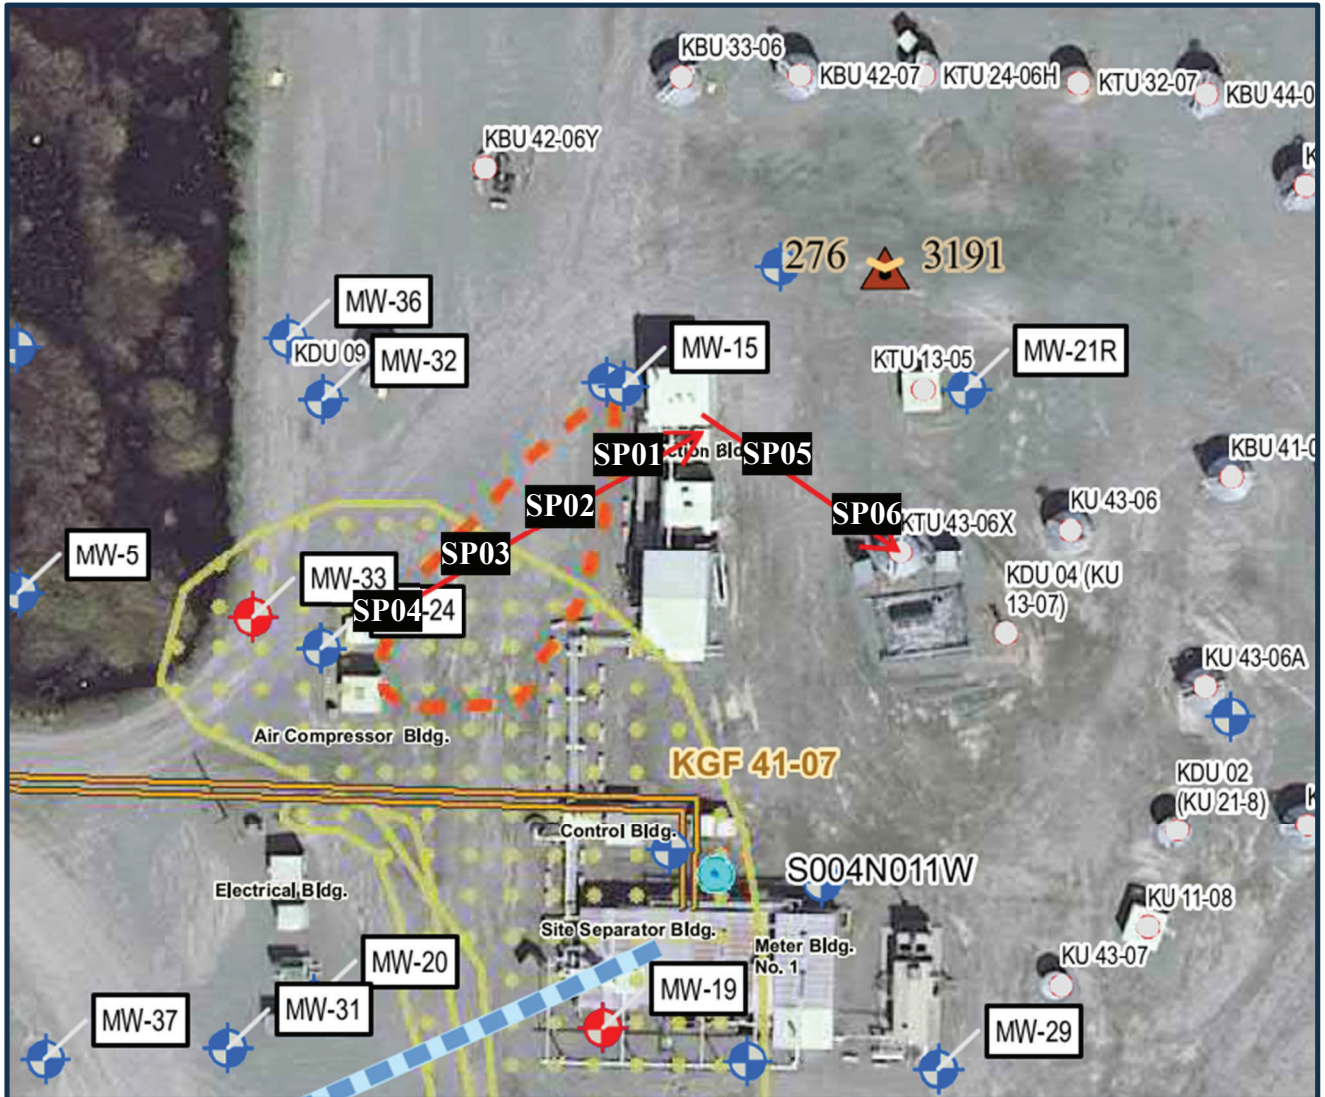
Figure 2

41-7 Facility Site and Soil Stockpile Location Origin Map

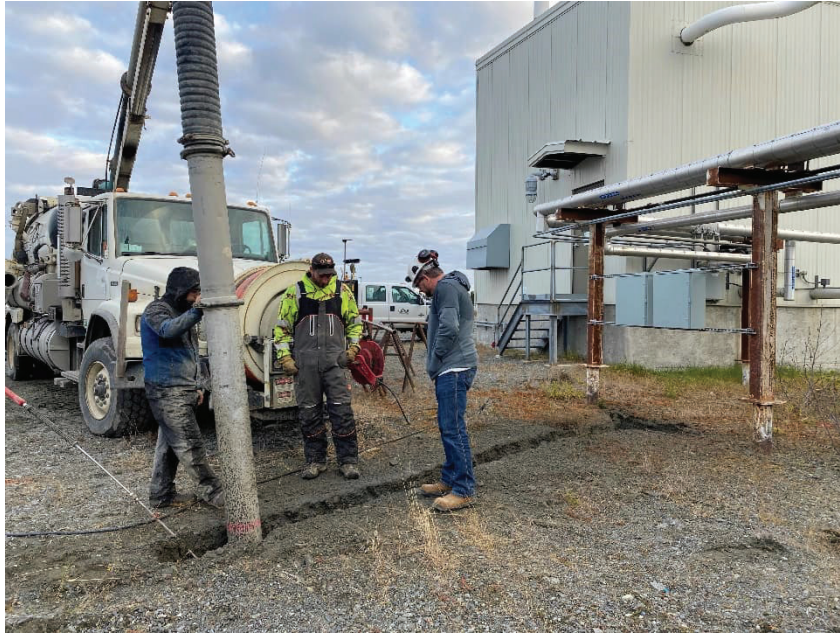
**Photo 1:** Trench excavation began on the southwest end of the Production Building. This is the origin of SP01. Taken facing north (October 11, 2023).

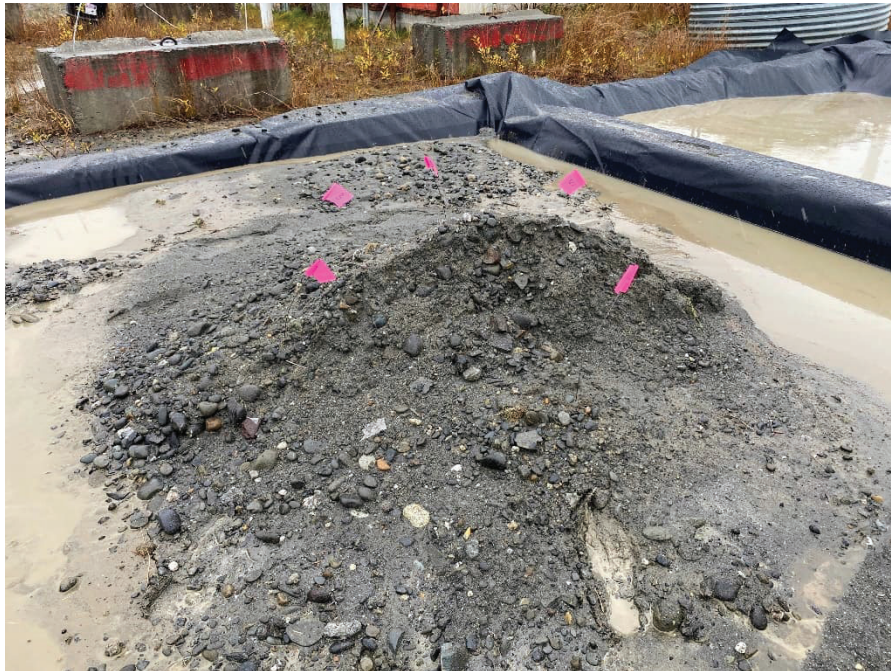
**Photo 2:** SP03 field screening locations (October 12, 2023).

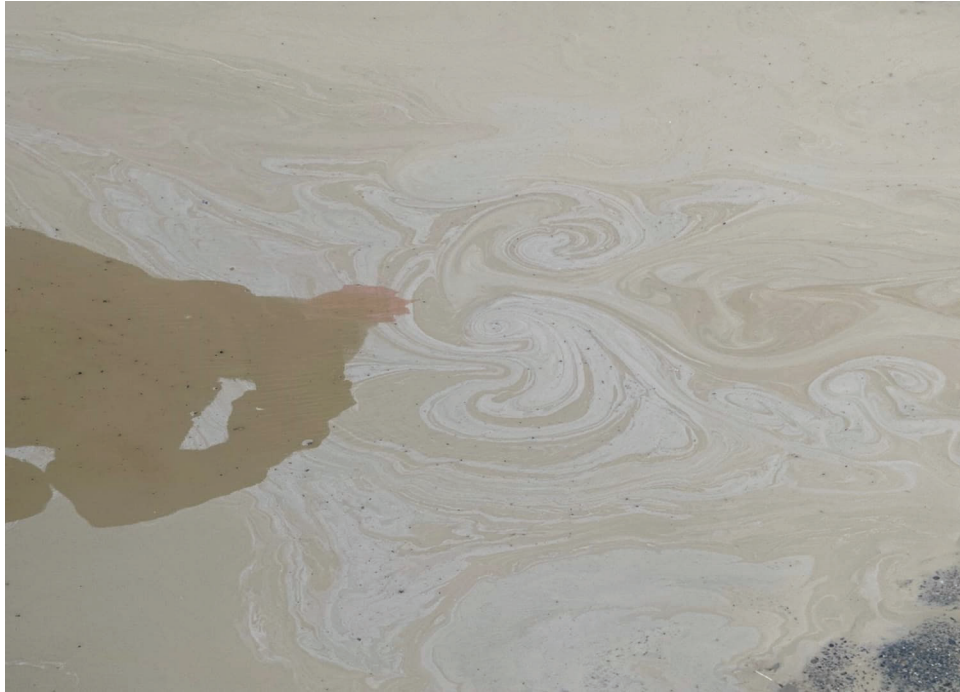
**Photo 3:** View of sheen in SP03 containment cell (October 12, 2023).

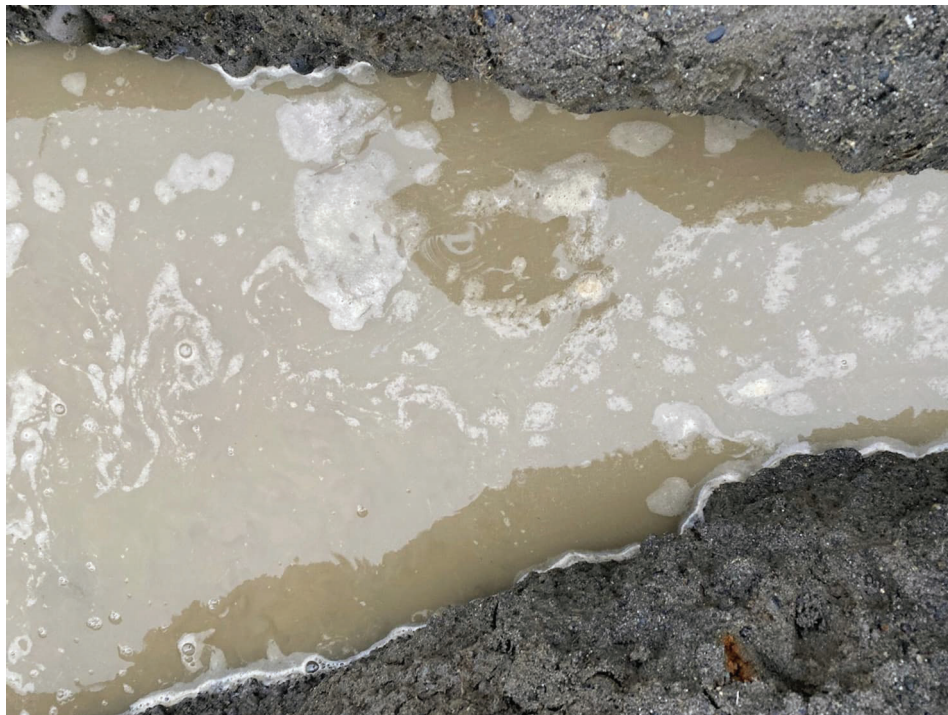
**Photo 4:** View of water filled trench water with sheen west of the Production Building (October 12, 2023).

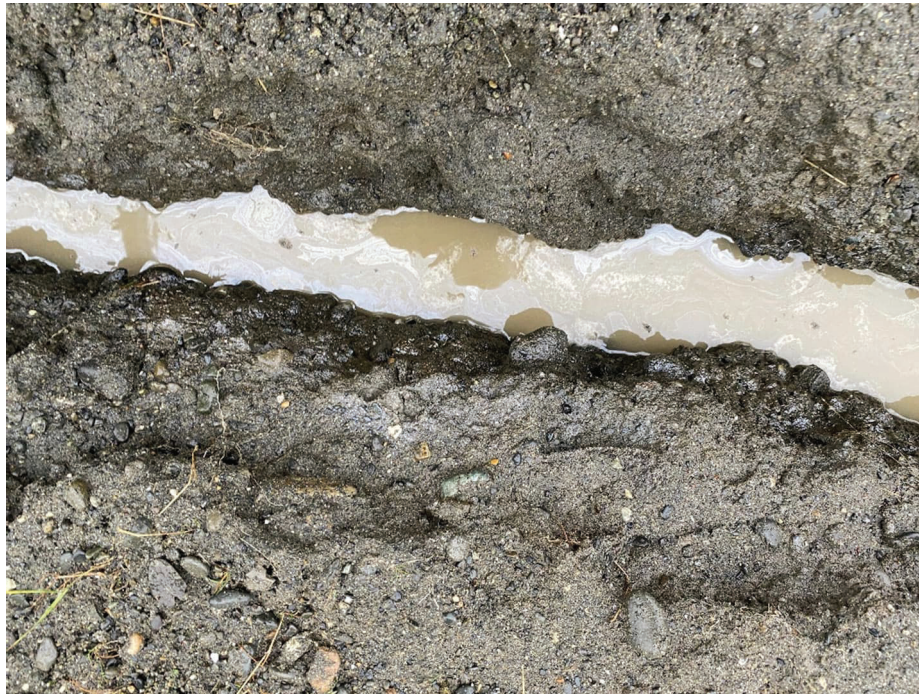
**Photo 5:** View of water filled trench water with sheen east of the Production Building (October 12, 2023).

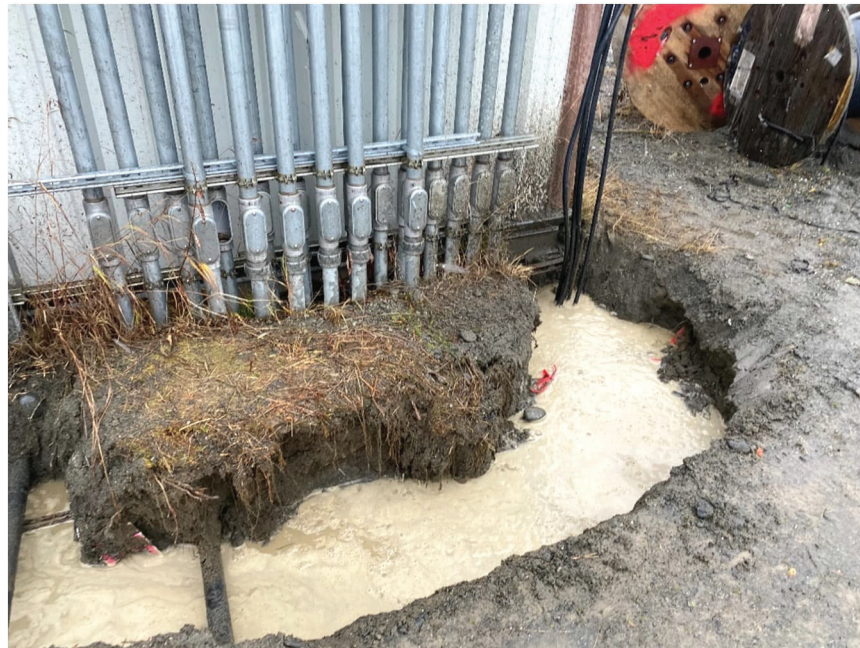
**Photo 6:** View of water filled trench before dewatering activities. Photo taken facing south (October 13, 2023).

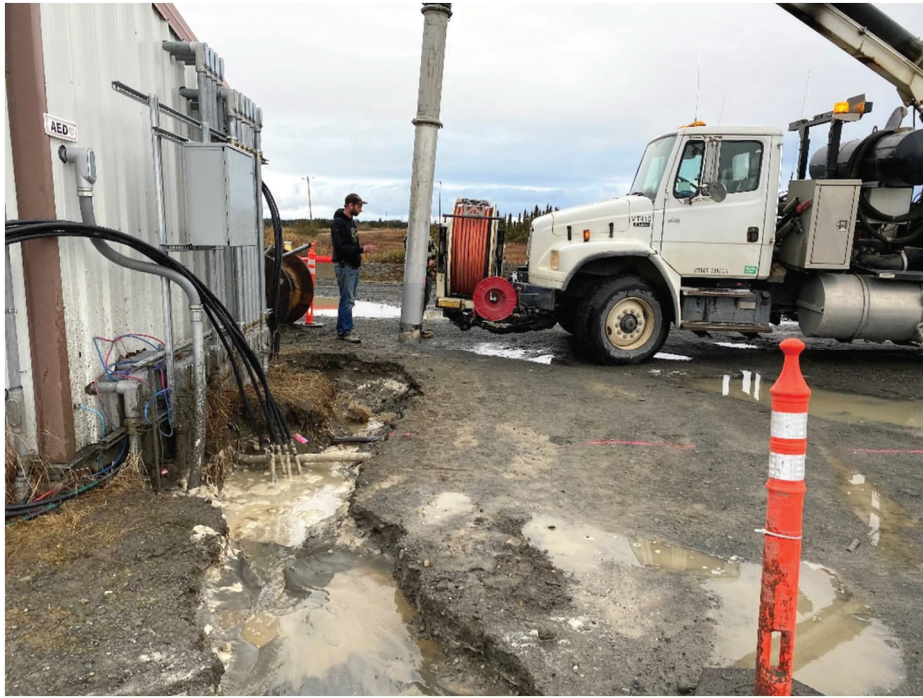
**Photo 7:** View of water dewatering activities. Photo taken facing south (October 13, 2023).
