**NORTECH, Inc.**

June 19, 2018

**RE: Well Decommissioning Report, University Car Care Center –  
Williams #5026, ADEC File No.: 100.26.023, Haz ID: 23798  
ADOT&PF Fairbanks Signal Upgrades Stage 1, Site 18, Fairbanks  
Street**

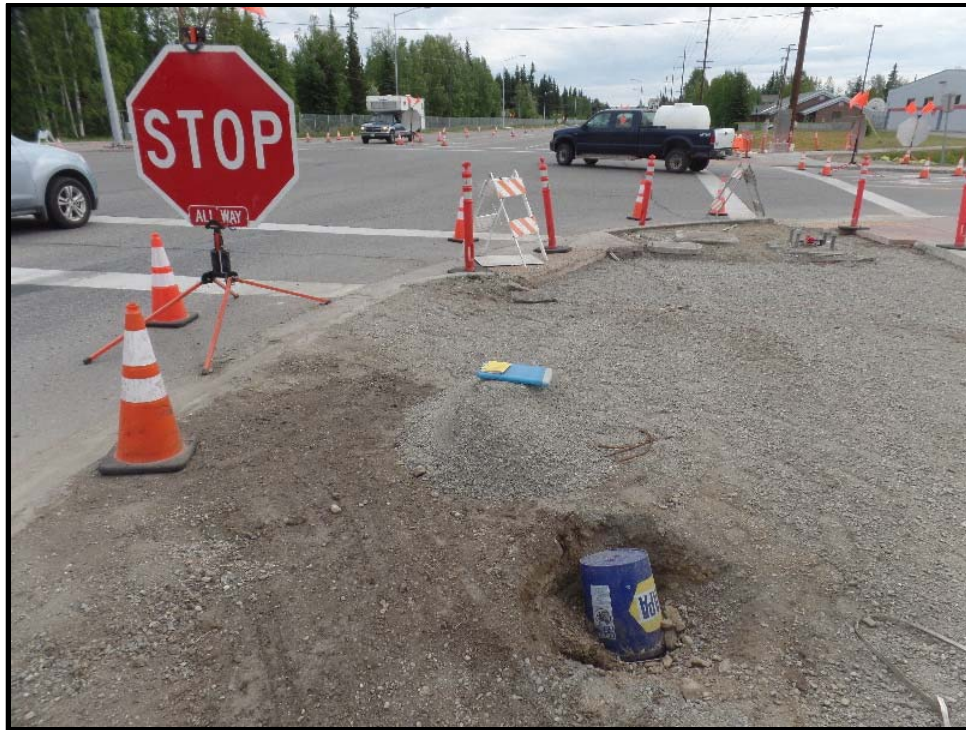
**Photo 1:** Looking east at the intersection of Fairbanks Street and Geist Road, the location of Vapor Extraction System well number eight (VES-8) is shown, protected by a blue, five-gallon bucket.

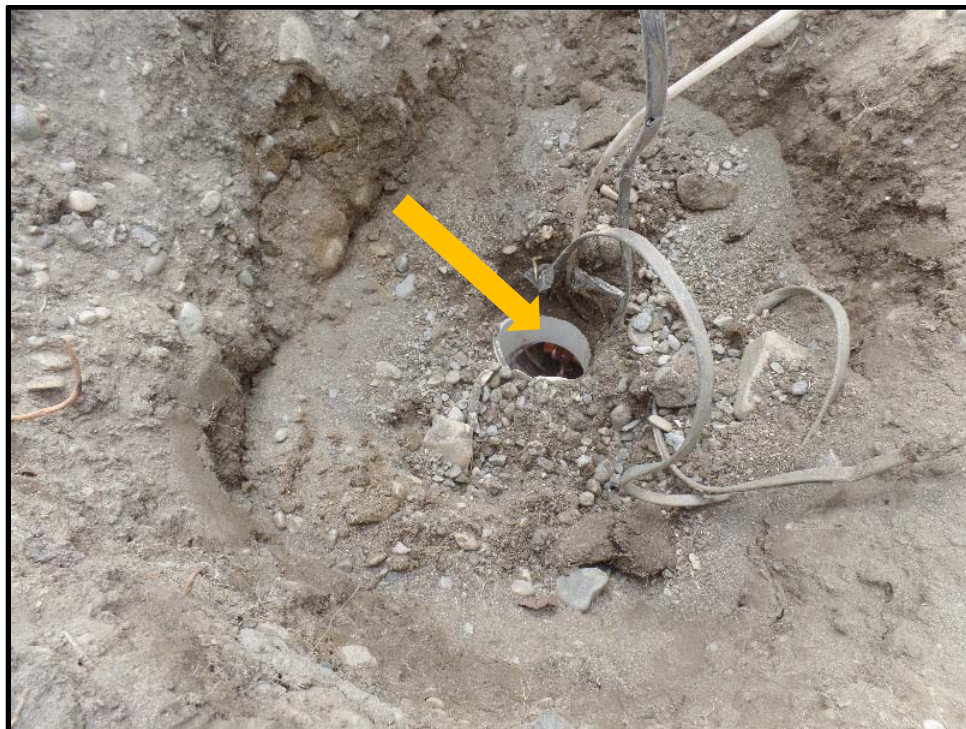
**Photo 2:** Shown above by the arrow, the orange, expandable, well-cap can be observed within the excavated top-of-casing housing for this well. The top-of-casing was measured to be approximately 20 inches below ground surface (in bgs). Heat trace wiring from the former air-sparg system is visible and was left in place. A small-diameter polyurethane tubing was tied to seal the tubing in place.

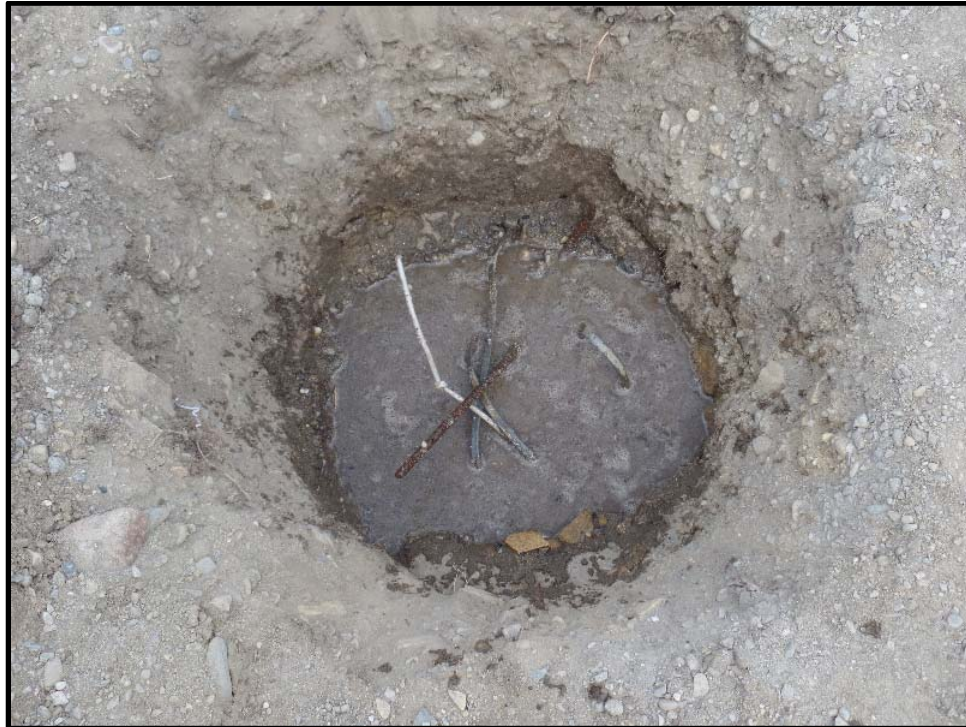
bentonite, hole-plug chips to just above the remaining top of casing and hydrated with approximately 10 gallons of clean water. The bentonite demonstrated an ability to repel a small volume of water poured over the decommissioned well as shown in attached Photo 3. Some pieces of rebar were then placed over the well and the hole was then backfilled to match surface grade.

**Photo 3:** Following decommissioning of the well with  $\frac{3}{4}$ -inch rock and  $\frac{3}{4}$ -inch, hole-plug bentonite chips, the well is shown to prevent water from entering the casing. Short pieces of rebar were added to provide a magnetic marker of the well location.

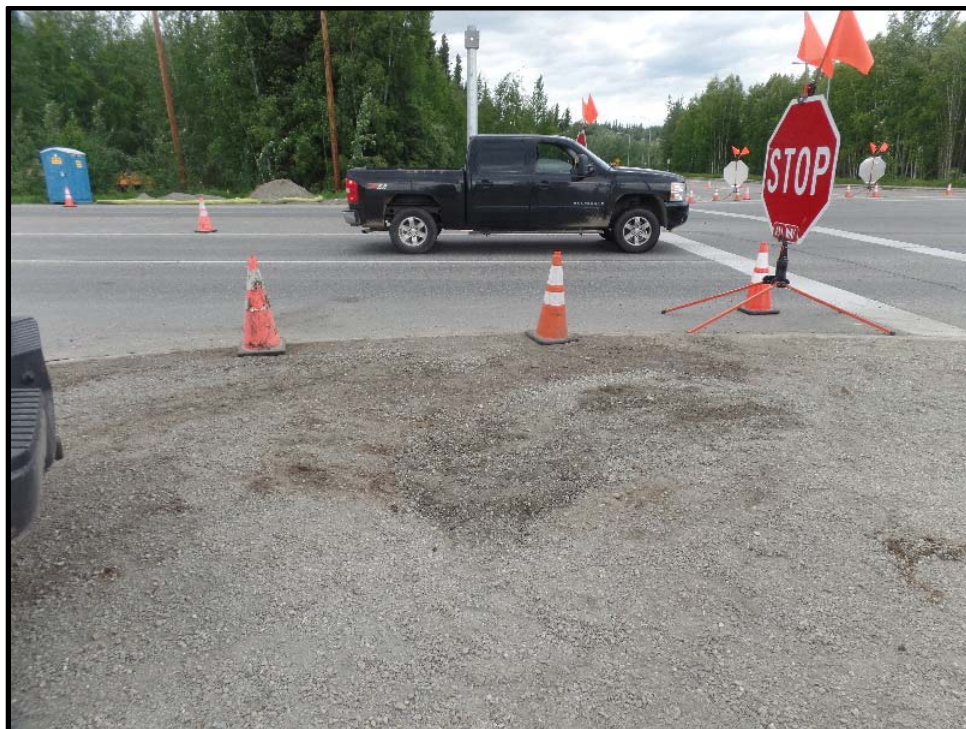
**Photo 4:** Looking north at the former location of VES-8, decommissioned-in-place, and backfilled to match the surrounding grade.
