Preliminary Assessment Report for Aqueous Film-Forming Foam Areas

Anvil Mountain Radio Relay Station

November 2023

USACE Contract W911KB20D0002 Delivery Order W911KB22F0080

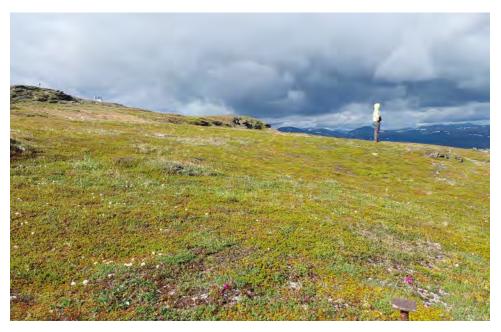
Photograph 6: Rebar north and adjacent to former installation, view north.

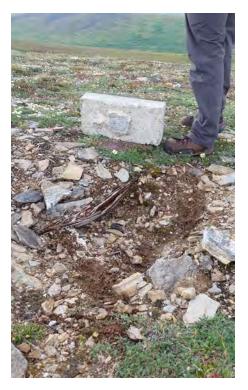
Photograph 11: Buried wood box, Styrofoam, and damaged cable housing, former tank foundation location, view west.

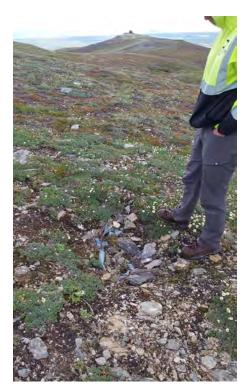
Photograph 12: Corrugated metal and wiring, former tank foundation location, view west.

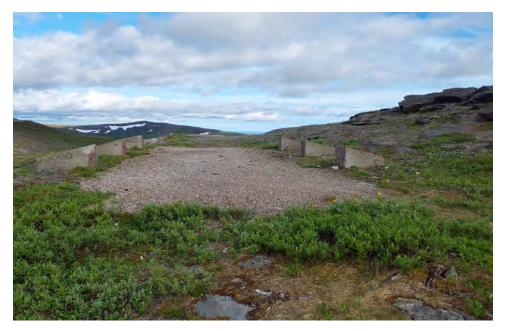
Photograph 13: Unknown former foundation, view southeast.

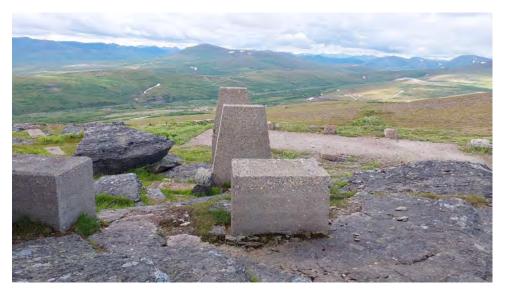
Photograph 14: Concrete pilings, unknown former structure, view north.
