**INITIAL SUBSURFACE SOIL AND GROUNDWATER
CHARACTERIZATION AND CORRECTIVE ACTION PLAN**

**LOT 10, BLOCK 1, METRO INDUSTRIAL AIRPARK
FAIRBANKS, ALASKA**

SEPTEMBER 20, 2006

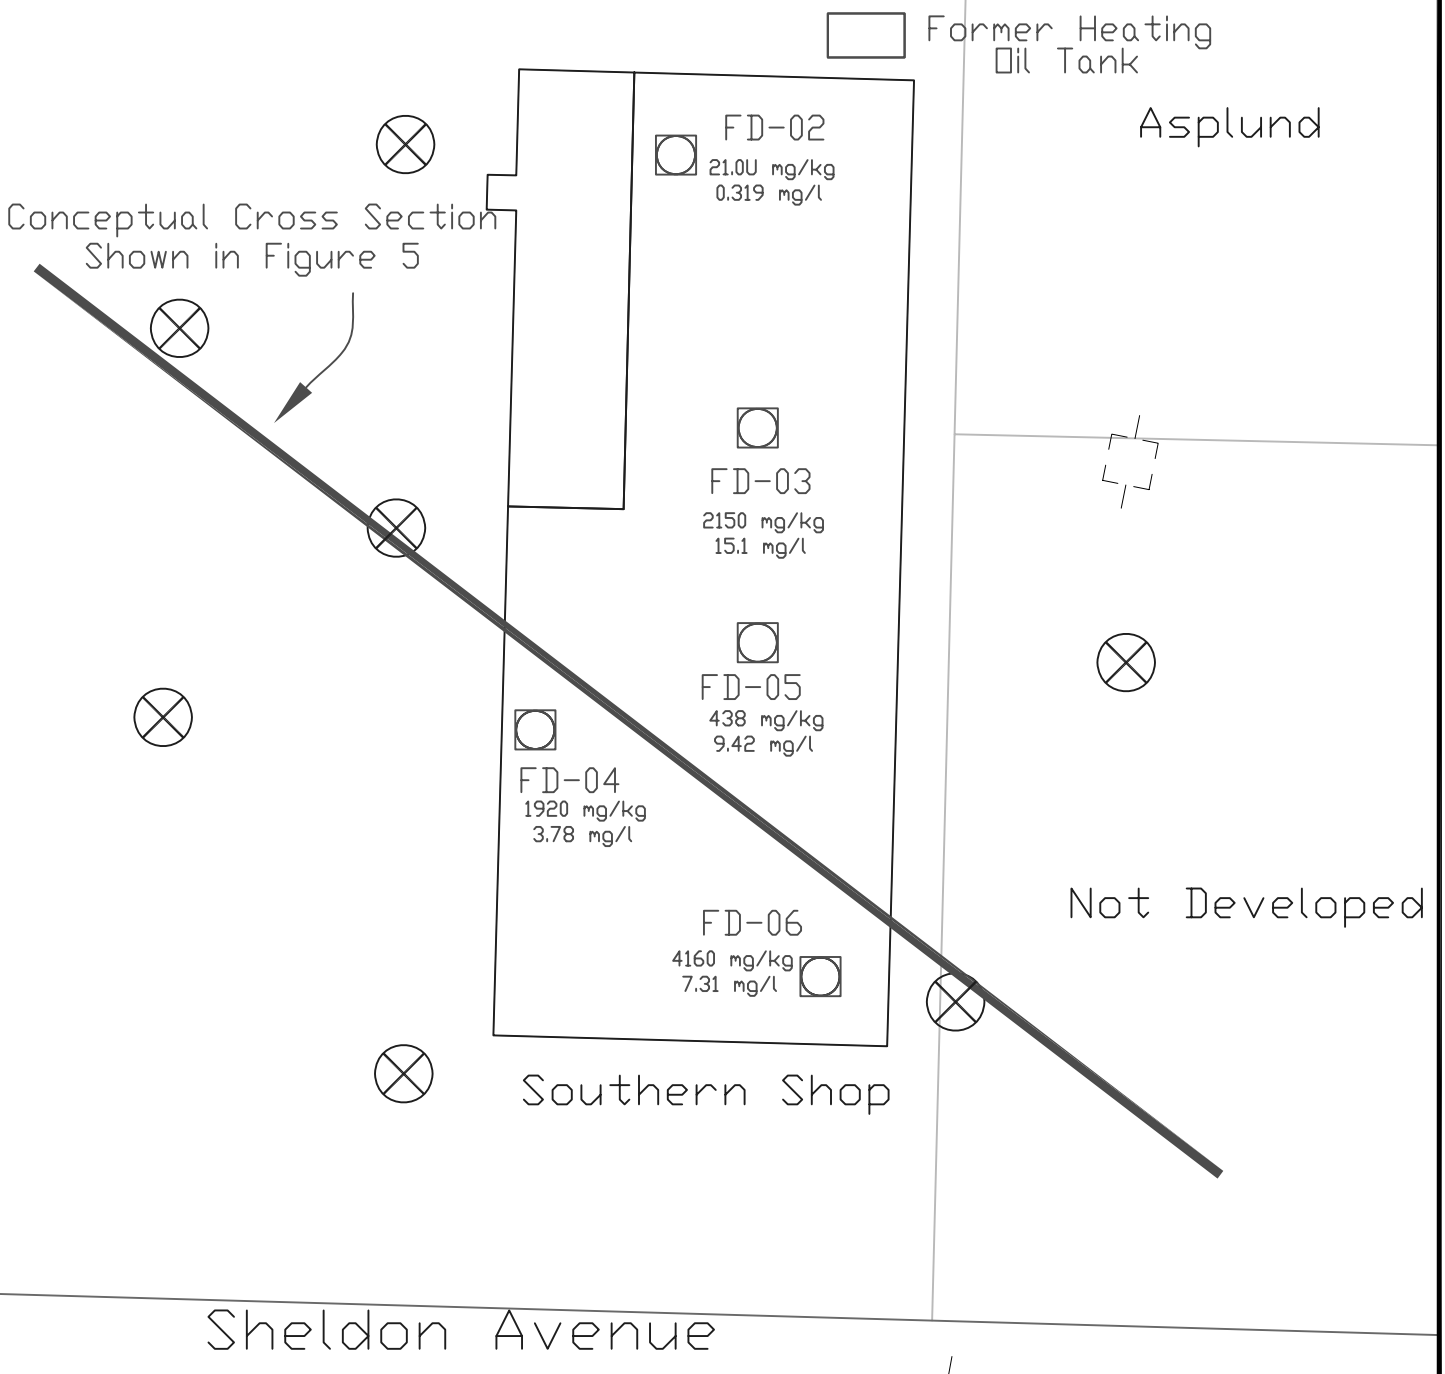
FIGURE
4

The field activities for this investigation were performed on July 19, 27, and 28, 2006. Peter Beardsley and Ron Pratt of **NORTECH**, and a two-person drill crew from GeoTek were present at the site during some or all the activities. Weather conditions during these field activities were generally dry and partly to mostly cloudy with high temperatures around 70°F with calm to light winds. The exploratory UST excavation and soil boring locations are shown in Figure 4.

On July 19, 2006, **NORTECH** personnel visited the site to conduct an assessment of the former heating oil tank location. Hand excavation of the former tank location identified the bottom of the copper lines approximately three feet below the ground surface. Additional excavation to approximately 4.5 feet below the ground surface indicated that no tank was present within the normal installation depth of buried heating oil tanks in Fairbanks. Soil removed during this excavation was field screened using the PID. Approximately 10 field screening samples were all in the expected background range (<5 ppm). Since no evidence of contamination was encountered during this investigation the excavation was backfilled. The location of this excavation activity is shown on Figure 4.
