Water Sampling Field Report

Client:	Michael Lattin	Date:	2/22/15
Project:	Moth Bay Mine Water Sampling	Time In:	8:30 am
Weather:	Cloudy; 45 degrees	Time Out:	2:00 pm

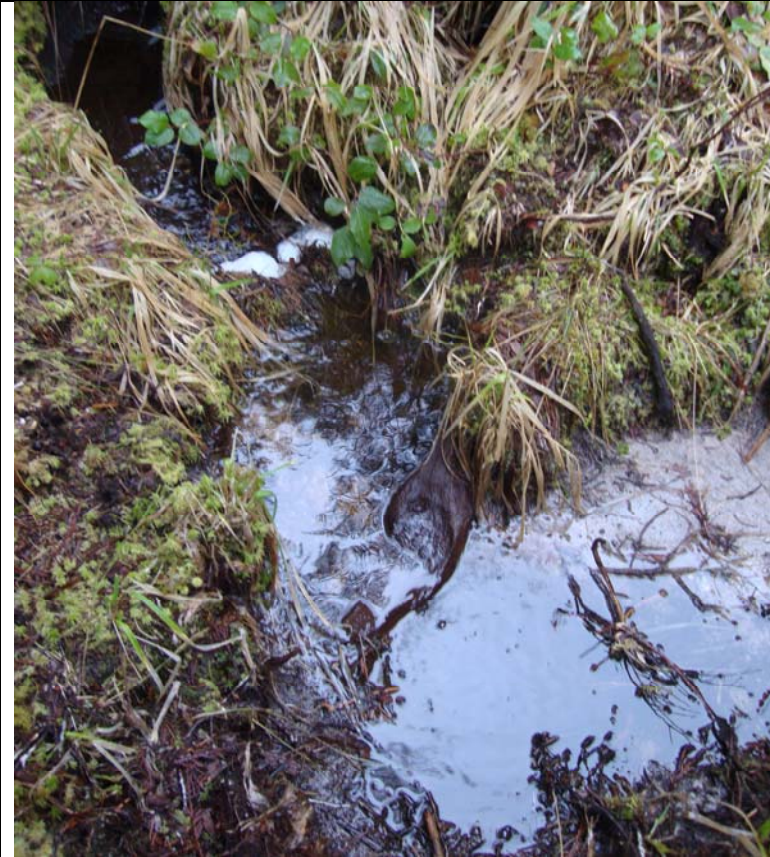
<p>Photograph No. 1</p> <p><u>Location</u> Pt 2</p> <p><u>Description</u> Moth Stream outfall at Moth Bay pH 6.17</p>
---	--

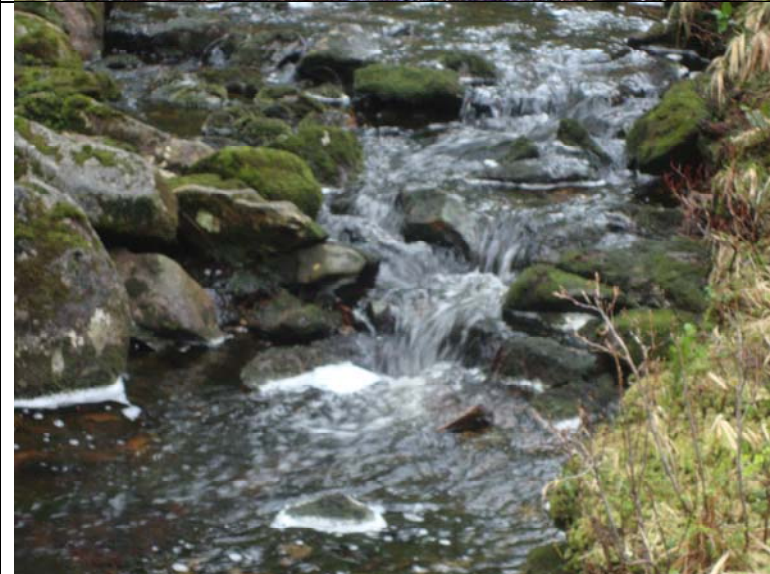
Photograph No. 2

Small stream near property line unaffected by waste rock. pH 4.8-4.75

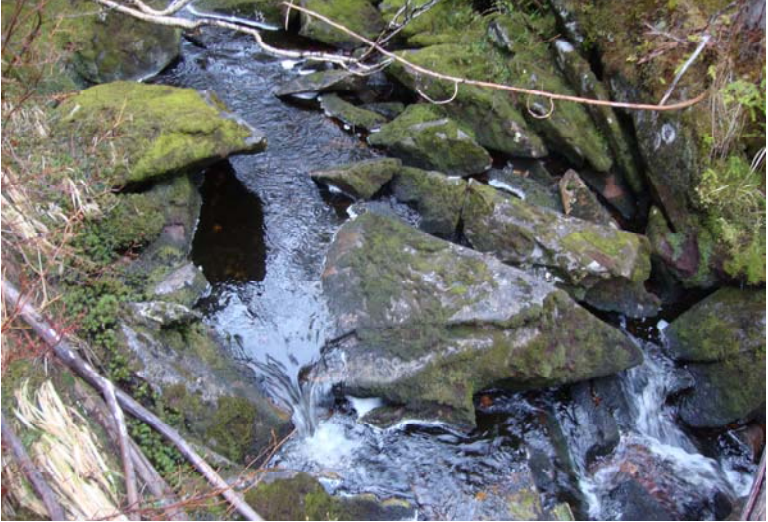
Photograph No. 3

Moth Stream near property corner pH 5.75

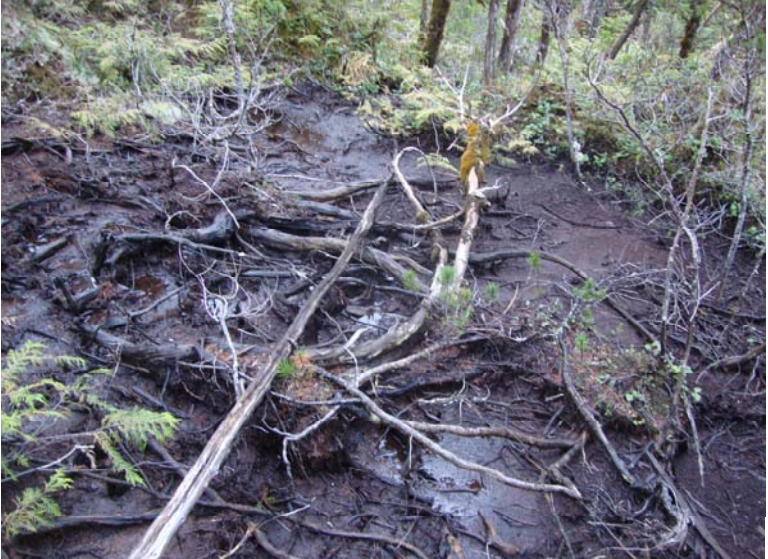
<p>Photograph No. 4</p> <p><u>Location</u> Pt 5</p> <p><u>Description</u> Tributary stream up slope from historic adit. pH 5.92</p>

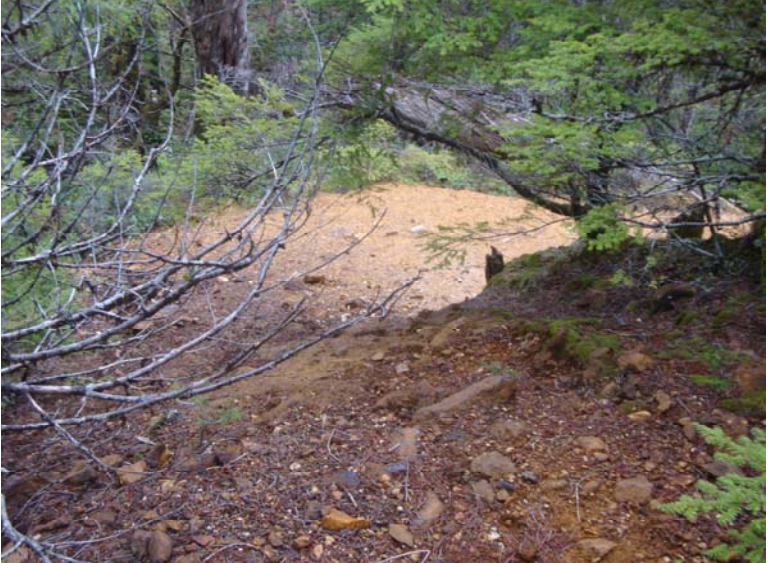
<p>Photograph No. 5</p> <p><u>Location</u> Pt 6</p> <p><u>Description</u> Standing water in muskeg in front of historic adit #1. pH 5.19</p>

Based on our observations currently Audit #1 is sheet flowing into an existing muskeg which is filtering the leachate from the mine tailings pipe and balancing the PH prior to the surface drainage leaving the property. Therefore it is our opinion that no further action should take place on the tailing pipe in front of Audit #1 since the surface runoff is filtered by the existing muskeg prior to leaving the property.

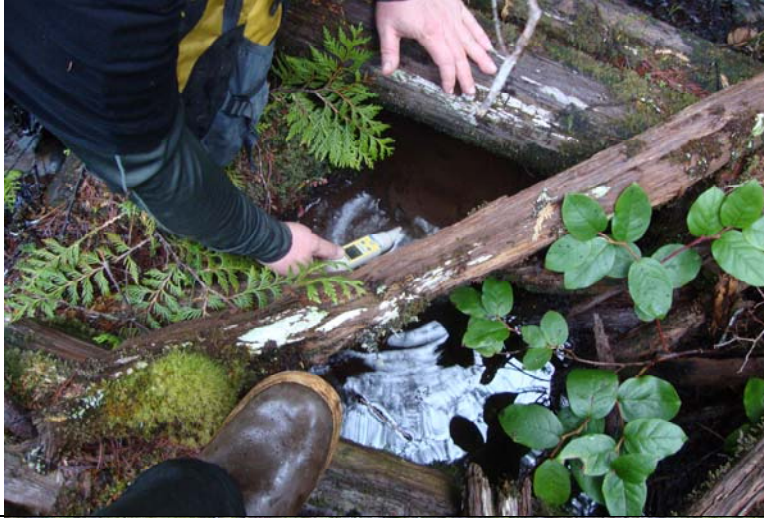
<p>Photograph No. 6</p> <p><u>Location</u> Pt 7</p> <p><u>Description</u> Soil sampling site</p>

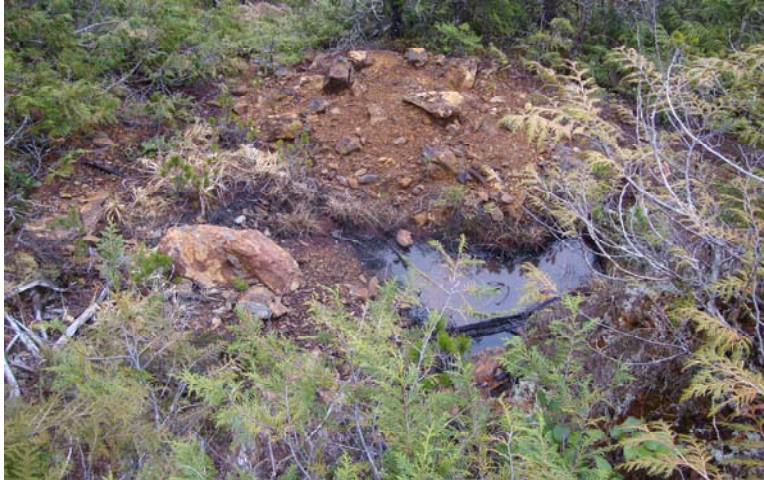
Photograph No. 7

Standing water downstream
of waste rock pile
pH 3.17

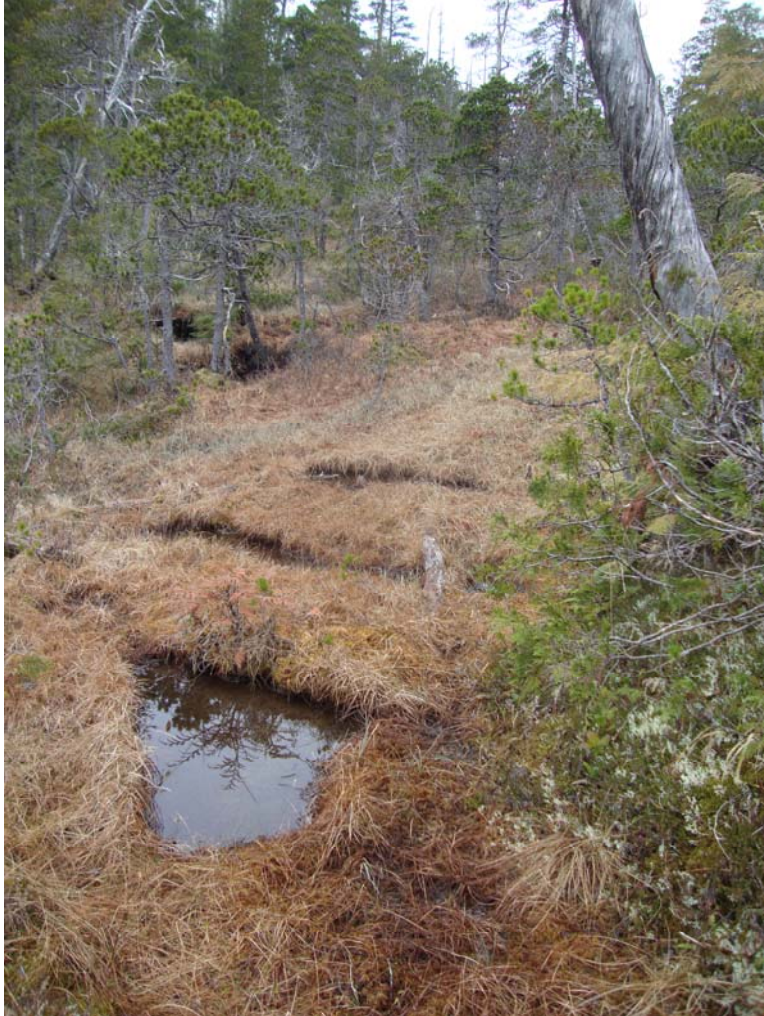
Photograph No. 8

Standing water adjacent to
waste rock pile
pH 3.52

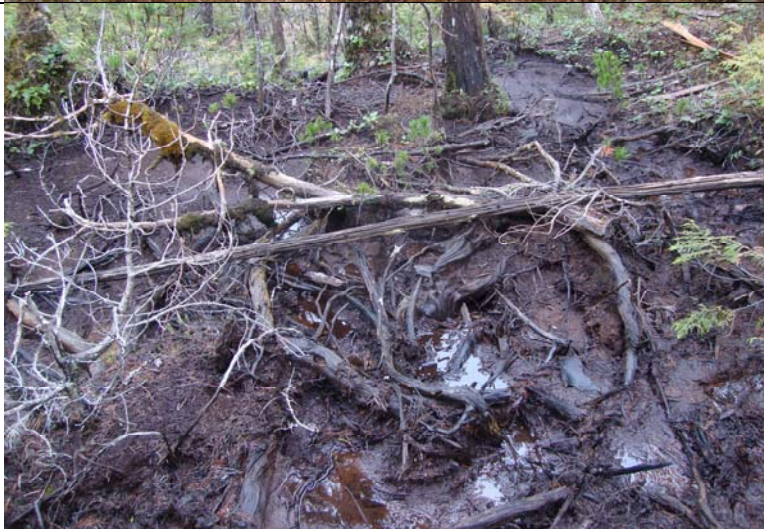
Photograph No. 9

Standing water unaffected by waste rock pile
pH 4.95

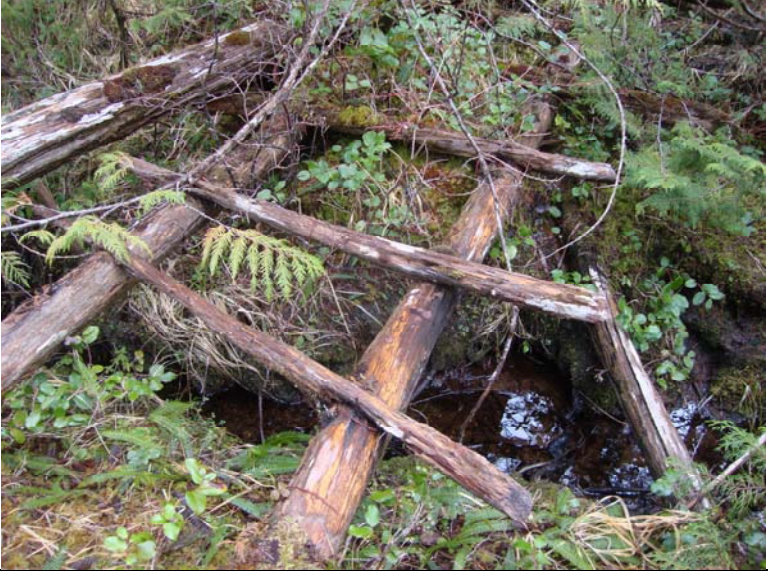
Photograph No. 10

Standing water in front of adit #2
pH 6.17

Finally prior to planning any mine reclamation work on the tailings pile in front of Audit #2 it is our recommendation that the potential environmental impacts of performing this work should be evaluated with the respect to the current impacts this historic tailings pipe has on the environment and a detailed review of the State of Alaska Statues should be performed.

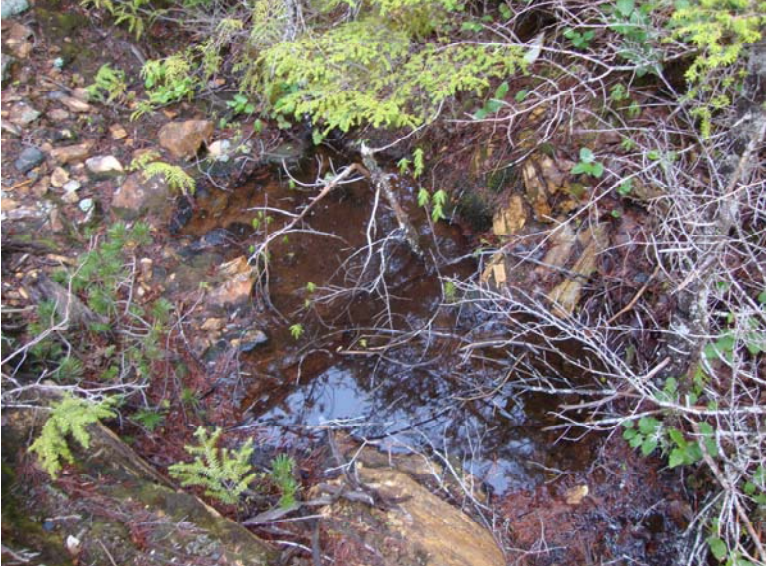
<p>Photograph No. 12</p> <p><u>Location</u> Pt 14</p> <p><u>Description</u> Cut pH 3.95</p>
