**CONTAMINATED SOIL REMEDIATION PLAN  
OLD BIA SCHOOL PROPERTY  
BLOCK 7, LOT 8  
BEAVER, ALASKA  
SEPTEMBER 30, 2023**

Location Map  
 Contaminated Soil Remediation Plan, Old BIA School Site  
 Beaver, Alaska

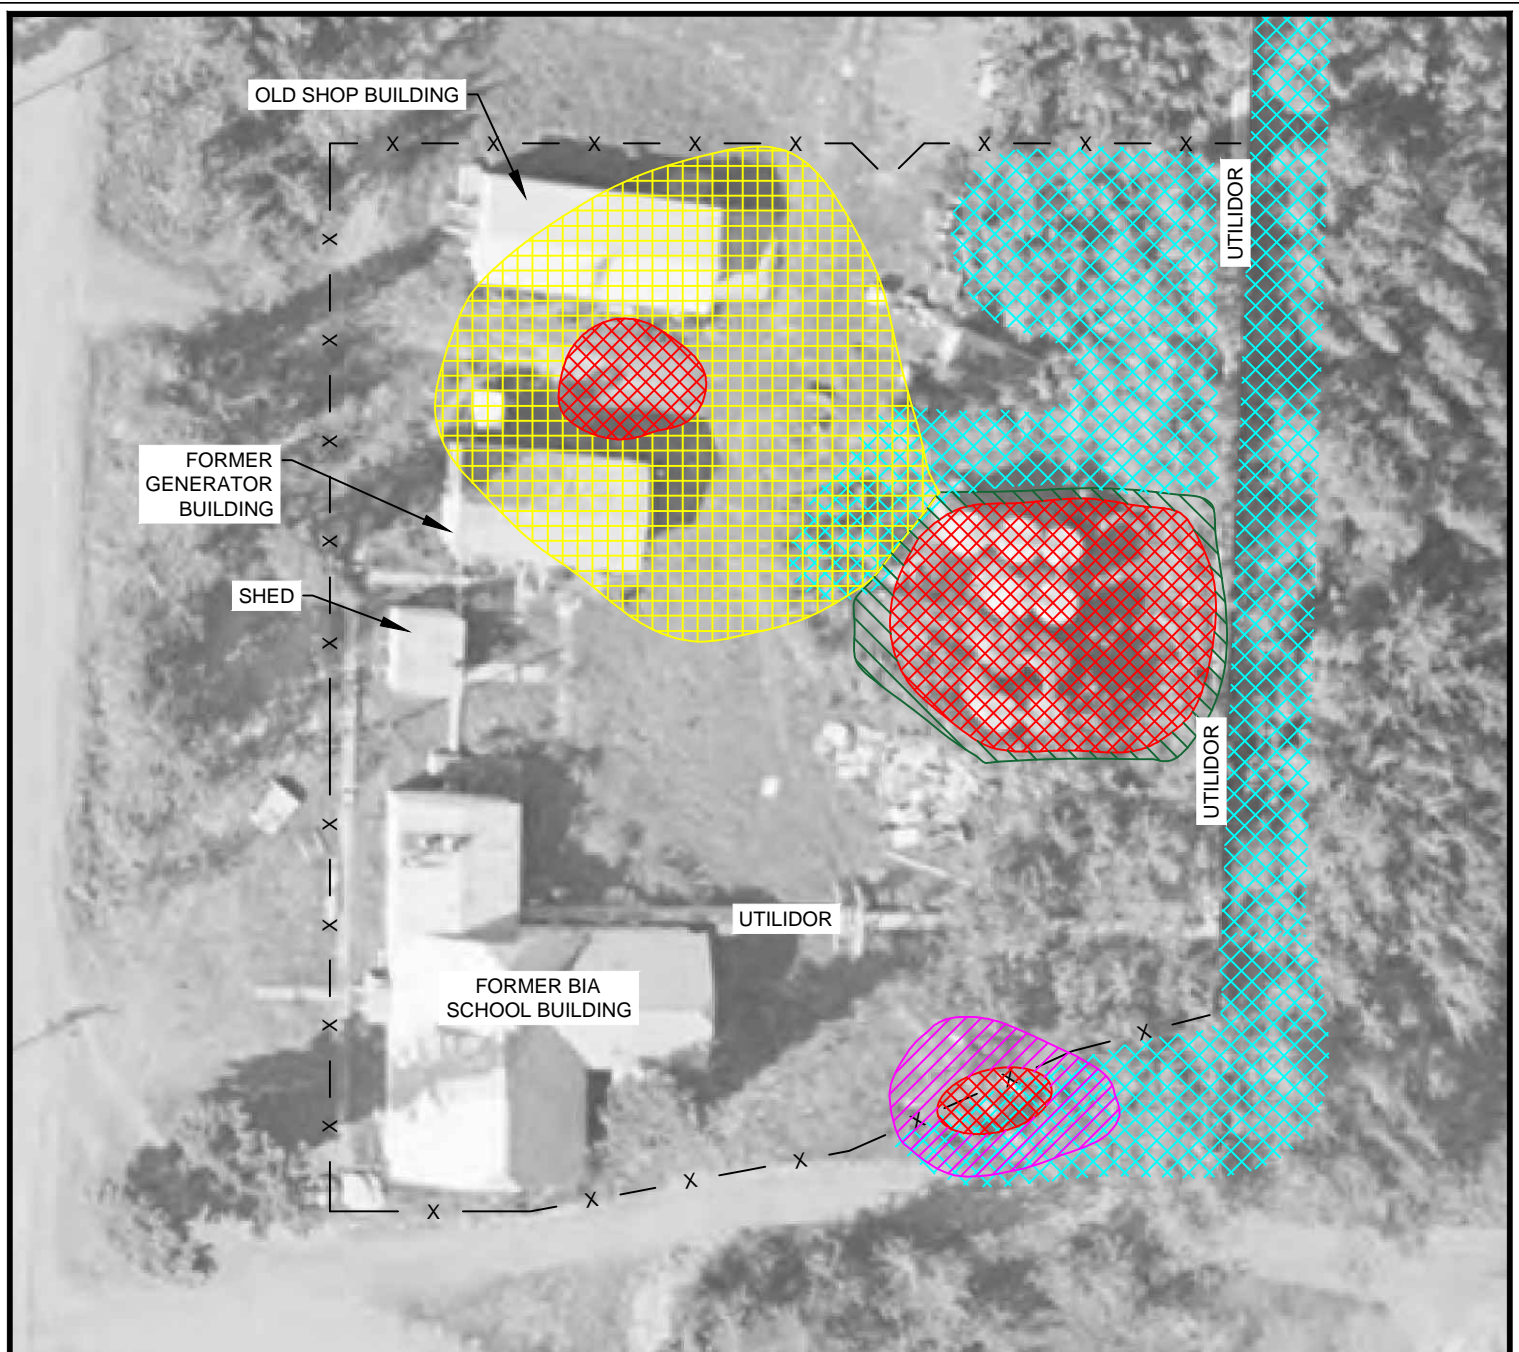
Areas of Excavation  
 Contaminated Soil Remediation Plan, Old BIA School Site  
 Beaver, Alaska

The area of impact surrounding the AST Farm footprint is estimated at 3,600 sf, which includes the initial historical area of impact on the east side of the AST Farm. Excavation in this area is likely to be required to 10 feet below grade at a minimum, or to the range of the equipment. Petroleum releases are likely to have had the opportunity to migrate deepest at this location due to long term leaks, coupling failures, and spill incidents. This has likely allowed the petroleum to reach a natural subsurface aquitard (such as permafrost, if present) and spread out laterally, or to reach the groundwater surface.

The south pipeline leak area is currently estimated with a surface area of about 1,170 feet, which was expanded from the initial estimation in 2001 by nearly 10 times during the 2009 SLR assessment. Contaminant concentrations exceeded the most stringent cleanup levels at 4 feet below grade 30 feet to the east of the north-south transect along the removed pipeline that previously connected to the river barge location.

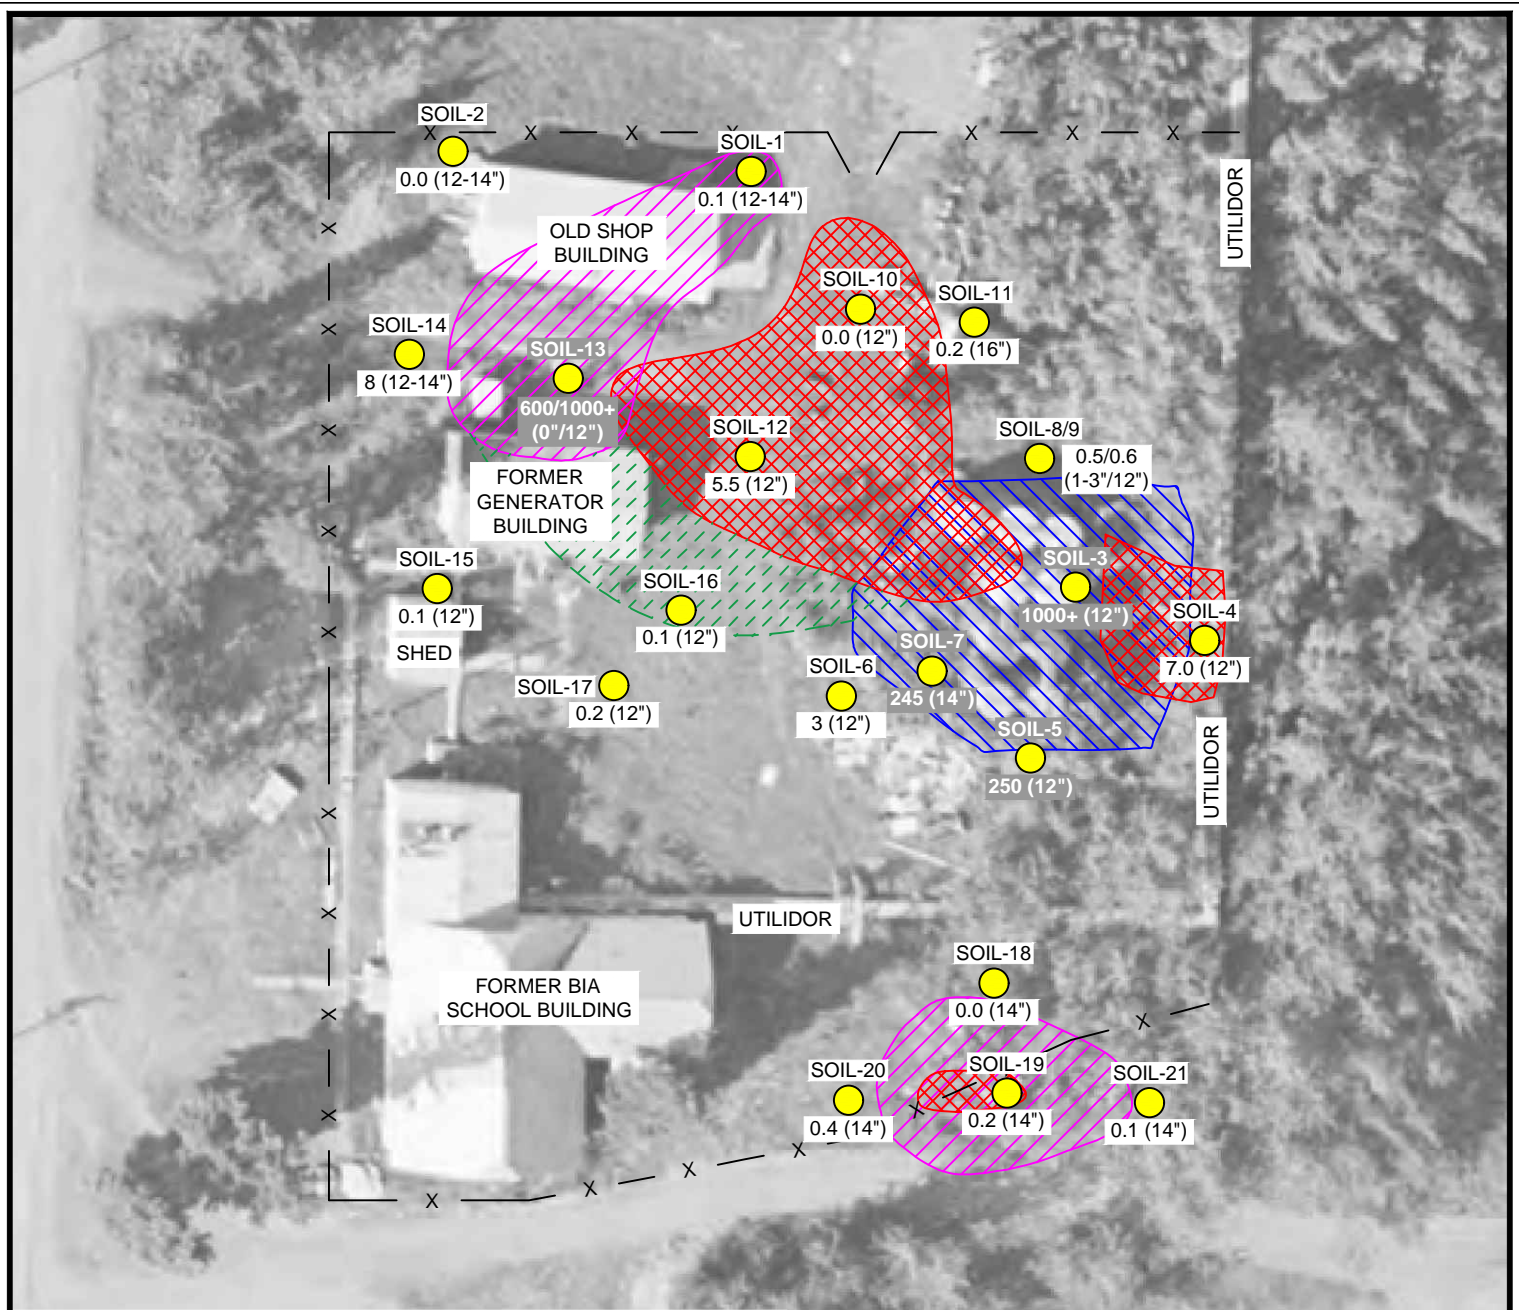
PID Soil Sample Locations & Results  
 Contaminated Soil Remediation Plan, Old BIA School Site  
 Beaver, Alaska

Samples collected in this area (samples ‘Soil-18 -21’) were collected initially near the surface and then advanced an additional 14 inches and did not identify any significant impacts, although a slight odor was observed. The soil in this area had been reworked by heavy equipment (grader or loader) following the removal of the vegetative cover in this area. This surface leveling work was reported to have been completed in 2022 and likely relocated minor near-surface petroleum impacts leading to the observed odor.

The field screening results generally confirmed the previous analytical findings, with the exception of where the ground surface had been reworked with equipment to the south. Coupled with onsite observations, no additional areas of concern were clearly visible, and the extent of petroleum contamination is generally defined based on previous assessments. Ten years of natural attenuation and limited potential re-working of near surface soils are assumed to have reduced concentrations in the top 12 to 18 inches and possibly deeper. The low-level impacts observed at the edge of the defined areas indicate that any new releases were not substantial beyond the previously defined areas of impact summarized in the 2019 ADS report.

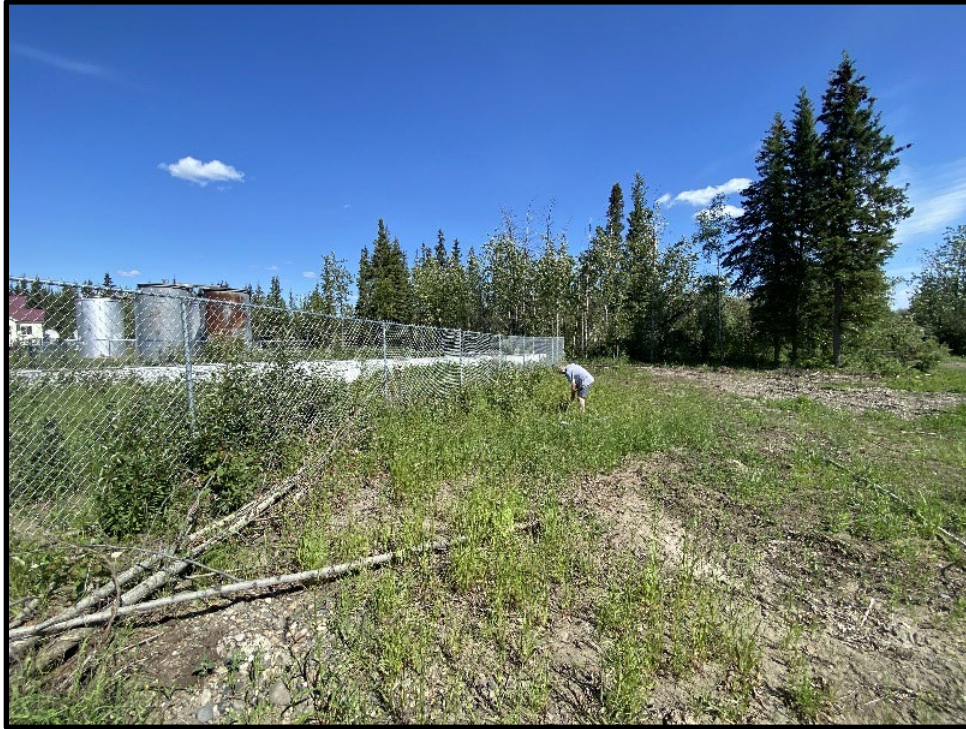
The area to the south where a long-term pipeline leak was documented could not be fully evaluated with near surface sampling as the area had been regraded with earth-moving equipment. Staff were informed that the debris and items in this area were removed, and subsequently, the site reworked as part of site clearing and preparation activities. Considering that the releases in this area were reportedly consistent and extended over a long period of time, it is likely that the impacts will be limited laterally, but potentially extend to 15 feet or greater. For the purposes of estimating costs associated with this review, the depth was limited to 10 feet in the core area of the leak.

**Photo 5:** Standing outside fenced area looking northeast, collecting soil sample near location of Area 3 – Pipeline leak. Area had been regraded with surface material relocated.

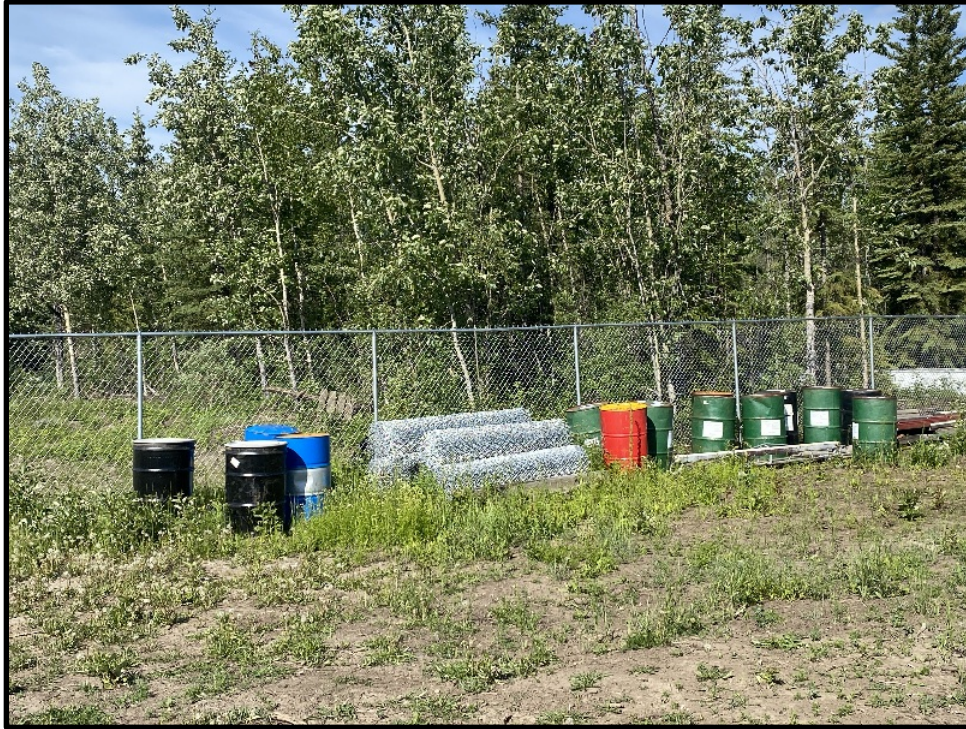
In addition to the structures and ASTs, more than one dozen drums were stored within the fenced area. The drums appeared to be in good condition with sealed open-top lids. Unused rolls of fencing were stored adjacent to the drums along the south side of the fence line. Much of the site has been reworked with a bulldozer to remove the vegetation growth as bulldozer tracks were observed. A village elder confirmed that this was performed in 2022. The area to the south of the utilidor leading to the former school was also reworked with heavy equipment in the area of the previously identified pipeline leak.

**Photo 7:** Looking northwest toward drums and unused fencing material along northern fence line.

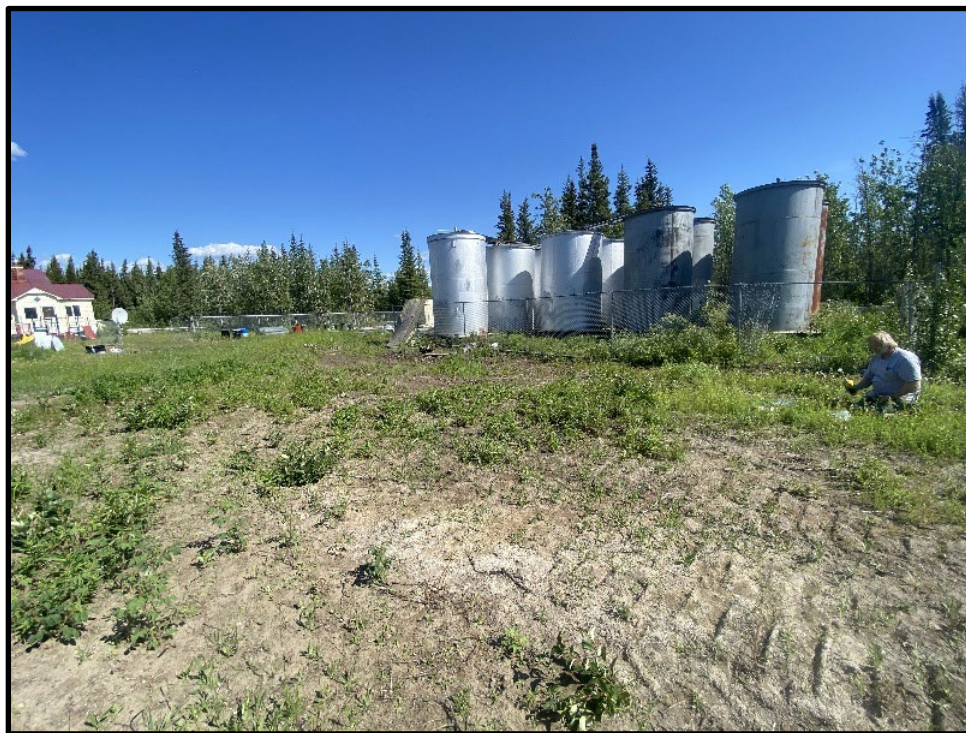
**Photo 14:** Looking northeast toward AST farm. Note heavy equipment tracks across foreground.

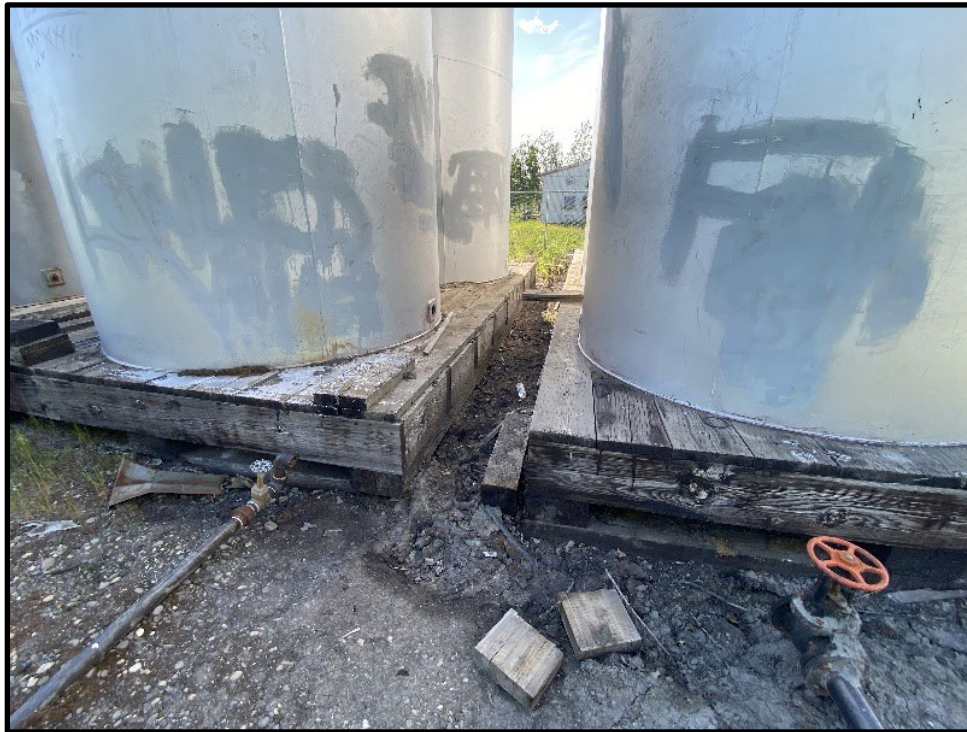
**Photo 15:** Gross staining and stressed vegetation surround the former AST farm, indicative of past releases. Significant petroleum impacts are located beneath the former footprint.

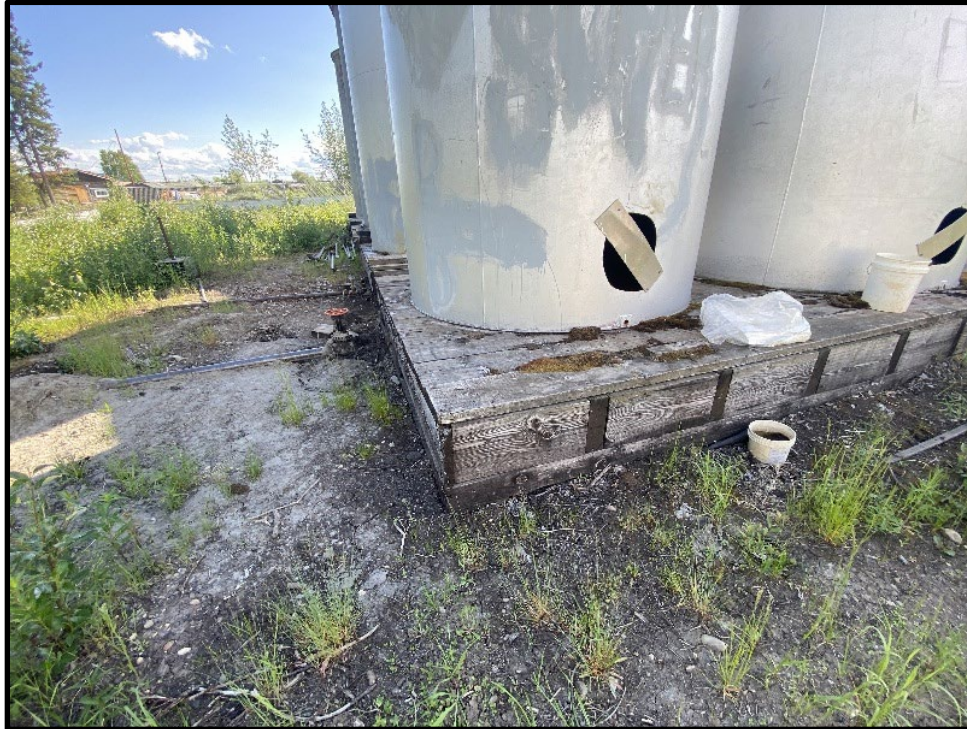
**Photo 16:** Additional staining and stressed vegetation on opposite side of AST farm.
