January 29, 2024

Subject: FINAL 2023 AFSC Former Cross-Town Pipeline Maintenance Inspections Arctic Boulevard and Tudor Road Intersection Report, Anchorage DEC Hazard ID: 2018; DEC File Number 2100.38.438

Photographic Log
Arctic Boulevard and Tudor Road Maintenance Inspection

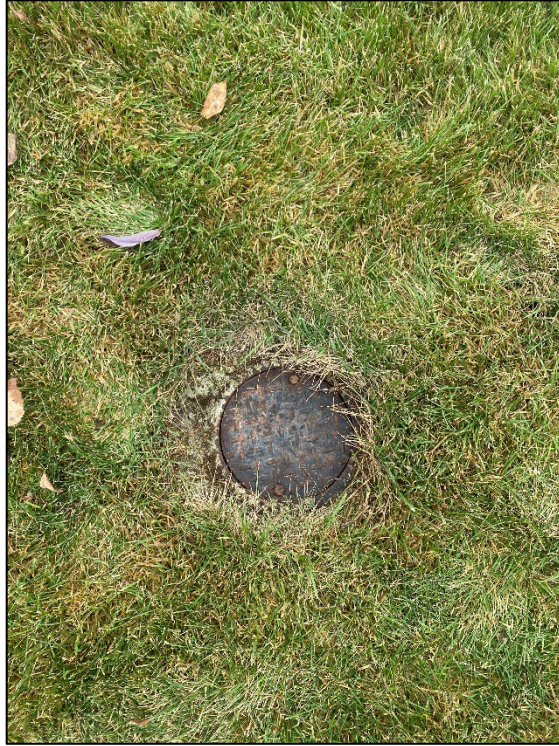
The well monument, cap, and riser of MW-30R were all in good condition. Because MW-30R is a newly installed well, previous Global Positioning System data did not exist, so its location was surveyed.

Photograph 1: View looking down. MW-30R closed.

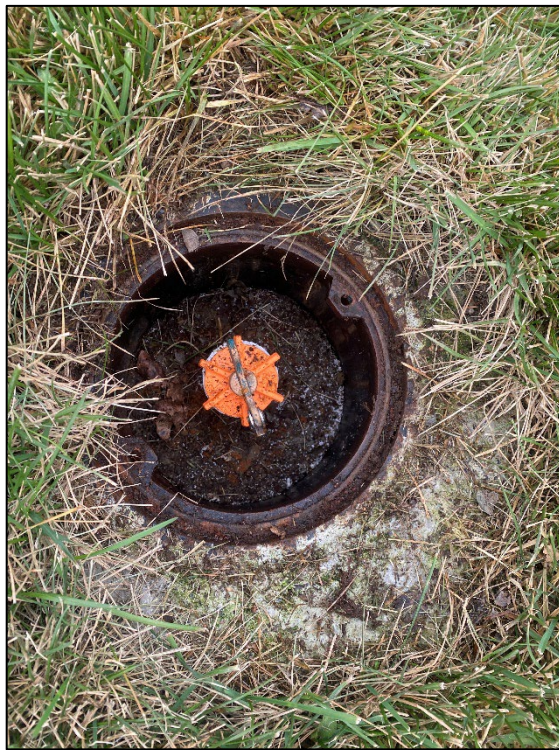
Photograph 2: View looking down. MW-30R opened with well cap on.

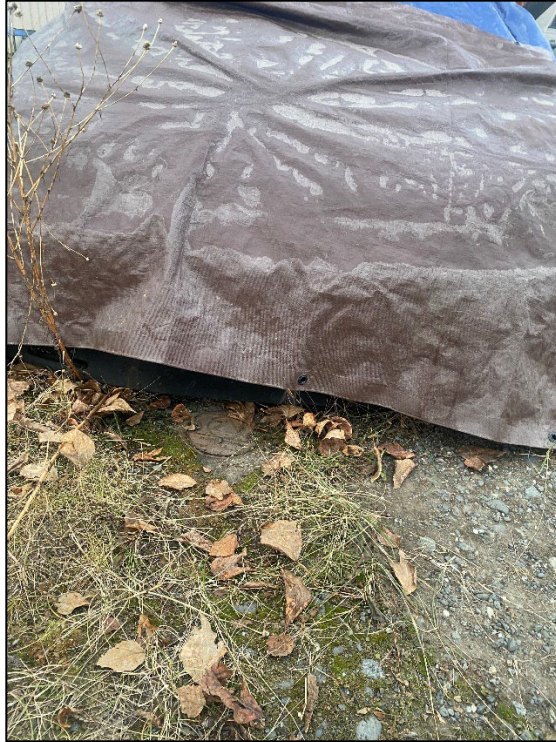
MW-123 was mostly covered by a non-functioning car but was still accessible. The well monument was in good condition. Soil inside the monument was nearing the top of the casing but is not currently an issue.

Photograph 3: View looking northwest. MW-123 location relative to the non-functional vehicle.

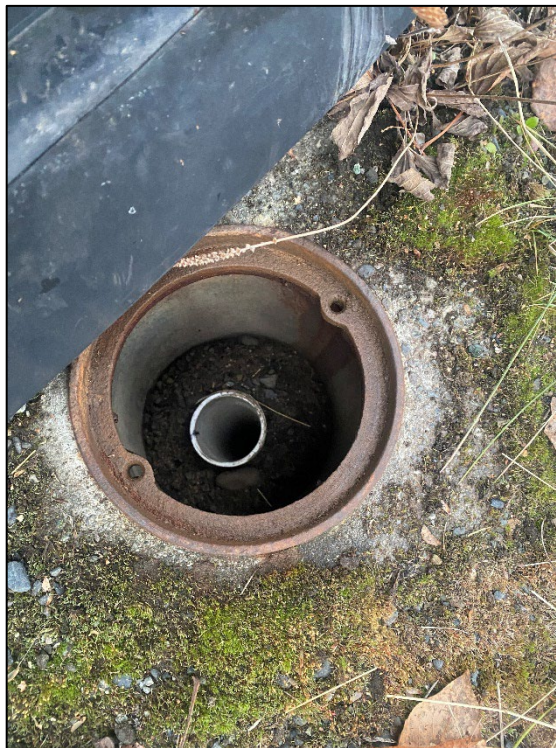
Photograph 4: View looking down. MW-123 opened with well cap off.

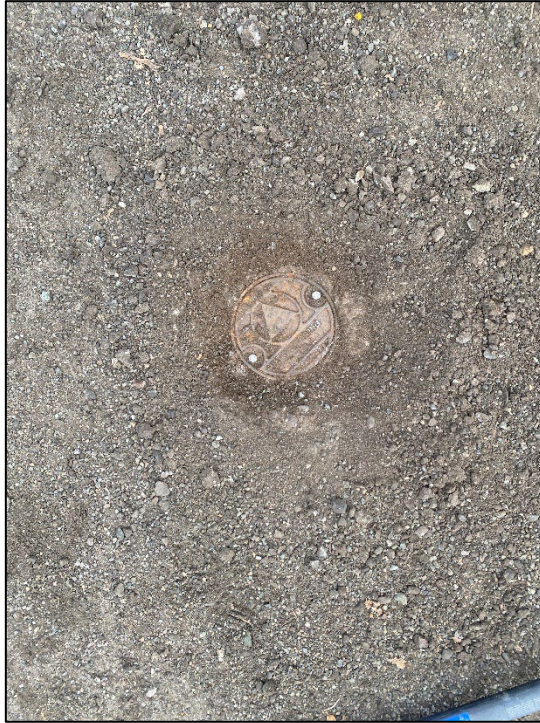
MW-124 was located with the magnetic detector because the flush mount was covered with approximately 2 inches of gravel. The monument was in acceptable condition. The well riser was below the soil level inside of the monument. The well cap did not fit on the riser due to soil that had encroached around the top of riser, and the inside of the riser appeared dirty, indicating soil may have fallen in the well. The soil was frozen solid and could not be removed. The bolt threads on the monument were found to be stripped when closing the well.

Photograph 5: View looking down. MW-124 closed after gravel covering it was removed.

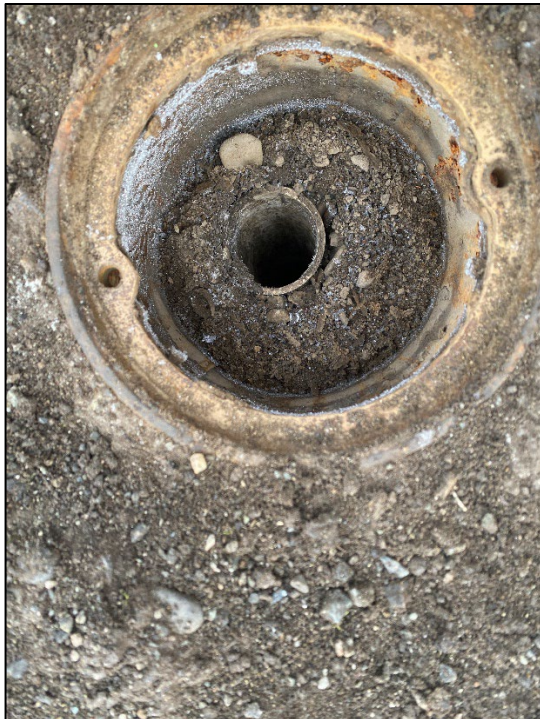
1120 ARRIVE AT MW-124. WELL
IS IN ROAD AND BURIED UNDER
2 INCHES OF GRAVEL. MONUMENT
IS IN OK CONDITION. WELL RISER
IS BELOW THE SOIL LEVEL IN
THE ~~WELL~~ ^{ME} MONUMENT. CAP FOR WELL
DOES NOT FIT ON THE RISER.
INSIDE OF WELL CASING APPEARS
DIRTY, LIKE SOIL HAS FALLEN
IN THE WELL. WELL CAP JUST
SITS IN SOIL ABOVE RISER.
NO LOCK IS ON WELL CAP.
BOLT THREADS APPEAR TO BE STRIPPED
ON THE MONUMENT.

Photograph 6: View looking down. MW-124 opened with well cap off showing high soil level in the monument and dirt inside of the riser.

Additionally, the bolt holes in the monument of RW-1 and MW-124 appeared to be broken, preventing the monument lid from being bolted down. The lid to each well was placed back on the monument after the lock was replaced. If RW-1 and MW-124 are scheduled for continued use, it is recommended the monuments be replaced in spring 2024 once the ground has thawed. It was noted that numerous wells contain soil inside the well monuments, near the top of the well casings. If further monitoring continues, it would be beneficial for the soil to be removed in the spring, once the ground has thawed.

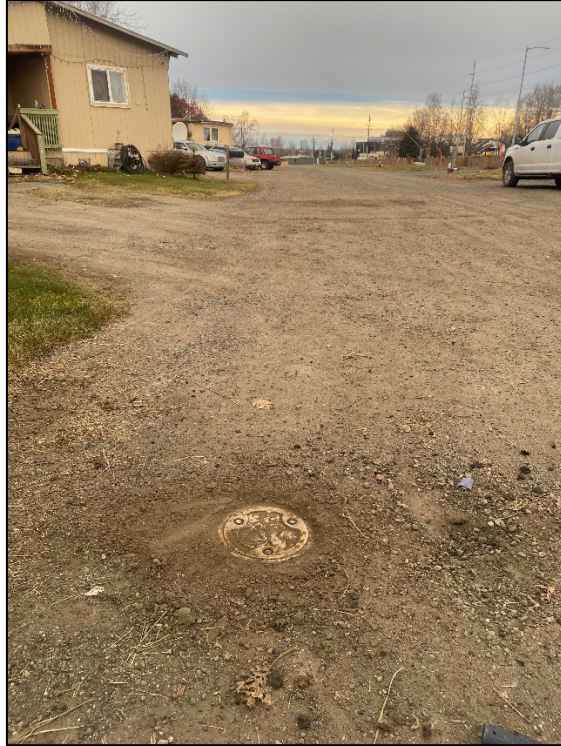
The flush mount for MW-125 was covered by approximately 1 inch of gravel and had to be located with the magnetic detector. MW-125 had a smaller monument inside of the outer monument. The

Photograph 7: View looking north. MW-125 after being dug out in relation to the rest of the trailer park.

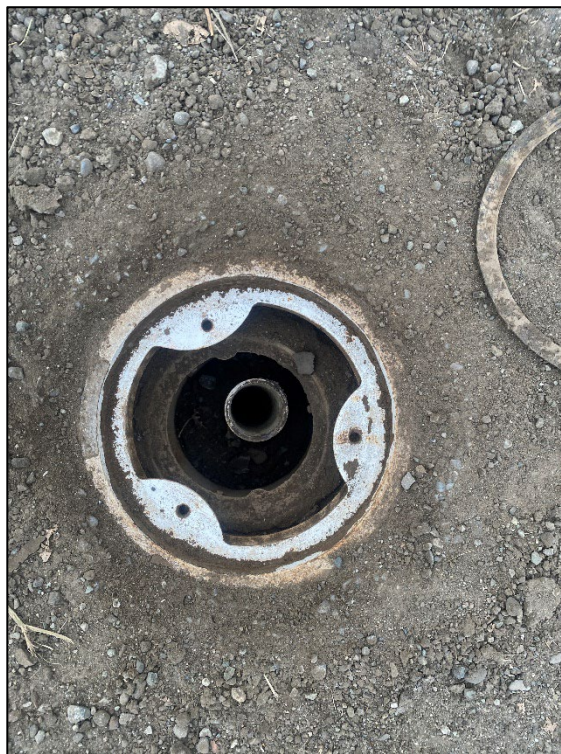
outer monument was in good condition. The top of the riser, while in good condition, was just below the inner monument.

1025 ARRIVE AT MW-125. WELL IS IN
THE ROAD AND UNDER 1 INCH OF
GRAVEL. MONUMENT IS IN OK
CONDITION. THERE IS A SMALLER
MONUMENT IN THE OUTER MONUMENT.
THE WELL TOP OF CASING IS JUST
BELOW THE INNER MONUMENT. WITH
THE WELL CAP ON IT IS ABOVE
THE INNER MONUMENT. THE
OUTER MONUMENT IS IN GOOD
CONDITION. NO LOCK IS ON THE
WELL. WELL RISER IS IN
GOOD CONDITION.

Photograph 8: View looking down. MW-125 with the well cap off after being opened and cleaned. The smaller monument inside of the outer monument is visible.

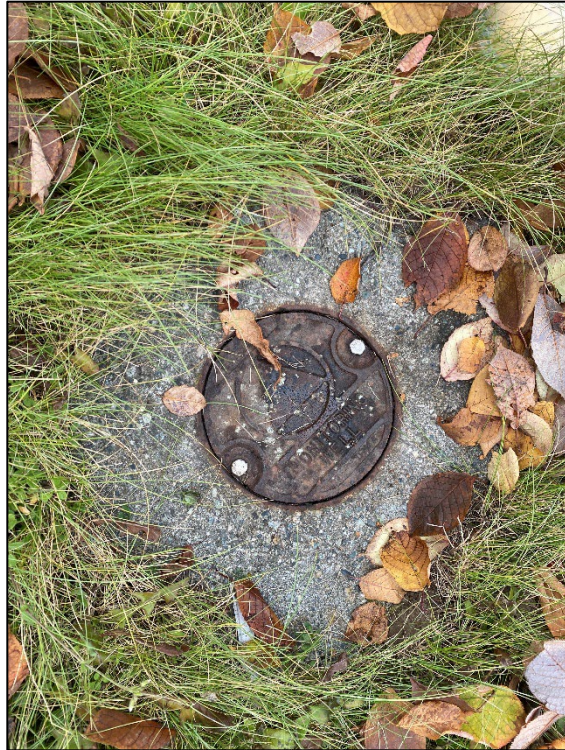
Photograph 9: View looking down. MW-126 closed.

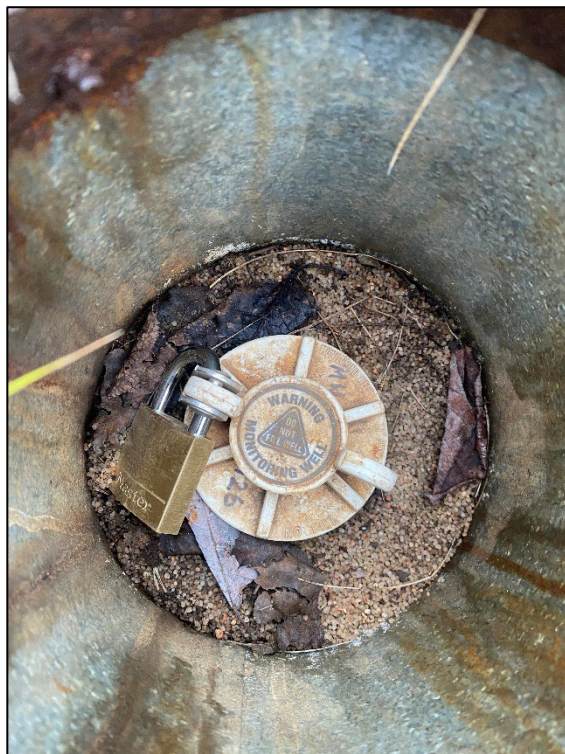
MW-126 had concrete surrounding the monument that was in good condition. The monument and riser were also in good condition. Sand inside the monument was near the top of the casing but not over the well casing causing any damage to the well. The lock on the well cap was found to be corroded, so a new lock was placed on the well cap before closing the monument.

Photograph 10: View looking down. MW-126 opened with new lock installed on well cap. Shows high sand level.

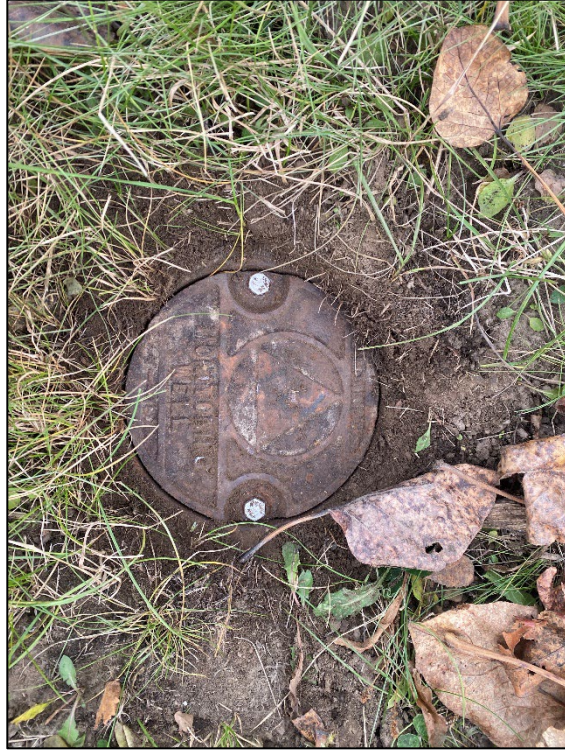
Photograph 11: View looking down. MW-127 closed after being cleaned.

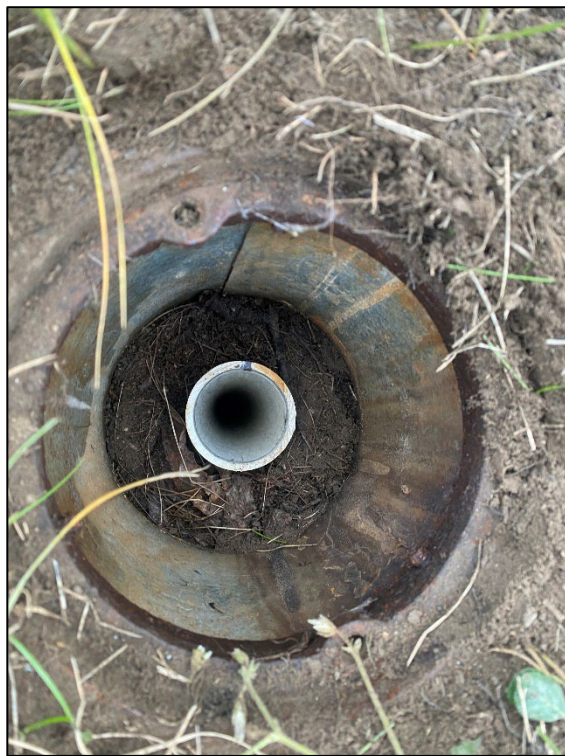
The monument, riser, and well cap of MW-127 were all in good condition. The soil inside the monument was near the top of the casing but not over the top of the casing. The lock on the well cap was corroded and replaced with a new lock before closing the monument.

Photograph 12: View looking down. MW-127 opened with well cap off.

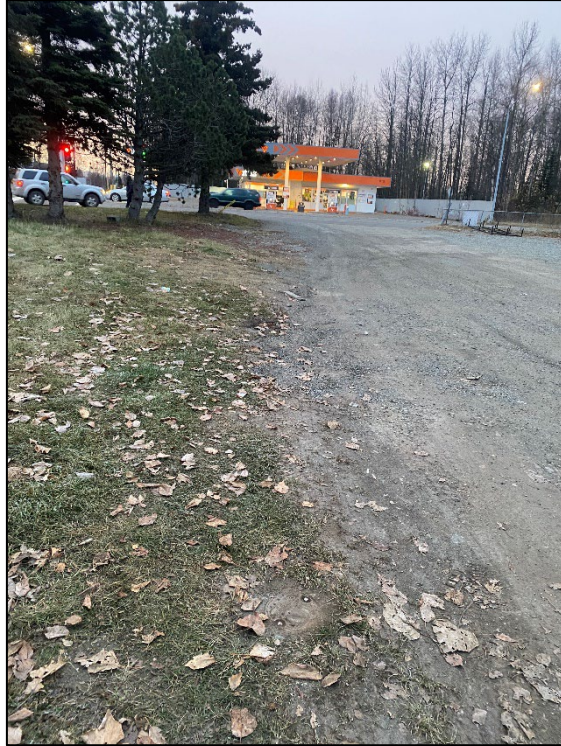
Photograph 13: View looking south. MW-128 unopened in relation to Tudor Road.

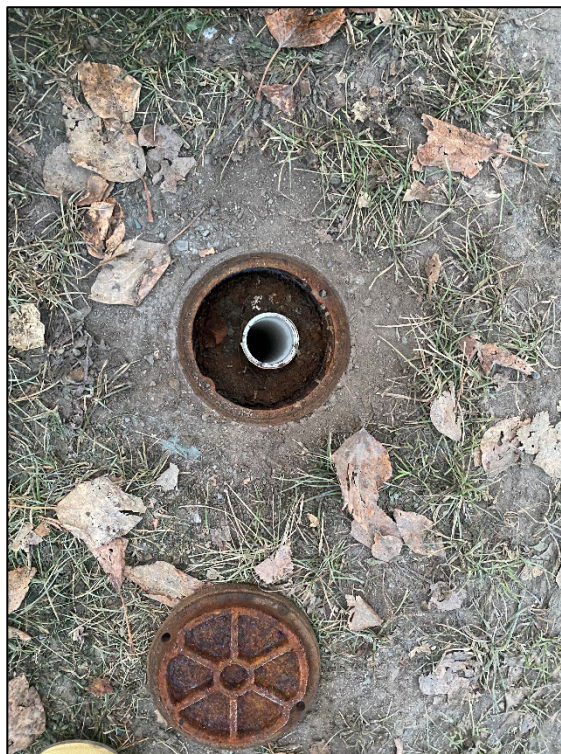
The bolts and lid on the monument of MW-128 were covered with silt and were cleaned prior to opening. The monument was in good condition. The soil in the well vault was close to the top of the casing but was not causing any damage to the well.

Photograph 14: View looking down. MW-128 opened with well cap off.

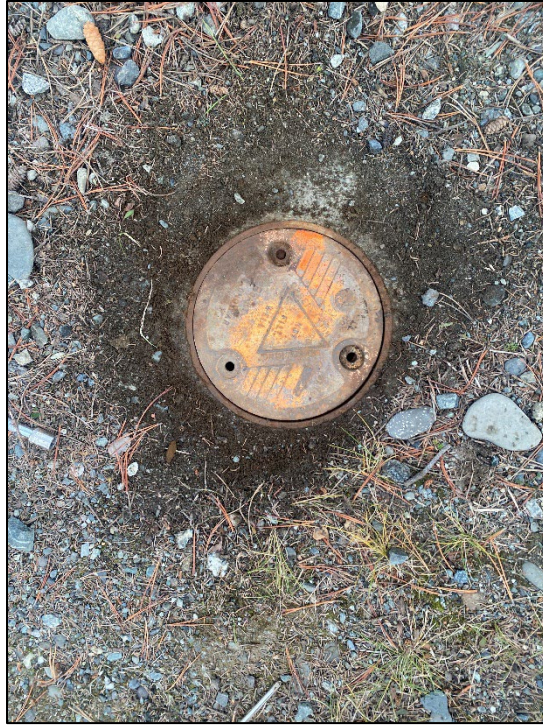
Photograph 15: View looking down. RW-1 closed and cleaned.

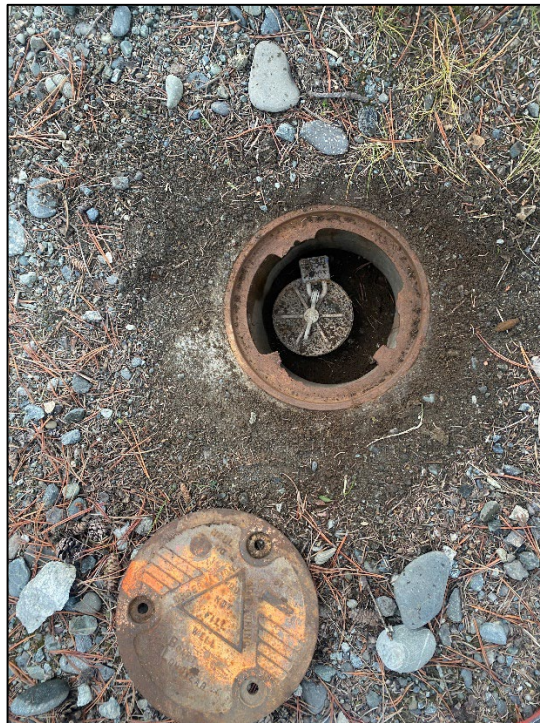
The monument for RW-1 was missing all three bolts and the bolt holes showed signs of damage in the monument. RW-1 is a 4-inch well with a riser in good condition. The well lock showed signs of corrosion and was replaced with a new lock.

1040 ARRIVE AT RW-10. WELL IS MISS-
ING ALL 3 BOLTS FOR THE MONUMENT
LED. BOLT HOLES IN MONUMENT
ARE DAMAGED MAKING IT IMPOSSIBLE
TO SEAL THE WELL JUNCT/MONUMENT.
WELL IS 4 INCH WELL AND
RISER IS IN GOOD CONDITION.
WELL WAS LOCKED WITH A DAMAGED
LOCK. LOCK WAS REPLACED.

Photograph 16: View close up. RW-1 opened with old lock on well cap. Missing bolts and damaged bolt holes shown.
