December 12, 2023

**Subject: Final 2023 Initial Vapor Intrusion Investigation Survey Report, AFSC Off-Airport Fuel Facility, Port of Alaska**

2023 Initial VI Investigation  
 AFSC Off-Airport Fuel Facility  
 Anchorage, AK

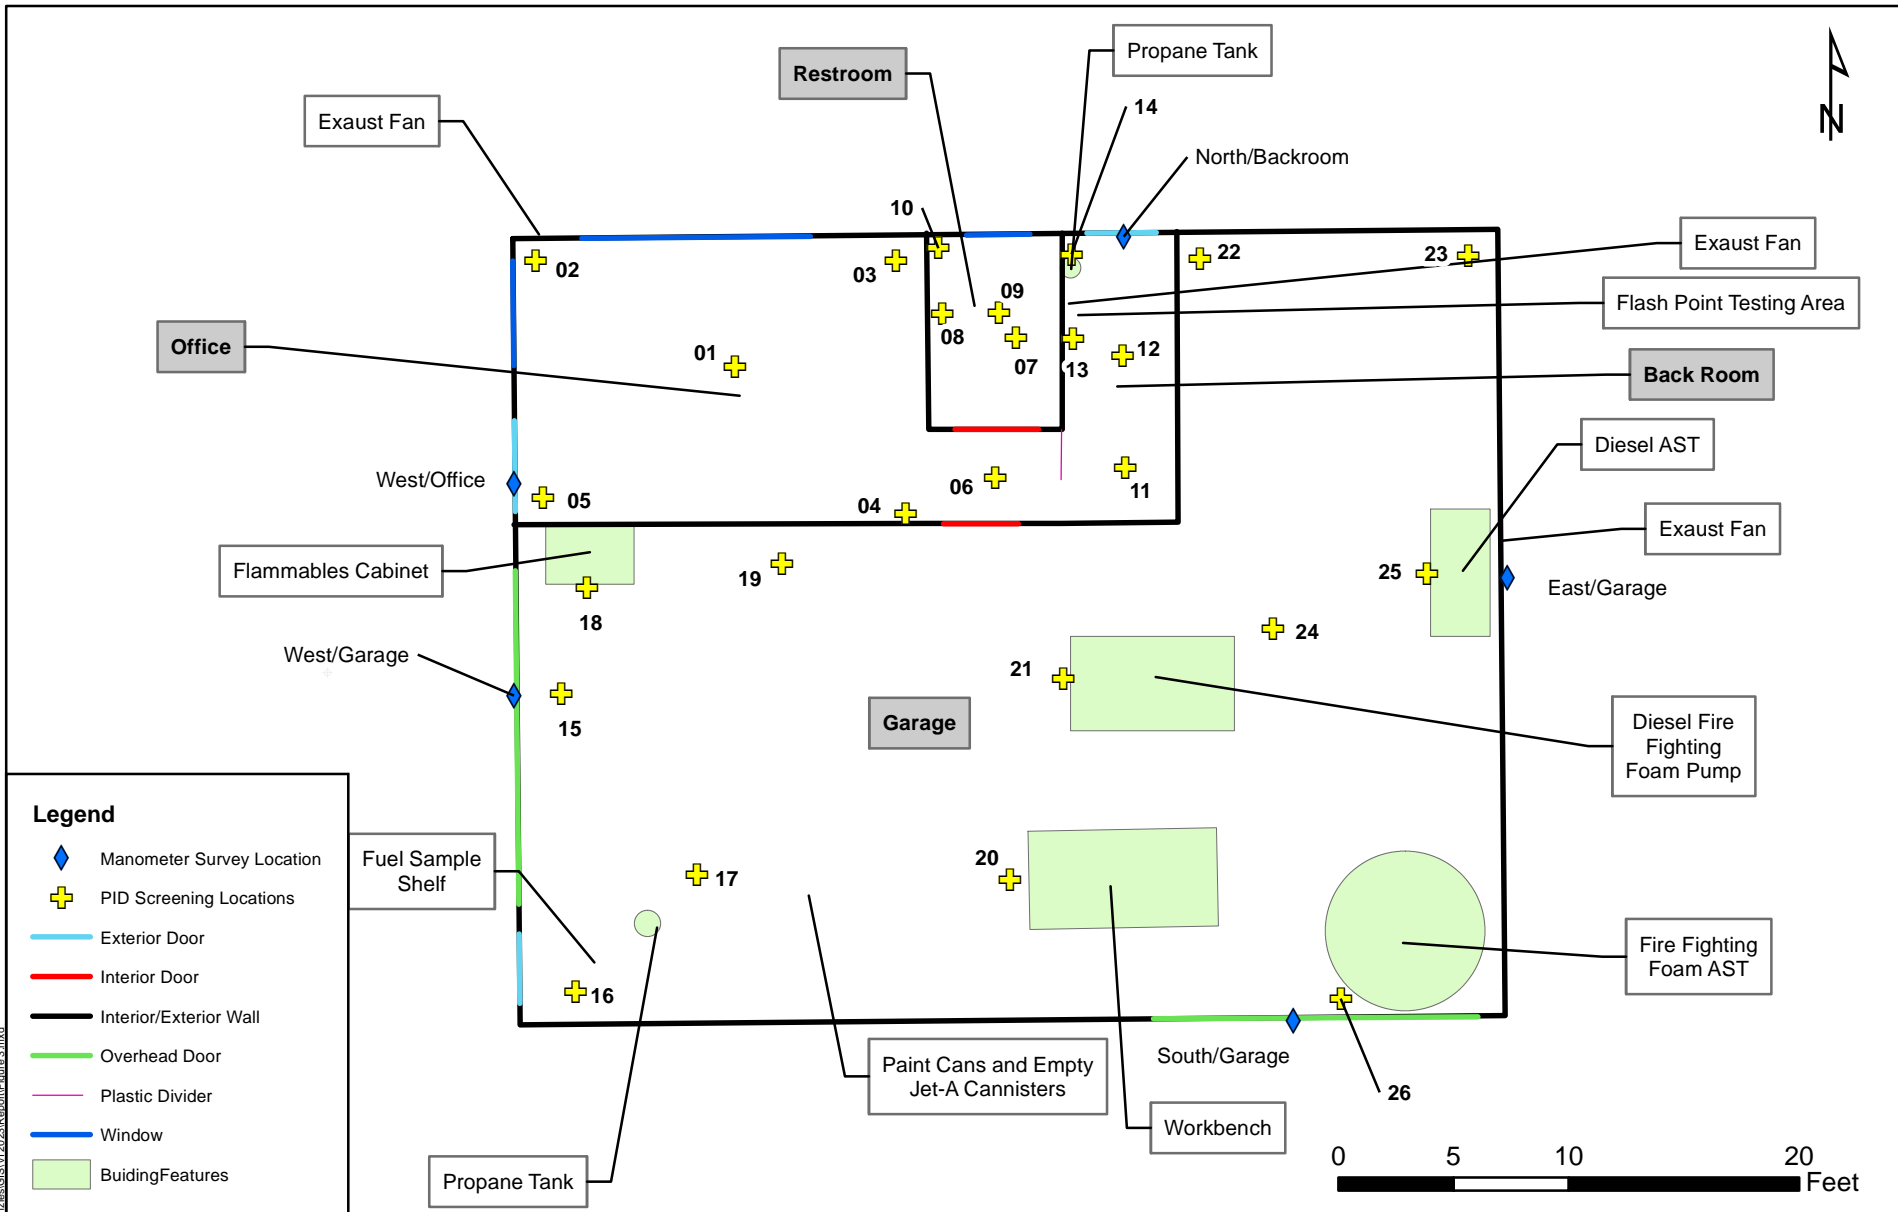
**Control Building Layout**

During the VI inspection, Ahtna personnel recorded observations specific to each room of the control building. Figure 3 presents the layout of the control building, PID screening locations, and manometer survey locations. Additional observations were recorded on the BSIASQ form in Attachment 3.

The pressure differential on all four sides of the building was screened using a digital manometer. The west side of the building was screened twice, once in the office and once in the garage. The positive tubing end of the manometer was placed outside of the building and the negative tubing end was placed inside the building. Manometer readings were between 0.000 and 0.008 inch of water column. These results suggest there is a very slight pressure differential between the outdoor and indoor air that causes the air to flow into the building from all sides of the building, except for the east side, which had a zero result. Wind was blowing from the northwest to the southeast resulting in the north and west sides of the building to be the upwind sides of the building and the west and south sides of the building being the downwind sides. Table 3 presents the results of the manometer survey and Figure 3 shows the locations that were surveyed with manometer.

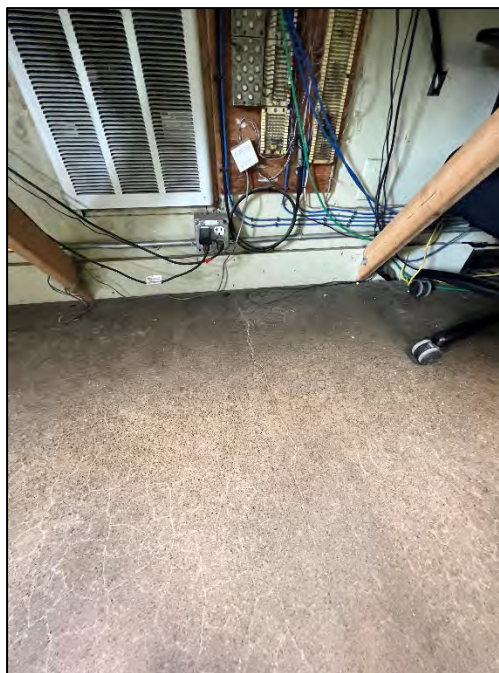
Photograph 6: View looking north. Under the office desk along north wall. Note radiant heater and small cracks in the concrete floor.

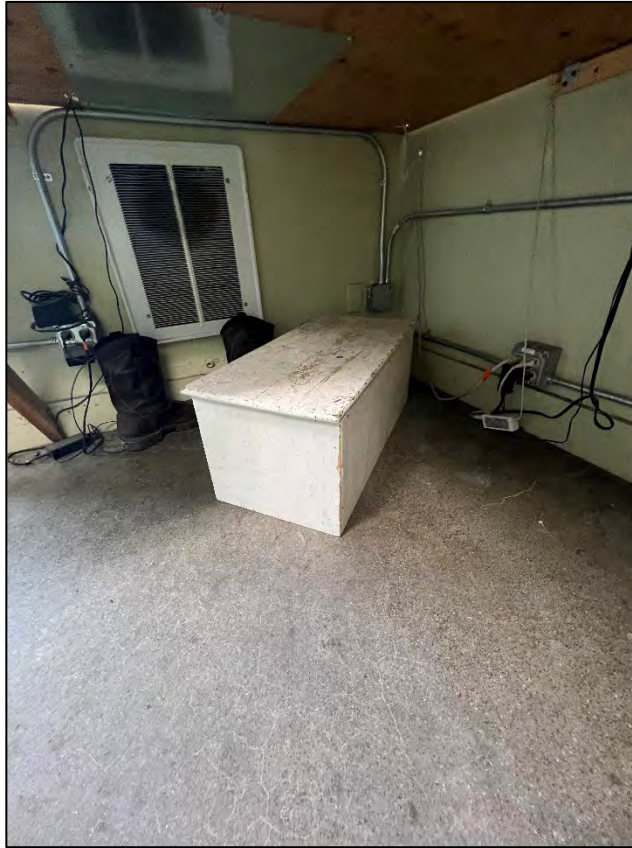
Photograph 7: View looking northeast. Area under office desk along northeast wall. Note heater and cracks in concrete floor.

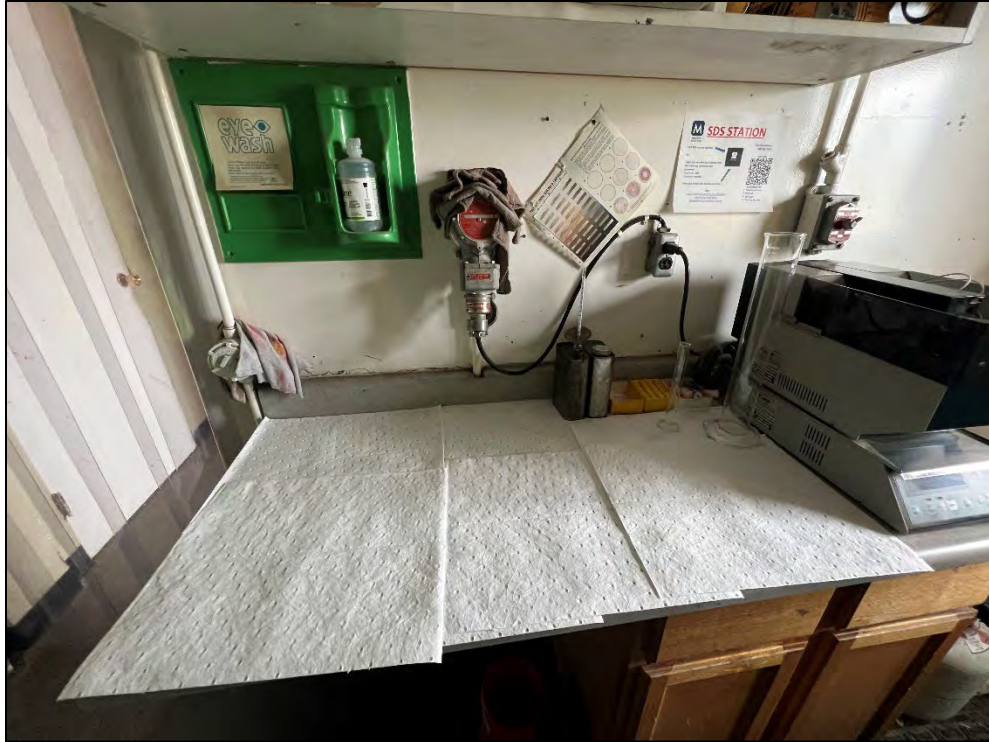
Photograph 10: View looking west. Flash point testing station. Note metal sample containers and flash point testing machine located in the back room.

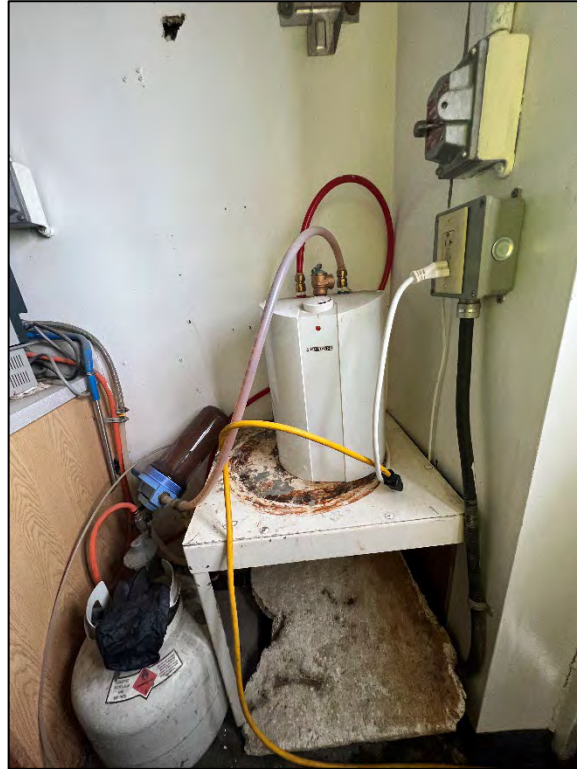
Photograph 12: View looking west. Area to the right of the flash point testing station (when facing counter) in the back room. Note 20-pound propane tank hooked up to the flash point testing machine and the electric water heater.

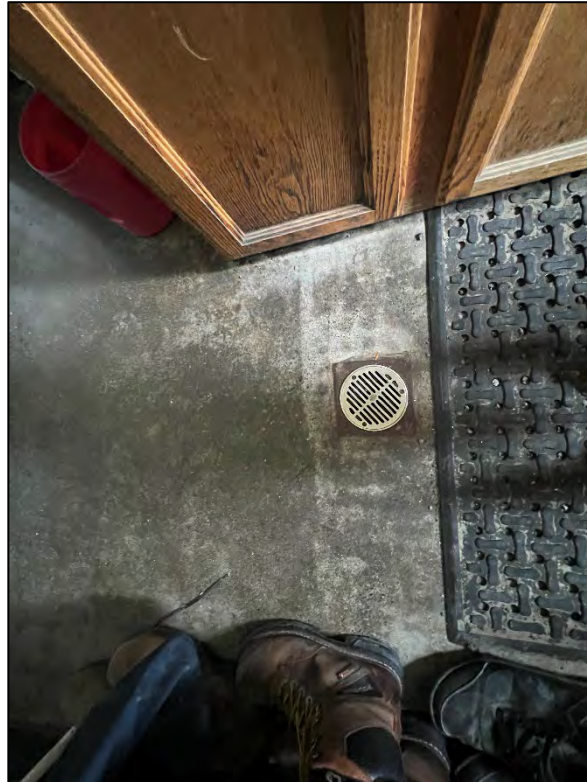
Photograph 15: View close up. Floor drain in the back room.

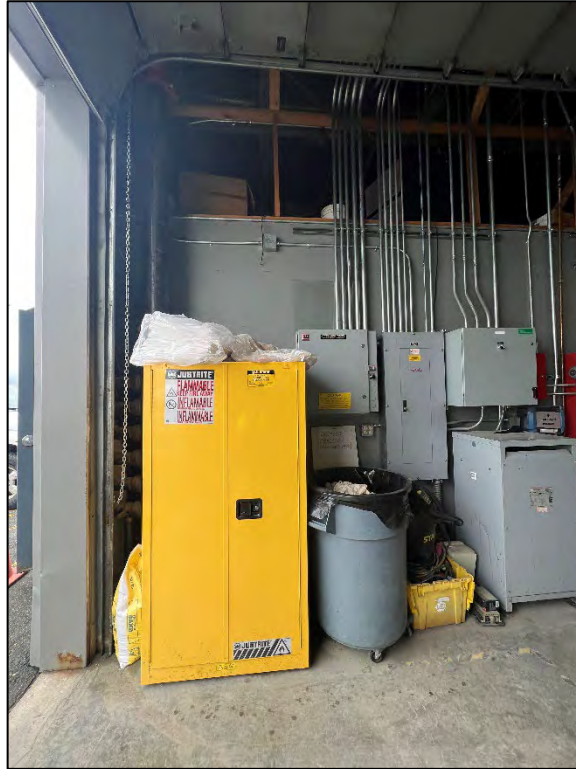
Photograph 20: View looking north. Flammable storage cabinet and oily rags disposal cannister. Garage overhead door on left of the photo.

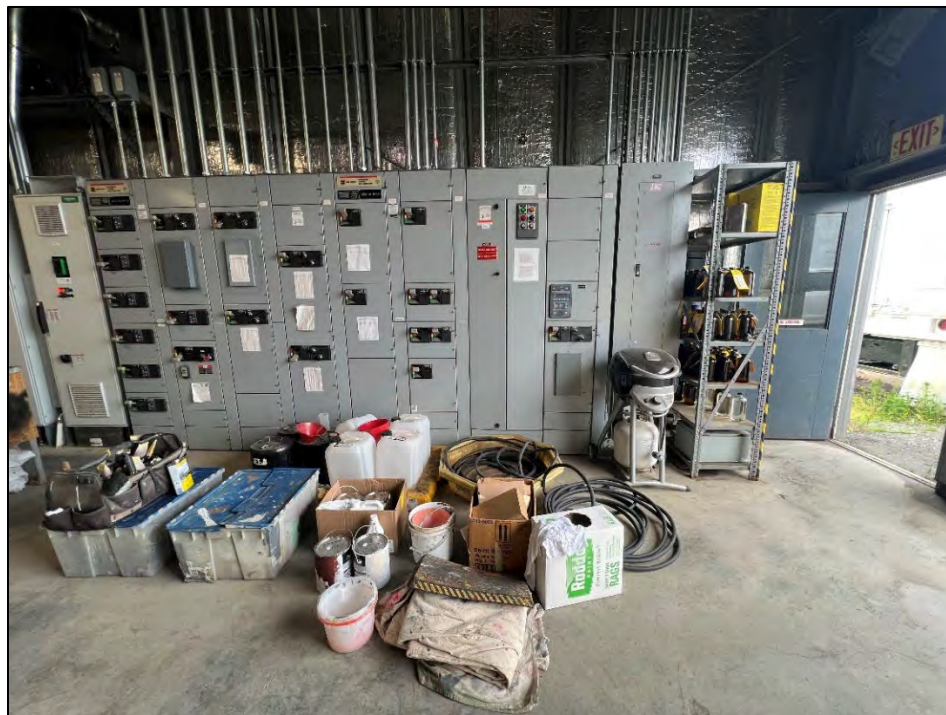
Photograph 21: View looking south. Storage area with paint cans and empty Jet-A fuel cannisters located in the garage.

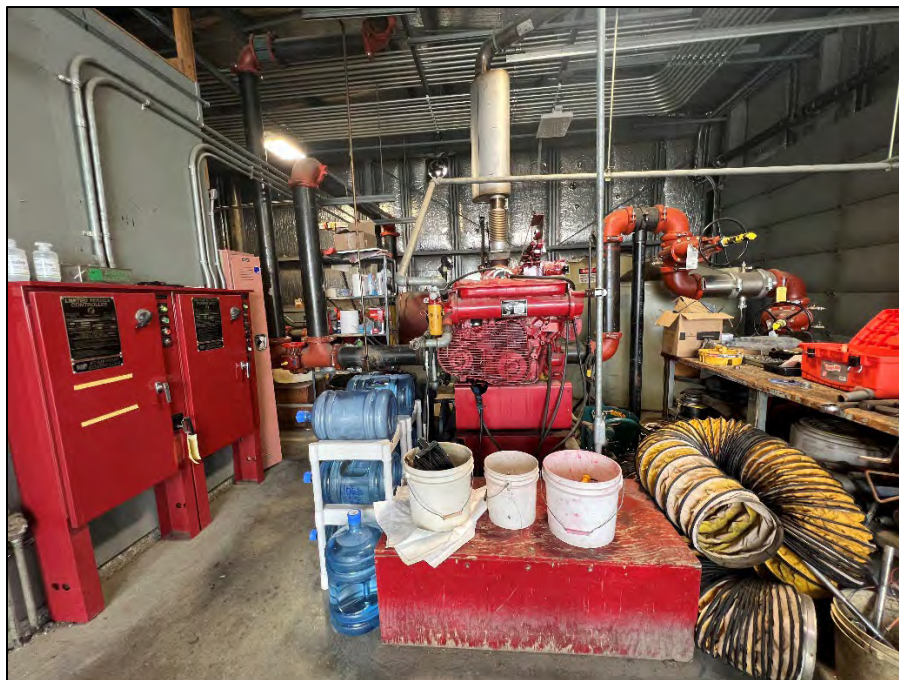
Photograph 23: View looking east. Diesel powered fire fighting foam pump in center of picture. Note exhaust coming from top of pump.

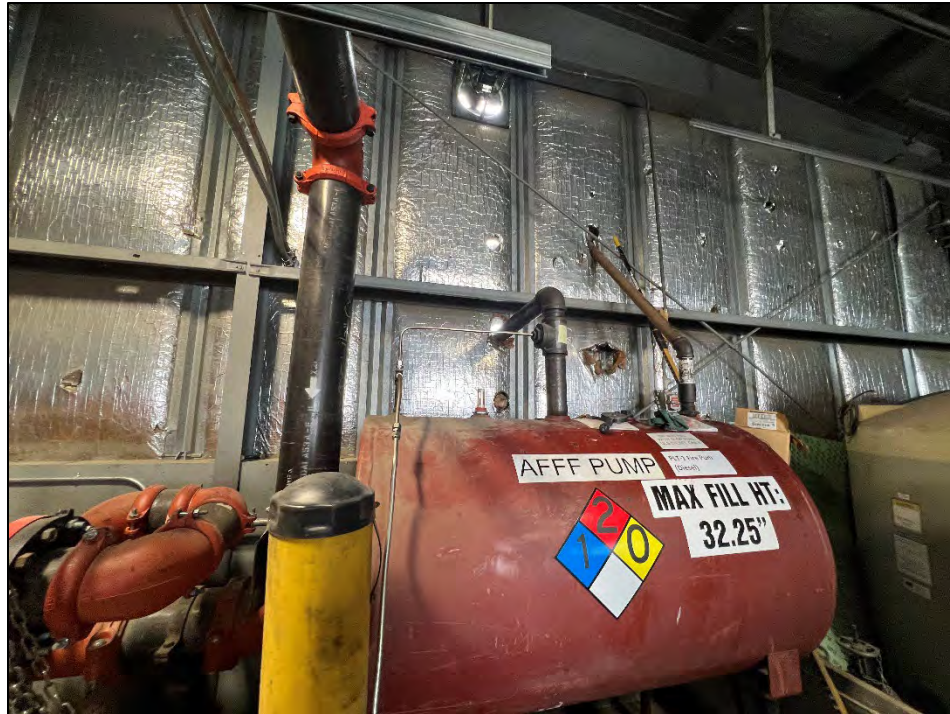
Photograph 30: View looking east. East wall of the garage. Diesel AST in front. Fire fighting foam AST on right side of photo. Note vent fan on the top of the photo near garage ceiling. Note holes in walls for diesel tank filling access.

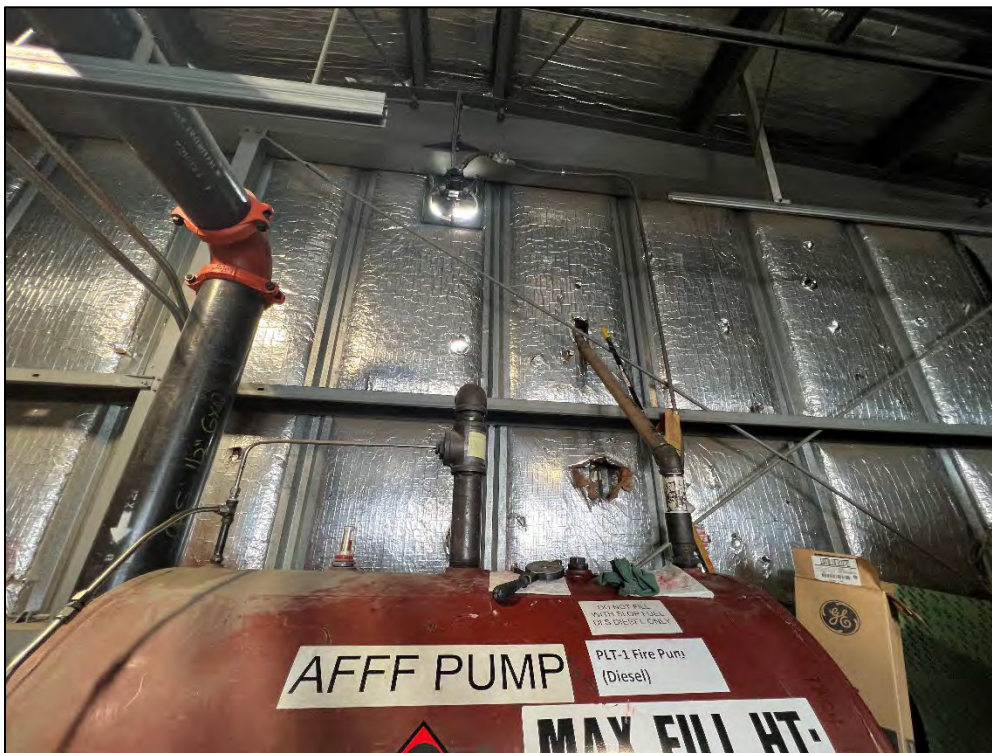
Photograph 33: View looking east. East wall above diesel AST. Note fan near ceiling and various holes in the wall.

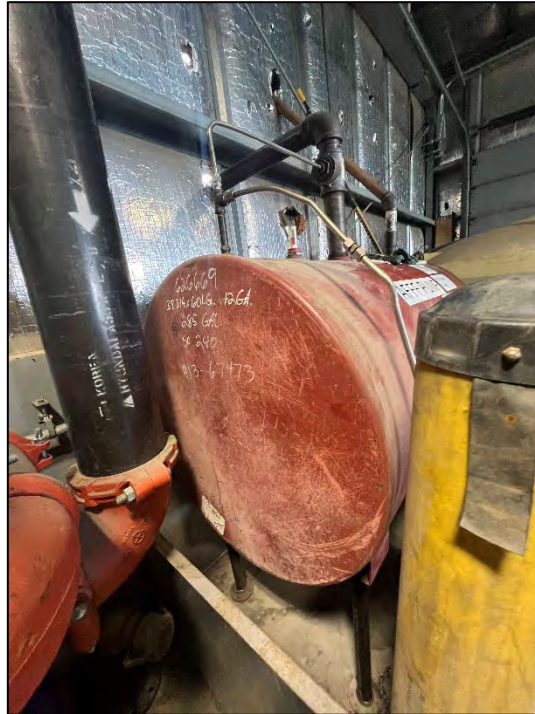
Photograph 36: View looking southeast. Markings on side of diesel tank. Note dry containment, tank does not appear to leak or have history of leaks.

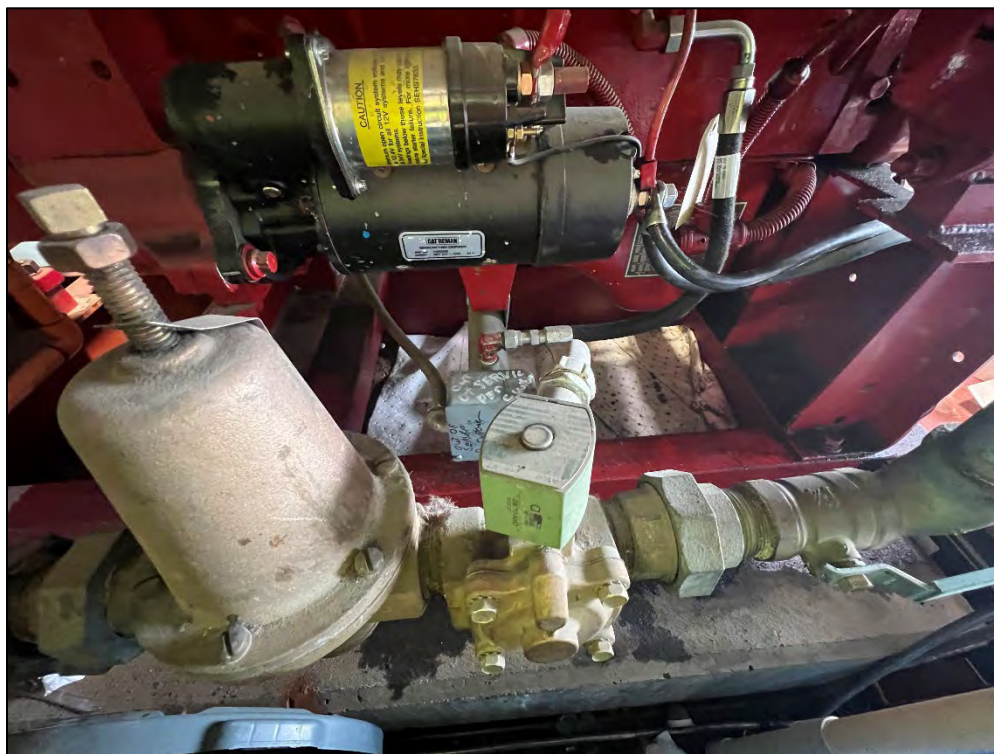
Photograph 37: View closeup. Diesel powered firefighting foam pump closeup. Note small minor leaks under pump.
