SUBJECT: Letter Report for Thorne Bay Warehouse Area Corrective Action

Thorne Bay Warehouse Area Corrective Action Letter Report

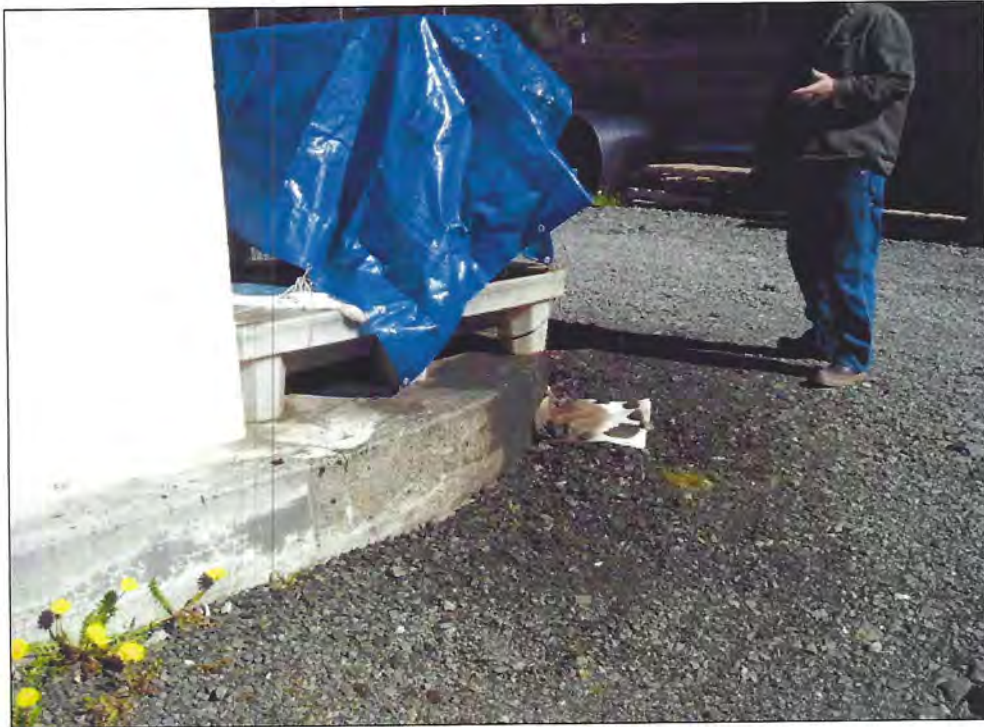
The spill was located adjacent to the southeast end of the fuel island structure located south of the USFS Warehouse. The location was readily apparent as a dark surface-stain on the soil (crushed rock pad fill and cap material) immediately adjacent to the concrete fuel island slab (Figure 1). The stain was approximately 10 feet in diameter and extended from the surface to a

depth of up to 10 inches below ground surface (bgs), and penetrated deepest immediately adjacent to the slab where the product spilled off of the concrete onto the ground (Photograph #1). It appeared that the stained soils continued beneath the slab, but this removal action was not intended to chase contamination and compromise the integrity of the structure. The intent was to remove surface contamination and prevent further migration of the petroleum during precipitation events.

Photograph #1 Warehouse Area spill. Note staining on fuel island slab and adjacent ground surface; view north (5/25/05).

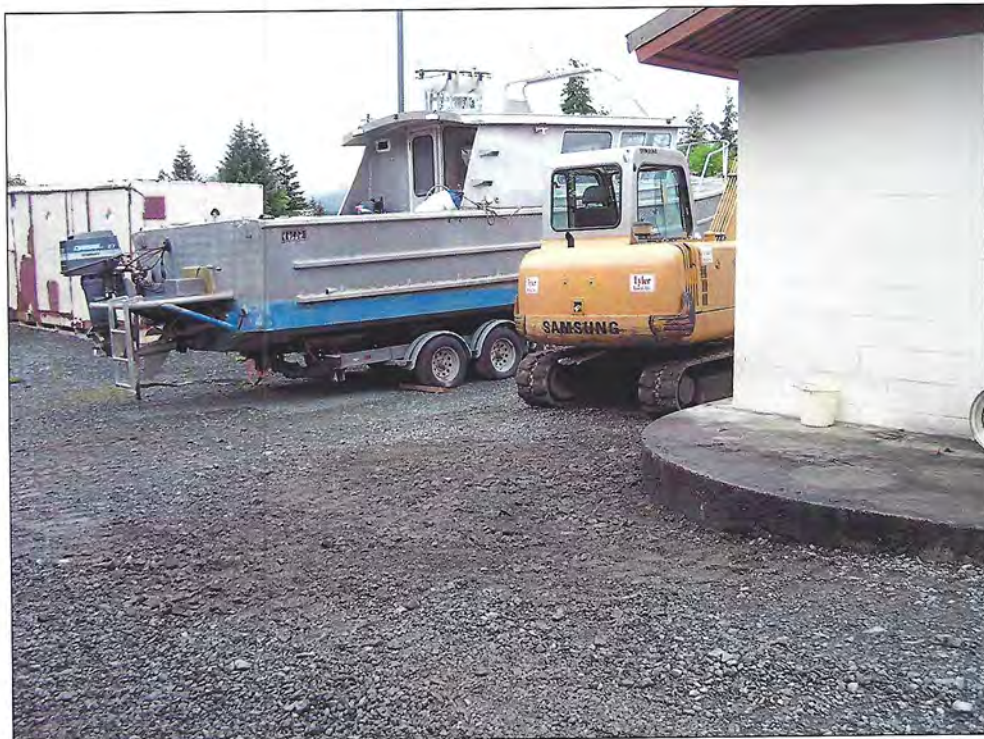
Photograph #2 Spill/excavation site after backfilling and grading. Excavator used for soil removal is along side building; view south (6/29/05).

When analytical results were received, they were reviewed by the BNCI Project Manager, the USFS Onsite Inspector, and the USFS Contracting Officer Representative. BNCI was directed by the USFS to backfill the warehouse excavation for safety reasons using clean crushed rock already onsite. BNCI backfilled and regraded the warehouse excavation on June 29, 2005 (Photograph #2).

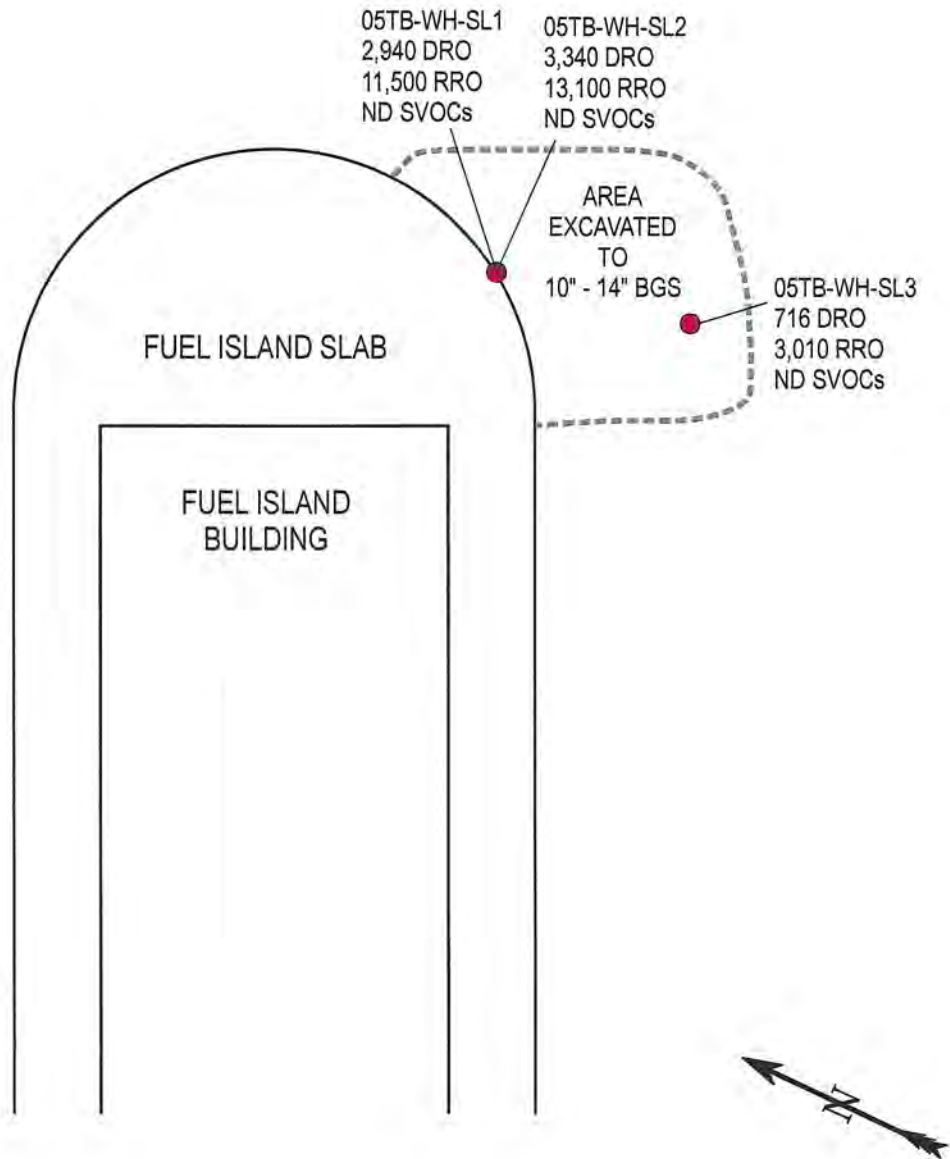
FIGURE 1 WAREHOUSE SPILL EXCAVATION

Analytical results from sample 05TB-WH-SL1 were 2,940 mg/kg DRO, 11,500 mg/kg RRO, and non-detect for SVOCs. Results from the duplicate sample were 3,340 mg/kg DRO, 13,100 mg/kg RRO, and non-detect for SVOCs. The results from both samples exceed the proposed ACL of 441 mg/kg DRO and the Method Two cleanup level of 8,300 mg/kg RRO. RCRA metals were non-detect or below the ADEC Method Two cleanup level except for arsenic which exceeded the Method Two cleanup level of 1.8 mg/kg with a concentration of 7.01 mg/kg in the primary sample and 4.56 mg/kg in the duplicate. These arsenic values likely represent local background conditions and are not considered anomalous at this site. Analytical results from sample 05TB-WH-SL3 are 716 mg/kg DRO and 3,010 mg/kg RRO, exceeding the proposed ACL cleanup level for DRO. These results are summarized in Table 1 (attached). A copy of NCA's laboratory final report is also attached.
