**TUNTUTULIAK SITE RECONNAISSANCE
AND RECOMMENDATION REPORT
TUNTUTULIAK, ALASKA
DRAFT**

**ADEC Aboveground Storage Tank Program
410 Willoughby Avenue, Suite 105
Juneau, Alaska 99801-5207**

**Bristol Environmental & Engineering Services Corporation
2000 W. International Airport Road, #C-1
Anchorage, Alaska 99502
(907) 563-0013**

January 2001

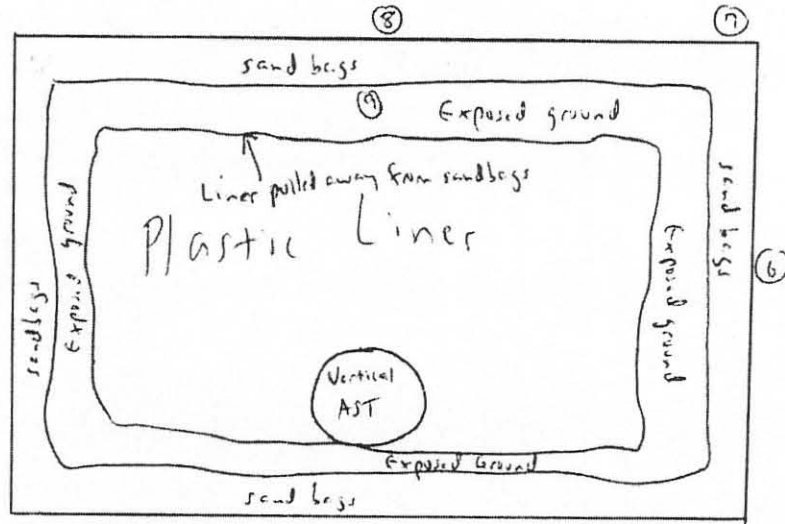
BRISTOL Environmental & Engineering Services Corporation Contract No: 18-5001-10	Site 1 - Tuntutuliak Community Services Association, Electric Plant - Field Drawing Tuntutuliak, Alaska	Date: January 2001	Figure 3
		Drawn By: CJL	Project No: 21071
		Checked By: JSR

All soil samples collected from the site were screened with a PID, and readings ranged from zero to ten units. The soil sample with the PID reading of ten units, collected from location number 8 (see Figure 3), was submitted to the laboratory for analysis. An identification of TPPTF8-SL (Tuntutuliak Power Plant Tank Farm, location 8, SoiL) was assigned to this sample. PID readings, sample intervals, and their associated soil boring locations are shown on the following table:

BORING LOCATION	PID READING (units)	SOIL SAMPLE INTERVAL (inches)
1	0	0-6
2	2	0-6
3	0	0-6
4	0	0-6
5	0	0-6
6	0	0-6
7	0	0-6
8	10*	0-6
9	0	0-6

Analytical results for soil sample TPPTF8-SL collected from boring location 8 are shown in the following table, and are also included in Appendix D:

DRO (mg/kg)	GRO (mg/kg)	BENZENE (mg/kg)	TOLUENE (mg/kg)	ETHYLBENZENE (mg/kg)	XYLENES (mg/kg)	TOTAL BTEX (mg/kg)
182	7.54	ND (0.029)	ND (0.115)	ND (0.115)	ND (0.115)	ND

The highest PID reading of the nine soil samples collected at this site was 10 units. Laboratory analysis of this sample indicates that only DRO and GRO were detected, and at relatively low concentrations. No visible signs of contamination at the site were noted. No additional investigative activities are recommended at this site.

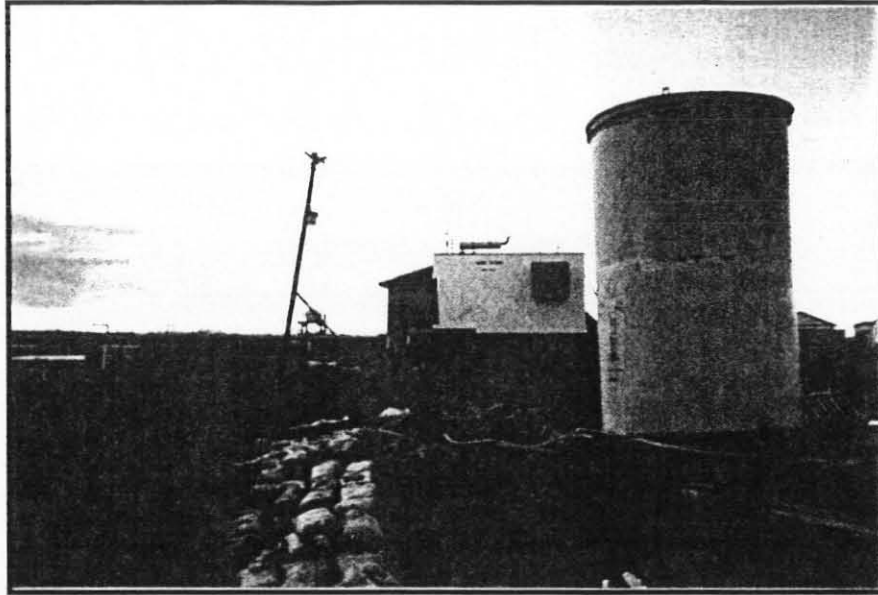
One AST is located at this site. From tapping its side, the AST, marked “#10”, sounded as though it contained little, if any, fuel. According to Mr. Robert Enoch, General Manager of Tuntutuliak Community Services Association, the tank had been moved to the present location from another tank farm, and was currently being used for temporary fuel storage. A wooden dike, which reportedly had been present when the tank farm was active, is absent from the site. The tank farm’s liner was present, but rolled back from the edges, away from the partly-stacked sandbags that still outline the tank farm (photograph 1, Appendix A).

Village: Tuntutuliak Photo 1
ADEC Site Number: 1
Site Name: Tuntutuliak Community Services Association, Electric Plant
Direction: W
Description: Foreground to background is sand bag berm, #10 AST, generators (yellow), Washeteria (red), one of two ASTs (elevated, behind pole) at Washeteria.

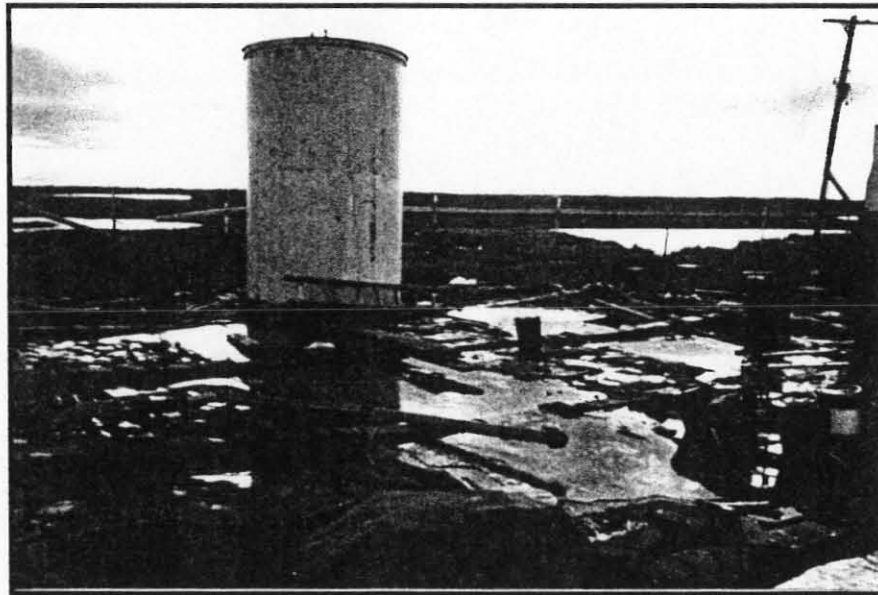
Village: Tuntutuliak Photo 2
ADEC Site Number: 1
Site Name: Tuntutuliak Community Services Association, Electric Plant
Direction: SW
Description: Number 10 AST with Washeteria (Site No. 2, Village Safe Water Plant) Lagoon in background.

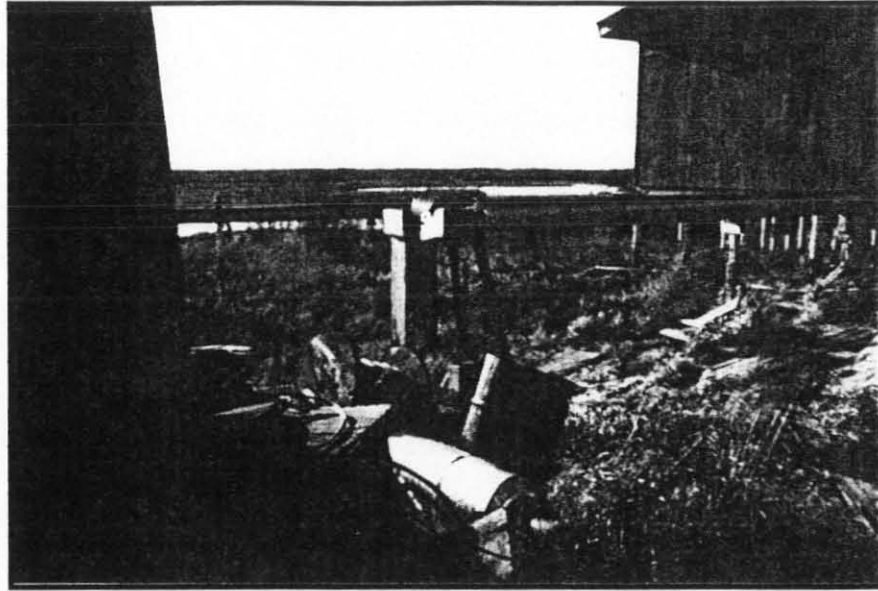
Photo 3

- The nearest drinking water well is located approximately 100 feet east of the Washeteria tank farm. This well provides drinking water to the Washeteria.

Description: Water-supply well for Washeteria is in the center of the photo. This well is approximately 90 feet from the Washeteria tank farm.

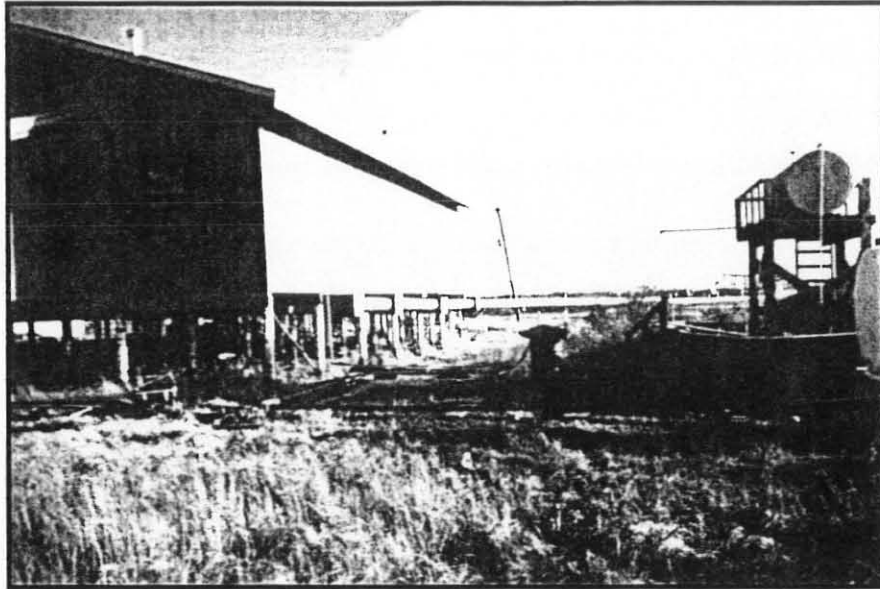
Photo 4

Two ASTs are located at this site (photographs 4 and 5). One horizontal AST, with a capacity of 500 gallons, is located within the diked, lined tank farm and is on a wooden, elevated stand. A new horizontal tank, with a capacity of approximately 2,000 gallons, is located outside and adjacent to the tank farm, to the west. This tank rests on a metal stand.

Village: Tuntutuliak
ADEC Site Number: 2
Site Name: Tuntutuliak Community Services Association, Village Safe Water Plant
Direction: NE
Description: Along the south side of the Washeteria. 2,000-gallon AST is seen on the right, and 500-gallon AST is seen to its left.

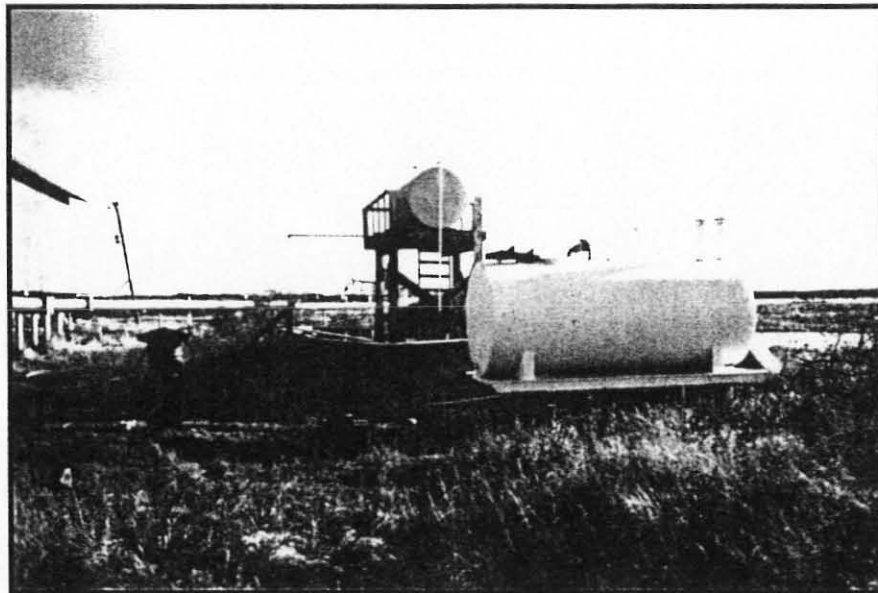
Photo 5

Village: Tuntutuliak
ADEC Site Number: 2
Site Name: Tuntutuliak Community Services Association, Village Safe Water Plant
Direction: E
Description: Same as Photo 4.

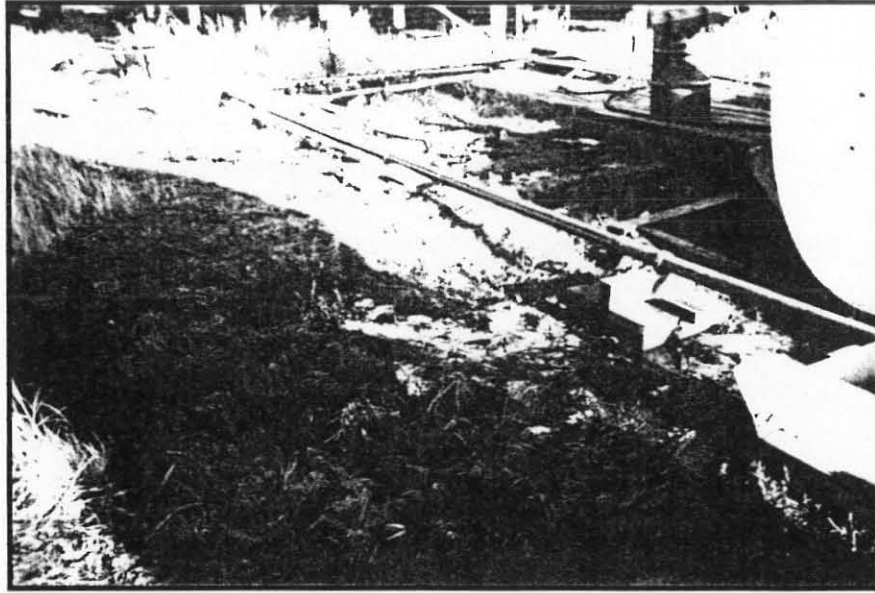
- *Soil staining observed:* Soil staining was seen to the north and east of the 2,000-gallon AST, as well as on the northern side of the tank farm, along the western side (Photograph 6).

The highest PID reading of the six soil samples collected at this site was 104 units. Laboratory analysis of this sample indicates the presence of DRO, GRO, and xylenes. While concentrations of GRO and xylenes are relatively low, DRO was detected at a concentration of 1,020 mg/kg following silica-gel cleanup and re-analysis. The site was visibly stained with petroleum, and a sheen was visible on the surface water.

Village: Tuntutuliak Photo 6
ADEC Site Number: 2
Site Name: Tuntutuliak Community Services Association, Village Safe Water Plant
Direction: N-NE
Description: Stained areas are in the right foreground and background. Shadows are not to be confused with stains.

Given the concentration of DRO detected in the soil sample, the presence of soil staining and surface water sheen, the proximity of the site to the Washeteria drinking water well, and the possible variability of the direction of groundwater and surface water flow, additional investigative activities are recommended at this site.

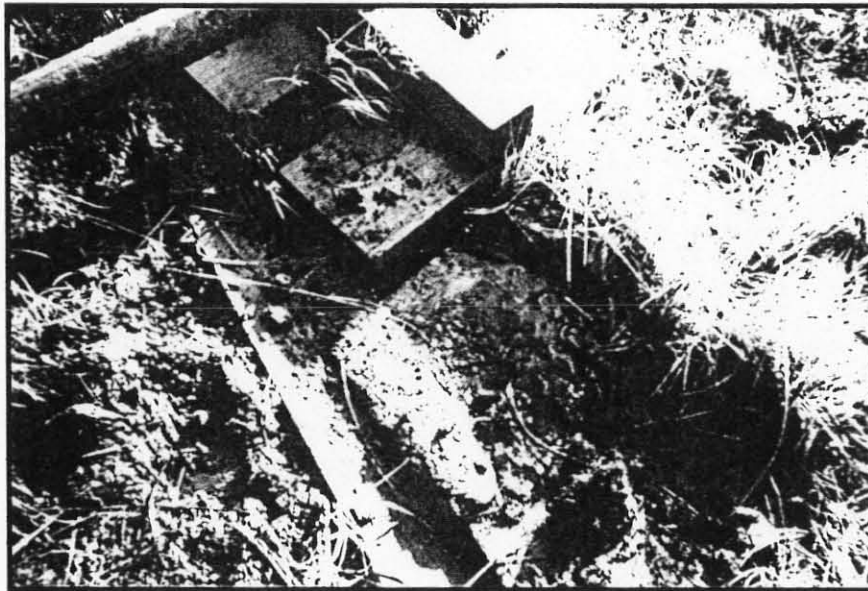
- *Sheen on water observed:* A sheen was visible on the surface water near boring location no. 1, at the southern end of the boardwalk (photograph 7).
- *Soil description:* Peat to 6 inches, underlain by gray silt.

Village: Tuntutuliak Photo 7
ADEC Site Number: 2
Site Name: Tuntutuliak Community Services Association, Village Safe Water Plant
Direction: SE
Description: Sheen on water near boring location no. 4. This location is near the green tote seen in the upper left-hand corner of Photo 6.

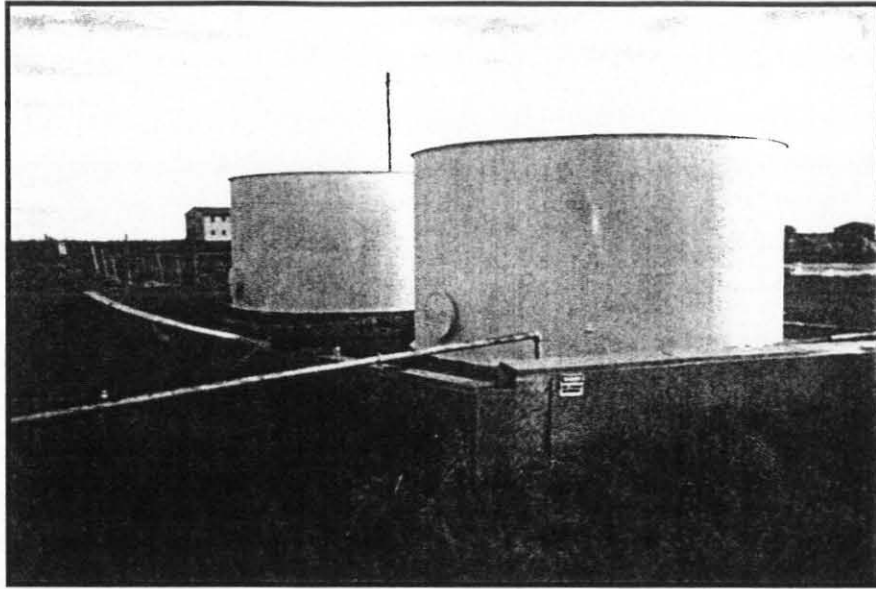
Photo 8

No signs of spills were visible at this site, and PID readings indicated no detectable fuel contamination in the soil surrounding the tank farm. No additional investigative activities are recommended at this site.

Village: Tuntutuliak
ADEC Site Number: 4
Site Name: Lewis Angapak Memorial School, LKSD
Direction: NE
Description: Two ASTs surrounded by dike and underlain by liner.

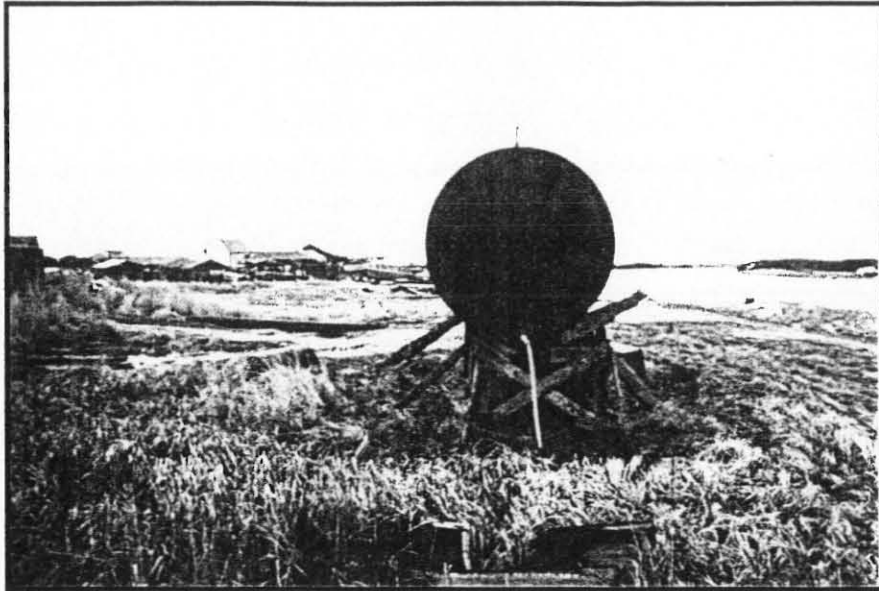
Photo 9

Village: Tuntutuliak
Site Name: Residential Site, Tribal Council
Direction: N
Description: South end of tank. Short length of hose attached to valve. Kinak River on the right.

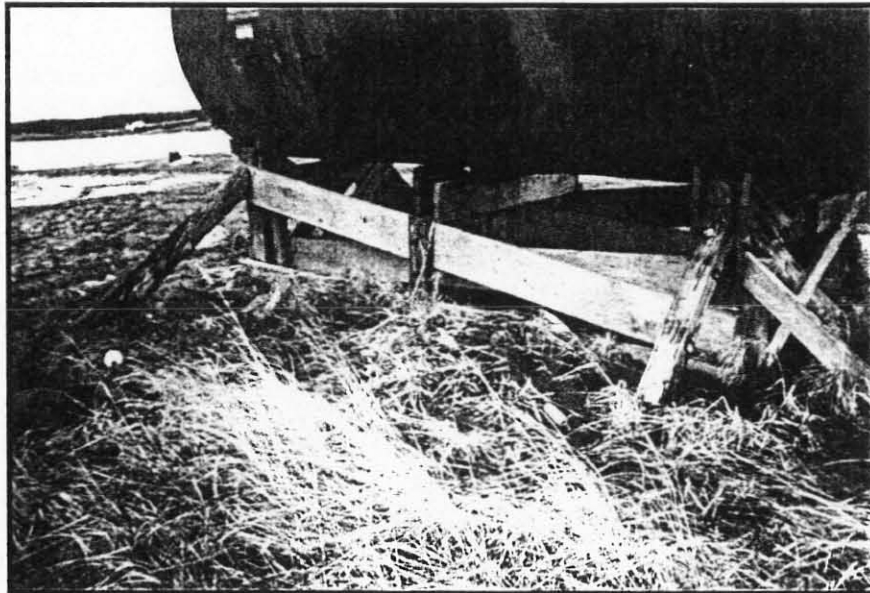
Photo 10

Village: Tuntutuliak
Site Name: Residential Site, Tribal Council
Direction: NE
Description: West side of the tank. Kinak River in the upper left-hand corner of the photo.

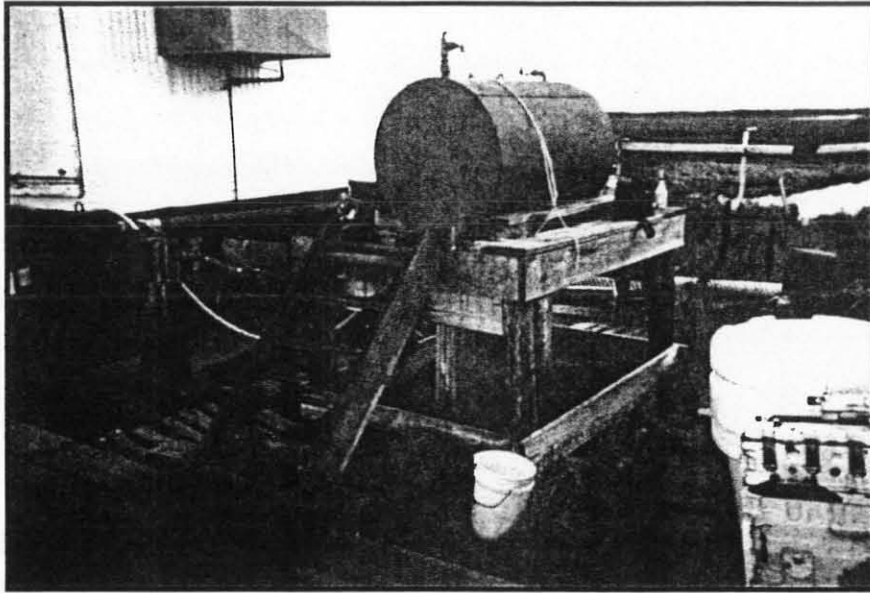
Photo 11

- *Soil staining observed:* Soil staining was seen underneath, and south of the tank (photograph 11). Soil staining was also visible underneath, and south of the western-most generator (Photographs 12, 13). It could not be determined whether the staining underneath the generator was from the tank spill, or from the generator itself. A hose is routed through the floor of the generator building into a 5-gallon bucket. Possible spillage of the fluid (appears to be oil) from this bucket may have contributed to the staining.

Village: Tuntutuliak
Site Name: Addition Reconnaissance Area (Electric Plant)
Direction: SE
Description: 300-gallon AST on the west side of the western-most generator.

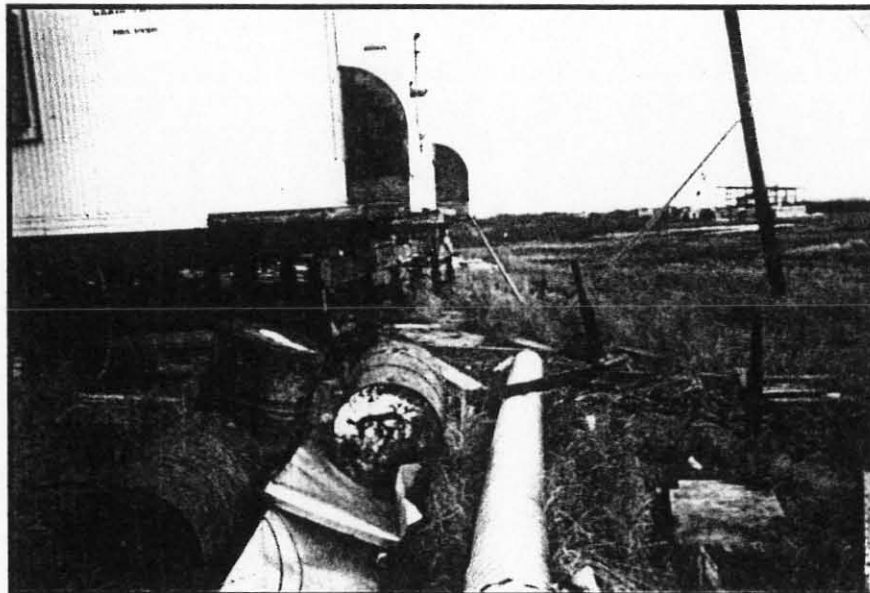
Photo 12

Village: Tuntutuliak
Site Name: Addition Reconnaissance Area (Electric Plant)
Direction: E
Description: On the south side of the three generators and tank, looking east.

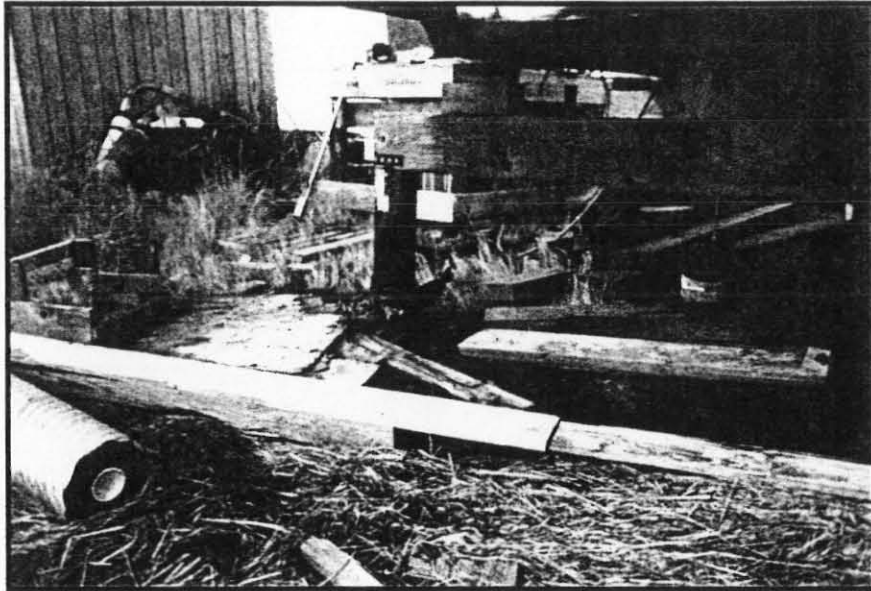
Photo 13

Description: Staining on the ground south of the tank (red, center top of photo), and underneath the western-most generator. Five-gallon bucket with hose running from floor of generator building is visible. This bucket may contain oil.
