**Petro Marine AKDOT Project  
Delta Western Tank Farm  
Haines, Alaska  
June 2013**

## **1.0 INTRODUCTION**

This report presents the methods and procedures followed during excavation, transportation and stockpiling of soil from the ditch area along Beach Road, below the Delta Western Tank Farm (Former Petro Marine) in Haines, Alaska.

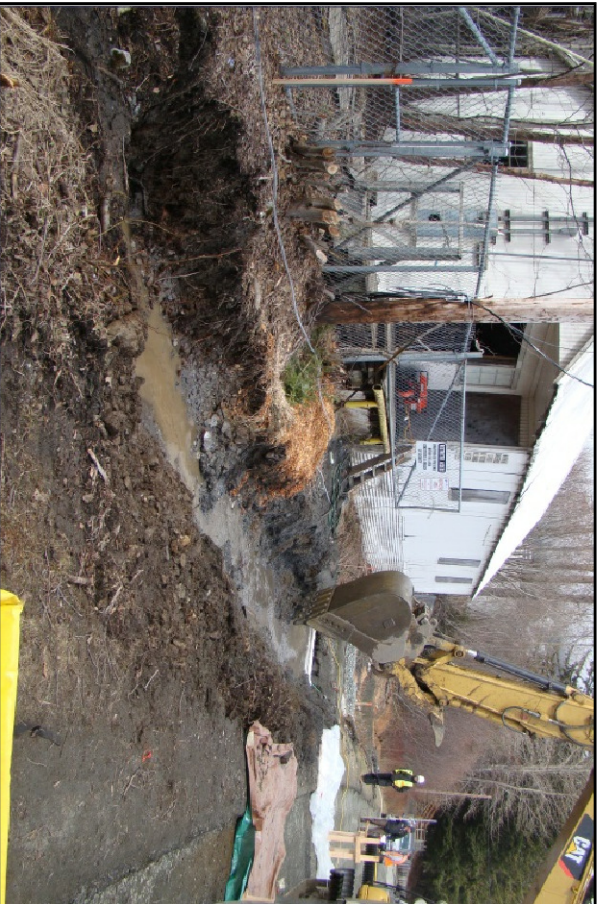
Driveway Excavation

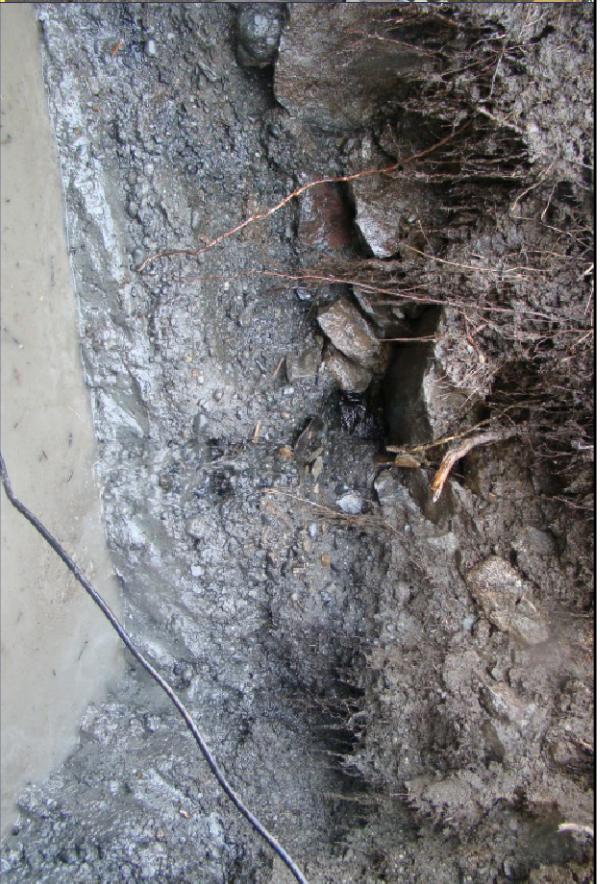
Driveway Excavation Uphill Sump Hole

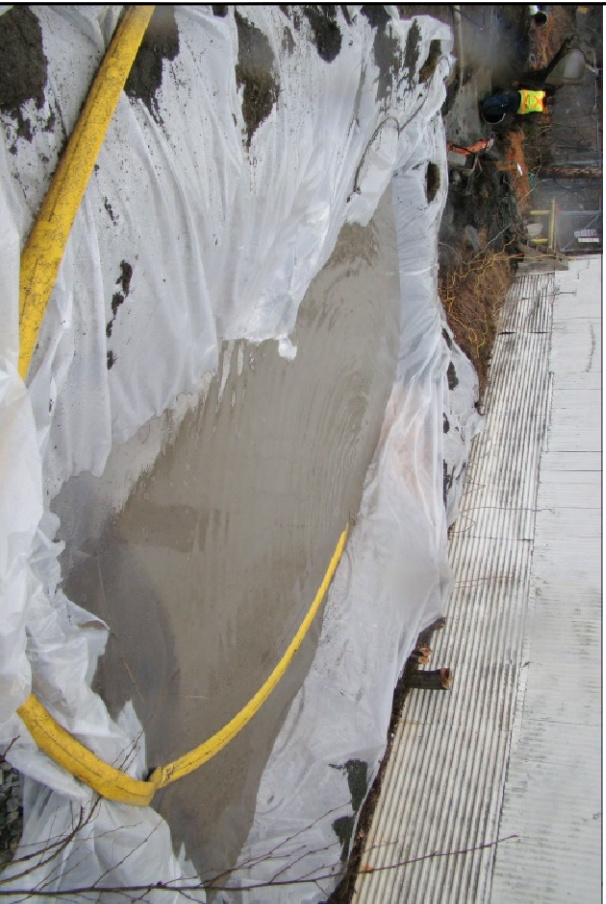
Temporary Containment Pond

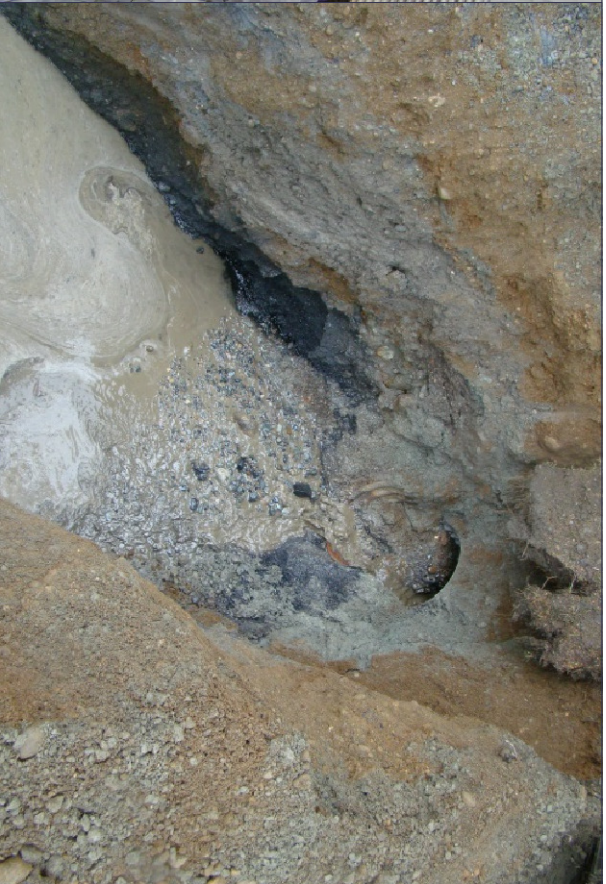
Roadway Excavation

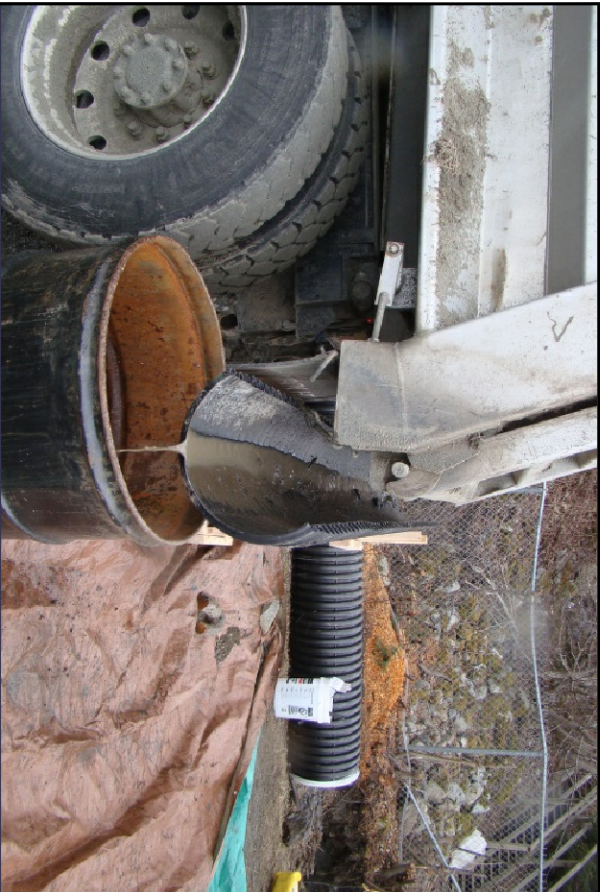
**Dewatering Trough**

Most of the contaminated soil removed was saturated. To dewater the material for transport, the saturated material was placed in the dump trucks and bed raised with a trough under the back of the truck to catch the water dripping out of the truck. From the trough, the water was directed into a 55-gallon salvage drum. When the load stopped dripping water, the material was considered to be stable for transport. Assumed contaminated soil was then transported and placed in the stockpile. All stockpiled soil was covered by 12-mil HDPE liner and weighted down with sandbags.

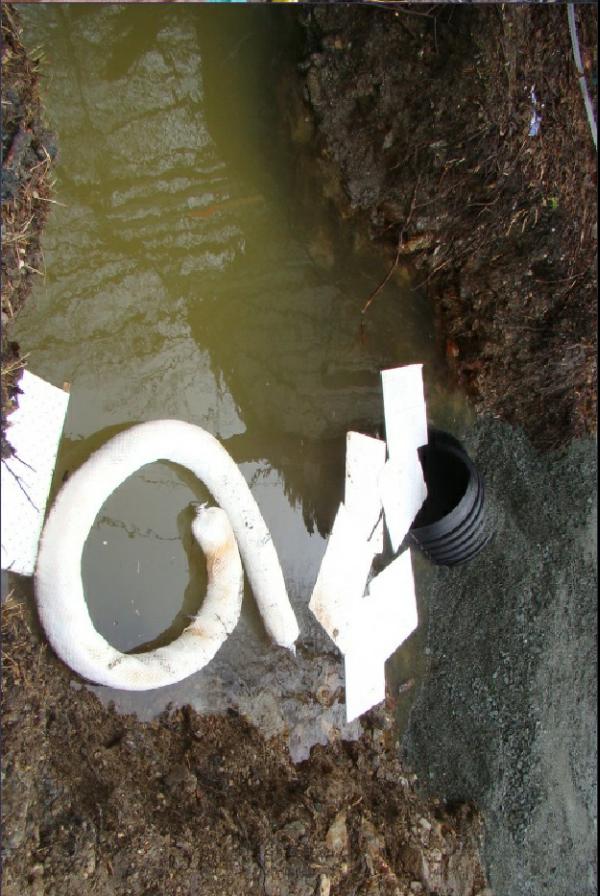
**Driveway Culvert Uphill Sump Hole**

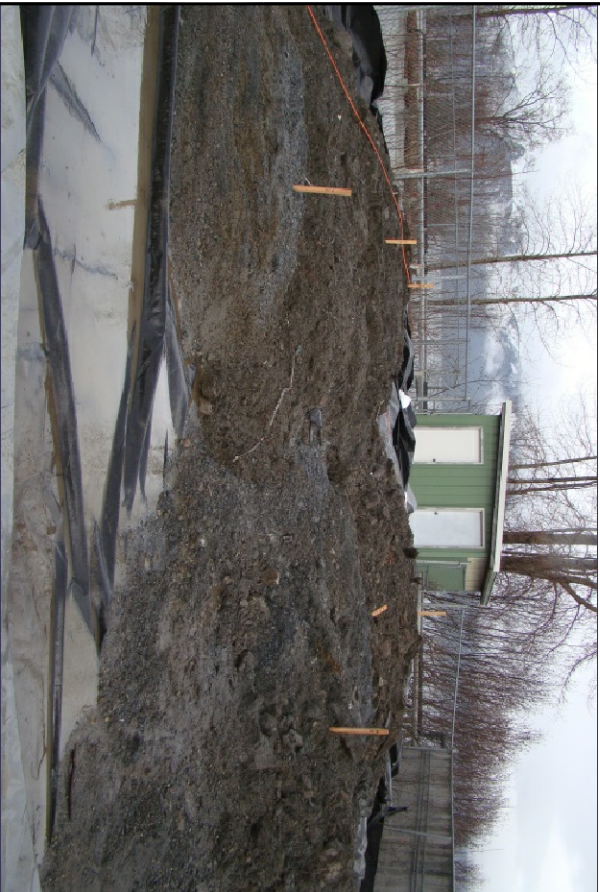
**Contaminated Stockpile**

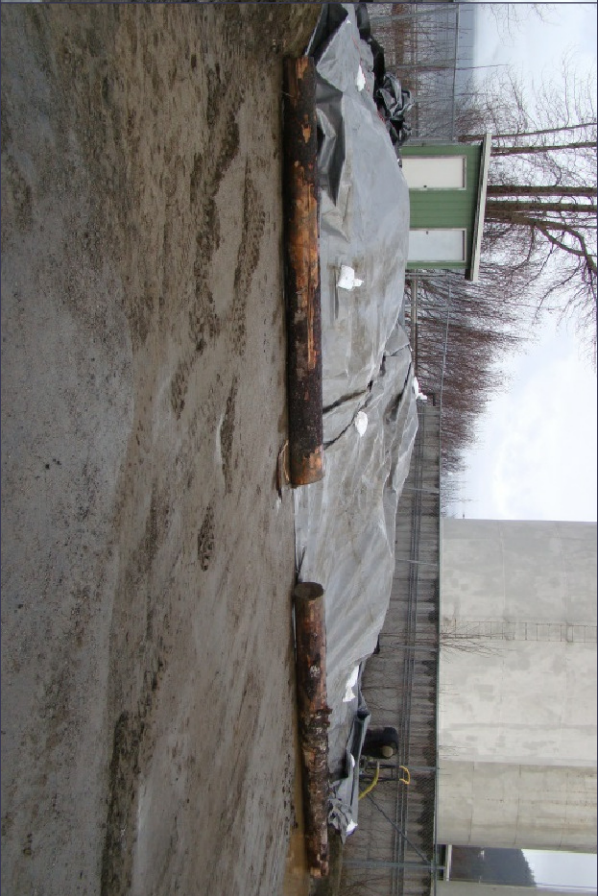
**Covered Contaminated Stockpile**
