**Remediation Equipment
Operation Completion Report
Bentley Mall
Fairbanks, Alaska**

REMEDIATION EQUIPMENT OPERATION COMPLETION REPORT

**Bentley Mall
Fairbanks, Alaska**

January 2011

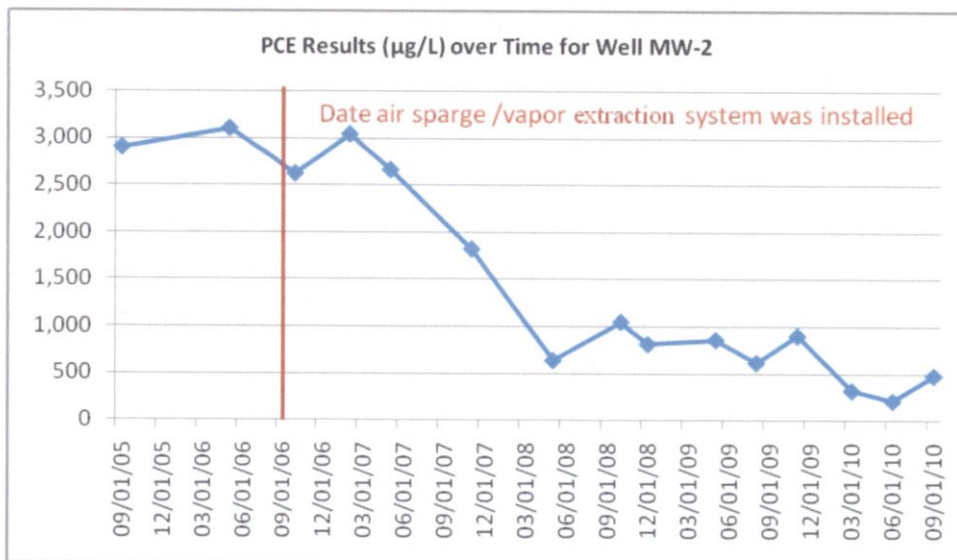
Graph 1
Groundwater Analytical Results over Time for Well MW-2

The Graph 1 below depicts the trend for PCE results for well MW-2 since the start-up of the sparge/vapor extraction system.

- ❖ An overall 88% reduction in PCE and TCE dissolved in groundwater in source area well MW2. Groundwater quality improvements were largely made during the first few years of remediation system operation, and diminishing returns have been seen with continued system operation.

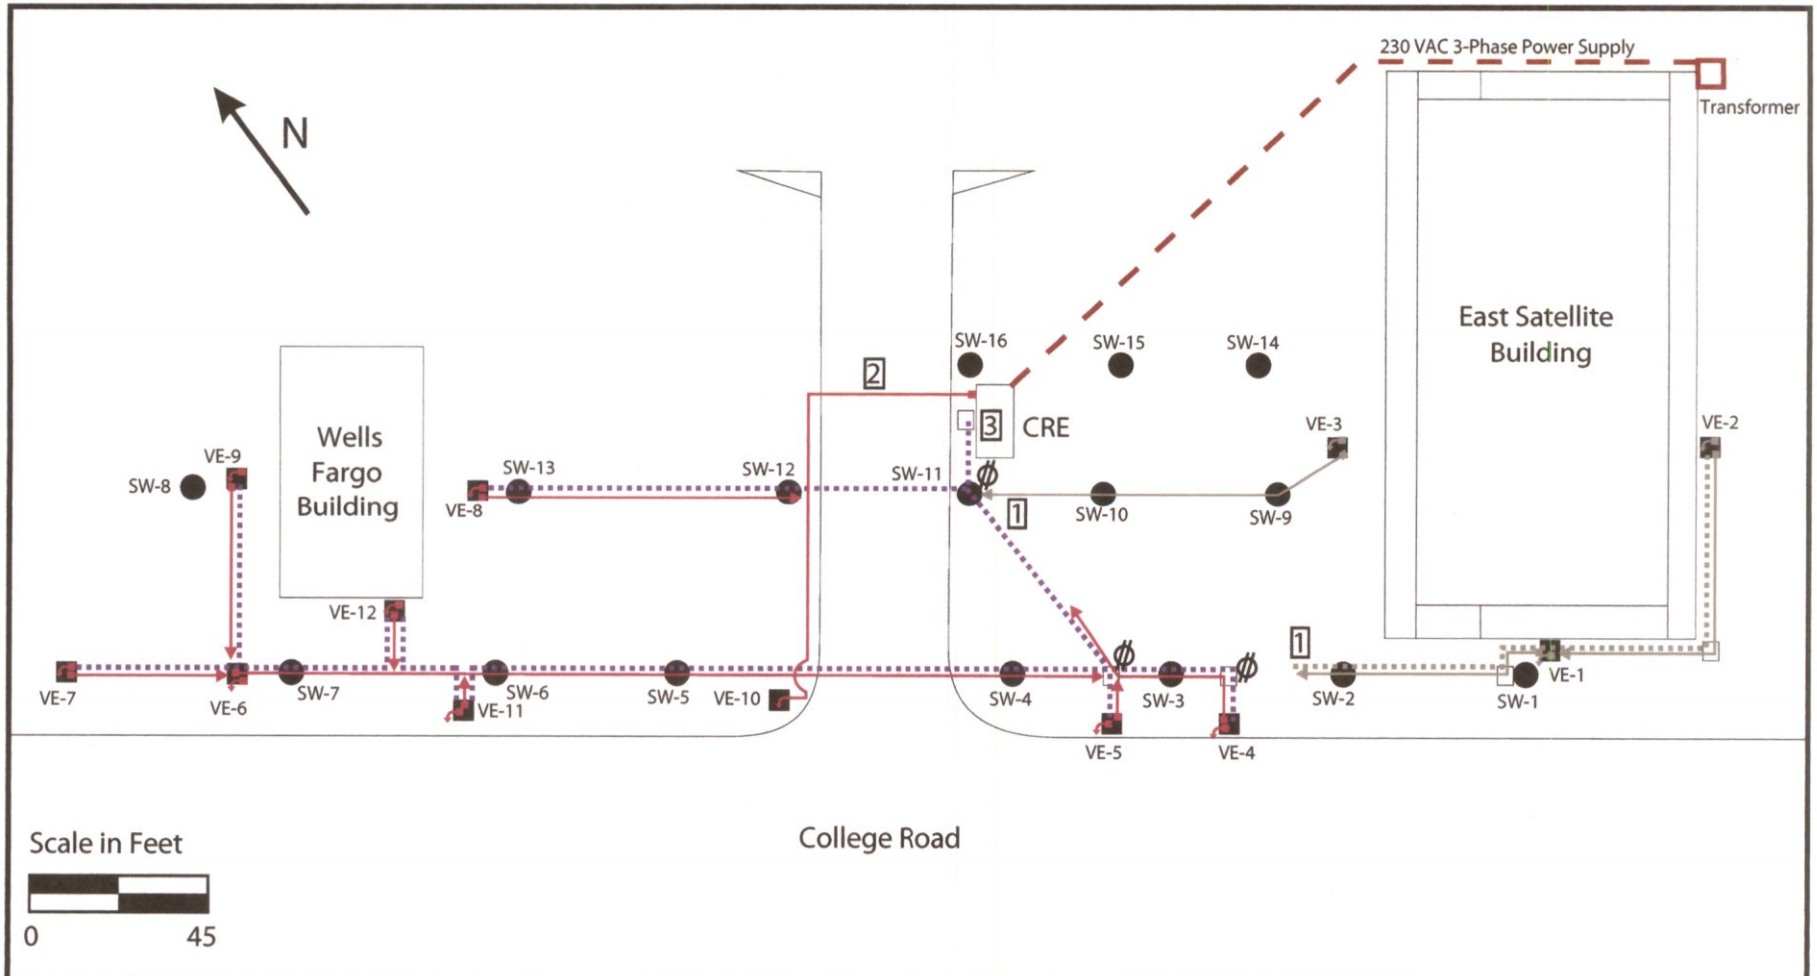
Figure 2. Bentley Mall SVE System Layout 2010

- ① During work activities in September 2009 some non-required electrical and heat trace lines were disconnected and left non-powered in place. These locations are marked as listed in the legend.
- ② This heat trace run is on electrical circuit number four. All other heat trace is on circuits 5 and 6.
- ③ A short heat trace run above ground behind CRE connex for the sparge lines to run from the connex into the ground. (Circuit # 5).

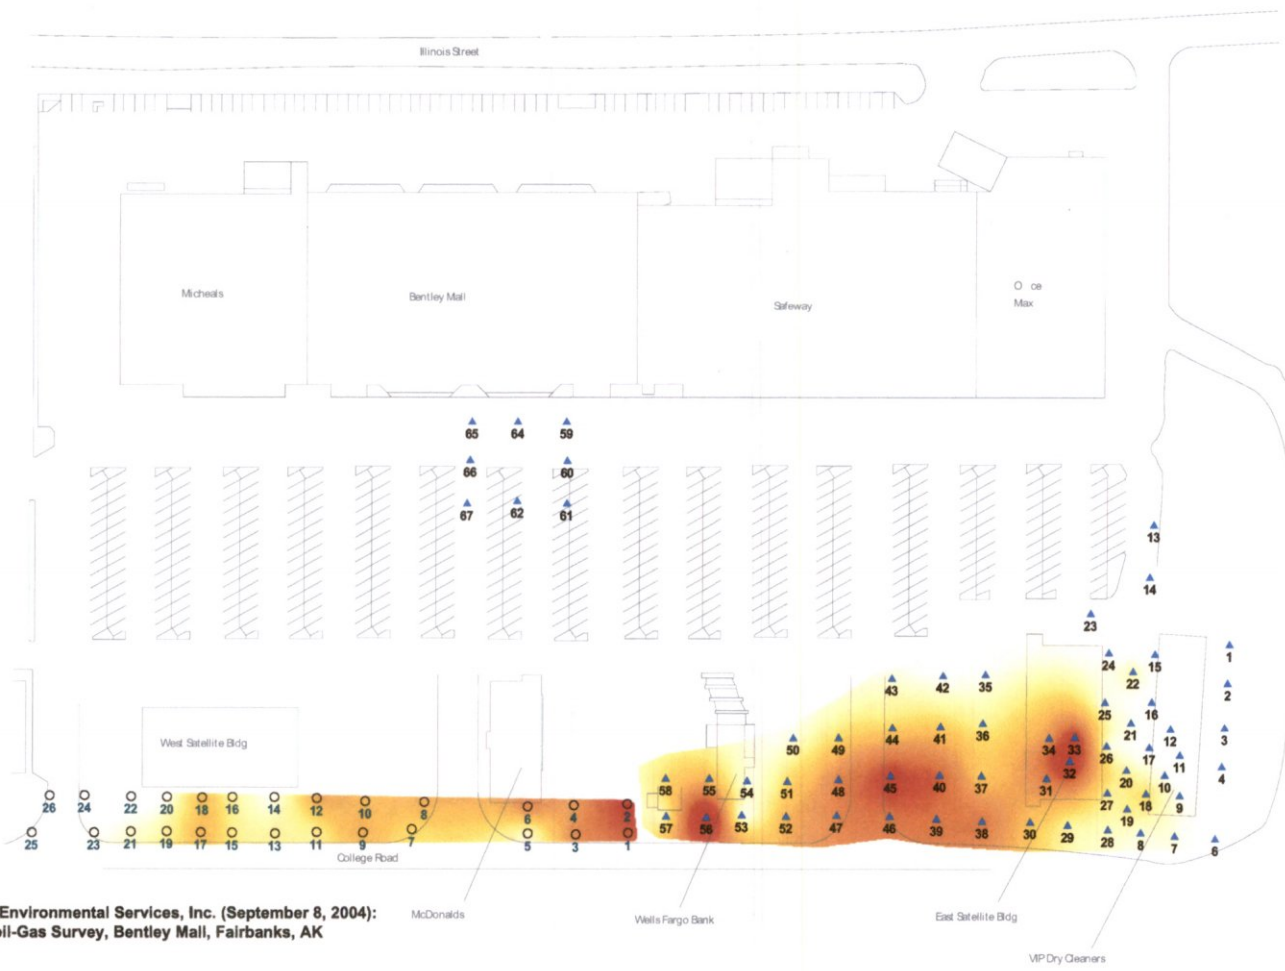
FIGURE 3A:
Past Passive Soil-Gas Survey Results for Tetrachloroethene (PCE), August 2003 - June 2004 Surveys Bentley Mall, Fairbanks, Alaska

The investigation results indicate an approximately 84% decrease in PCE and TCE when the PSG sampling results for October 2010 are compared to the baseline PGS sampling results for August 2003-June 2004. The PSG survey results provide evidence of source removal by remediation efforts with reduced PCE and TCE levels in subsurface soil in the southern portion of the Bentley Mall. PSG maps showing results for October 2010 (**Figure 4A and 4B**) and August 2003-June 2004 (**Figure 3A and 3B**) are attached for comparison.
