SPILL PREVENTION & RESPONSE Contaminated Sites Program

Subject: **DECISION DOCUMENT: No Further Action**

Petroleum Contaminated AOCs at FAA Lake Minchumina

Above-Ground Storage Tanks (ASTs) at Buildings 100, 102, and 402

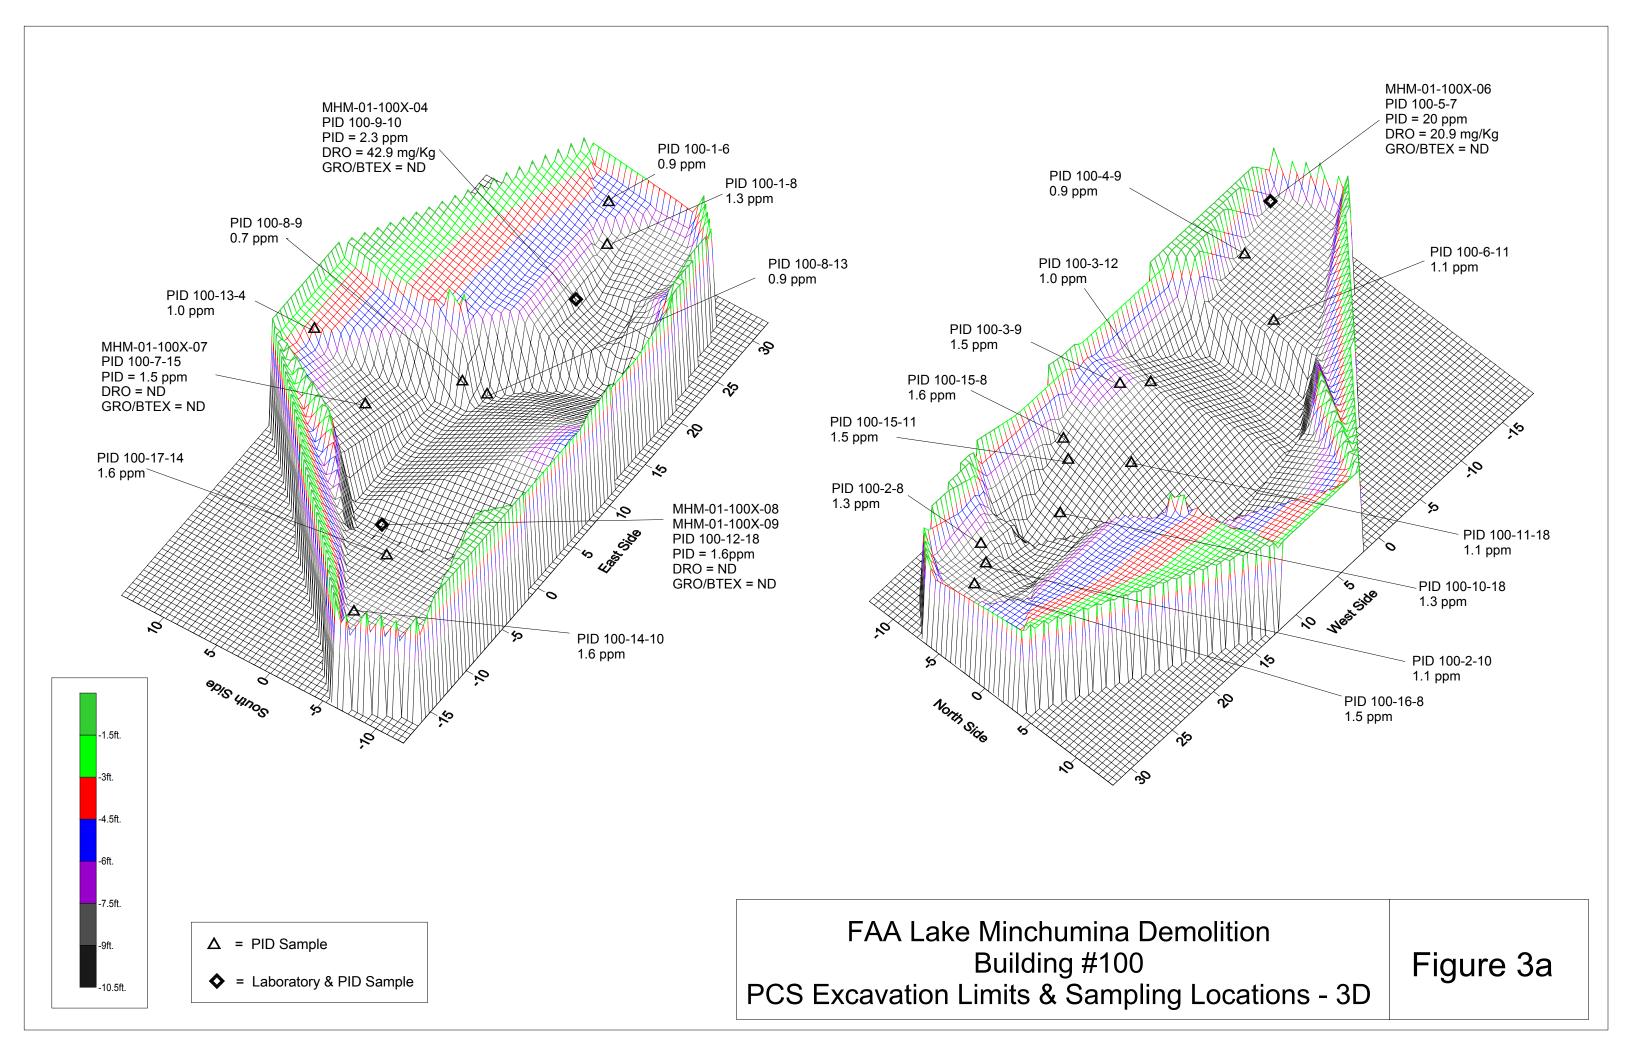
Additional site characterization conducted in 2001 included the excavation and stockpiling of 218 cy of petroleum contaminated soil, as well as the removal of 10 ft of buried utilidor from the southeast side of the excavation to access all contaminated soil. The final excavation limits were approximately 48 ft. x 17 ft. x 18 ft. maximum depth (Figure 3a). Soil samples collected from excavation limits and analyzed for DRO, GRO, and BTEX indicated that the former AST site had been delineated to below migration to groundwater cleanup levels found in 18 AAC 75.341(c).

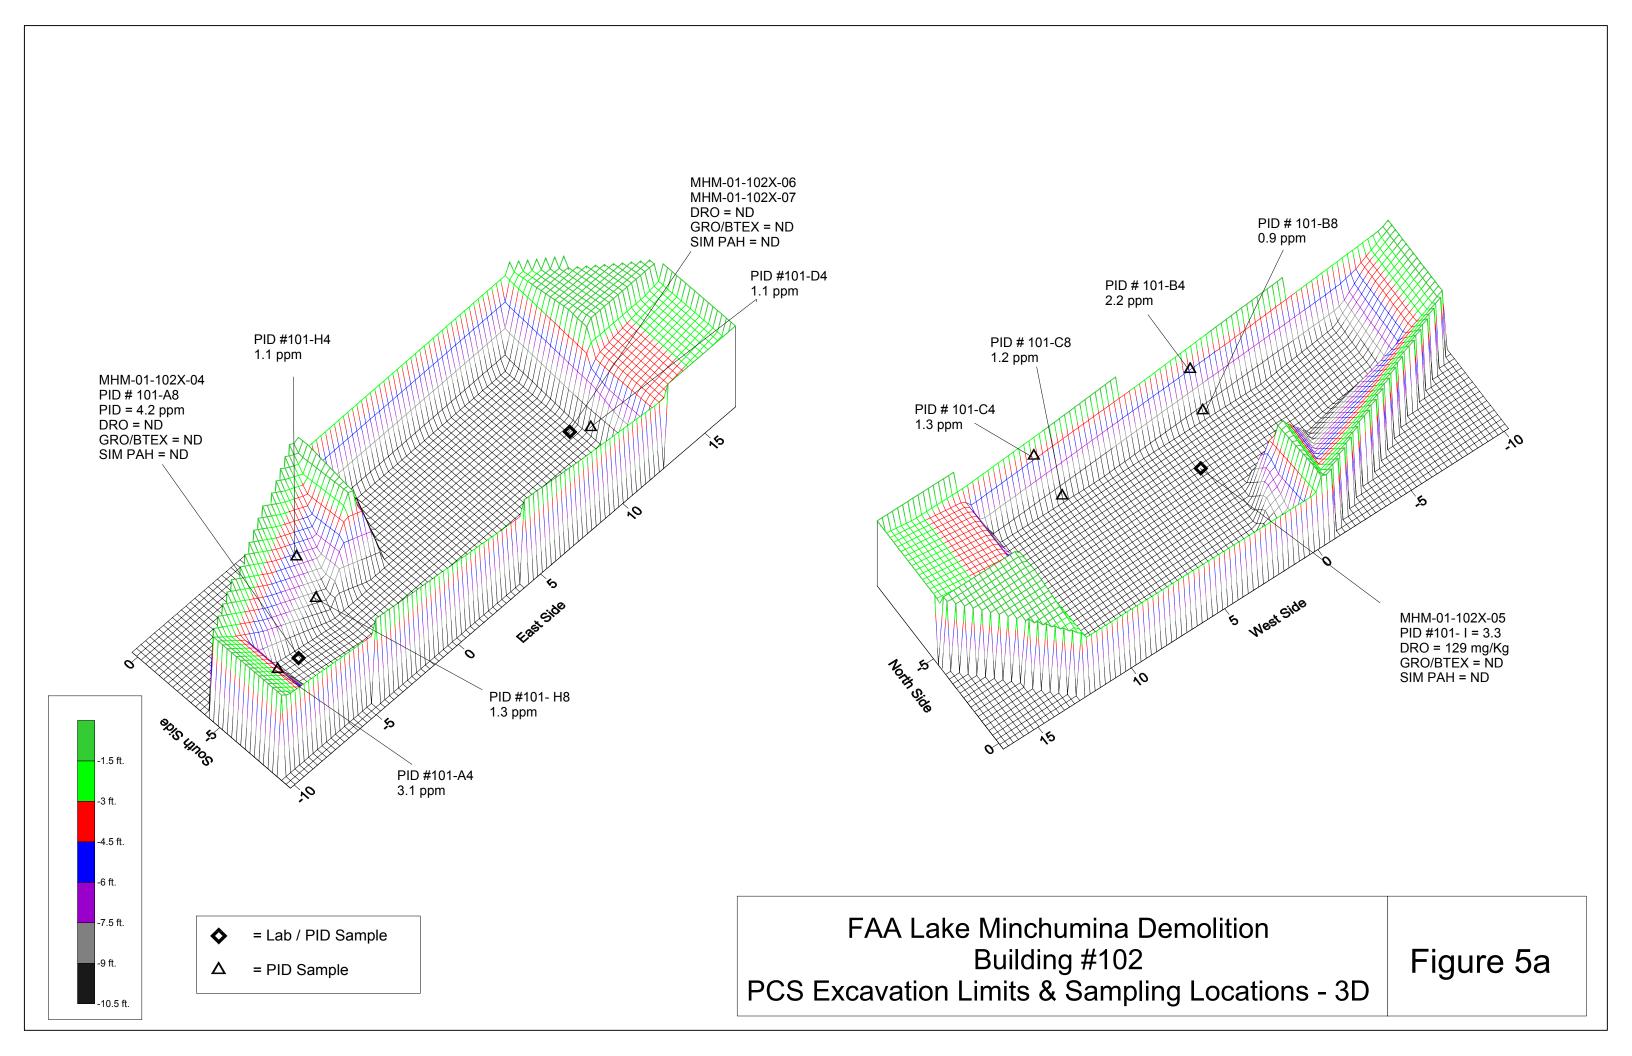
Additional site characterization was conducted in 2001 included the excavation and stockpiling of 42 cy of petroleum contaminated soil and the collection of seven soil samples to ensure all contaminated soil was removed. Additionally, 18 ft. of buried utilidor had to be removed from the east side of the excavation to access remaining soil contamination. The final limits of excavation were approximately 27 ft. x 10 ft. x 12 ft. maximum depth (Figure 5a). Soil samples collected from excavation limits and analyzed for DRO,

GRO, and BTEX indicated that the former AST site had been delineated to below migration to groundwater cleanup levels.

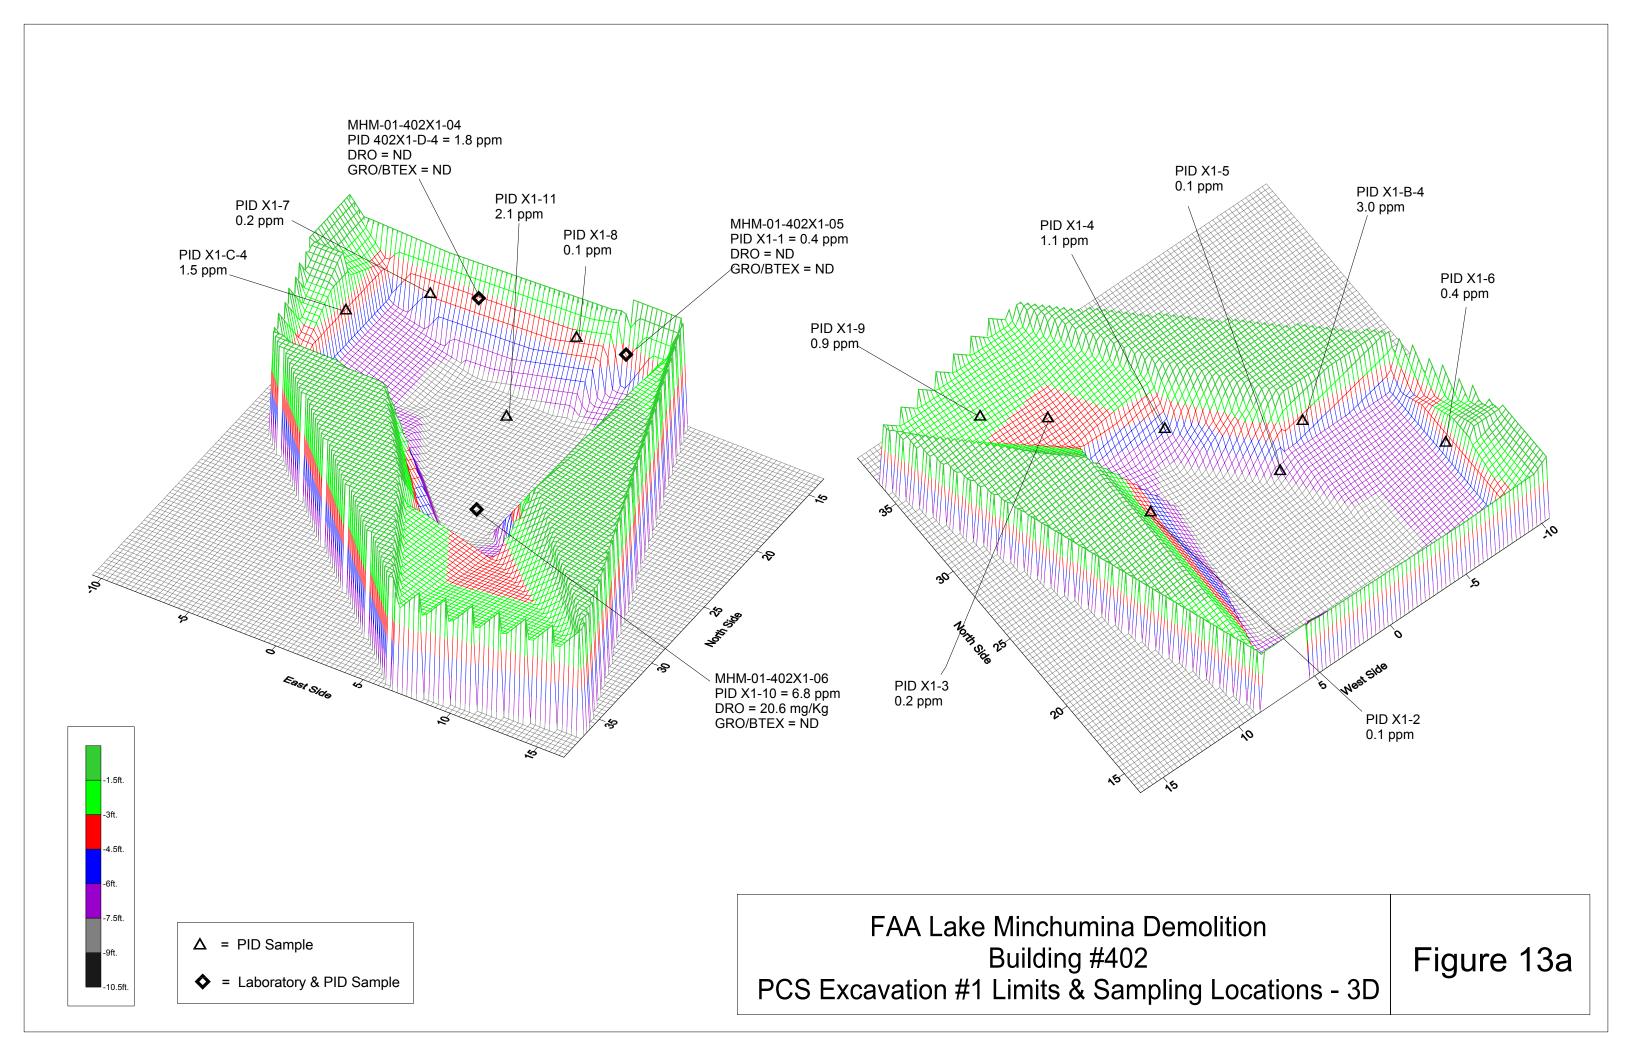
Additional site characterization conducted in 2001 included the excavation and stockpiling of 57 cy of petroleum contaminated soil and the collection of six soil samples to ensure proper delineation of the former AST area. The final limits of excavation were 10 ft. x 25 ft. x 8 ft. maximum depth (Figure 13a).

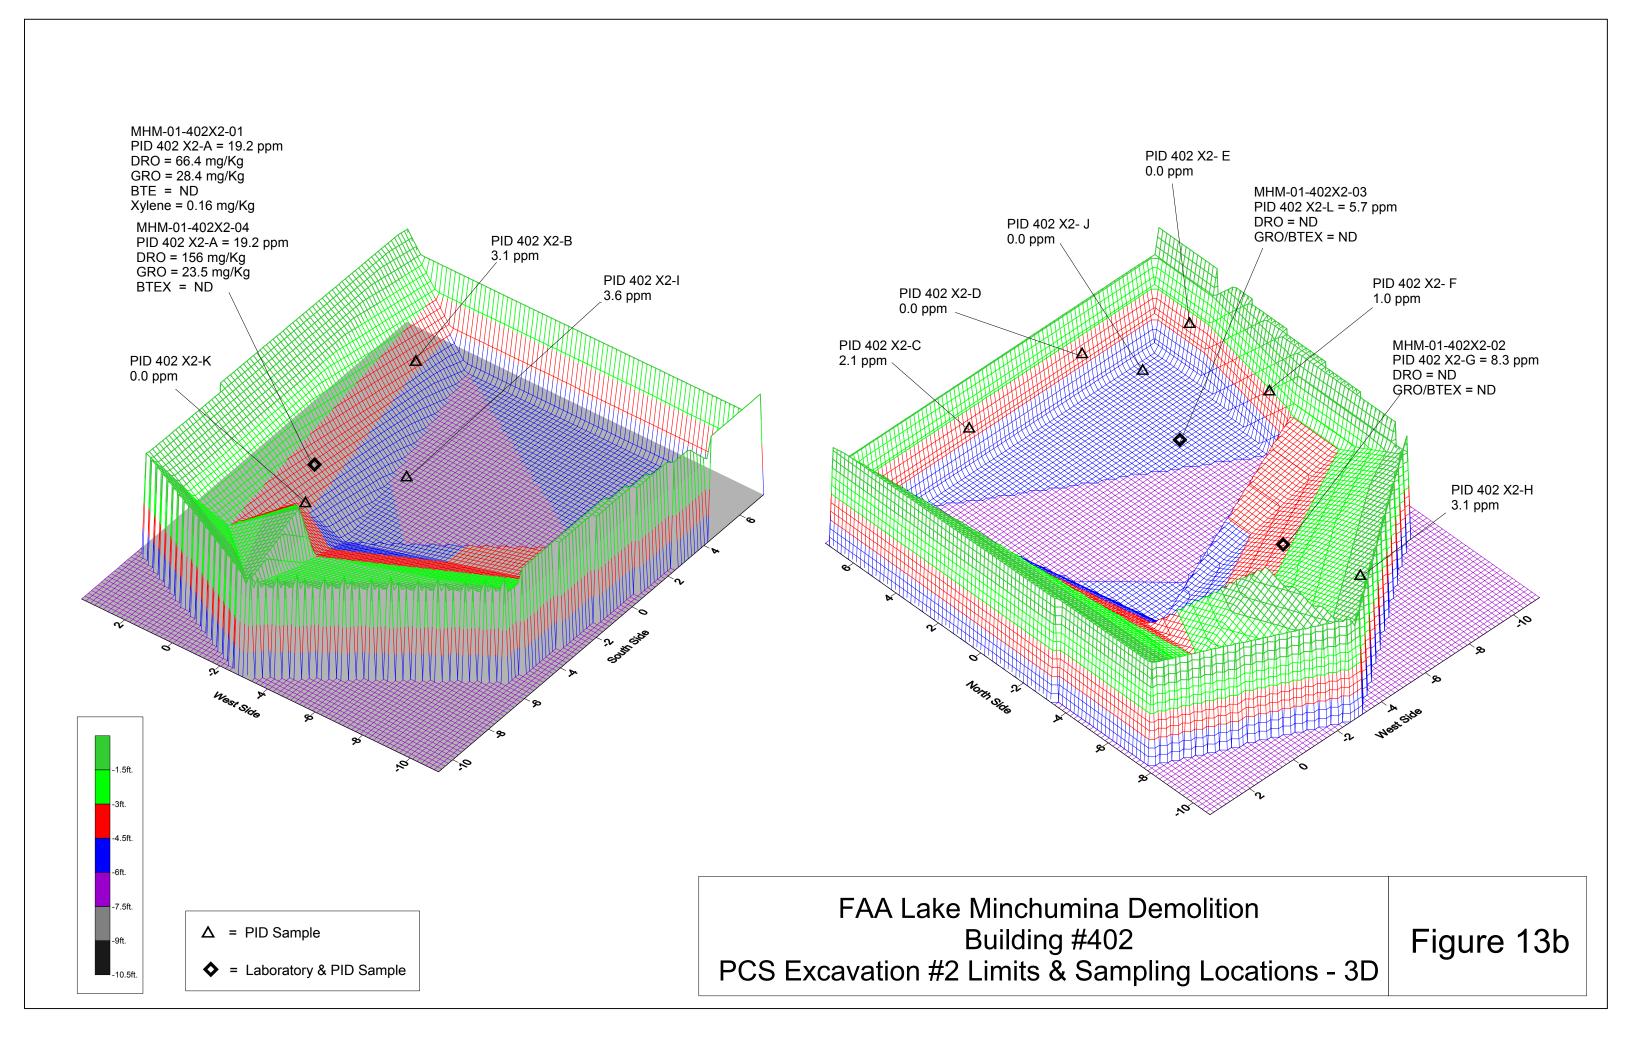
A secondary, unknown source of petroleum contaminated soil was also identified in 2001 during the demolition of former Building 402. Approximately 30 cy of contaminated soil was removed, and four laboratory samples were collected. Final limits of excavation were 15 ft. x 15 ft. x 6 ft. (Figure 13b). Soil samples collected from both excavation limits were analyzed for DRO, GRO, and BTEX indicated that the two excavation areas had been delineated to below migration to groundwater.
