Subject: **Decision Document: FAA Farewell Station
No Further Action for the Building 300 Dry Well (QS AOC 13)**

FAA Farewell Station
Bldg. 300 Dry Well
~63 Miles ESE of McGrath
62°30'21.8" N, 153°53'45.2" W

File No.: 2548.38.001
Hazard ID.: 1873

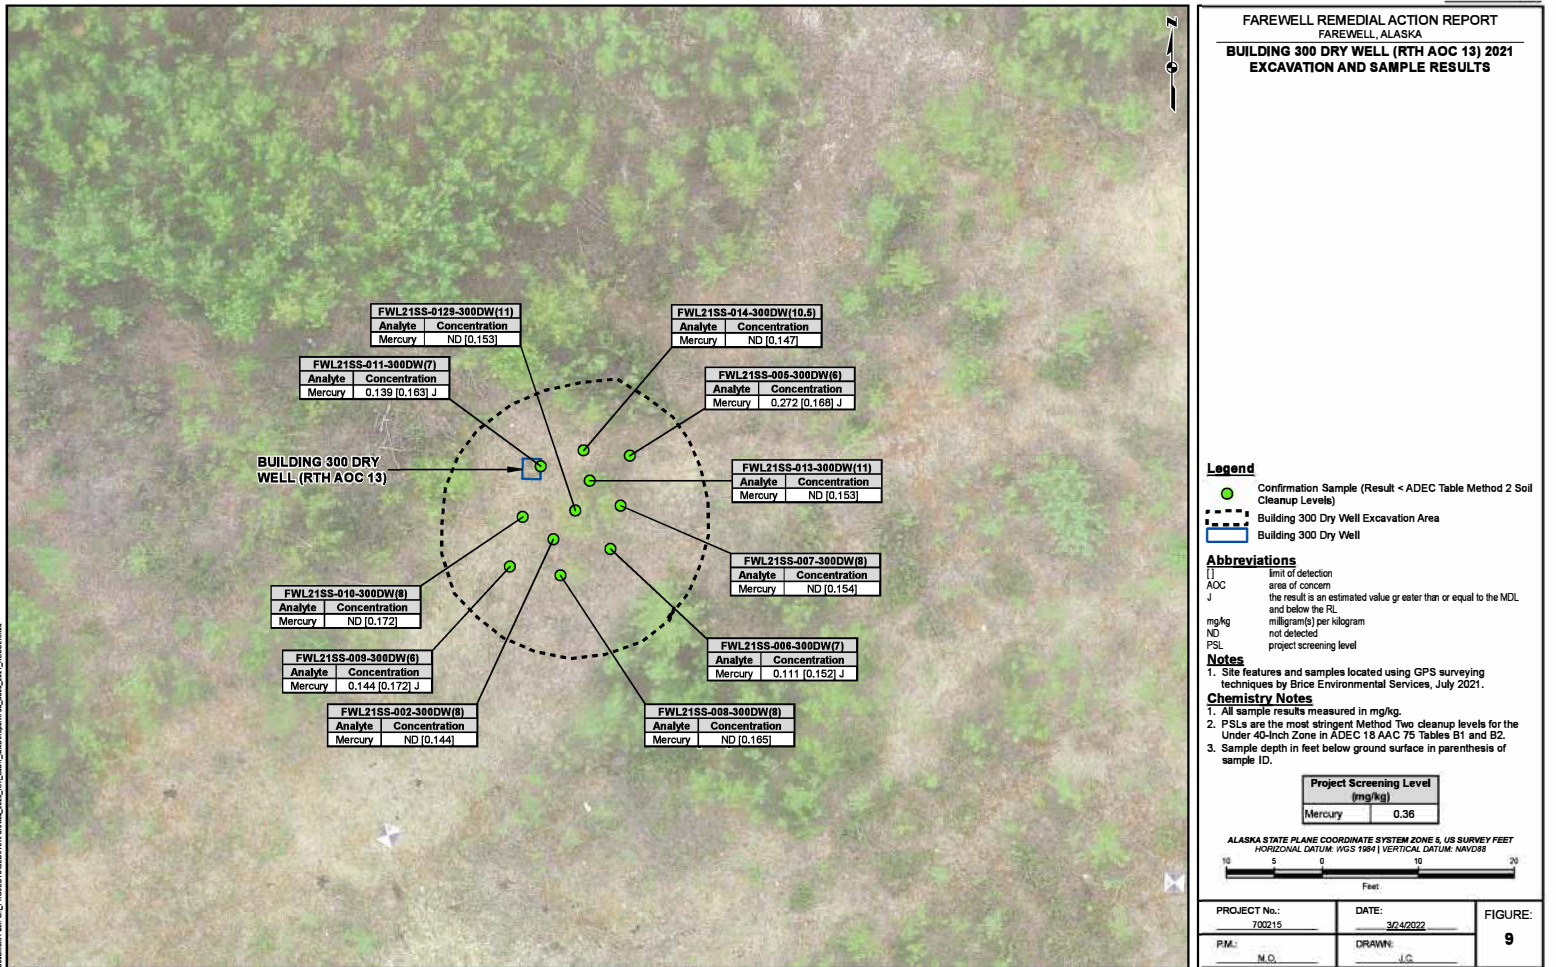
Figure 2

The maximum concentrations of contaminants remaining at the site are shown in Table 2. These concentrations are all below their respective approved cleanup levels. Sample locations referred to in Table 2 are shown in Figure 2.

Contaminant	Sample Location	Sample ID	Date Sampled	Soil (mg/kg)
Mercury (Elemental)	(Sidewall)	FWL21SS-005-300DW	06/05/2021	0.272

Approximately 22.5 tons of mercury-contaminated soil was removed from the former Building 300 Dry Well AOC during initial excavation efforts. A total of 11 confirmation soil samples were collected (three base and eight sidewall) from the excavation limits. In 2021, an additional 20 tons of soil was removed from the areas where previous samples had exceeded cleanup levels. The excavation was extended to approximately 11 feet bgs. Confirmation samples (three base and one sidewall) were collected from the new excavation boundaries and analyzed for mercury. Concentrations of mercury in all final confirmation soil samples were below the cleanup level (0.36 mg/kg), ranging from non-detect to 0.272 mg/kg. The final excavation was roughly circular, with an approximate diameter of 27 feet, and final depth of 11 feet bgs. Analytical results for all overburden stockpile samples were also below the applicable cleanup level. After analytical confirmation, overburden soil was used to backfill the excavation.
