**2005 GROUNDWATER MONITORING REPORT
PUBLIC WORKS FACILITY
CITY OF FAIRBANKS
FAIRBANKS, ALASKA**

DECEMBER 30, 2005

City of Fairbanks
Engineering Department
800 Cushman Street
Fairbanks, AK 99701-4615

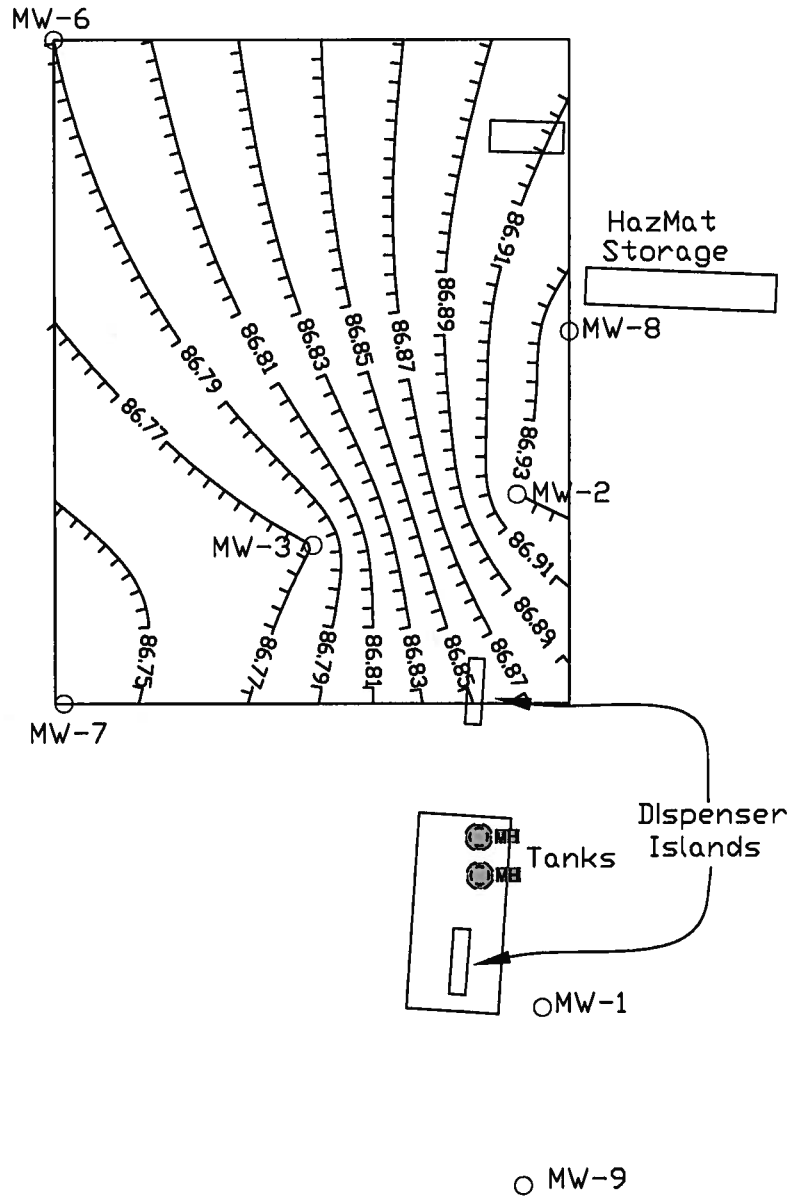
FIGURE
3

The five wells that were sampled are located west, northwest and north of the tanks and dispenser system. Hydraulic gradient data gathered during 2000 and 2001 indicated that the groundwater flow is generally to the west-northwest with the potential for deviation to the west-southwest. The current survey and elevation results indicate the gradient is to the west with an overall magnitude of approximately 0.001 feet/foot (see Figure 3). Overall, the hydraulic gradient seems to vary between northwest and southwest with the potential for localized effects due to frozen ground.

Hydraulic Gradient - 11/04/05
City of Fairbanks Public Works Facility
Fairbanks, Alaska
