TECHNICAL MEMORANDUM

Landfill Assessments at LF024 and LF026

Eareckson Air Station

June 2025

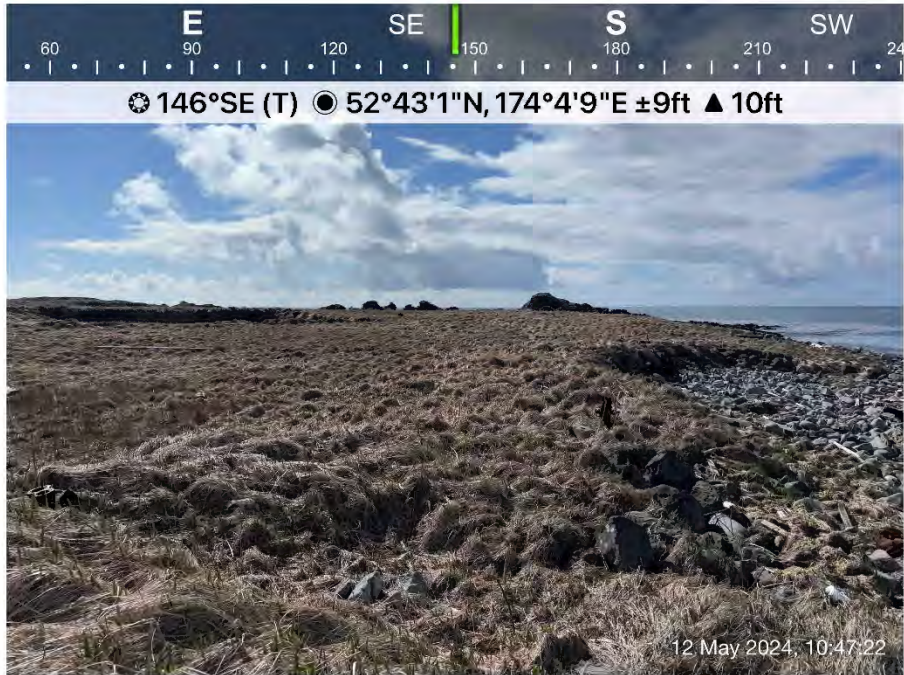
- A large volume of surface metal debris was observed scattered along the bluff that included several pieces of heavy equipment and smaller partially buried debris around the remnant burnt wood area in the central part of the site (Attachment B, Photographs 02, 04–09).

Photograph 02: Overview of the western area with metal surface debris outside of LF024 west boundary.

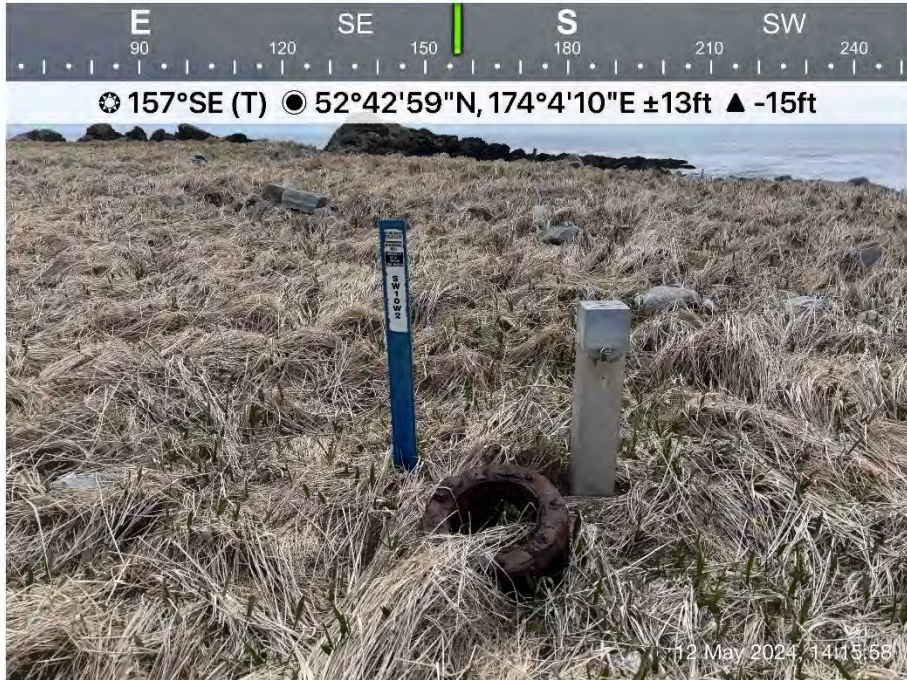
- Monitoring wells (labeled SW10W3 and SW10W2) were identified and visually found to be in good condition. There was no evidence of tampering, the wells were not frost jacked, and the well riser pipes were capped; however, the well lids were not locked, and the lid hinges had rusted off (Attachment B, Photographs 03 and 14).

Photograph 03: LF024 groundwater monitoring well SW10W2 and metal surface debris.

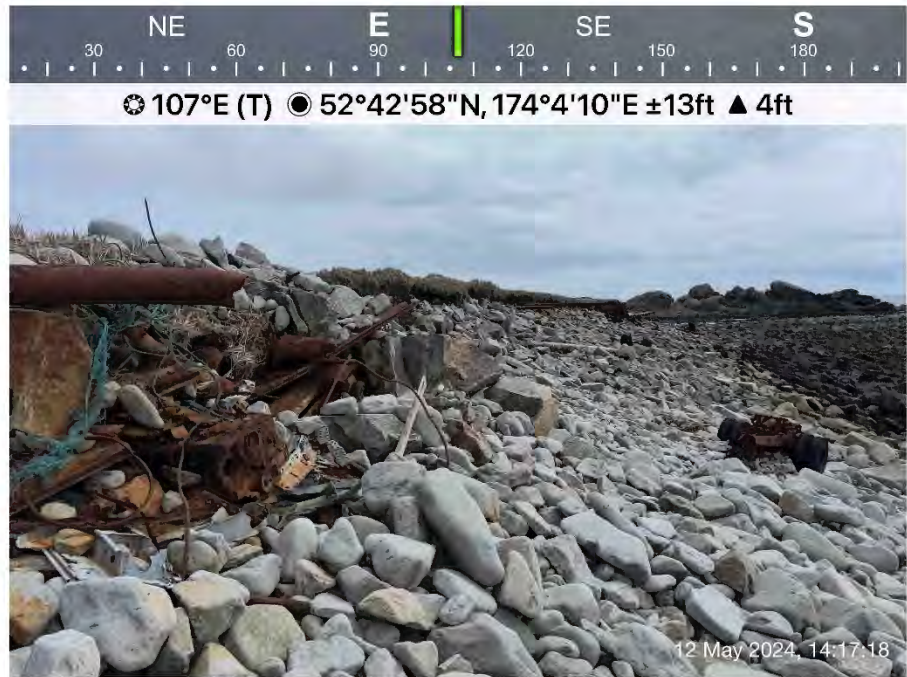
Photograph 04: Metal debris at southwestern beach bluff and high intertidal zone outside of the LF024 western boundary.

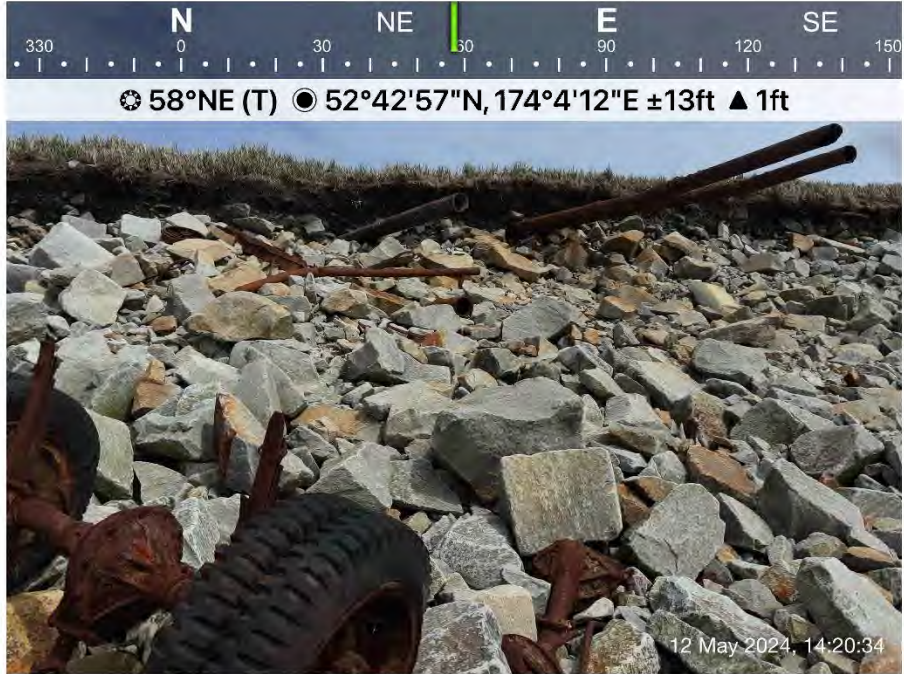
Photograph 05: Metal piping sticking out from the beach bluff and metal debris in the middle and high intertidal zone outside of the LF024 western boundary.

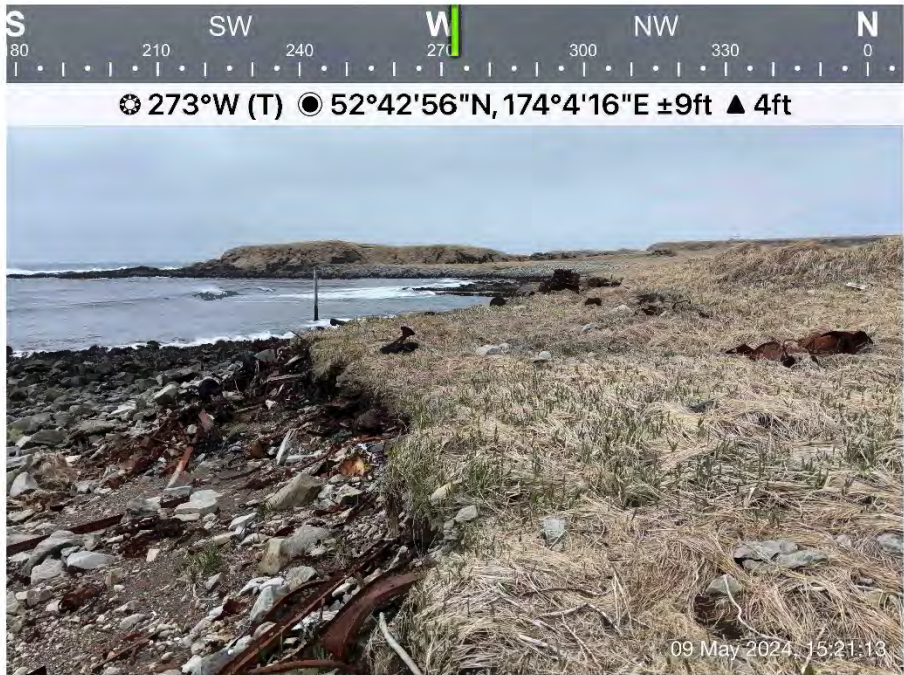
Photograph 06: LF024 southern bluff edge with scattered surface metal debris on the ground surface and eroding into the middle and high intertidal zones facing west.

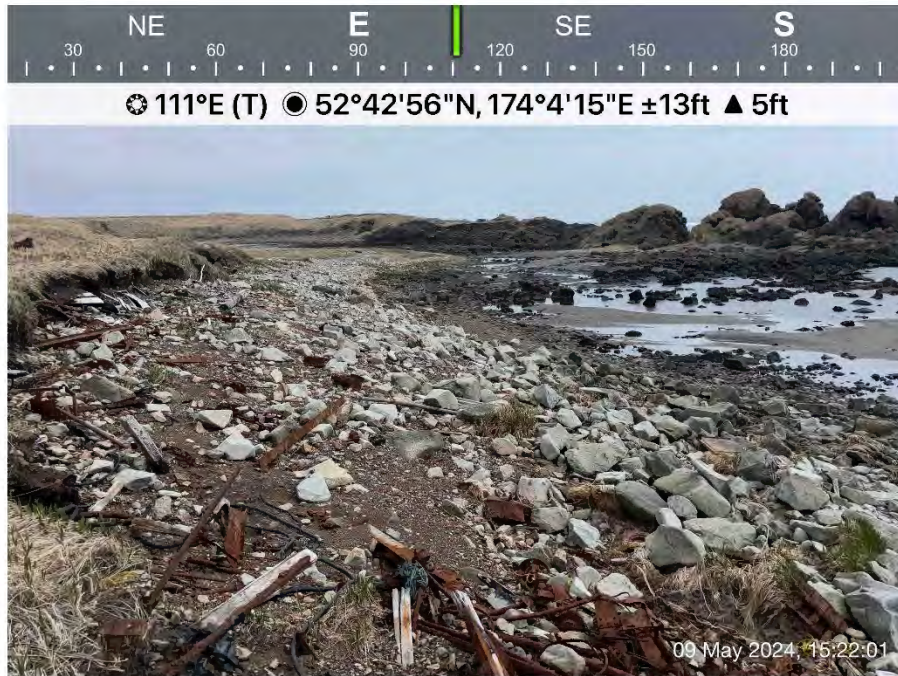
Photograph 07: LF024 southern bluff edge with buried and surface metal debris eroding into the middle and high intertidal zones facing east.

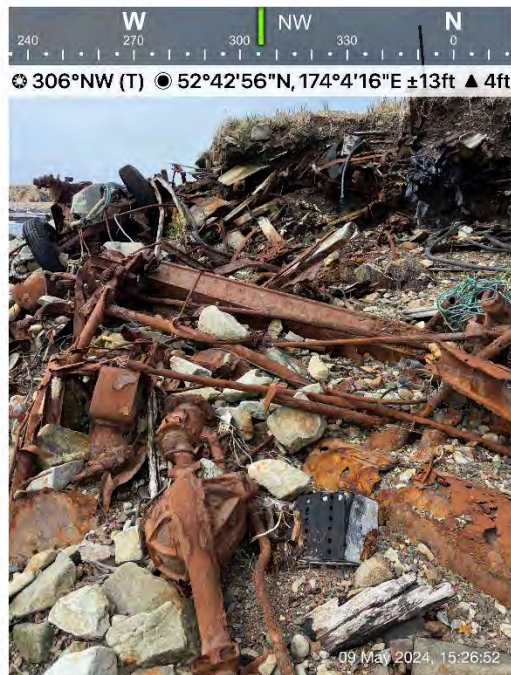
- Prohibited waste present in the high and middle intertidal zones along the southern beach bluff included five partial lead acid batteries, scattered bits of battery lead plates (Attachment B, Photograph 08) and two partial 55-gallon drums of suspected tar (Attachment B, Photographs 08 and 09). Scattered bits of battery lead plates among the debris and the rocks in the middle and high intertidal zones and loose suspected tar material around the drums indicates wave action is breaking apart and spreading these items. In addition, an intact lead acid battery was located near the end of the access road in the spray zone (Attachment B, Photograph 16).

Photograph 08: A broken lead acid battery in LF024 high intertidal zone below the southern bluff.

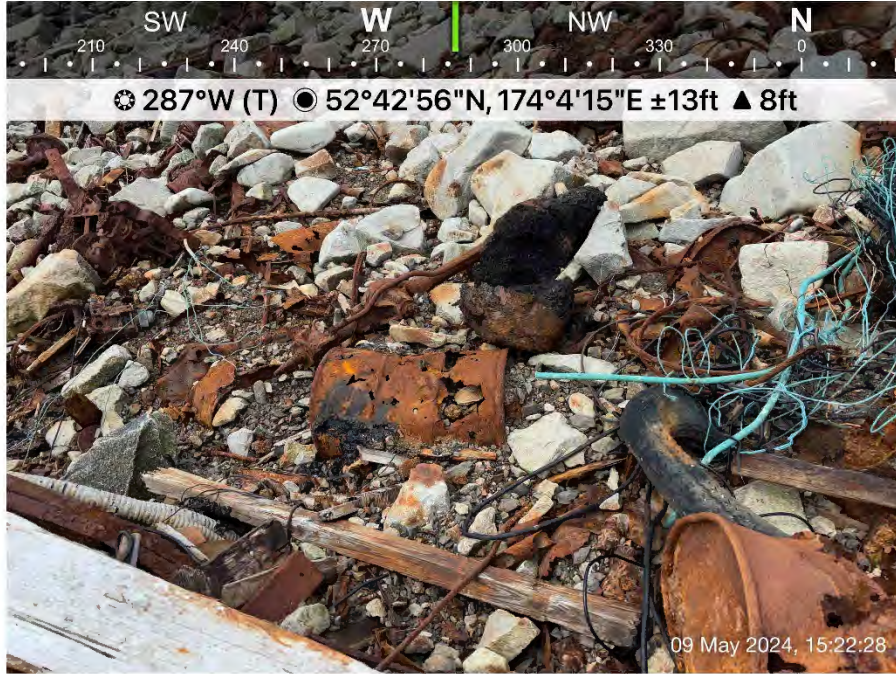
Photograph 09: Partial drums of tar in high intertidal zone of the LF024 southern debris area.

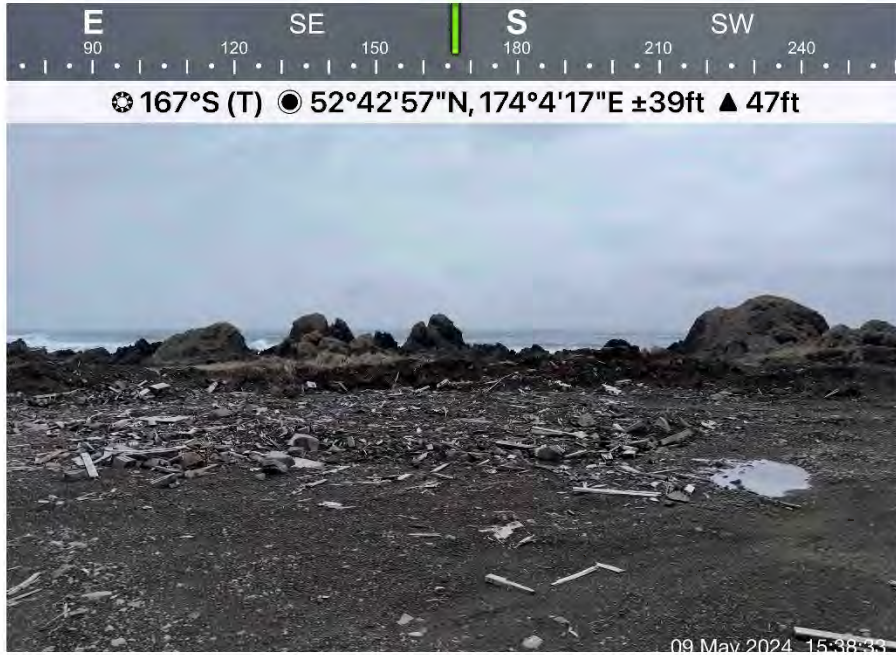
Photograph 13: LF024 burnt wood area with small metal debris.

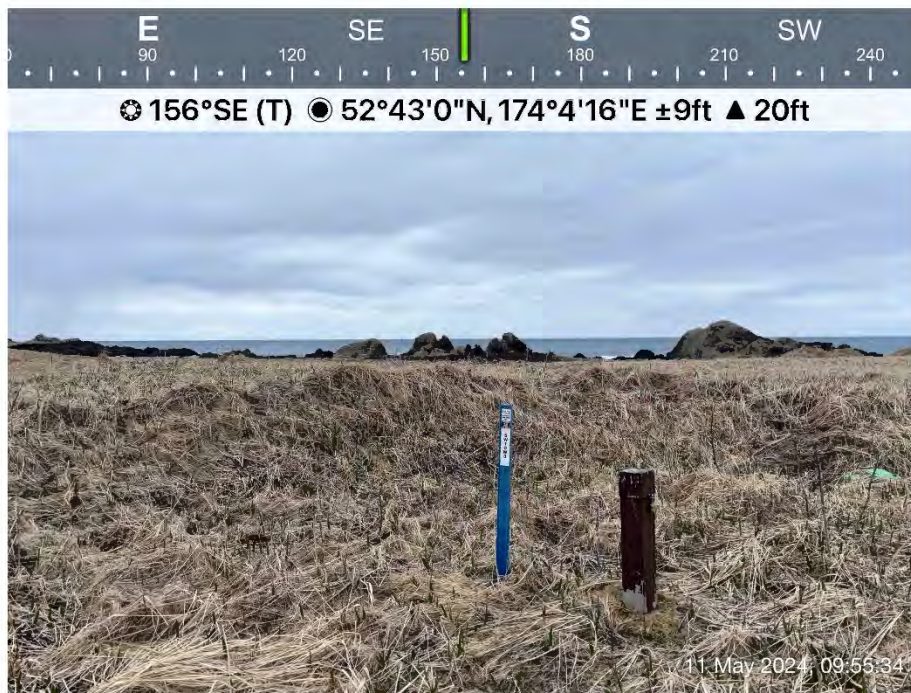
Photograph 14: LF024 groundwater monitoring well SW10W3.

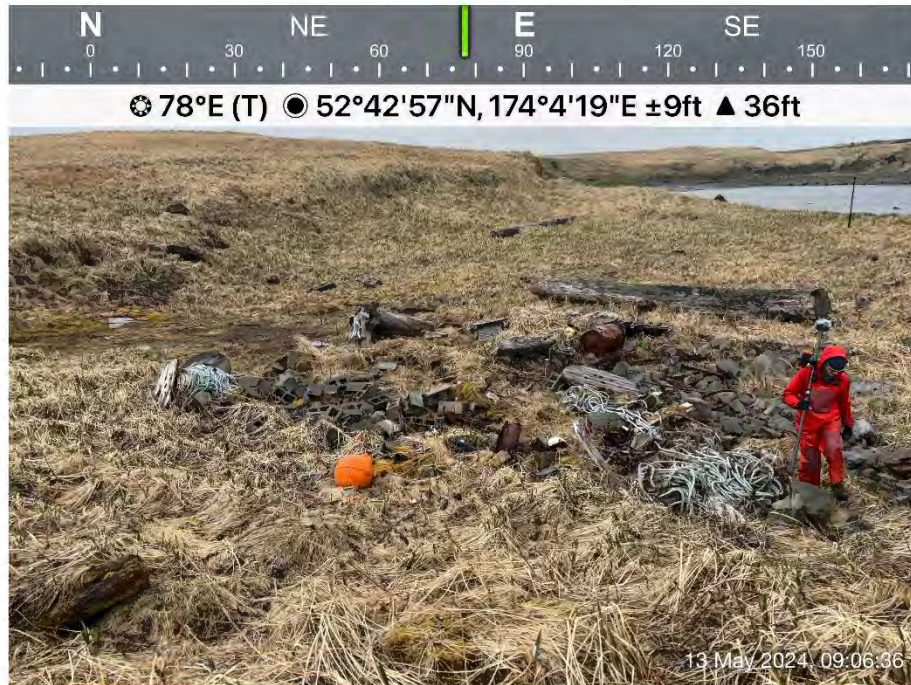
surface west of the anticipated landfill western boundary. Past unauthorized dumping of wood, rope and cement blocks were observed at the end of the access road to the east.

Photograph 15: LF024 unauthorized surface debris dumped at the end of the access road.

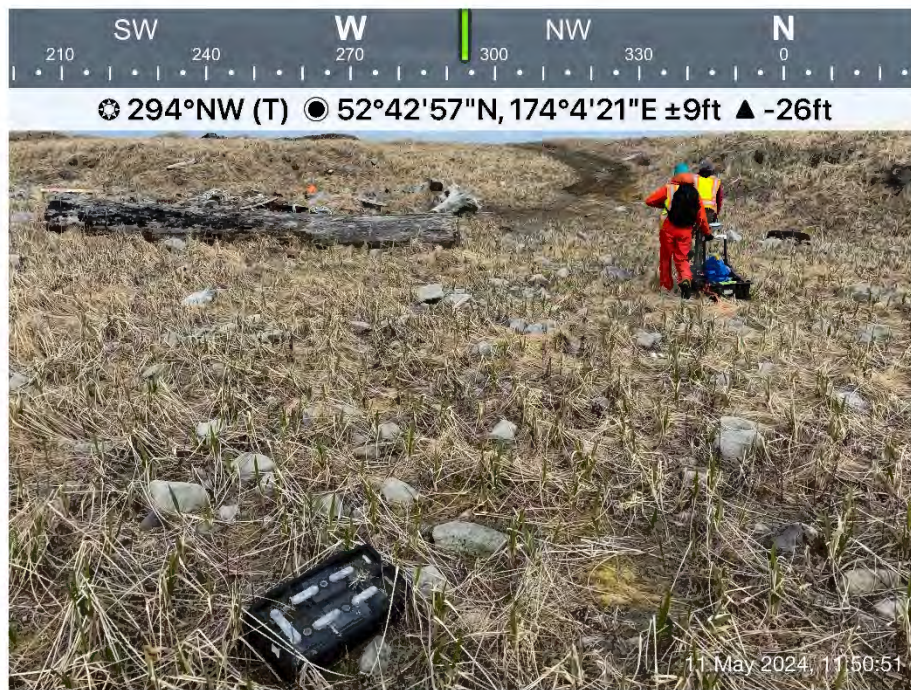
Photograph 16: LF024 GPR survey in progress and an intact lead acid battery near the end of the access road in the spray zone.

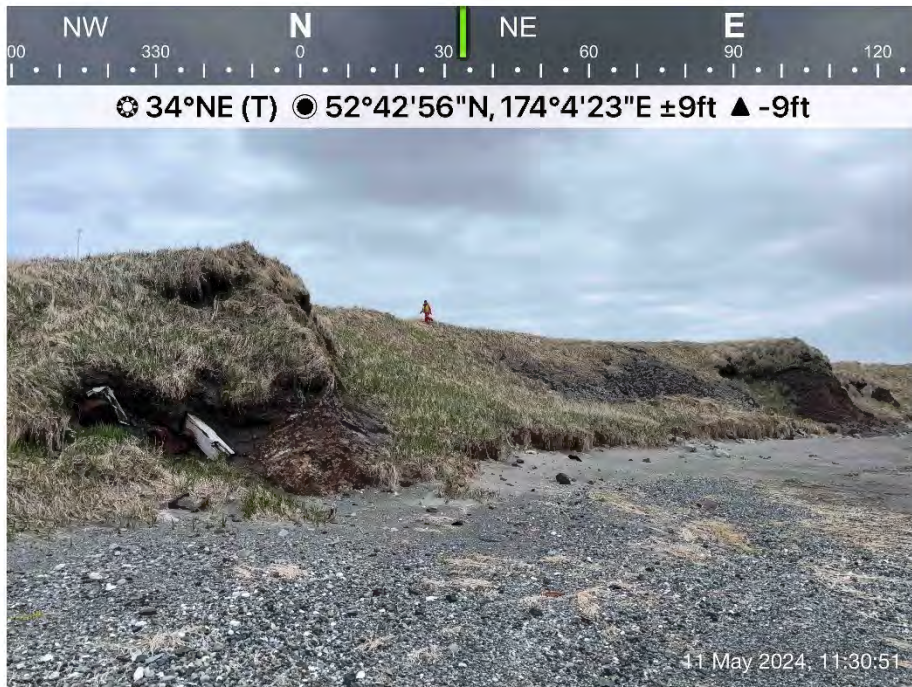
- Metal and wood debris was observed in two eroding sections of landfill cover on the beach embankment on the east side (Attachment B, Photograph 20).

Photograph 20: Buried metal and wood debris in the eastern beach bluff.

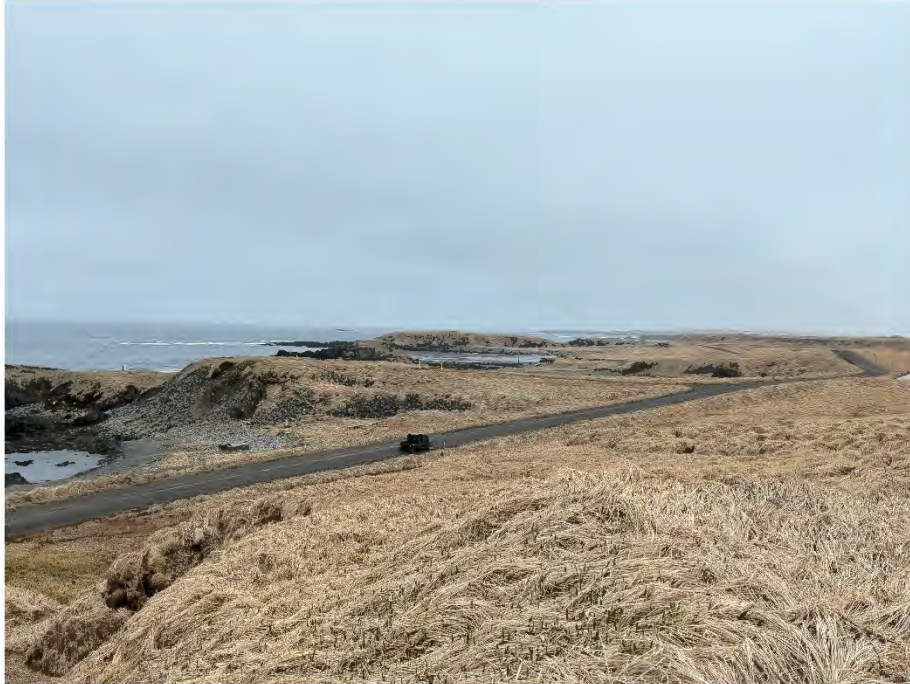
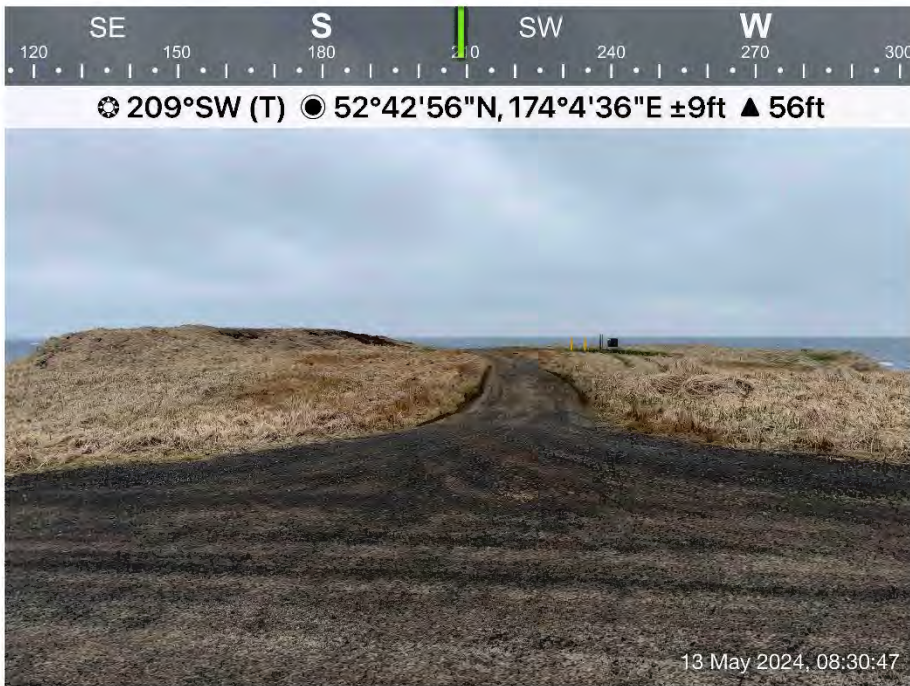
- Access to the area was not limited (no gate or traffic control) and no signage was observed to be posted (e.g., Land Use Control Signs) (Attachment B, Photographs 21 and 22).
- Site structures including the hazardous material storage shed, SP operations building and former weather instrument cluster were no longer present onsite. The continuously operating reference station (CORS) was still located onsite. An electrical transformer and stub up electrical panel box were newly installed midway down the western side of the access road.
- No evidence of unauthorized access or dumping was observed.

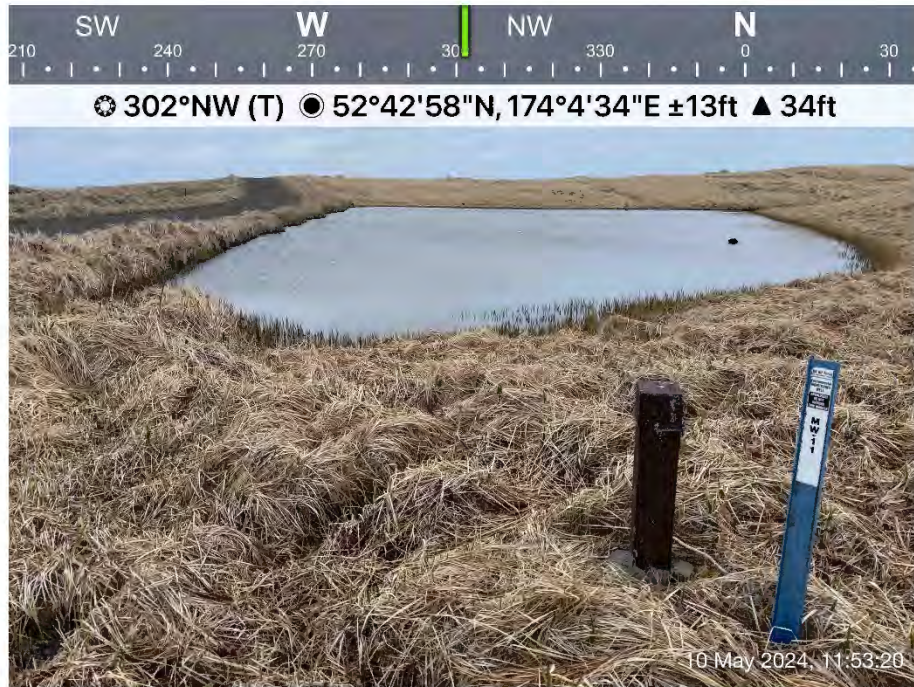
- Monitoring wells MW11, SW12W3, and an unlabeled well located at the beach adjacent to the WWII pillbox on the west boundary (possibly SW12W1, according to CH2MHill, 1990) were identified and were visually in good condition. There was no evidence of tampering, the wells were not frost-jacked, and the well riser pipes were capped. However, the well lids were not locked, and the lid hinges had rusted off (Attachment B, Photographs 23-25).

Photograph 23: LF026 groundwater monitoring well MW 11 near the intersection of South Road and Laundry Loop Road.

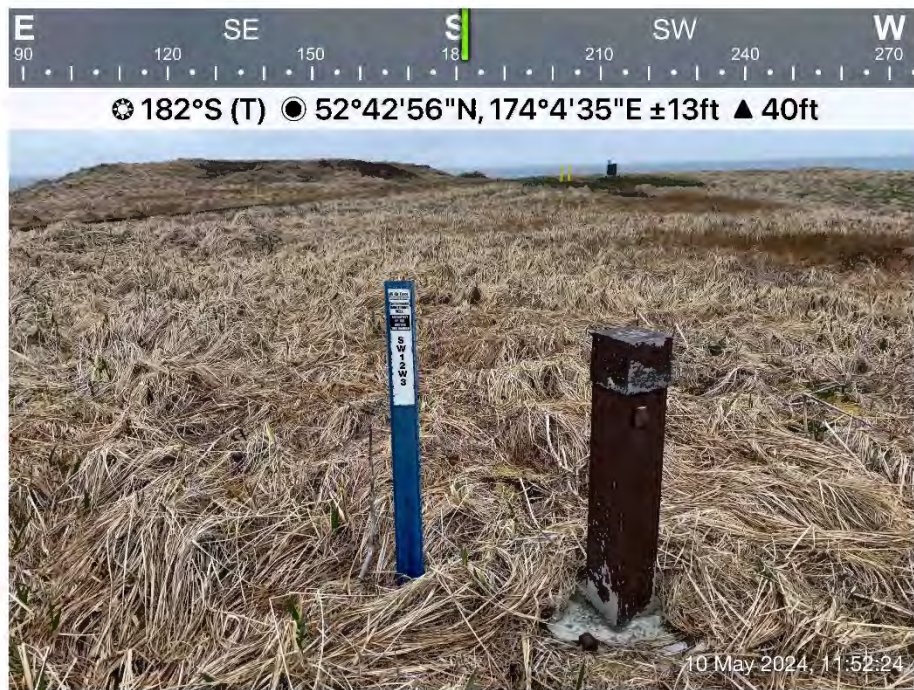
Photograph 24: LF026 groundwater monitoring well MW SW12W3.

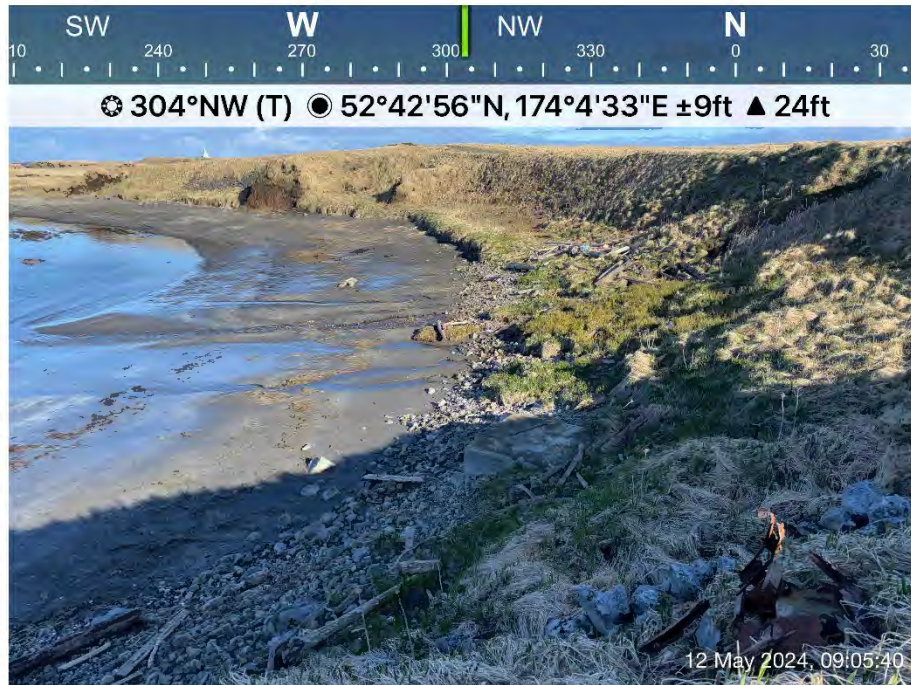
Photograph 25: LF026 western boundary with unmarked groundwater monitoring well in front of the WWII pill box.

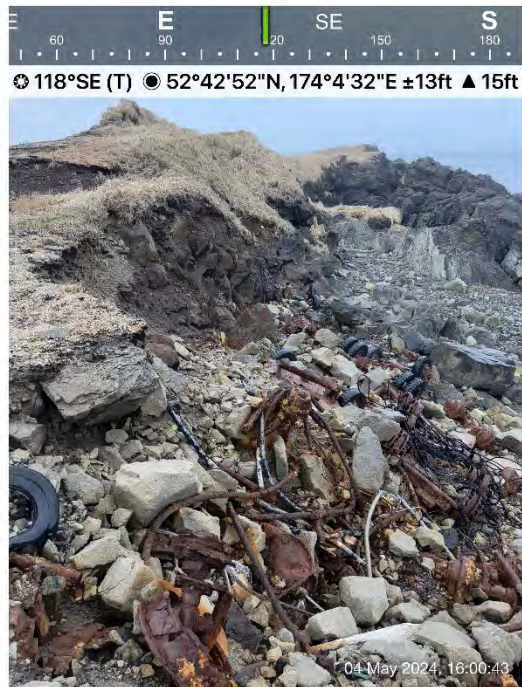
- Exposed debris was observed eroding into the ocean along the western, southern, and eastern landfill ocean bluff boundaries that receive direct exposure to ocean waves during higher tides and inclement weather events. Debris consisted of heavy equipment, truck axels, miscellaneous metal, tires and prohibited waste items (lead acid batteries and suspected tar material (Attachment B, Photographs 27-34, 39). Exposed debris in the beach bluff approximately ranged in thickness from 2 to 10 ft. The debris extended into the high and middle intertidal zones.

Photograph 29: LF026 southern boundary with exposed landfill debris along the beach bluff in the high intertidal zone.

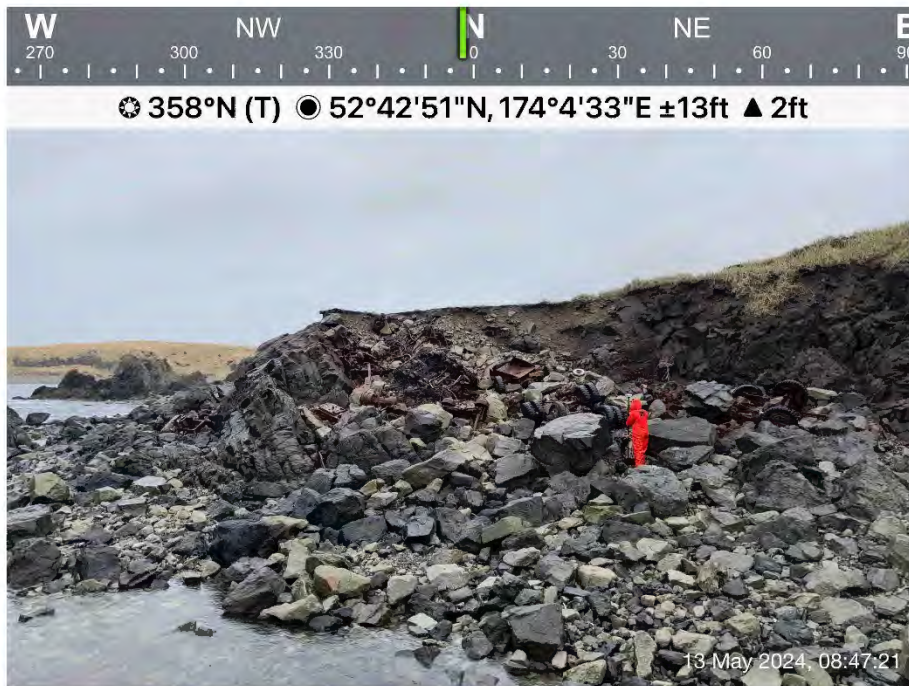
Photograph 30: GPS survey of exposed metal debris at the southern edge of LF026 in the high intertidal zone.

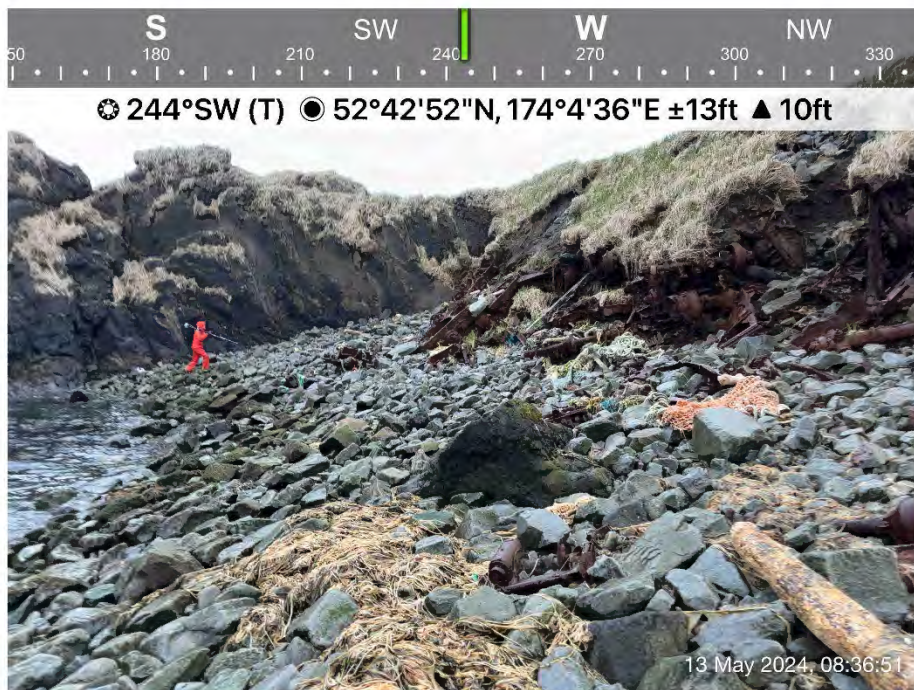
Photograph 32: GPS survey of LF026 southeastern boundary exposed landfill debris in the middle to high intertidal zones.

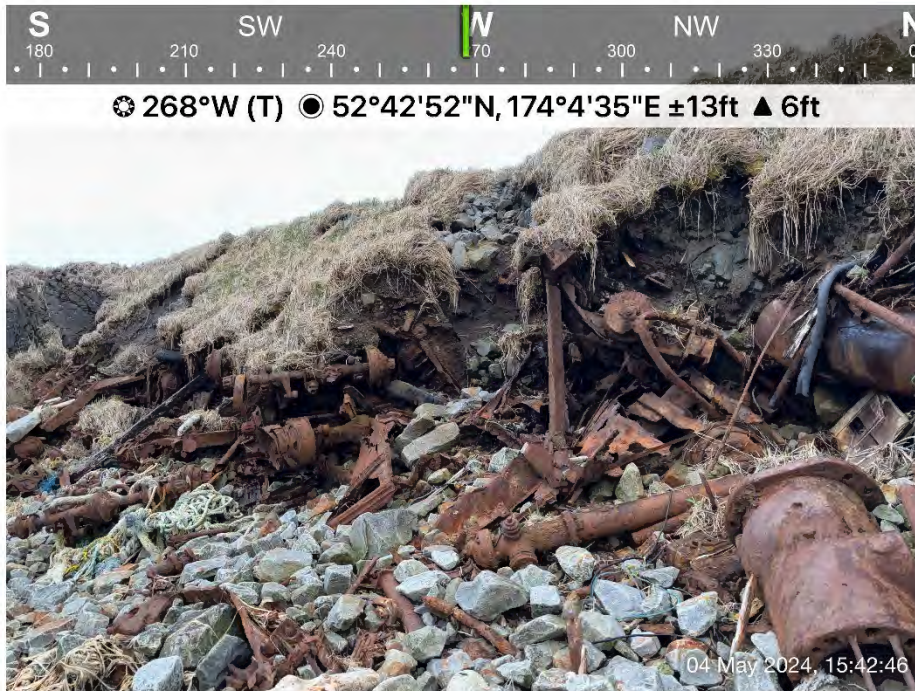
Photograph 33: LF026 eastern boundary with exposed landfill debris along the bluff.

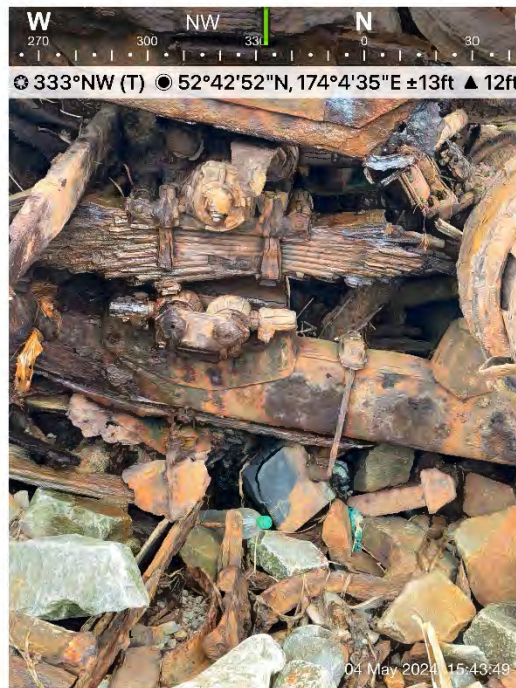
- Prohibited waste included clumps of suspected tar material on the western beach bluff (Attachment B, Photograph 39) and a lead acid battery was observed on the beach bluff on the eastern side in the high tidal zones (Attachment B, Photograph 34).

Photograph 34: LF026 eastern landfill debris with lead acid battery at toe of exposed bluff debris.

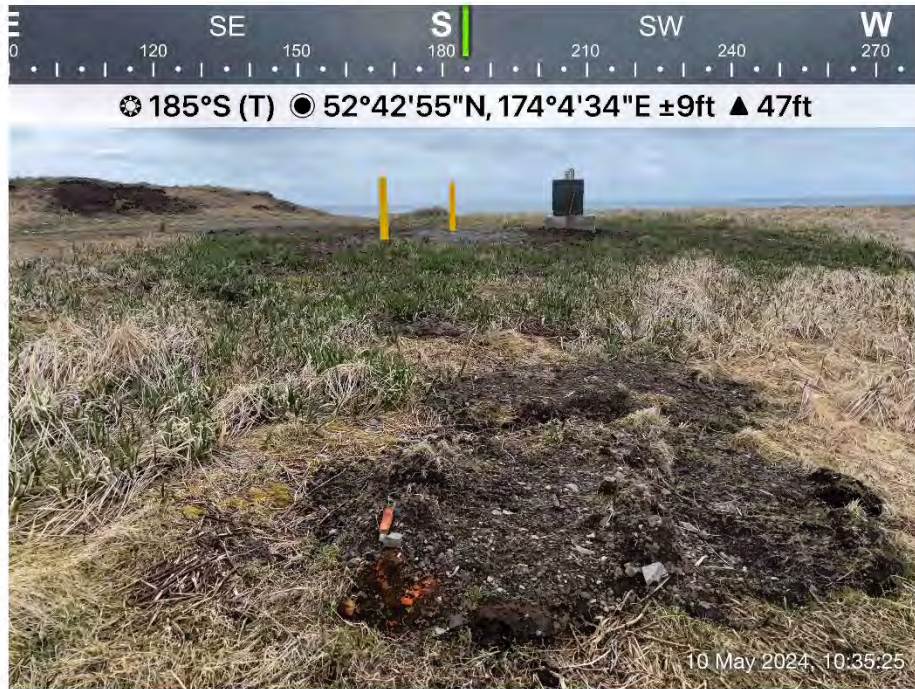
The LF026 landfill cap was well vegetated across approximately 90% of the site with the exception being where the cover was disturbed during a recent electrical upgrade at the site, a slough below the CORS station and landfill boundaries to the west, south and southeast being actively eroding by the ocean. The recent electrical upgrades at the site disturbed the landfill cover and resulted in exposed small metal debris near the surface. Exposed debris was observed along the southwestern/southern boundary and the southeastern boundary eroding into the ocean was mostly metal; however, a lead acid battery and clumps of tar were noted. Landfill cover thickness was observed to range from approximately 2-3 feet on the southern bluff to over 10 feet on the western bluff. The cover on the eastern exposed bluff was approximately 3-4 ft in thickness. Site structures including the hazardous material storage shed, SP operations building and former weather instrument cluster were no longer present onsite. No evidence of recent dumping of debris or trash was noted.

Photograph 35: Disturbed landfill cover with exposed debris from recent electrical upgrades.

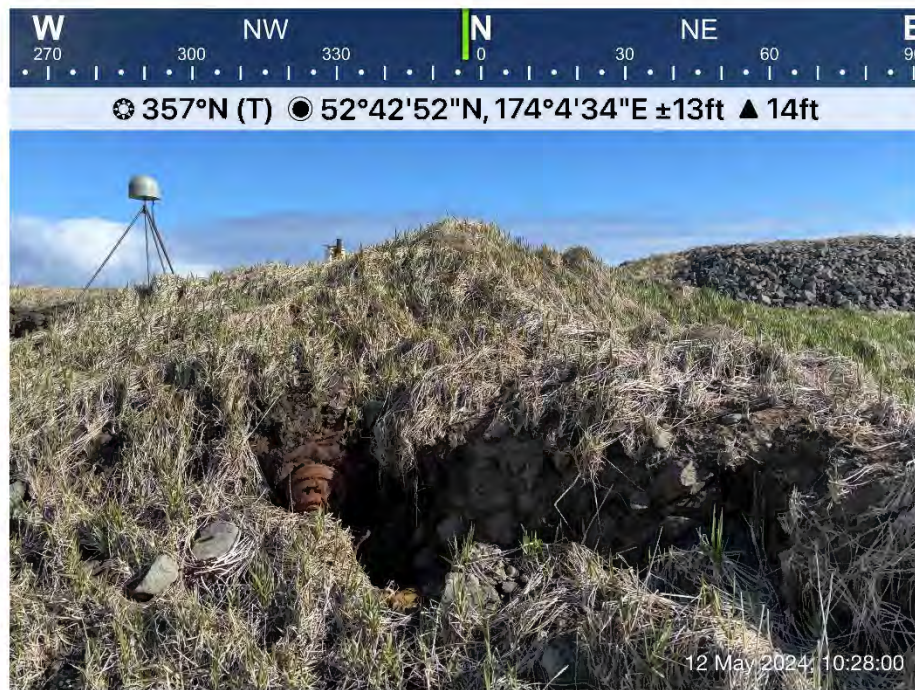
Photograph 36: LF026 exposed landfill debris in cover slough below the CORS station.

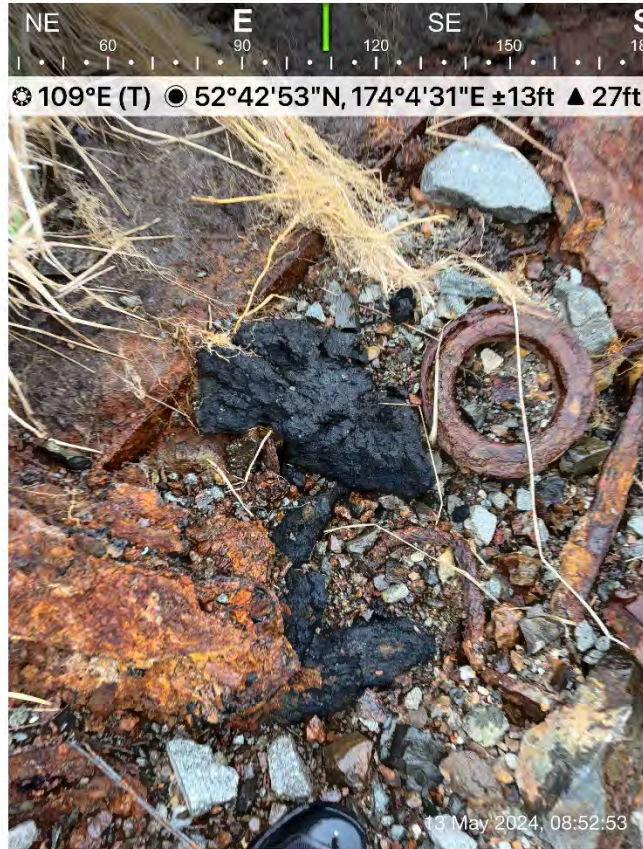
Photograph 39: Tar material observed on western bluff of LF026.

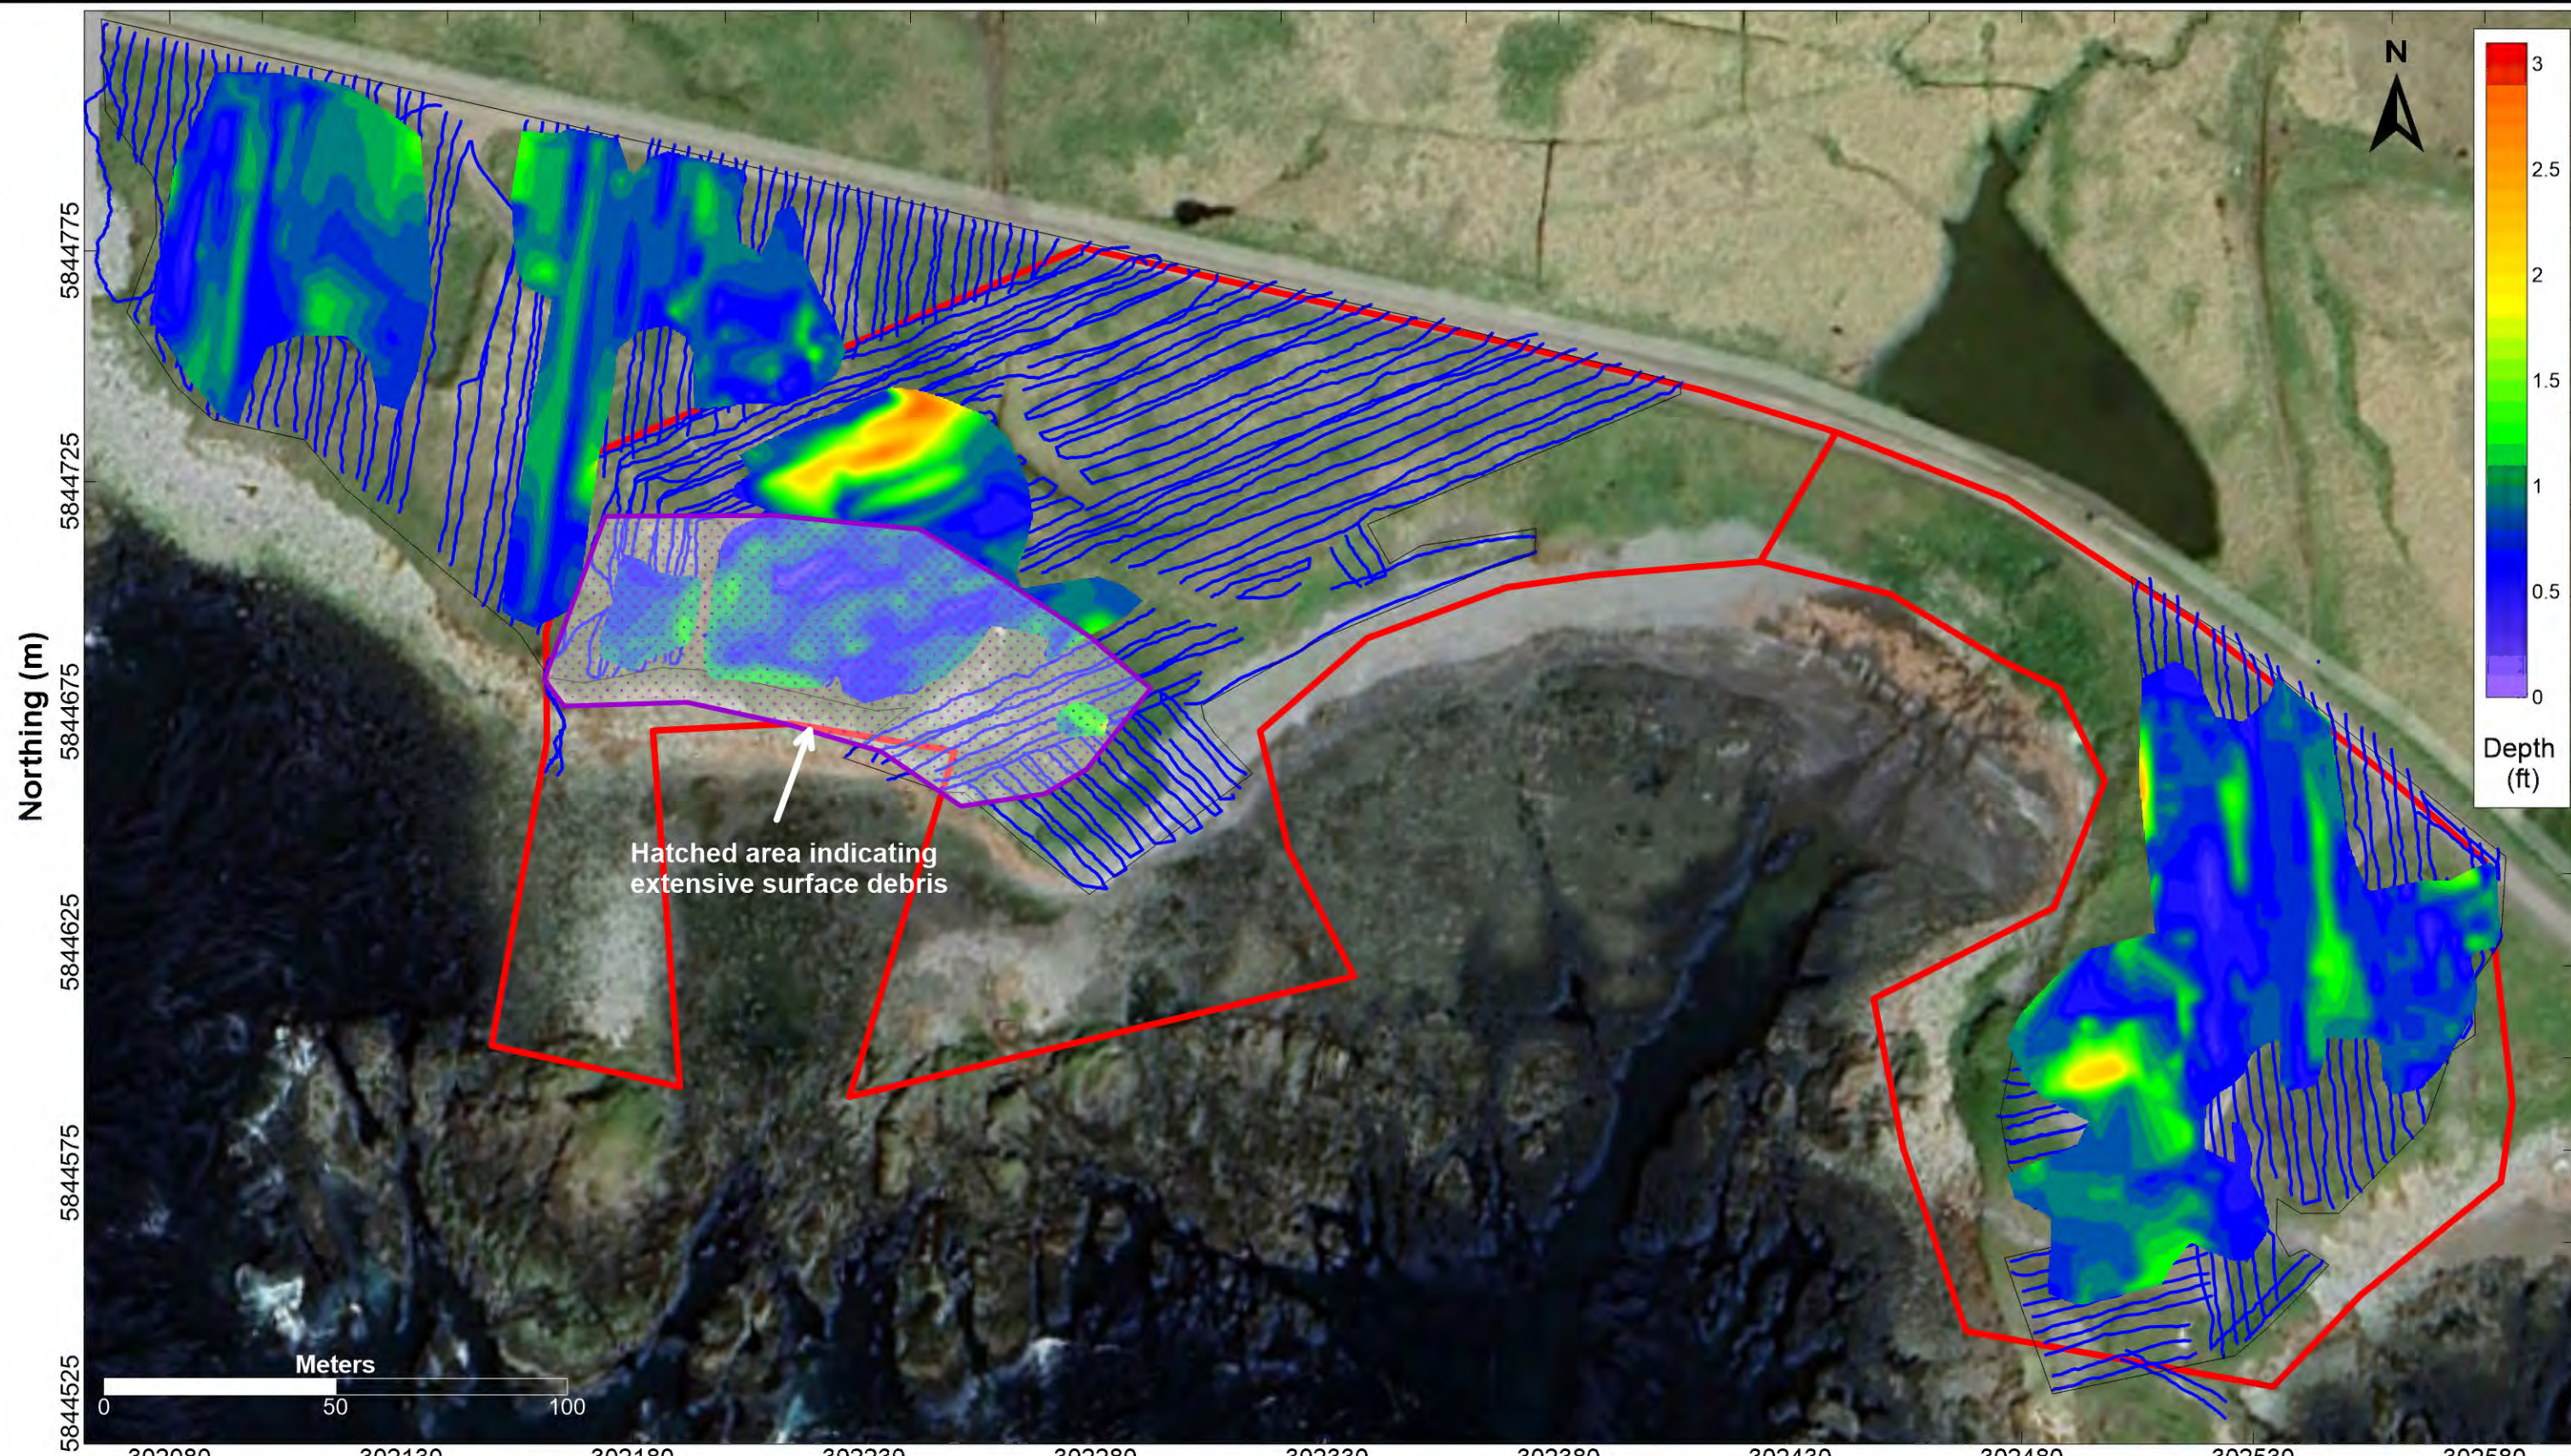
Figure 2
Interpreted Depth of Cover

The initial processing and interpretation of geophysical data provided estimates of the cover depth and lateral extents of the debris locations. The maximum depth of penetration with the GPR was approximately 12 feet. Figure 2 of the geophysical report (Attachment D) shows the lateral and vertical extent of the debris and Figure 3 of the geophysical report (Attachment D) shows the gridded surface elevations. The estimated depth below surface for the top of the debris ranged from 0 to 3 feet. Test pitting is recommended to ground truth the estimated depths.

Figure 2 shows the results from the GPR interpretation at Eareckson over the surveyed area for the lateral and vertical extent of the debris. Estimated depth below surface for the top of the debris ranged from 0 to 3 feet. A hatched area on Figure 2 provides an outline of the section of the landfill which had prevalent surface debris. Figure 3 shows the gridded surface elevations, ranging from ~1 to 17 m in NAVD88, Geoid12B.
