THE UNITED STATES AIR FORCE INSTALLATION RESTORATION PROGRAM

FIVE-YEAR ROD REVIEW REPORT

EIELSON AIR FORCE BASE, ALASKA

JANUARY 2004

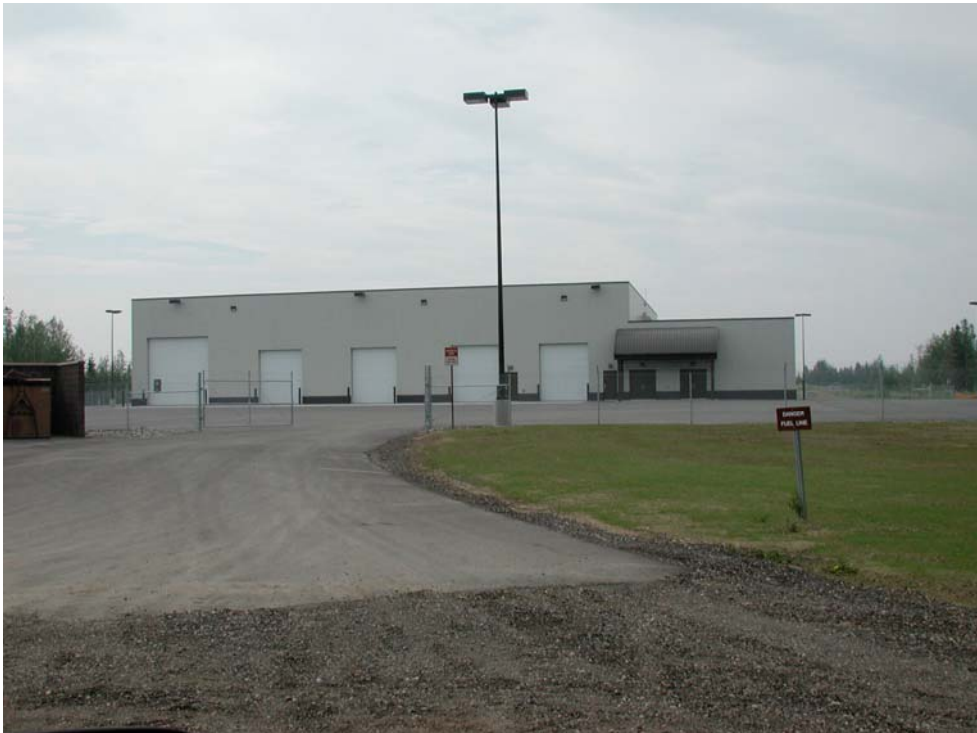
Photo 6: Munitions storage facility constructed at LF03.
