**LIMITED HAZARDOUS BUILDING MATERIALS INVENTORY  
HOMER EDUCATION AND RECREATION CENTER  
HOMER, ALASKA**

**ADEC FILE NUMBER 2314.38.043  
ADEC HAZARD ID 27933**

**SEPTEMBER 2025**

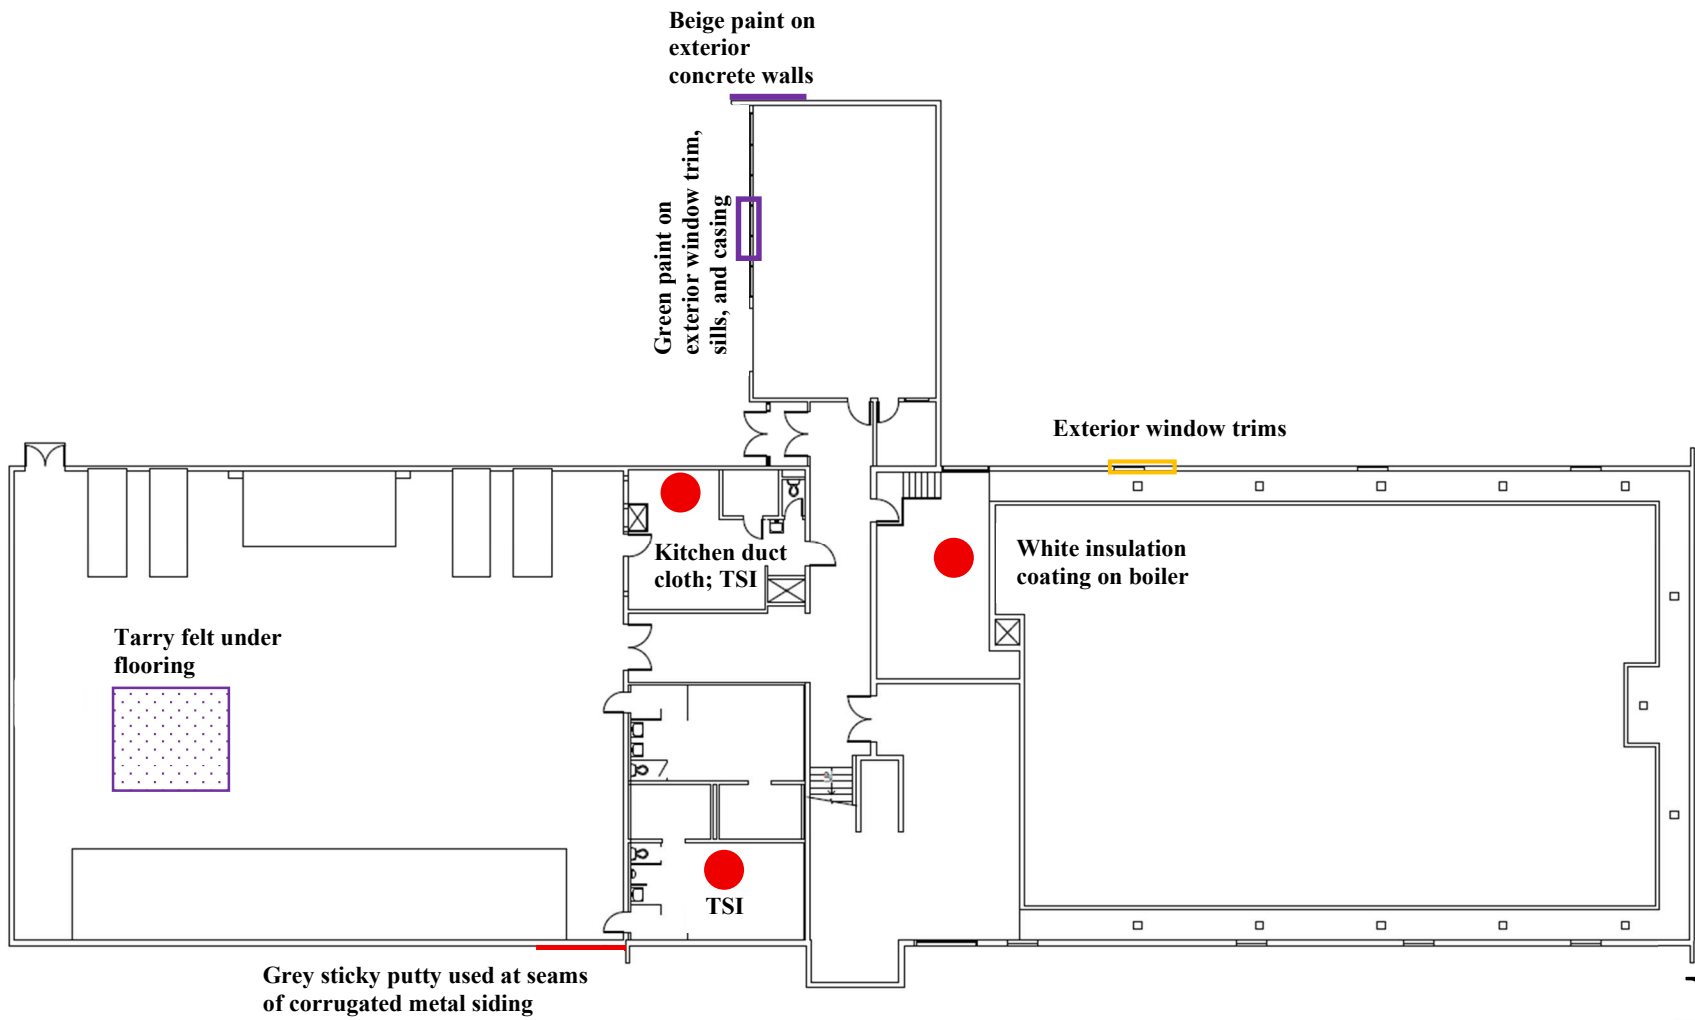
Figure 2

Homer HERC Buildings  
 Homer, Alaska  
**HERC 1 – 1<sup>st</sup> Floor**  
**Hazardous Building Materials**

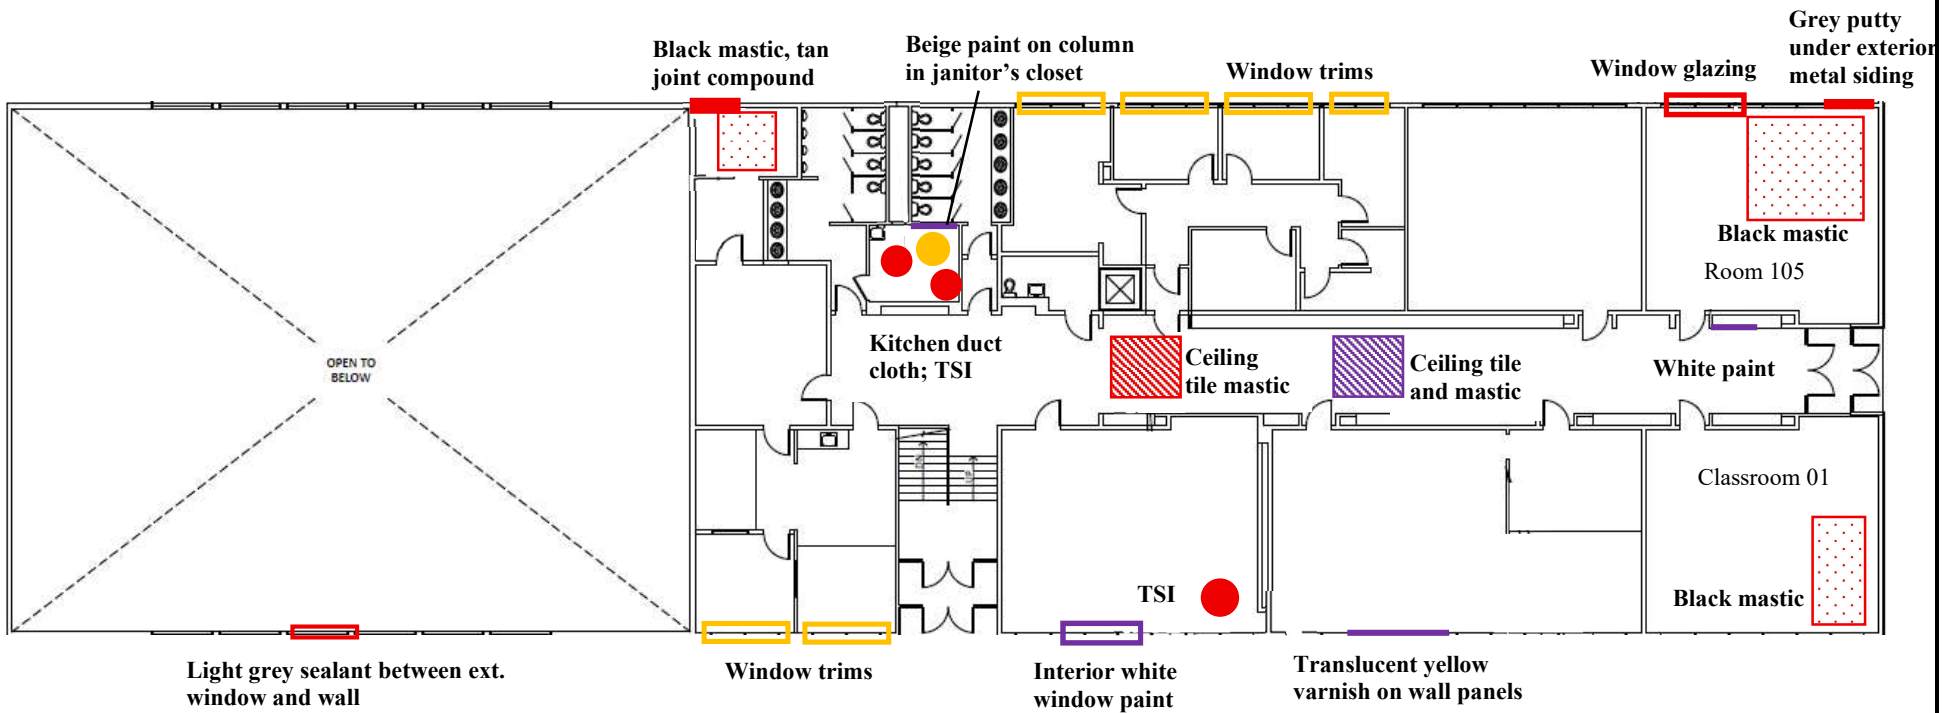
Homer HERC Buildings  
 Homer, Alaska  
**HERC 1 – 2<sup>nd</sup> Floor**  
**Hazardous Building Materials**

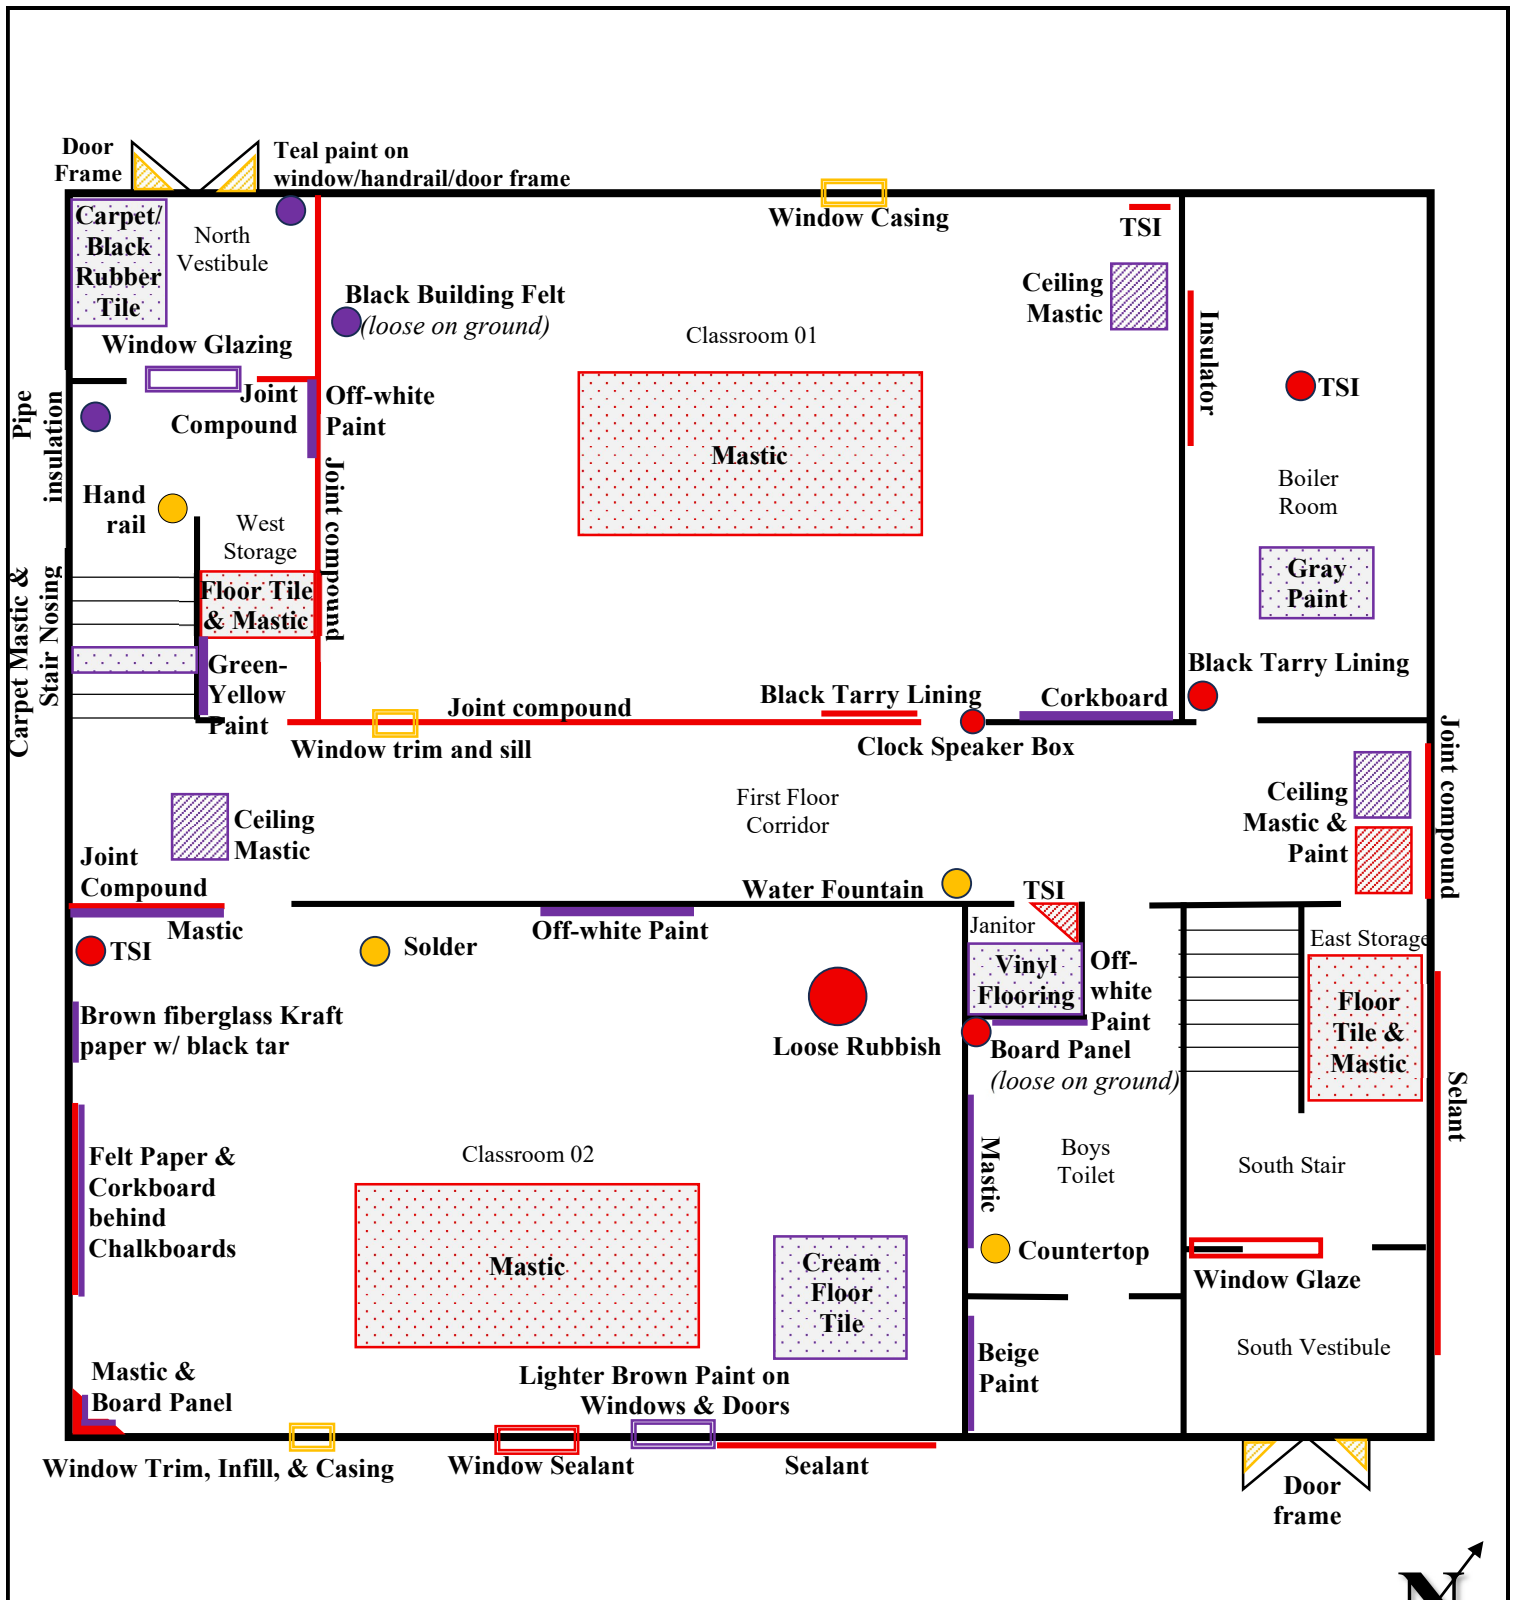
Homer HERC Buildings  
 Homer, Alaska  
**HERC 2 – 1<sup>st</sup> Floor**  
**Hazardous Building Materials**

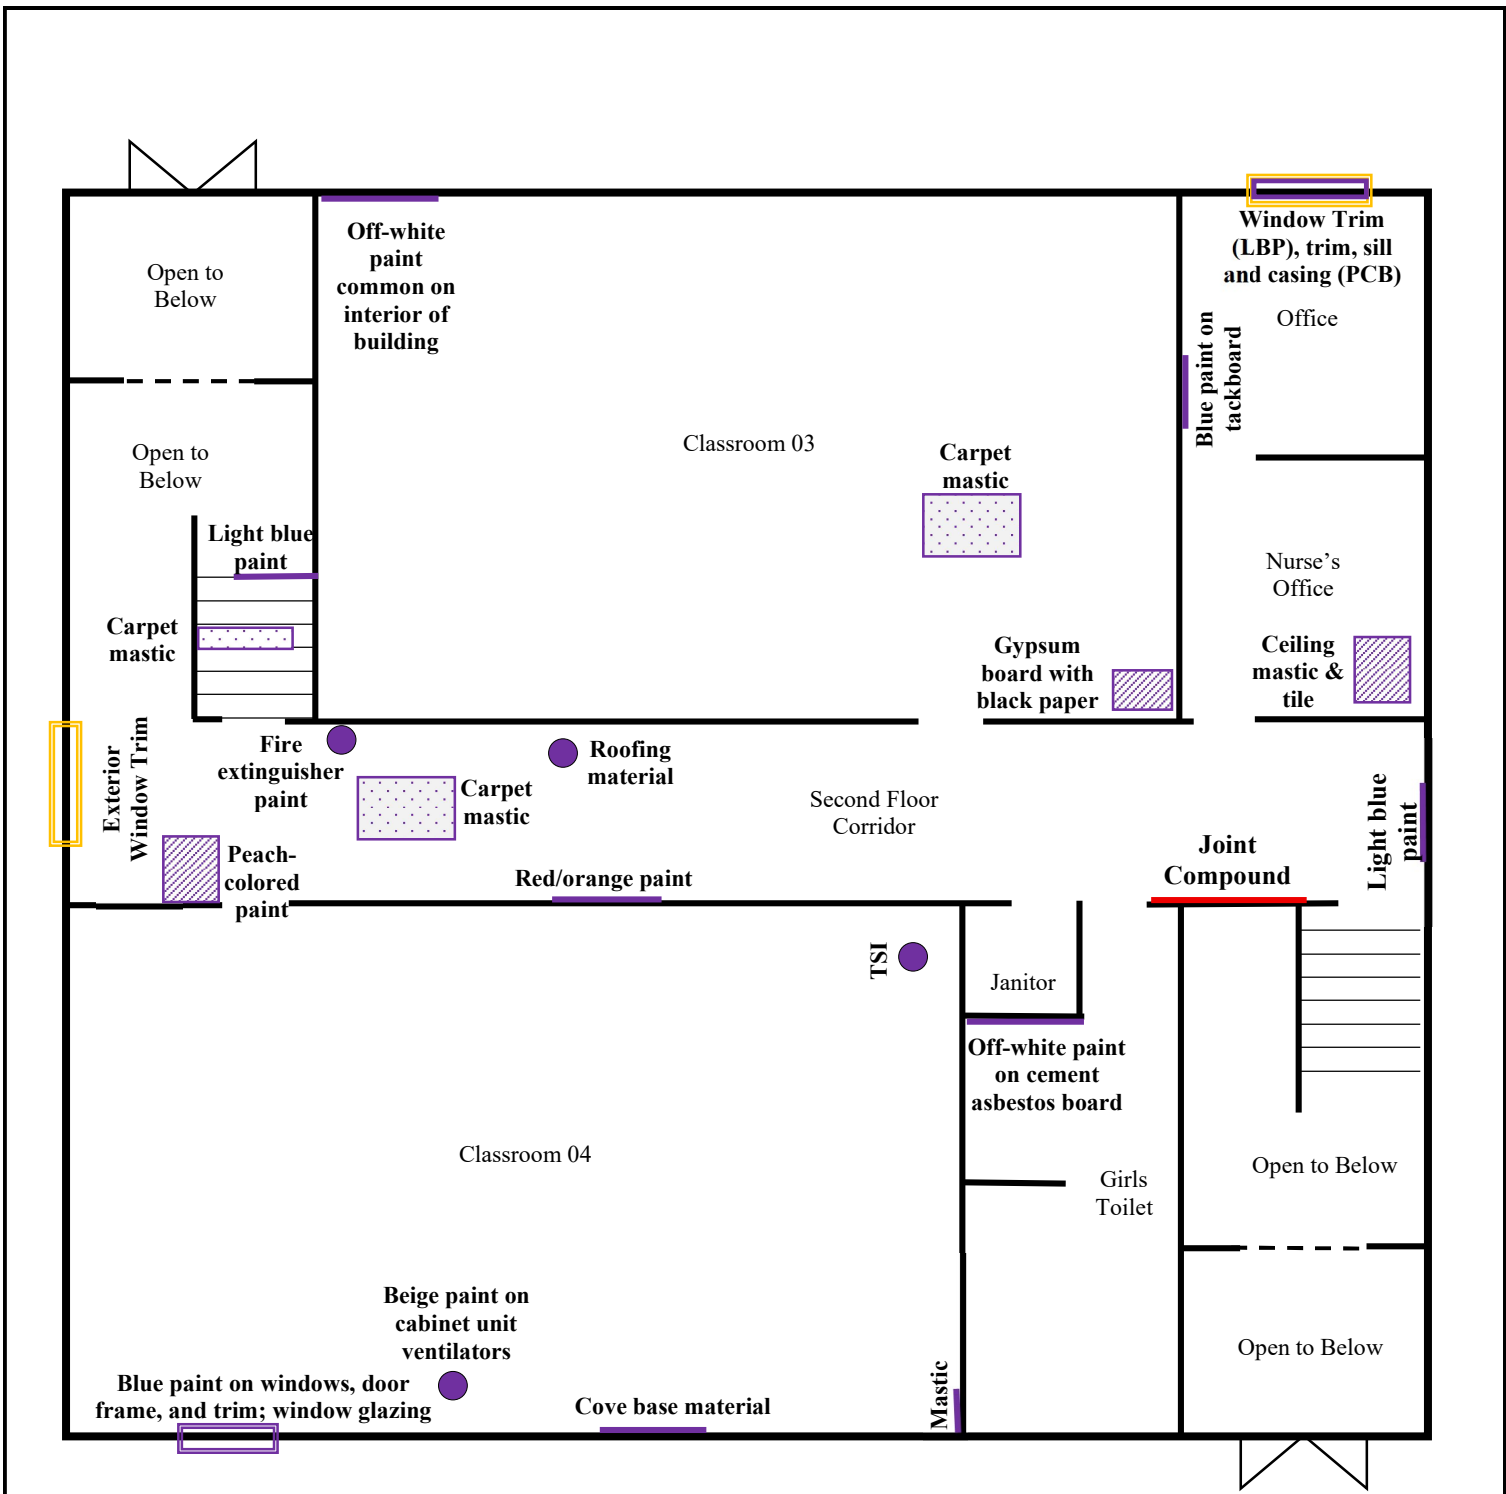
Homer HERC Buildings  
Homer, Alaska  
**HERC 2 - 2<sup>nd</sup> Floor**  
**Hazardous Building Materials**

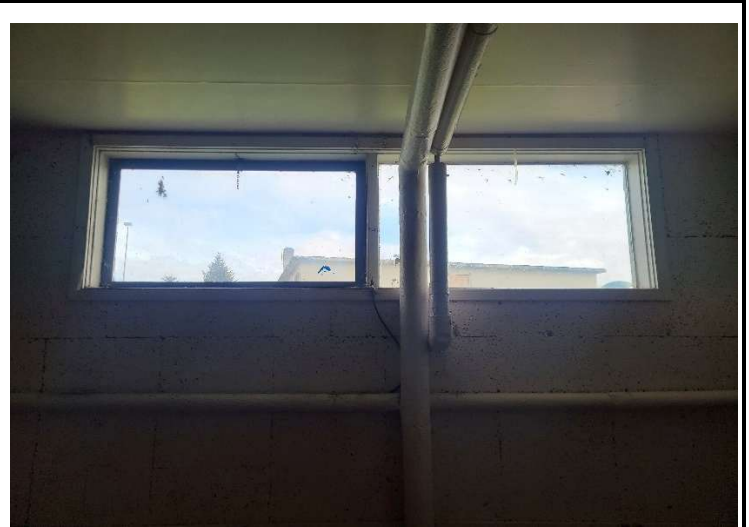
Photo 2. Basement Window; Lead Readings #49-54.

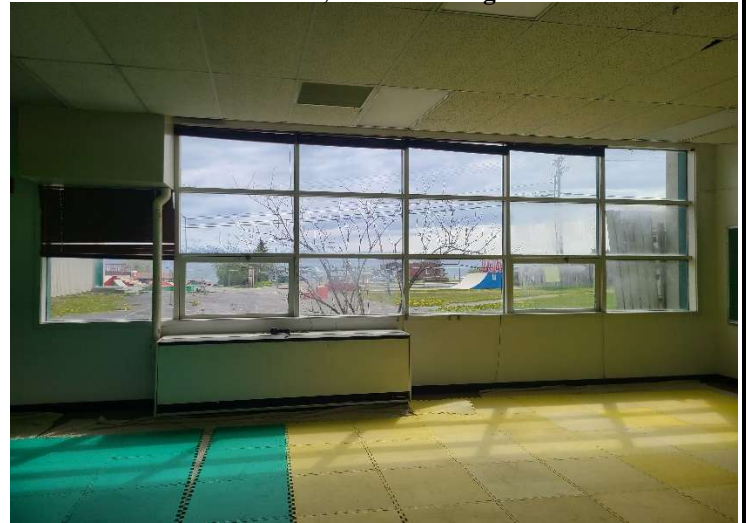
Photo 4. Multi-Purpose Room Window; Lead Readings #156-165.

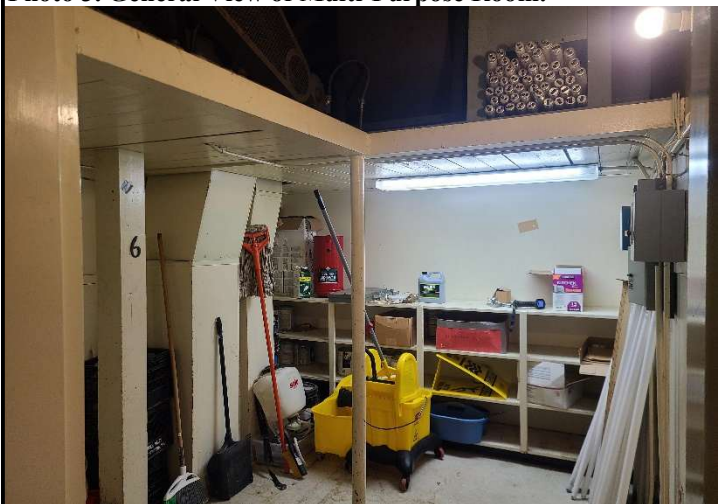
Photo 5. Men's Room Closet; Lead Readings #295-299.

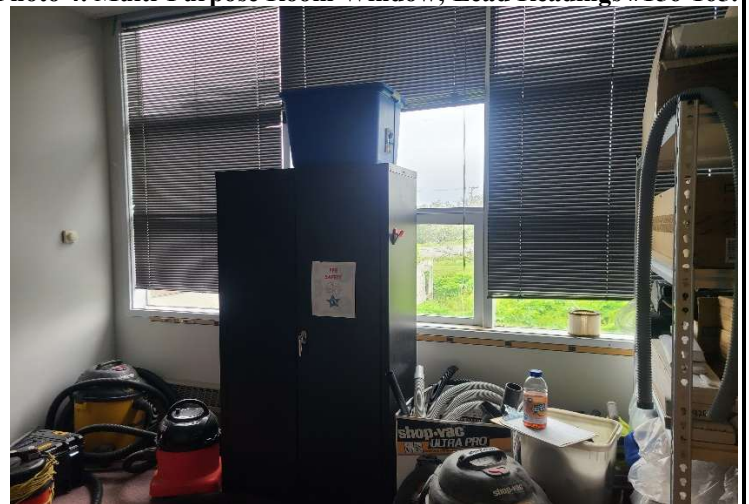
Photo 6. HERC Bldg. 1 Storage Room; Lead Readings #346-354.

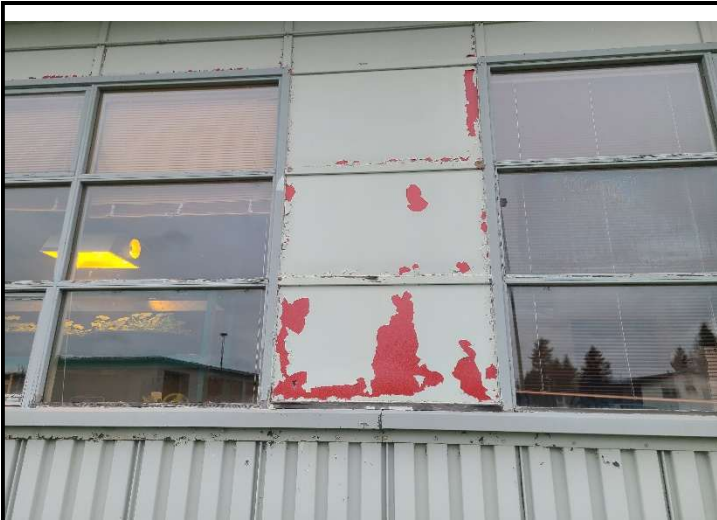
Photo 7. LBP Reading #617; Building 1 Exterior.

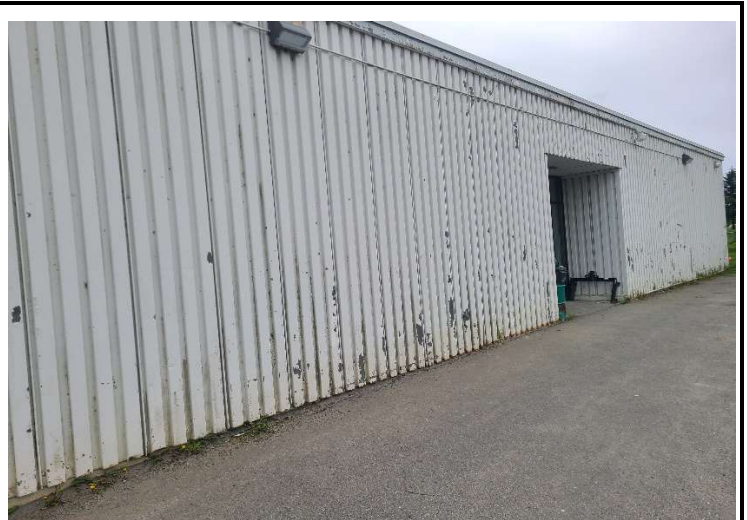
Photo 8. LBP Reading #620; Building 1 Exterior (Lookin S.W.).

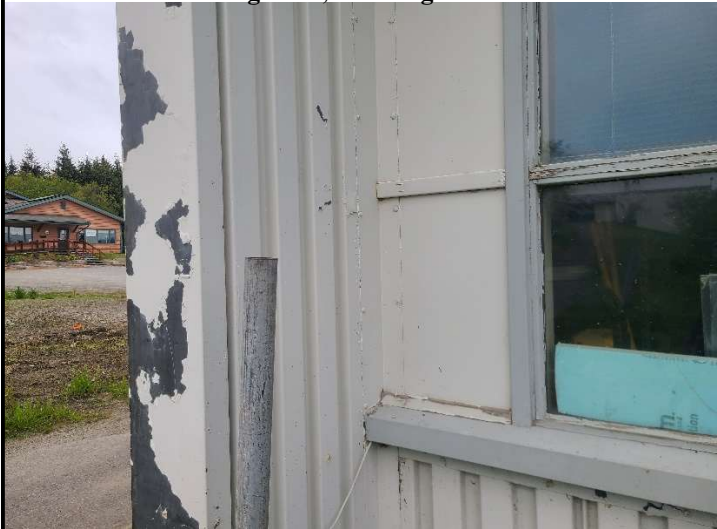
Photo 9. LBP Reading #622; N.W. Corner of Bldg. 1 (Looking N.).

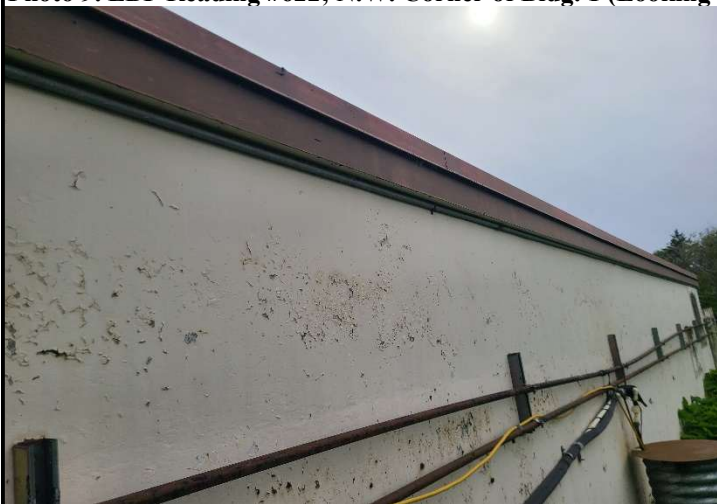
Photo 11. LBP Reading #628; Western Extension (Looking W.).

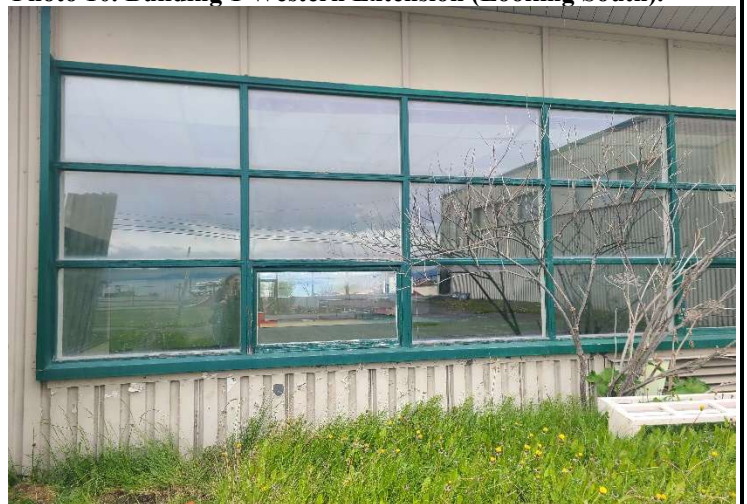
Photo 12. LBP Reading #633; Western Extension Window.

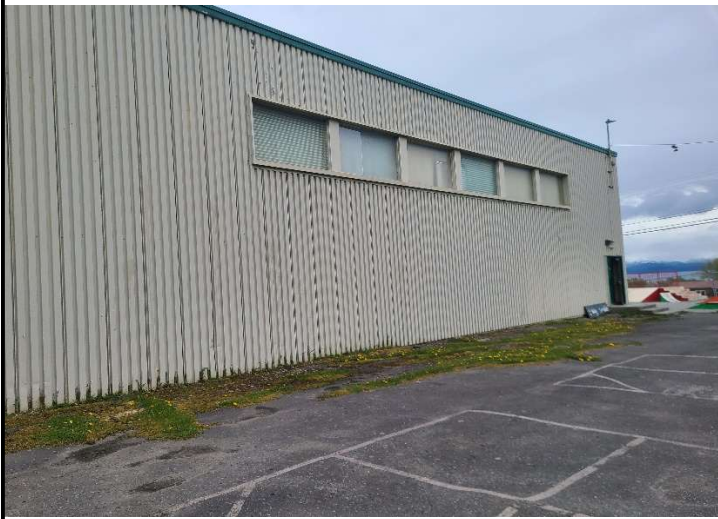
Photo 13. LBP Reading 638; W. Exterior Bldg. 1 (Looking S.).

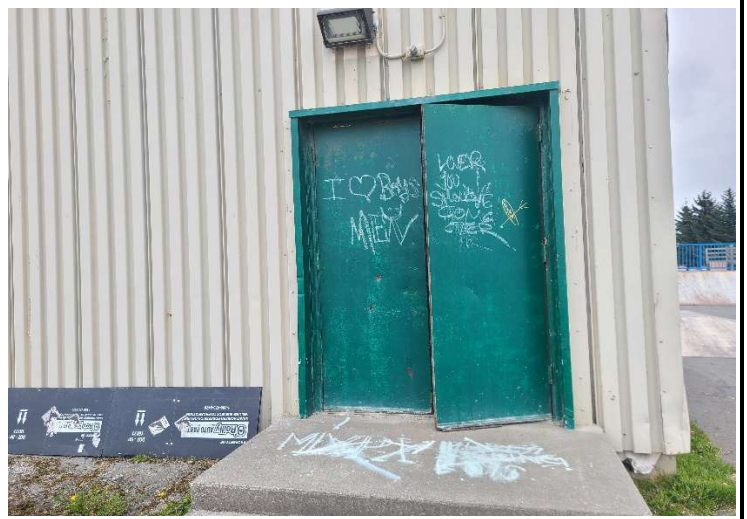
Photo 14. LBP Reading #640; Building 1 S.W. Entrance.

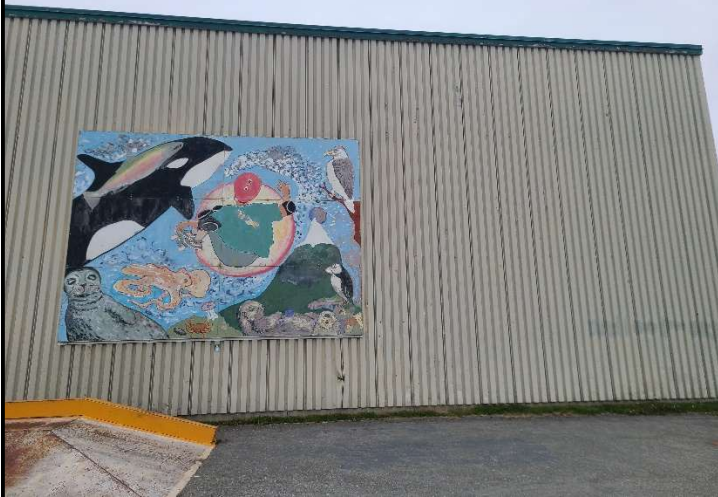
Photo 15. LBP Reading #642; Bldg. 1 South Exterior Wall.
