Alaska Department of Environmental Conservation (ADEC) Solid Waste Program (Sandra Woods and Trisha Bower) conducted a Coastal Impact Assistance Program (CIAP), Waste Erosion Assessment and Review (WEAR) site visit for Buckland on September 16, 2013., IGAP Coordinator Shannon Melton, participated in the site visit. The following narrative is a brief description of our findings during the September inspection.

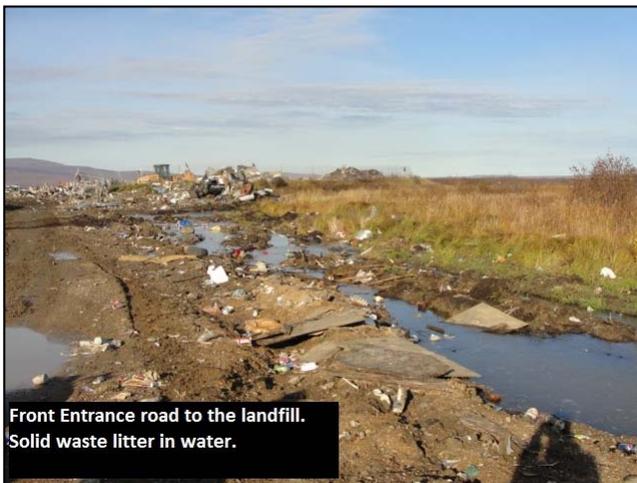
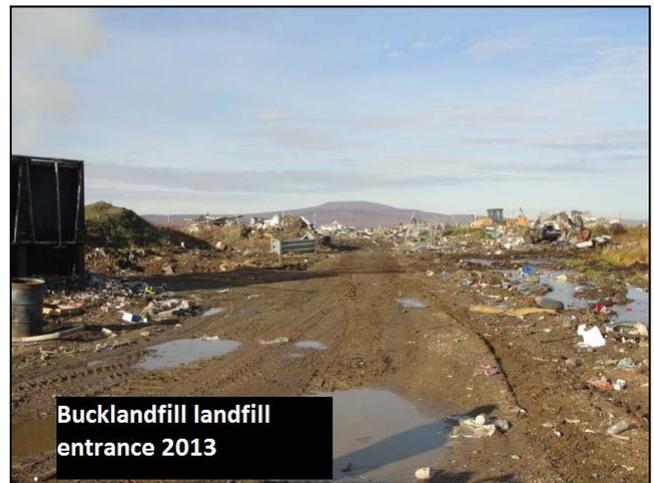
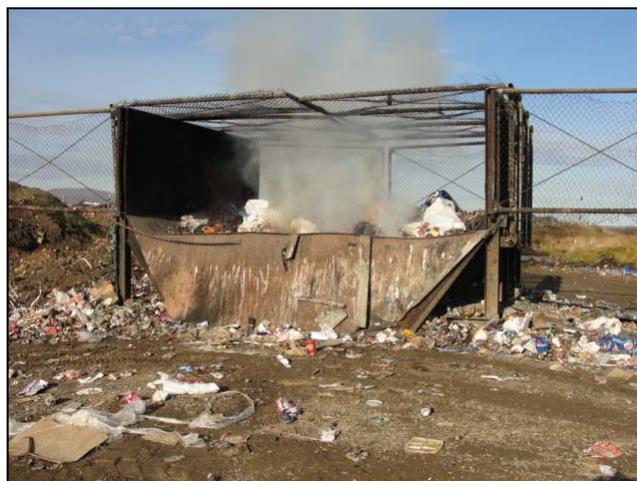
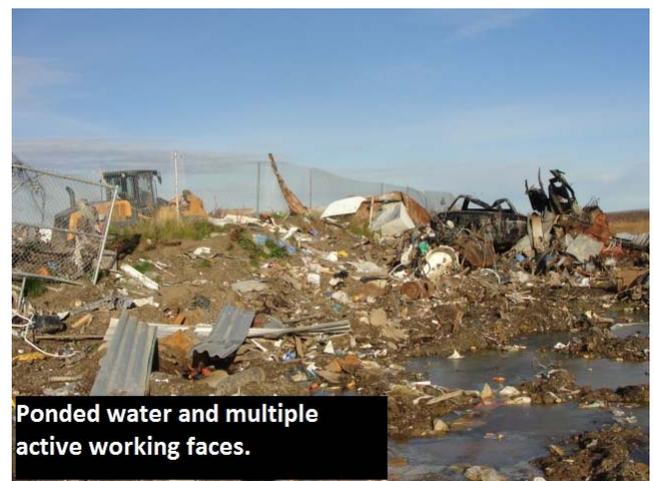
- **Landfill, 65.976782/-161.153284 (Active)** — This site is a fenced area fill landfill that is unpermitted. The current landfill is not well managed and is in a location that regularly floods in the spring, filling the landfill and surrounding areas with water. There are two City Employees who collect solid waste from the community and bring the waste to the landfill for either burning in Summit burn box or place it directly into the landfill. The landfill accepts municipal waste and construction and demolition debris. There is inadequate waste separation and diversion and limited recycling/backhaul in Buckland. At the time of the inspection, Shannon Melton works as the Buckland IGAP employee. Ms. Melton is currently working on a United States Department of Agriculture (USDA) landfill grant application to build a new landfill in an area that is less likely to flood. The current landfill is located approximately 1645 feet from the airport strip, 580 feet northeast from Keeyuk Creek that floods the landfill annually, and 2109 feet southwest of the Buckland River at its closest point.

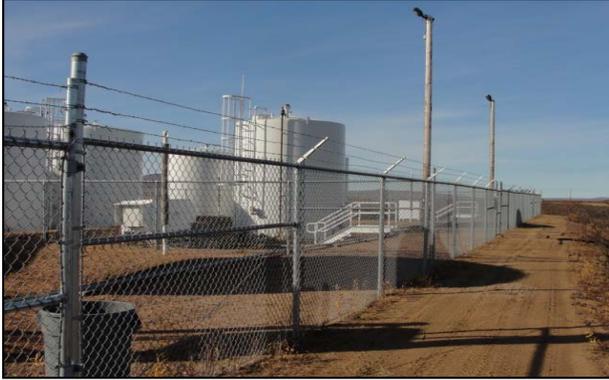
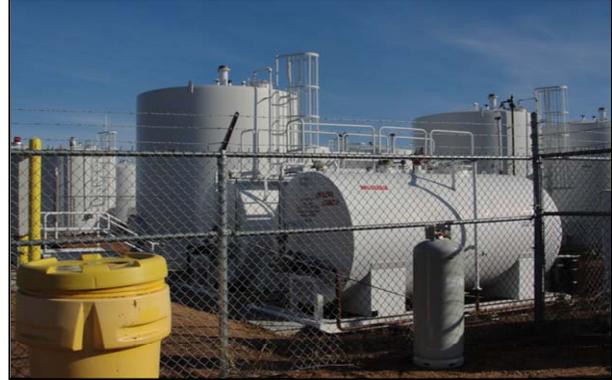
- **Community Tank Farm, 65.978896/-161.131984 (Active)** – This consolidated tank farm was constructed in 2004 through a Denali Commission project. It contains fuel tanks for the Native Village of Buckland, City of Buckland and the Northwest Arctic Borough School District. It is operated by the Native Village of Buckland. The tank farm is fully fenced with earthen dikes as secondary containment. This site is 640 feet southwest of Buckland River and 755 feet east the airstrip. The nearest source of erosion is the Buckland River to the northeast. The site is in good condition and generally flat and the soil was sandy with high organic content.

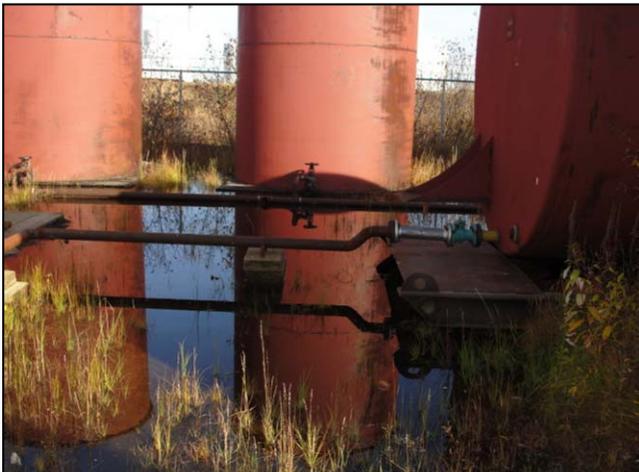
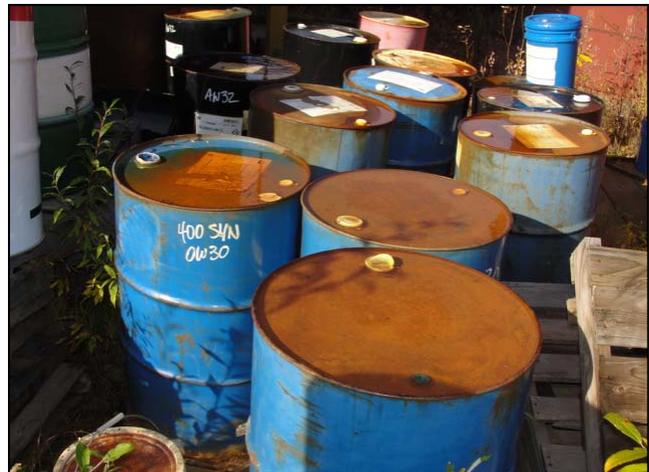
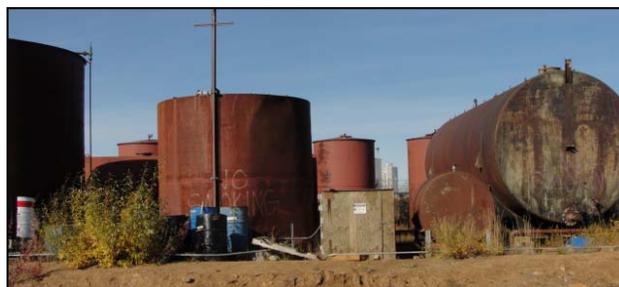
- **IRA Fuel Depot, 65.978327/-161.130767 (Active)** – This former tank farm is a known Contaminated Site (File ID 520.38.003) due to petroleum contamination. It was also the site of a 7,750 gallon fuel spill of which 3,100 gallons were recovered in 2008. This tank farm was operated by the Native Village of Buckland. It was in operation from around the 1980s until 2004 when the consolidated tank farm was constructed 100 feet west this site. The site currently includes eleven abandoned fuel tanks that may still contain an unknown amount of both diesel and gasoline. This site also contains many 55-gallon drums of used oil and other unidentified chemical substances. Most drums were intact but rusted and showing the potential to deteriorate and leak in the near future. The tank farm is fenced and contained within a lined earthen berm area; however it was full of water and oily residue during the inspection. The water level in the containment area was about at the maximum level. The soil around the site is sandy with high organic content. This site is located 780 feet southwest of the Buckland River and 1,064 feet southwest of the airstrip.

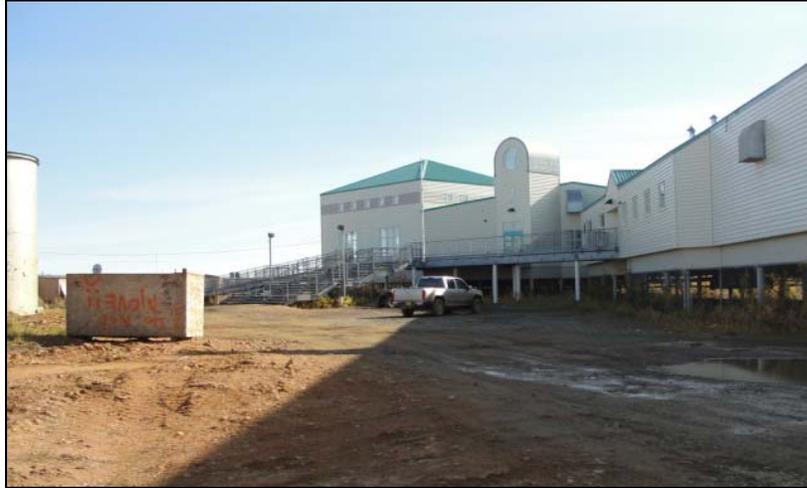
- **NABSD School Tank Farm, 65.978277/-161.125078 (Active)** – The former tank farm for the school was located on the east side of the school near the City of Buckland Tank Farm. It is an active Contaminated Site (File ID 520.38.006) due to petroleum contamination. It was owned by the Northwest Arctic Borough School District (NABSD) and was removed after the consolidated tank farm was constructed in 2004. The original location, next to the City Tank Farm, has been covered with clean fill and is partially under the handicap access ramp at the entrance to the school. The tank farm contained 5-7 vertical single-walled tanks at various times over the years with no fencing or secondary containment. It is located 390 feet from the Buckland River.

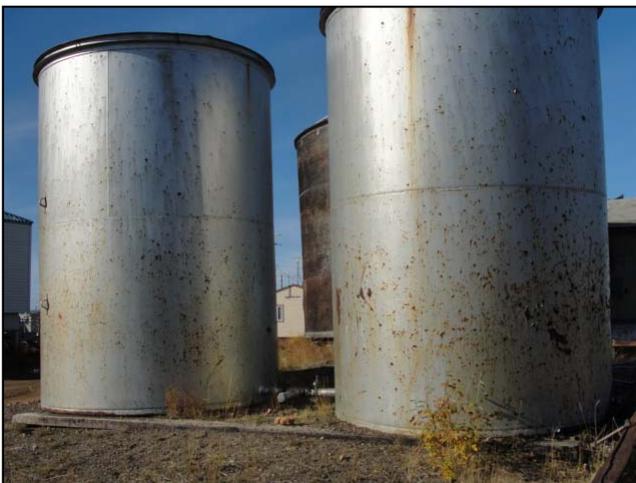
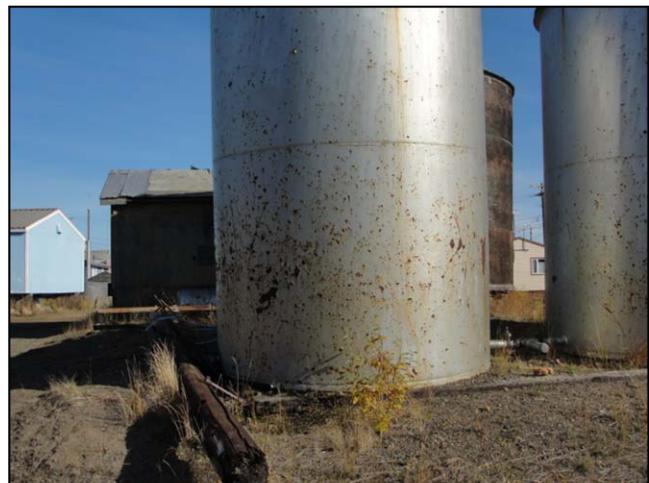
- **City Tank Farm, 65.978381/-161.124910 (Active)** – This tank farm is an active Contaminated Site (File ID 520.38.004) due to petroleum contamination. It is located 65 feet northeast of the school and is owned by the City of Buckland. This tank farm was used for supplemental heating fuel storage for the power plant & other city facilities. It contains two single-walled, vertical steel tanks that are not fenced or in secondary containment. There has been a tank farm in this location since the 1970s. The total capacity of the tanks is 14,800 gallons; however, they were reported to not be in use. It is located 370 feet from the Buckland River.

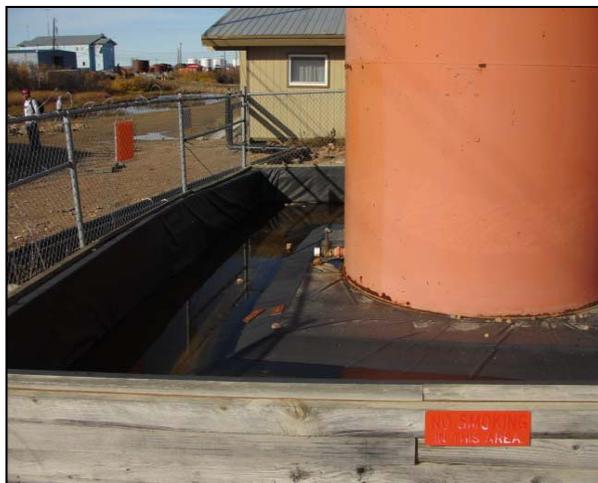
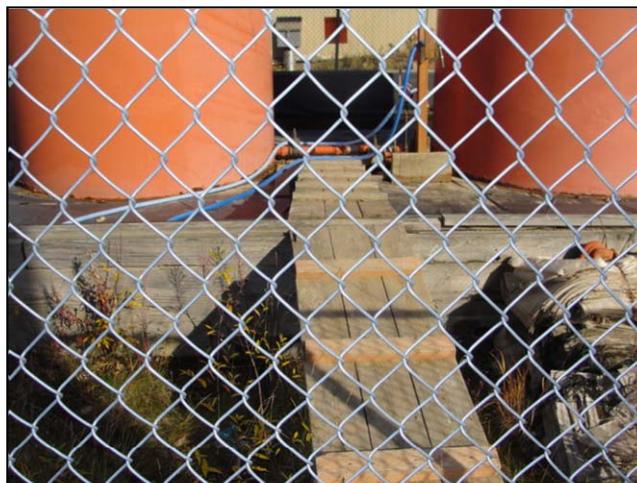
- **Water Plant Tank Farm, 65.977243/-161.125885 (Active)** – This tank farm is a known Contaminated Site (File ID 520.38.005) under the name ‘*City of Buckland Water Plant*’. This facility consists of two single-walled vertical steel tanks containing heating oil within a fenced and lined dike. This tank farm is used to dispense fuel to various city facilities. It is owned by the City of Buckland and was constructed around the 1980s. Total capacity of the tanks is 15,600 gallons. The Buckland River is 425 feet east of this site and is the nearest source of erosion.

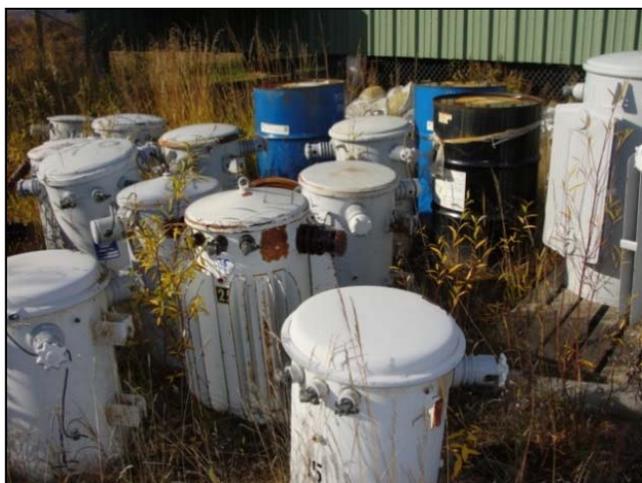
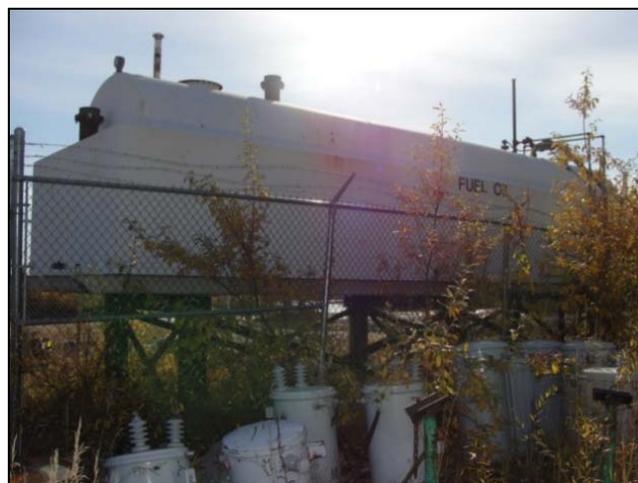
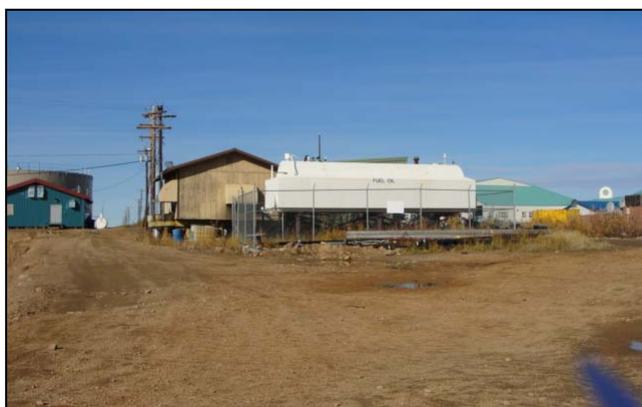
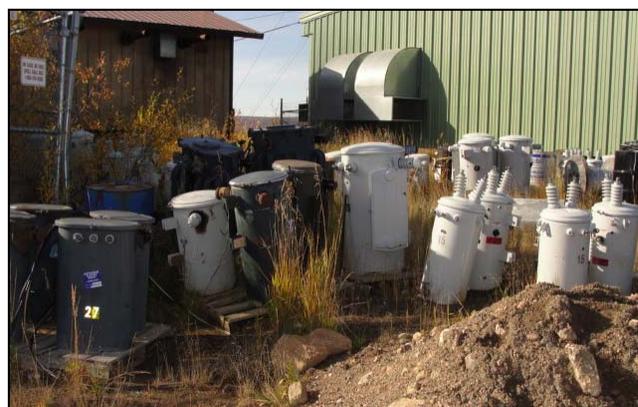
- **Power Plant Tank, 65.976543/-161.124405 (Active)** – This facility consists of one horizontal, double-walled diesel fuel tank. It is on raised pilings within a fully fenced area. Fuel from this tank is transferred via above-ground piping to the power plant that is operated by the City of Buckland. There are numerous abandoned transformers stored near the power plant. It is unknown if they contain any PVC or other hazardous waste. The nearest source of erosion is the Buckland River 170 feet to the east.
