Alaska Department Environmental Conservation (ADEC) Solid Waste Program (Trisha Bower, Sandra Woods, and Rebecca Colvin) conducted a Coastal Impact Assistance Program (CIAP), Waste Erosion Assessment and Review (WEAR) site visit for the Village of Golovin, September 12th, 2012. Carol Oliver, the IGAP Coordinator, Toby Anungazuk Jr., the IGAP Assistant and Peter Olson, the Public Works Director/Landfill Operator helped coordinate our visit. A follow-up inspection was conducted September 8, 2014 by Trisha Bower and Sarah Durand. The following narrative is a brief description of our findings during the September inspections.

WEAR Sites

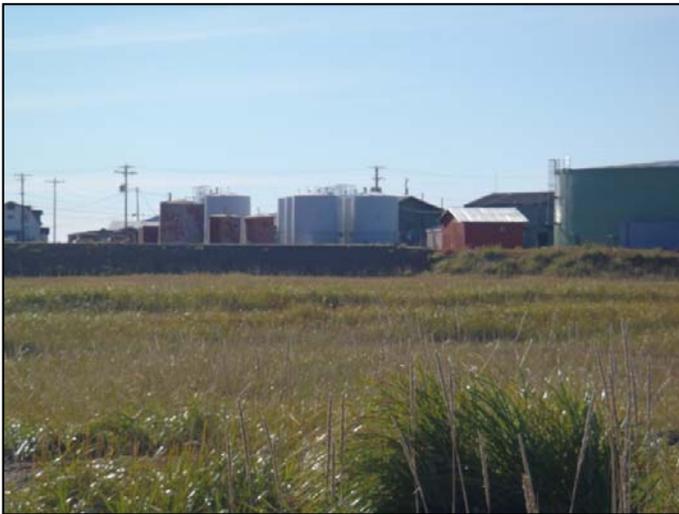
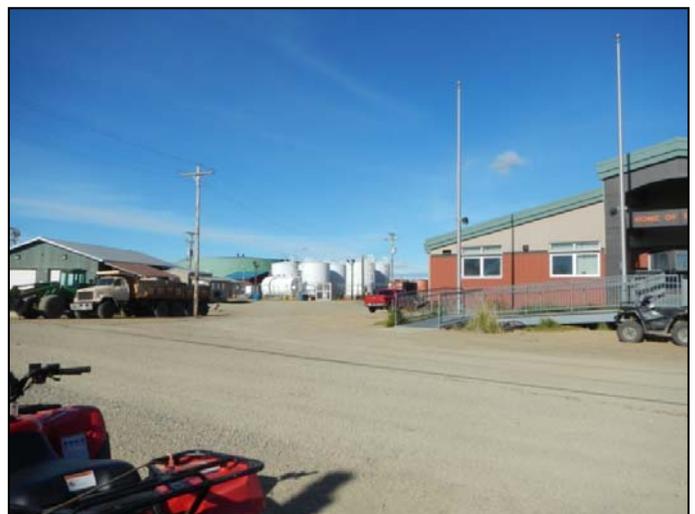
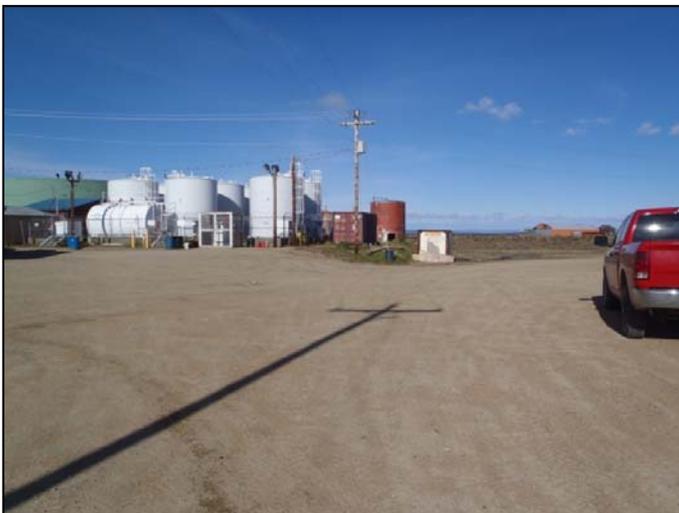
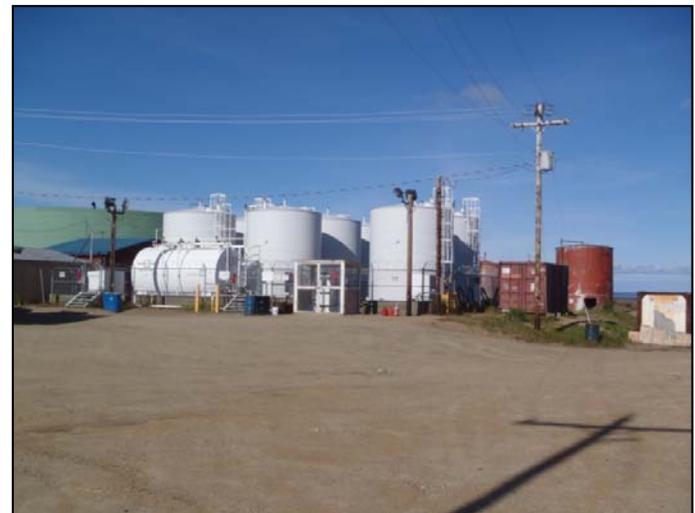
- **Tank Farm, 64.542884/-163.036550 (Active)** — The main tank farm is an engineered facility that is located on a raised platform within a fenced area with secondary containment. The tank farm is maintained and operated by employees only. The platform is built on a raised gravel pad. The tank farm is approximately 669.5 feet from Golovnin Lagoon and 544 feet from Golovnin Bay. The US Army Corps of Engineers 2009 study Alaska Baseline Erosion Assessment lists an estimated erosion rate of 4 feet per year. Golovin experiences both river and coastal erosion.

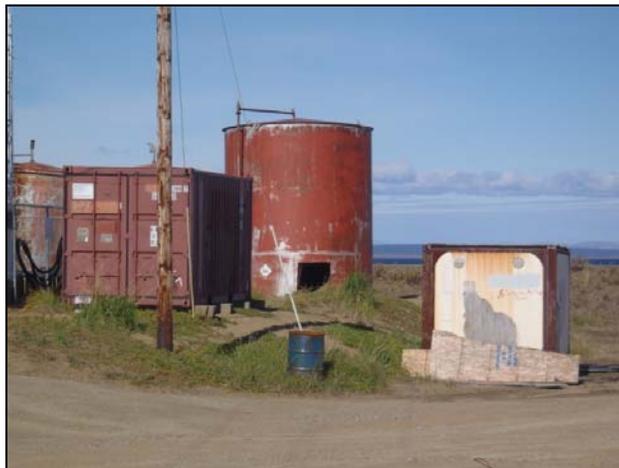
- **Staged Tanks, 64.5407/-163.042567 (Inactive)** – There are several smaller tanks located at the barge landing zone. They are decommissioned tanks with holes cut into the bottom that are waiting to be salvaged or backhauled. Golovin converts old fuel tanks into locally made burn units in the Golovin Landfill. There is not a known source of contamination located here.

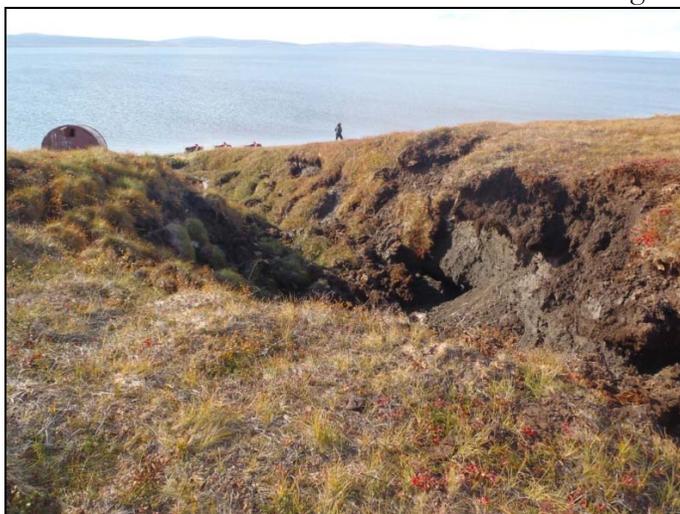
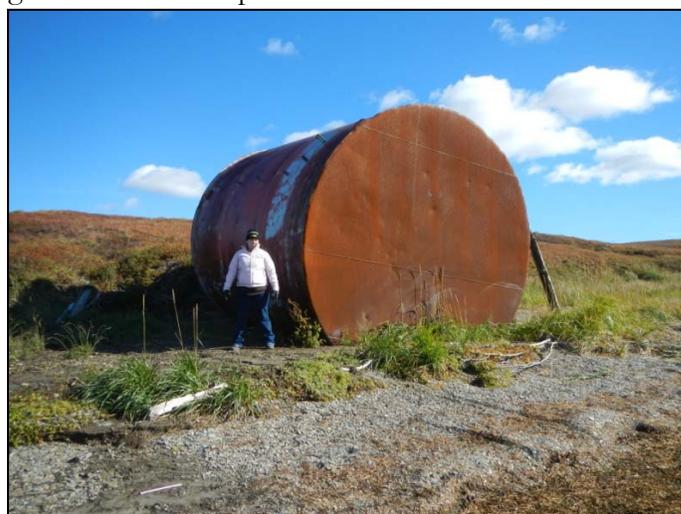
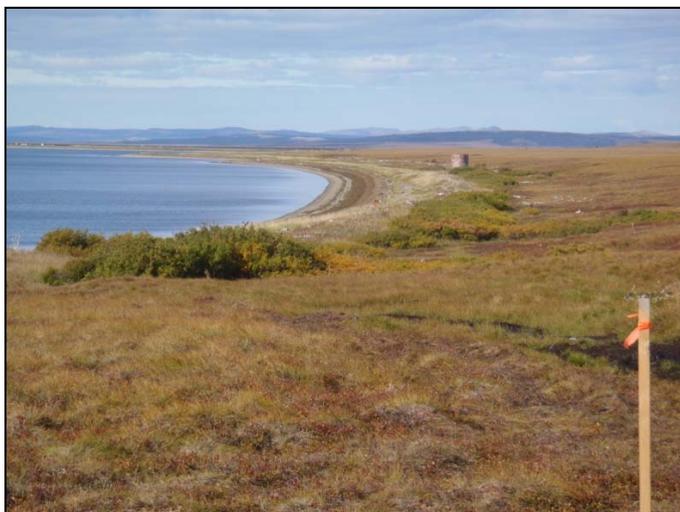
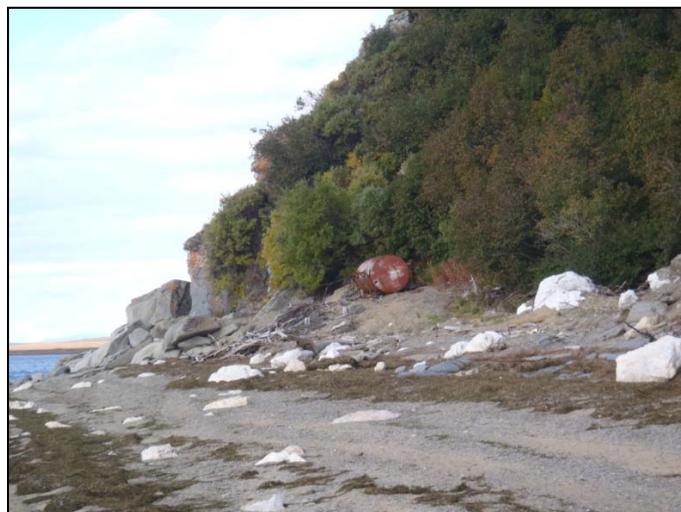
- **Abandoned Tanks, 64.585311/-163.037483 (Abandoned)** – There are 3 abandoned fuel tanks that have washed ashore north of Golovin during storms. They are large tanks and appear to be intact and empty of fuels. There is not a known source of contamination. It is possible that they will be washed out into the Golovnin Lagoon again and will be deposited somewhere else.

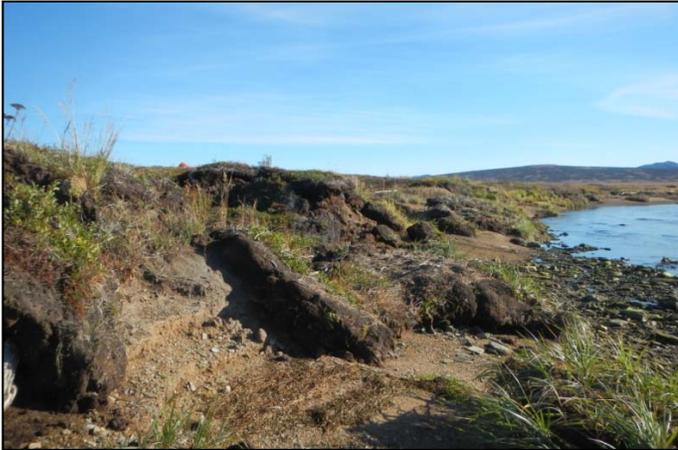
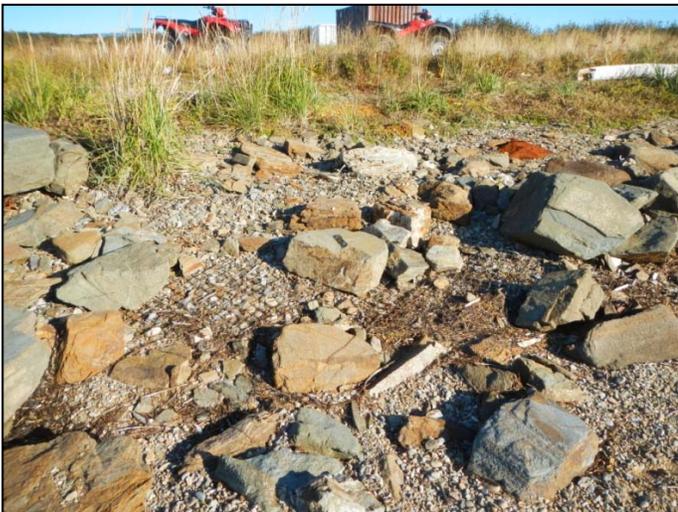
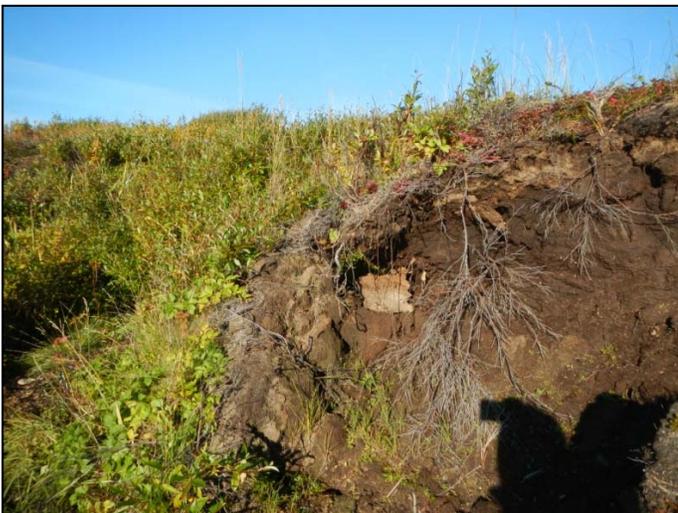
2012 Photos

- **Landfill, 64.543942/-163.0175 (Closed)** – This site has been assessed as a Brownfield site under the Contaminated Sites Program (File ID 590.38.003). It is located near the mouth of Chinik Creek, near the end of the runway. It is actively eroding into the creek, which is anadromous and is the village drinking water supply. The landfill operated from the early 1960s to 1996 when it was closed and covered with gravel and sand. It received municipal solid waste, special waste, and construction and demolition waste. It is being monitored by the local environmental staff, who is seeking funding to stabilize the creek bank to prevent further erosion of this landfill.

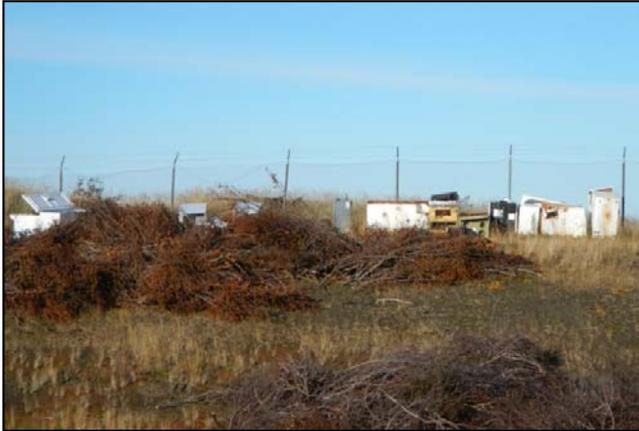
2012 Photos

- **1.7 Mile North Landfill, 64.566959/-161.013781 (Active)** – This permitted landfill is a fenced trench and fill landfill that is well-run. It was constructed around 1996 and is operated by the City of Golovin. There is a full-time Landfill Operator to manage the landfill, so there is adequate waste separation and diversion. It accepts municipal waste and construction and demolition debris. A homemade burn unit is used to burn municipal waste. There is a voluntary collection program in Golovin, but the majority of waste is brought to the landfill by self-haulers. The current IGAP Program Staff collect and recycle/backhaul fluorescent lights, aluminum cans, used oil, household batteries, lead acid batteries, and scrap metal. It is located 1.5 miles north of the community and is inland in an elevated area.

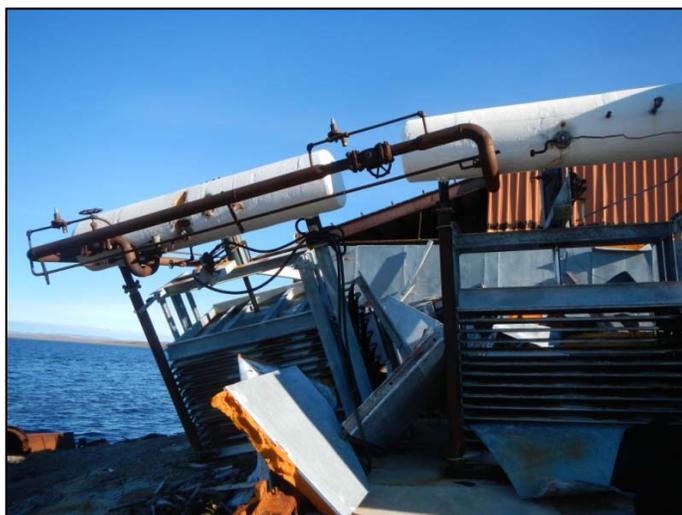
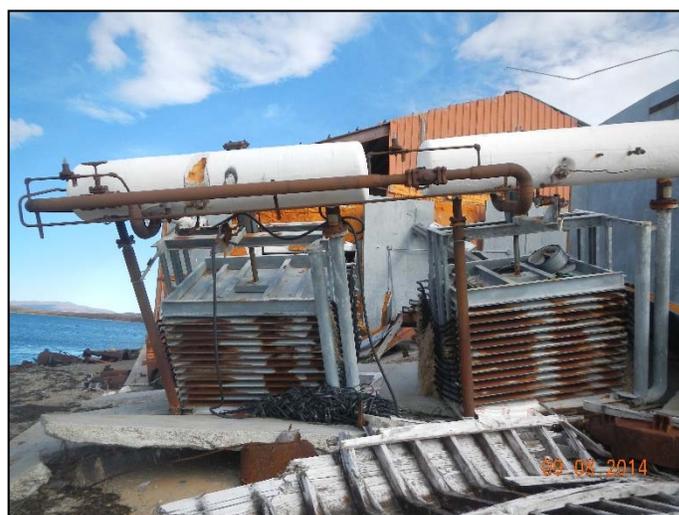
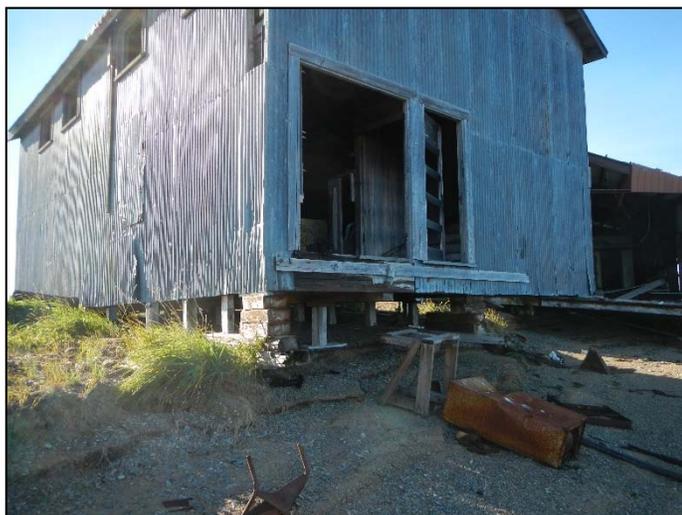
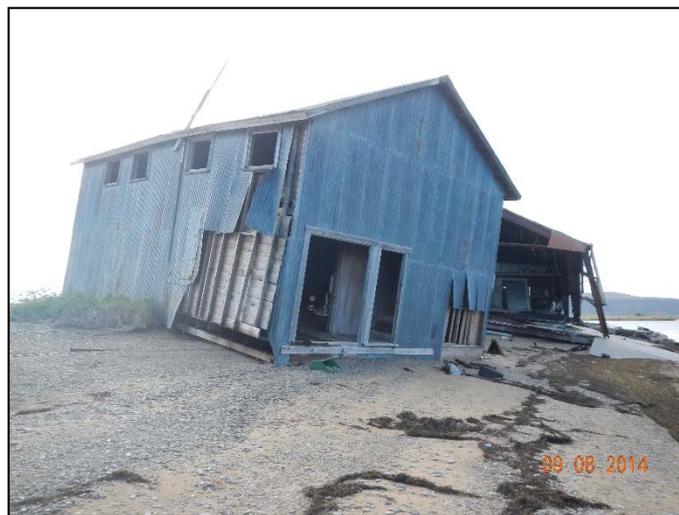
- **Fish Processing Plant, 64.545254/-163.038395 (Abandoned)** – This site is an abandoned processing plant that is actively eroding into the Golovnin Lagoon. The processing plant has not been stripped of valuable metals and equipment. Small equipment, fuel tanks, compressed gas tanks, lead acid batteries, and other possible contaminants are still located at this site. This site was revisited in 2014 and there was considerable erosion and loss of structural integrity since 2012. The blue building had cracked and was no longer level. The second building had also cracked, and the original concrete flooring was cracking off in slabs and falling into the Golovin Lagoon. Copper piping and other valuable metals were observed, in addition to multiple generators, ammonia tanks, fuel tanks, heavy equipment and used fuel filters. This site is privately owned according to local residents. During this inspection it was noted that the adjacent house is also part of this property and is reported to be substantially contaminated with creosote and petroleum products and has been abandoned since its owners passed away.
