CIAP WEAR Trip Report
Tuluksak (population 384)
August 30th, 2012

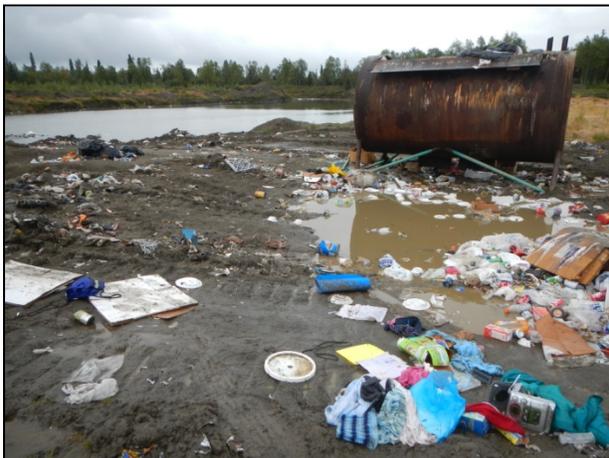
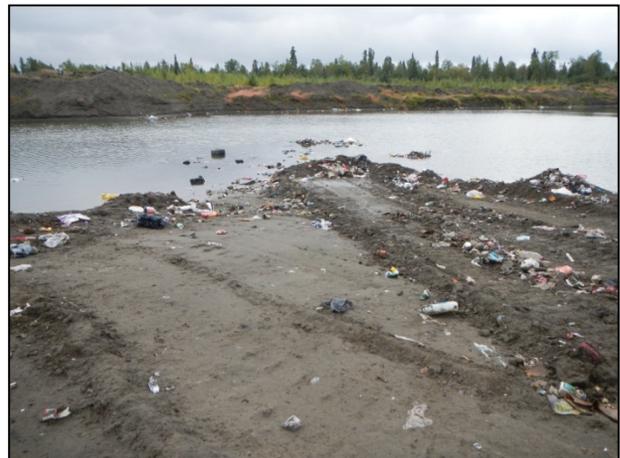
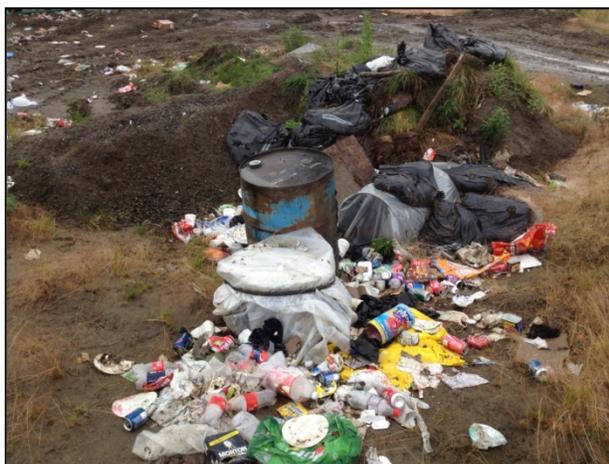
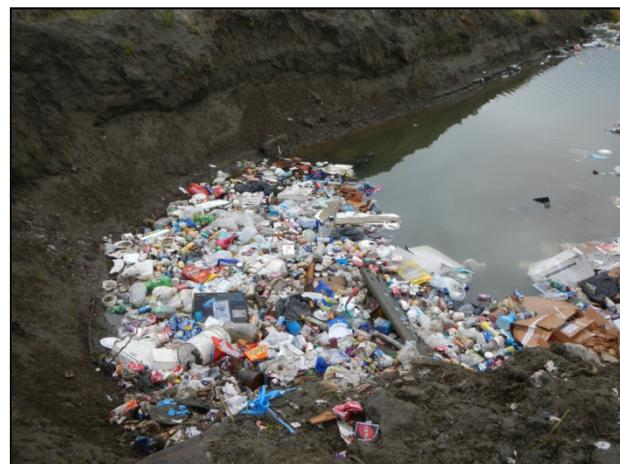
- **Dump Road Landfill, 61.092542/-160.957018 (Active)** – This is a self-haul landfill located roughly 1,500 feet from the village and 200 feet from the honeybucket lagoon. The site is approximately 1.75 acres with waste dumped in a soil excavation area that has filled with water to form a large pond. It has been in use since approximately 2011. There is a burn box on site, however there is open dumping and limited controls. The site is located approximately 2,000 feet from the Tuluksak River on silty ground. Waste in the landfill includes municipal solid waste and household hazardous waste. The site is owned and operated by the Tuluksak Native Community.

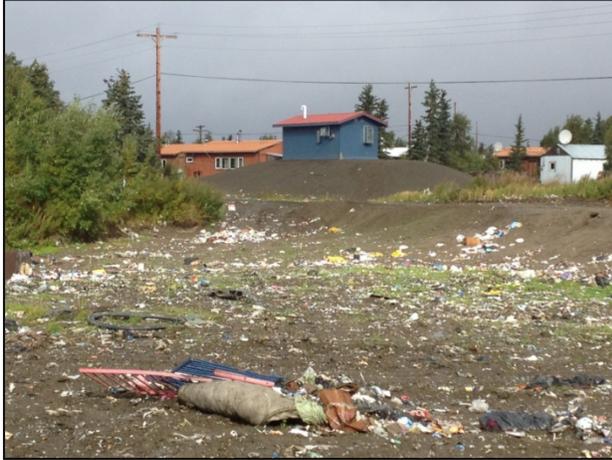
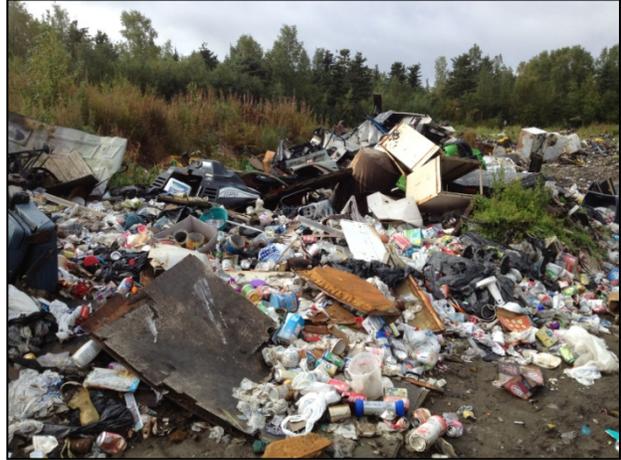
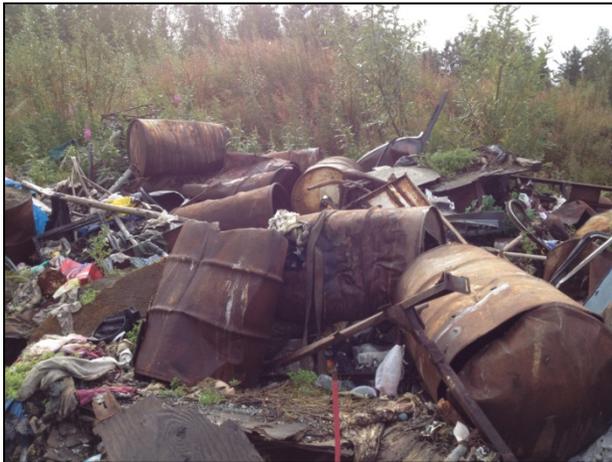
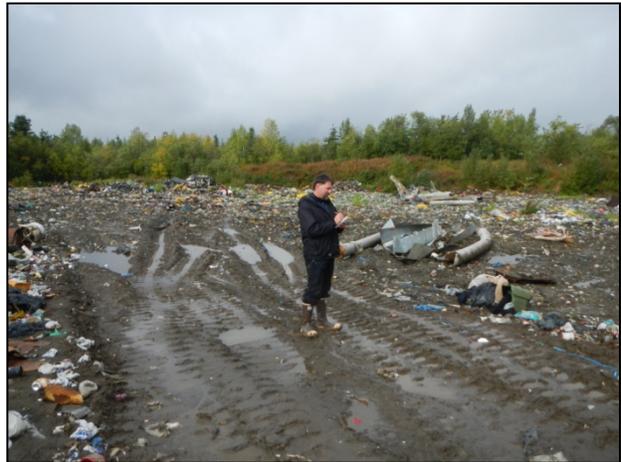
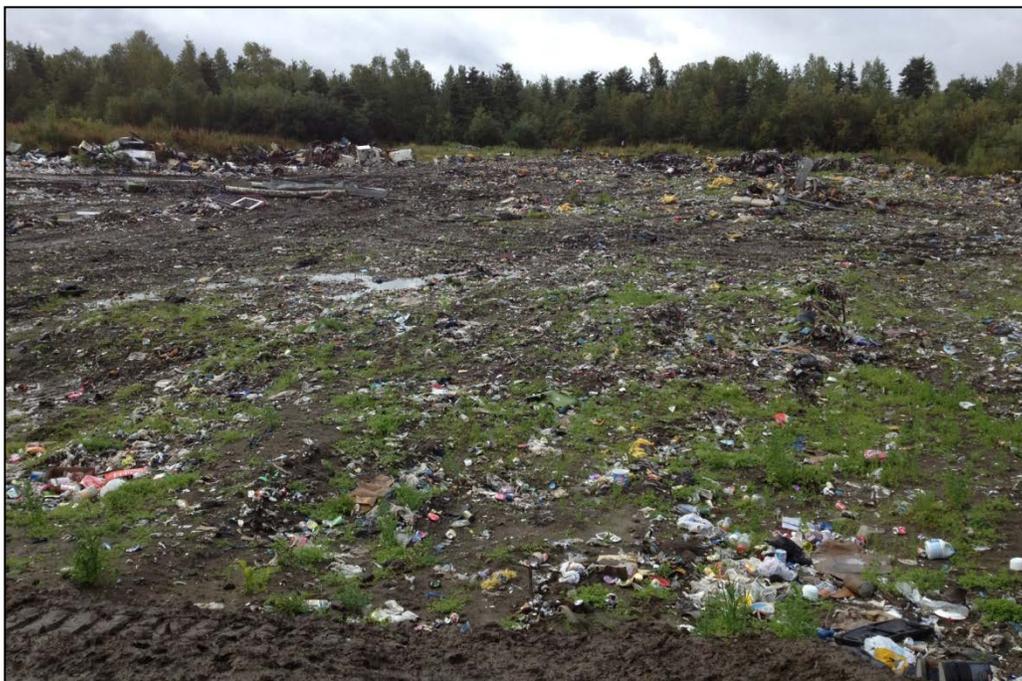
- **Landfill, 61.096939/-160.95954 (Active)** – The landfill, which is still used by the village, is in the process of being closed. It is approximately 2.2 acres in size. The closest residence is only 220 feet away. Open burning is performed, prohibited waste is present, and the landfill does not have sufficient cover. Waste in the landfill includes municipal waste, household hazardous waste, construction and demolition debris, and scrap metals. The site is owned and operated by the Tuluksak Native Community. It is 1,150 feet from the Tuluksak River.

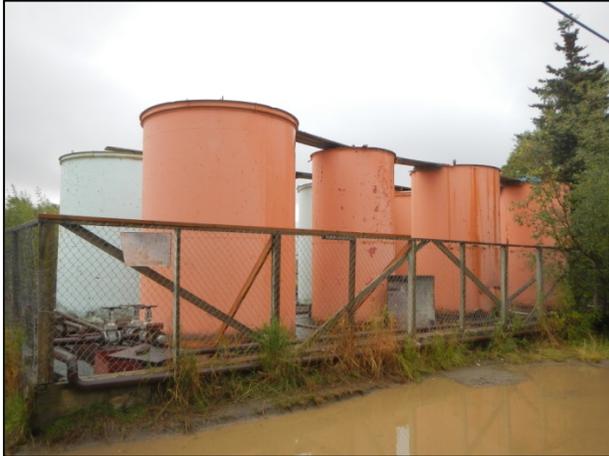
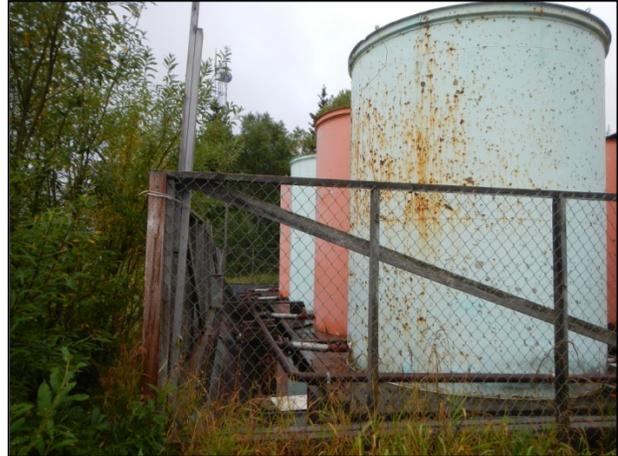
- **School Tank Farm, 61.099476/-160.956594 (Active)** – The site, which is maintained and used by the school, consists of eight vertical fuel tanks on wooden platforms. They are in a fenced area with secondary containment. It is approximately 185 feet from the Tuluksak River and 100 feet to the school. Local residents reported river erosion as significant in this section at greater than one foot per year. There are shrubs on the bank which is characterized by silty soil. No erosion mitigation efforts have been employed.

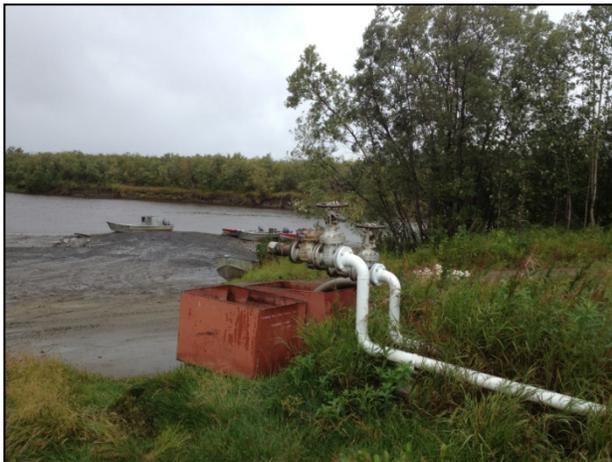
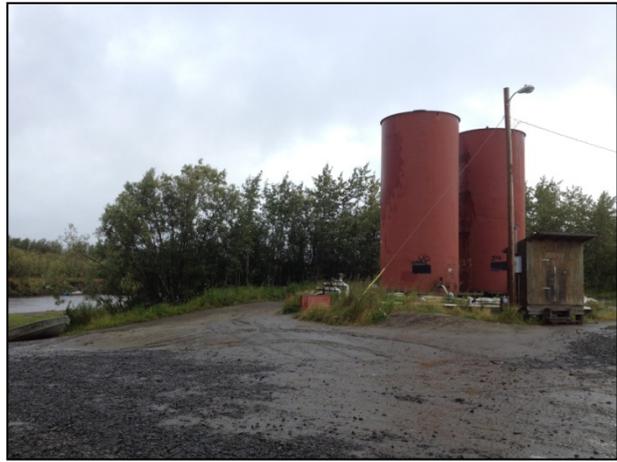
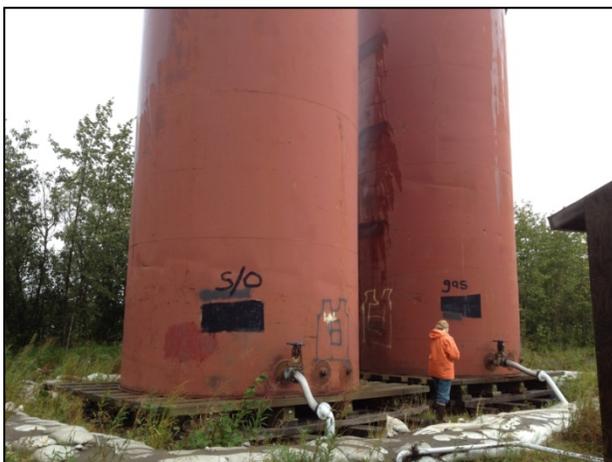
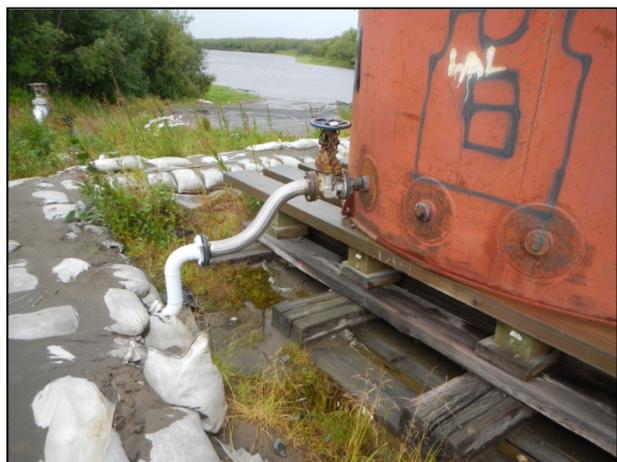
- **Gas Station Tanks, 61.098944/-160.968002 (Active)** – The gas station has two 10,000 gallon vertical tanks on wooden platforms. Secondary containment consisted of an earthen berm made of sand bags. The site is located 130 feet from the Tuluksak River, near a popular boat and barge landing. The site is owned and operated by the Tuluksak Native Community.
