**Phase I Environmental Site Assessment
3607 and 3609 Spenard Road
Anchorage, Alaska**

September 2012

32-1-17525-001

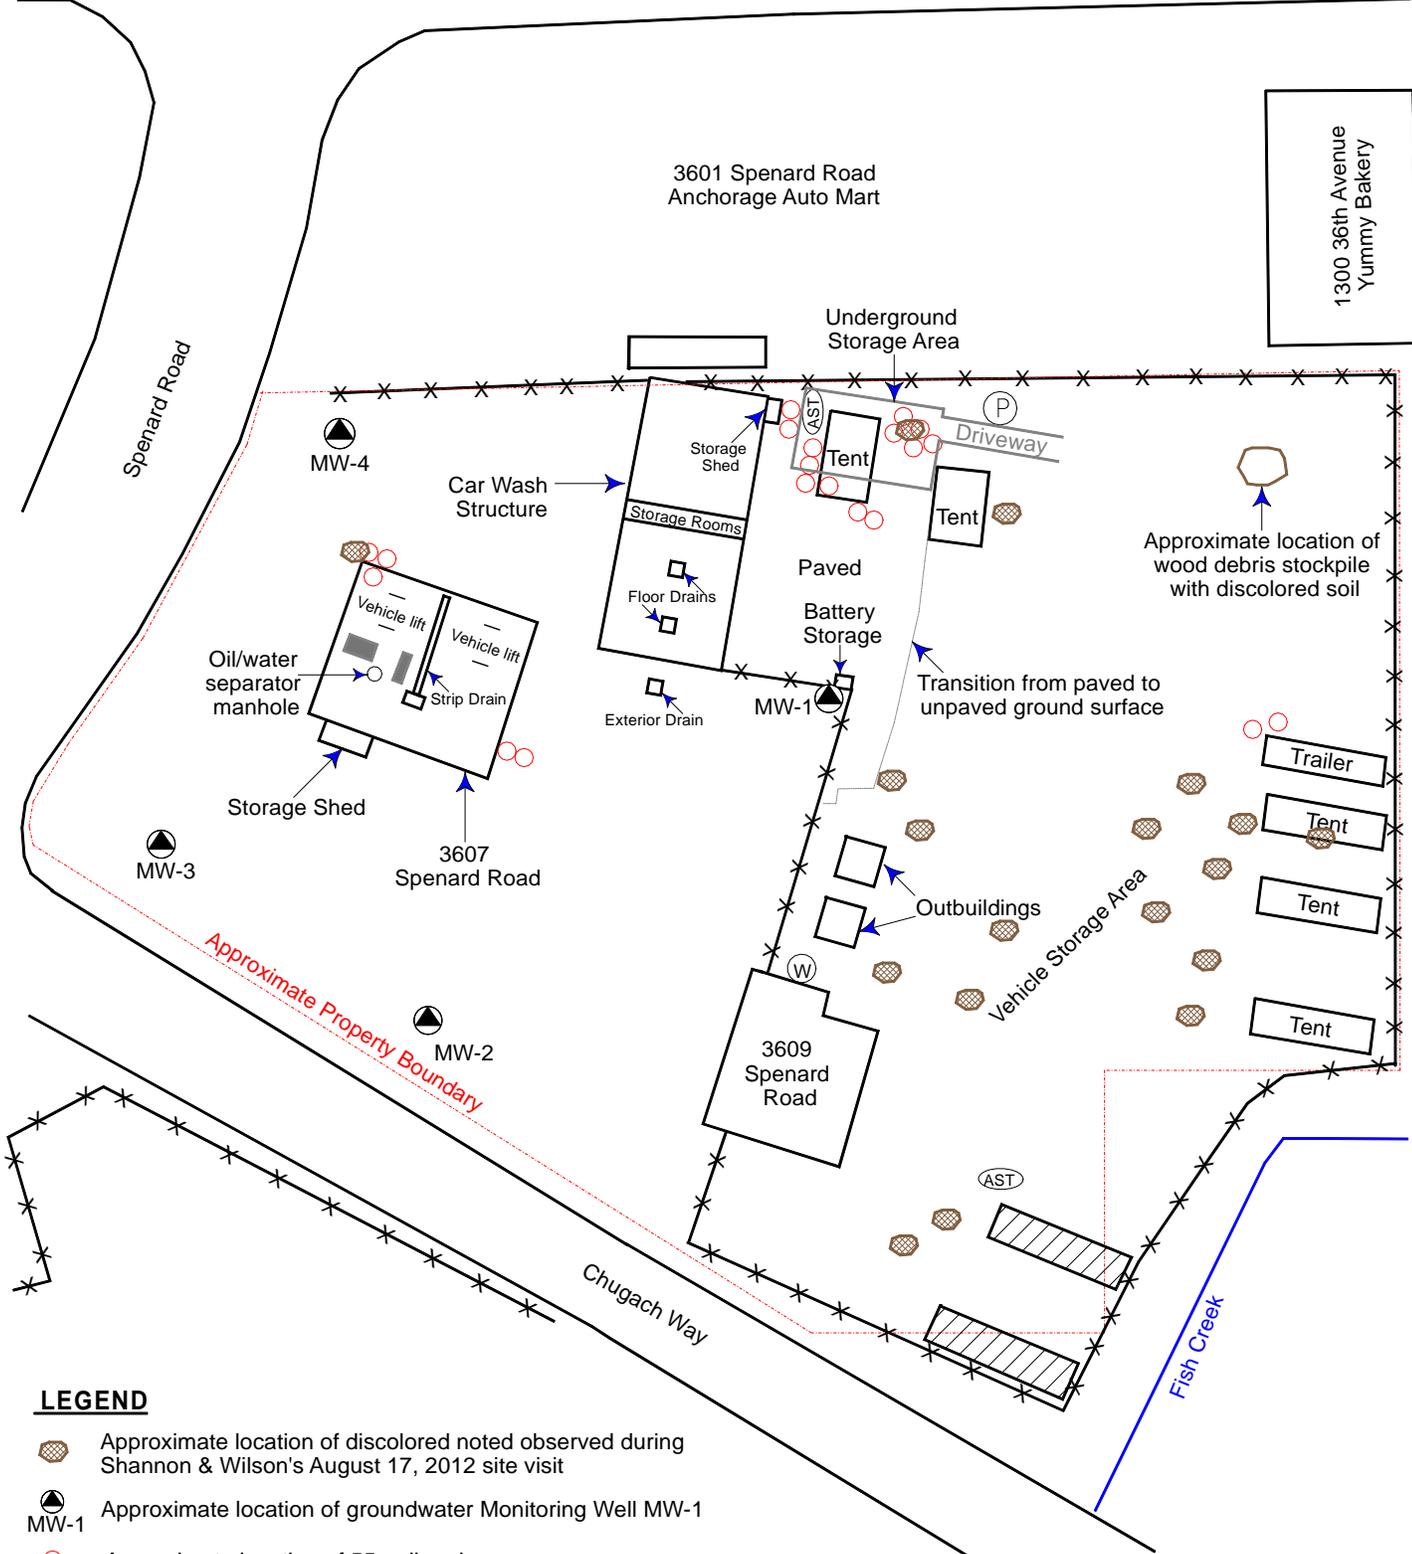
Fig. 3

Two empty 55-gallon drums were observed near the northwest corner of the Alpina Auto Repair structure (Photo 12). The drums were labeled as containing motor oil and transmission fluid. Surface stains were noted on the unpaved and paved ground surface adjacent to the drums. Additional surface stains were noted throughout the paved parking area associated with the Alpina Auto Repair structure. The approximate locations of surface stains observed during our August 17, 2012 site visit are shown on Figure 3.

Two additional empty 55-gallon drums were observed near the southeast corner of the Alpina Auto Repair structure as shown on Figure 3. Surface stains were observed on the concrete near the drums.

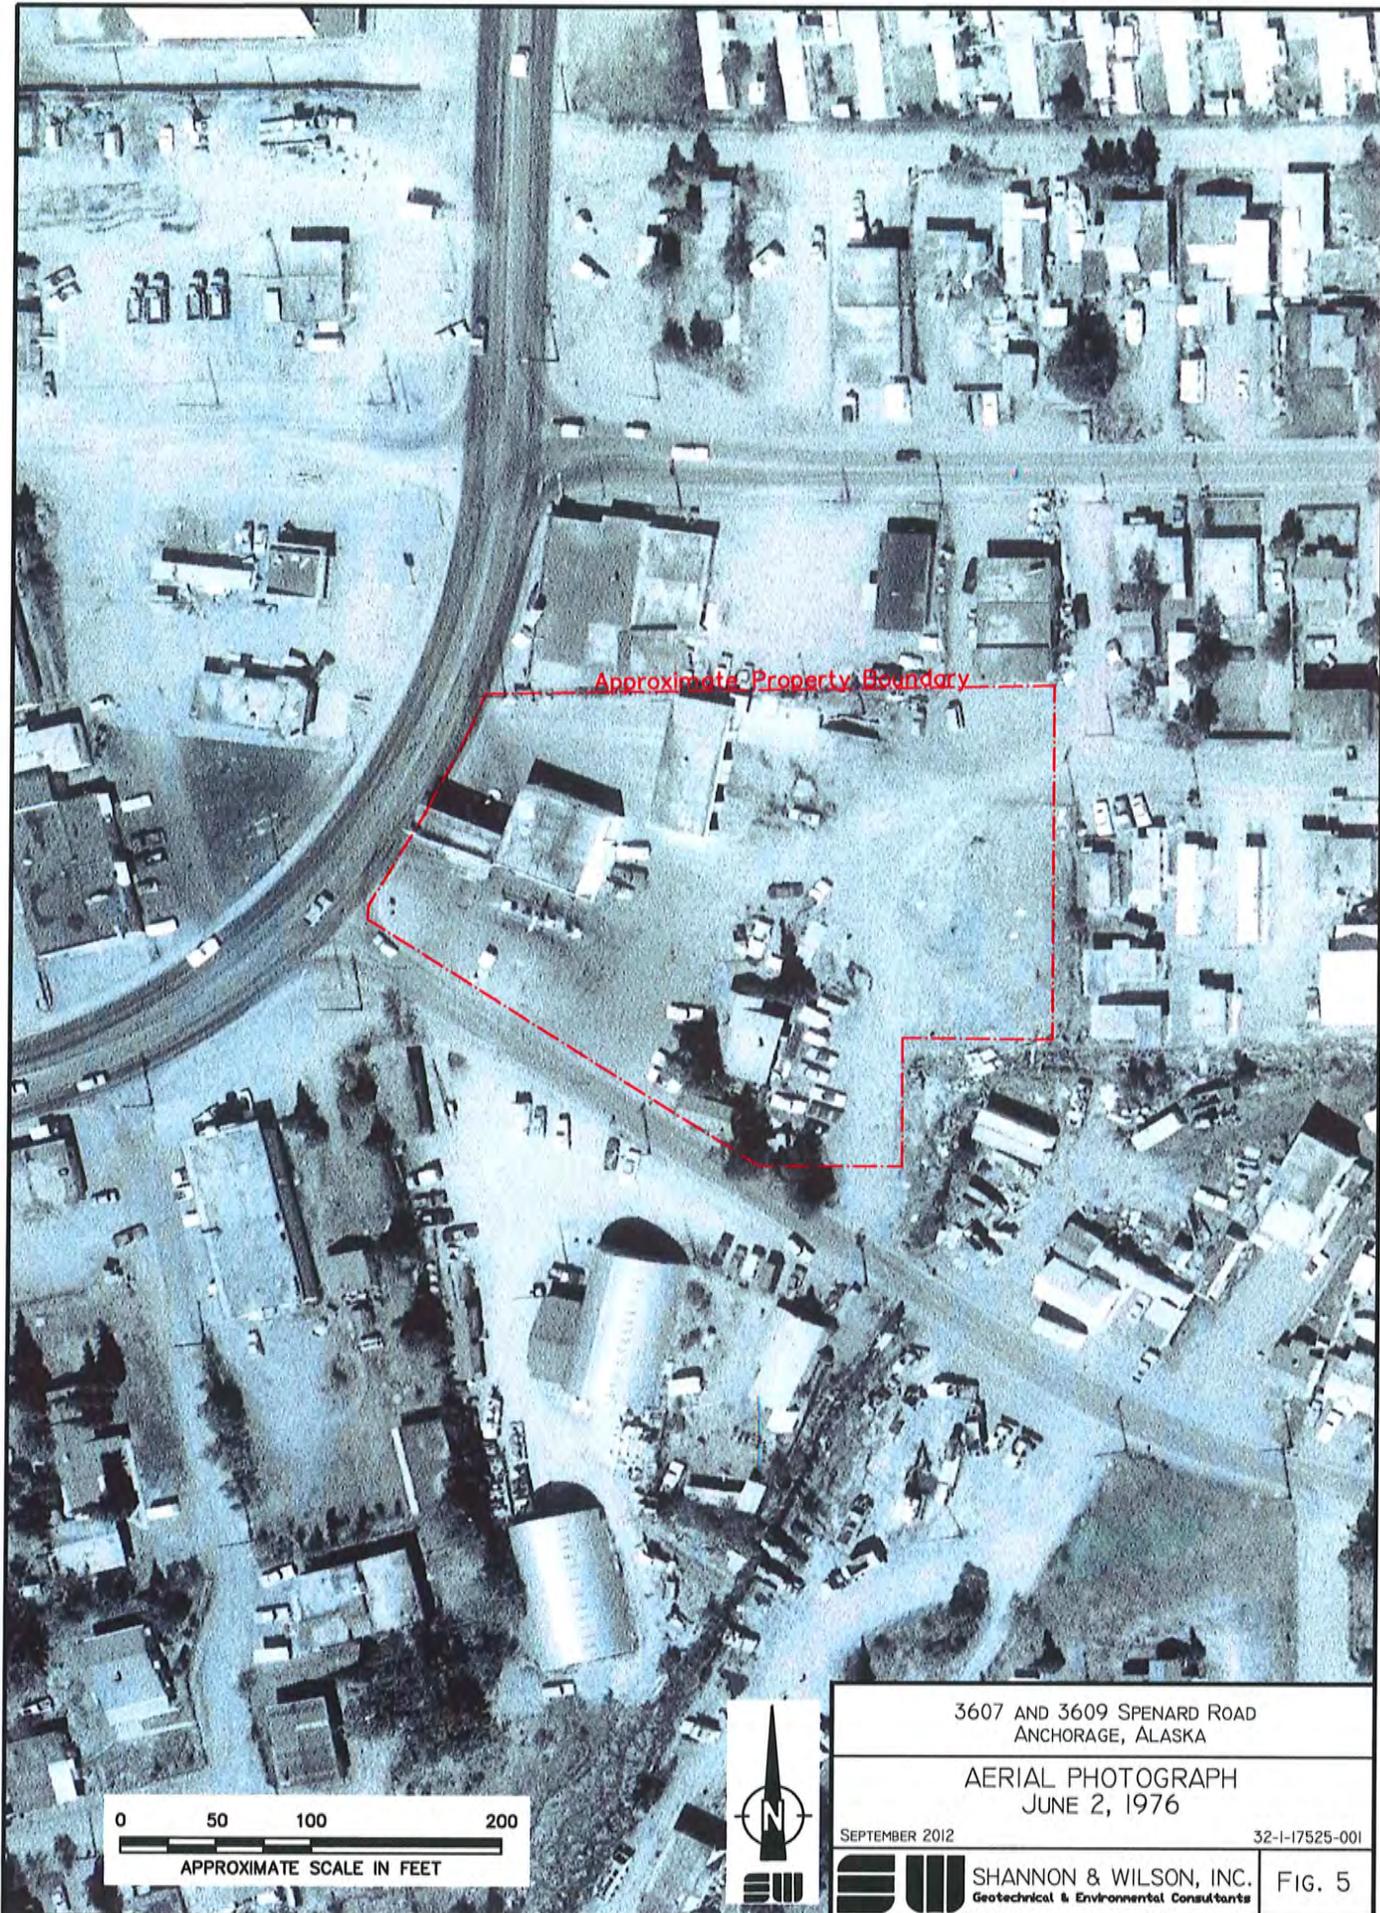
SHANNON & WILSON, INC. Geotechnical & Environmental Consultants	FIG. 5

The June 2, 1976 aerial photograph is included as Figure 5. A second fuel dispenser island is present south of the 3607 Spenard Road structure. Surface staining is visible in the immediate vicinity of the dispenser islands. Additional surface staining is visible east of the car wash structure. At least 14 vehicles are visible near the 3609 Spenard Road structure. Unidentifiable debris is visible on the parcel east of and adjacent to the southeast corner of the Property. A second Quonset hut has been erected on the parcel south of the Property. The remaining parcels appear similar to the 1970 photograph.

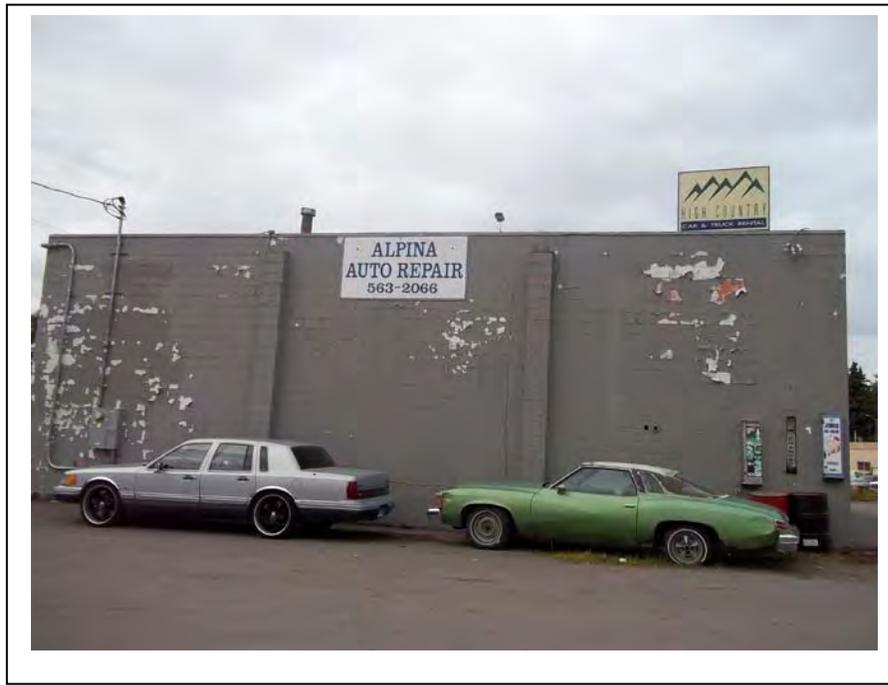
Alpina Auto Repair currently occupies the 3607 Spenard Road structure (Photo 1). Mr. Rasim Kadriu, owner of Alpina Auto Repair, accompanied Ms. Simmons during the August 17, 2012 site visit. Mr. Kadriu has been a tenant of the Property since 1989.

Photo 1: Alpina Auto Repair currently occupies the 3607 Spenard Road structure; looking southeast. (August 17, 2012)

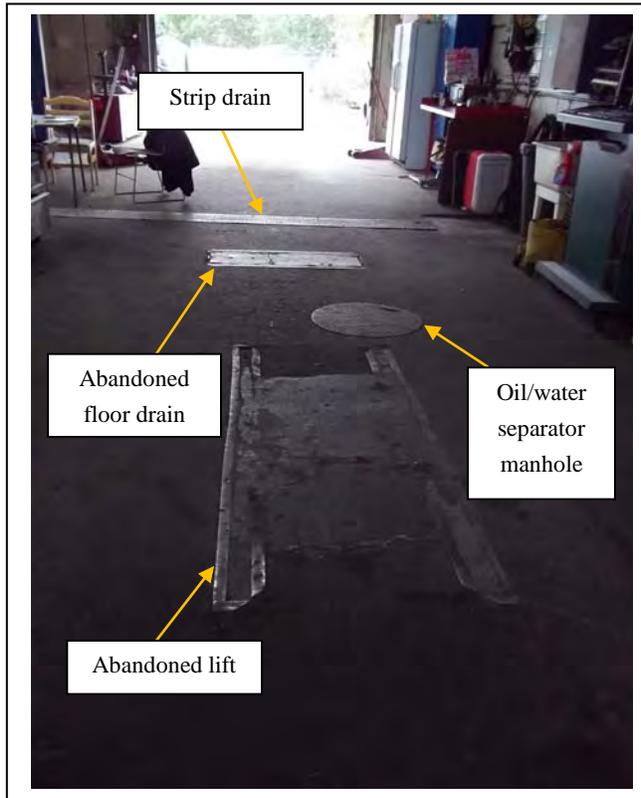
Photo 2: Interior of the 3607 Spenard Road structure. (August 17, 2012)

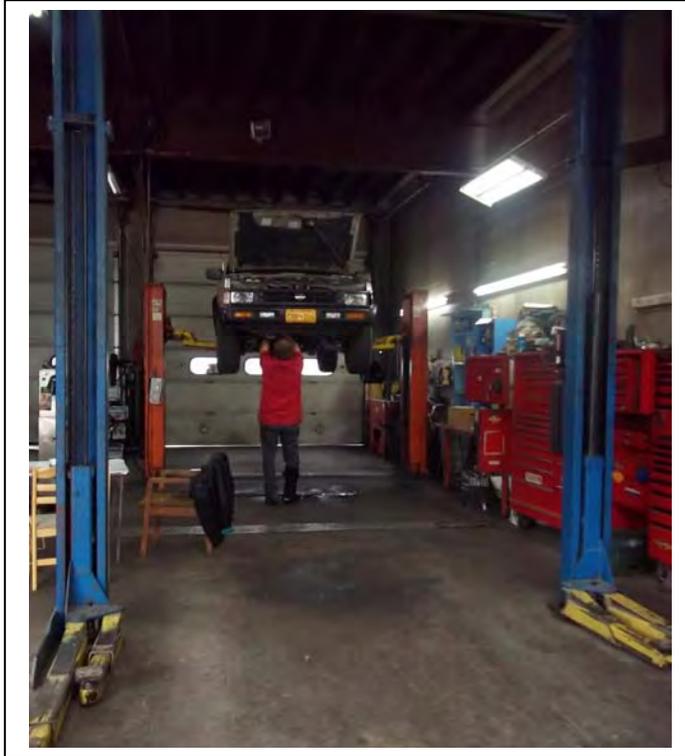
Two vehicle lifts are located in the northern garage bay (Photo 3). A tool storage area is located along the northern wall of the structure. Seven 5-gallon fuel containers were observed near a parts washing station (Photo 4). In addition, a 55-gallon drum was observed adjacent to the wash station. According to Mr. Kadriu, used oil is temporarily stored in 55-gallon drums. The used oil is then recycled at Hansen Transmission & Gear, a local business southwest of the Property.

Numerous surface stains were observed on the concrete floor of the structure as shown in Photos 3 and 4. Mr. Kadriu stated that the majority of the surface stains were present prior to his occupancy and he attributed the stains to poor housekeeping practices. In general, the concrete floor was in overall fair condition with surficial cracks observed.

Photo 3: Two vehicle lifts are located in the northern garage bay of the Alpina Auto Repair structure. (August 17, 2012)

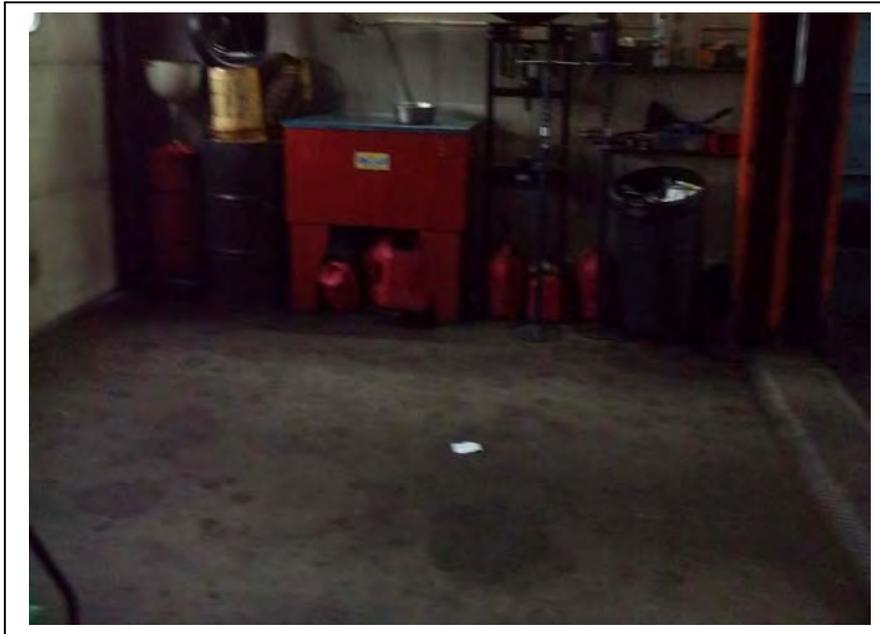
Photo 4: Seven 5-gallon fuel containers and a 55-gallon drum containing used oil were observed near a parts washing station in the northern bay of the Alpina Auto Repair structure. (August 17, 2012)

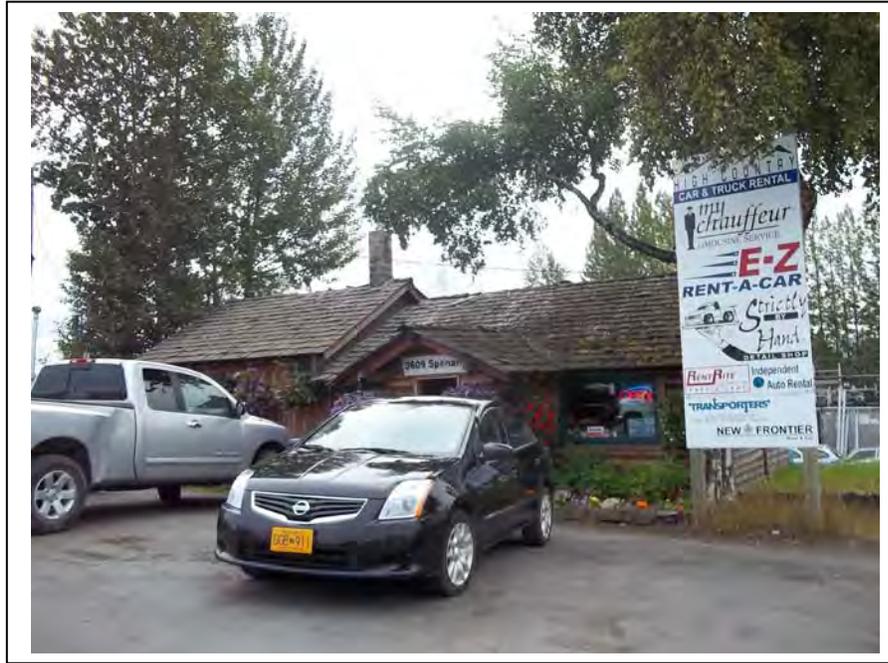
Photo 5: The 3609 Spenard Road structure is currently occupied by multiple vehicle rental companies; looking west. (August 17, 2012)

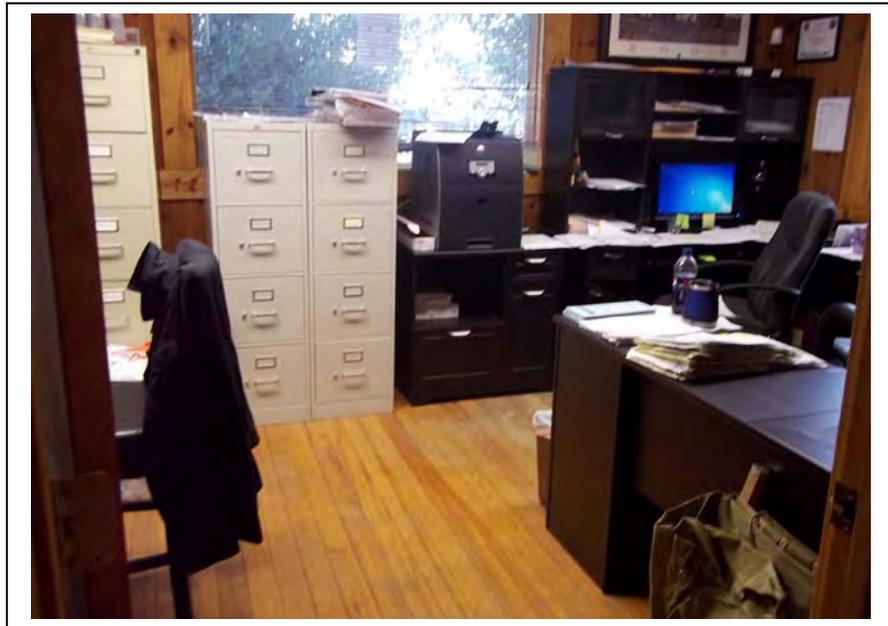
The upper floor of the structure is primarily used for office space (Photo 6). A kitchenette and restroom are centrally located on the upper floor. Evidence of environmental concern was not noted in the upper floor of the structure.

Photo 6: The upper floor of the 3609 Spenard Road structure is primarily used for office space. (August 17, 2012)

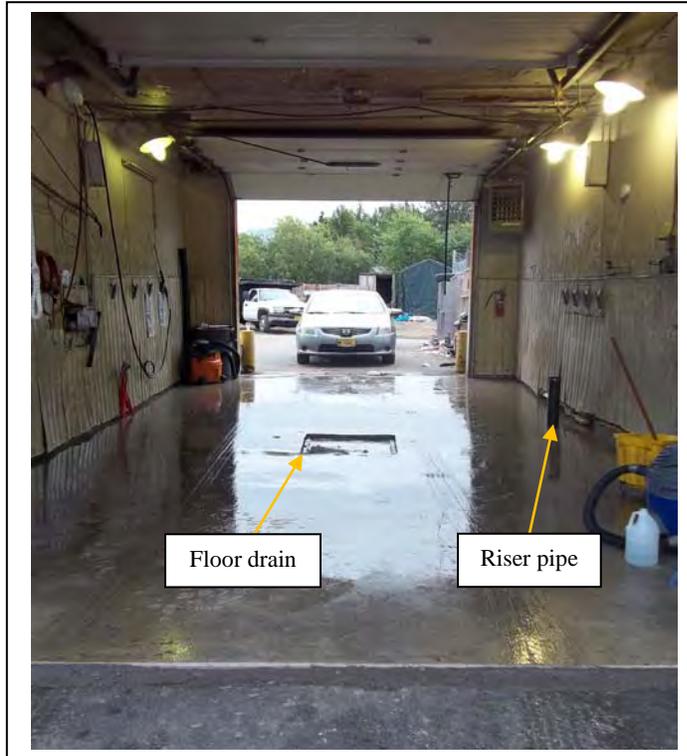
Floor drains were observed in the 3607 Spenard Road structure, the car wash structure, and adjacent to the car wash structure. The discharge point of these drains is unknown and may be associated with a dry well(s). The dry well(s), if present, may be classified as a Class V injection well subject to ADEC and Environmental Protection Agency (EPA) regulations. In addition, containers of petroleum products, solvent-based tire dressing, and commercial-grade cleaners were observed in close proximity to the drains suggesting a potential for these chemicals to enter the drain system.

Photo 7: The southern bays of the car wash structure contain floor drains; looking east. (August 17, 2012)

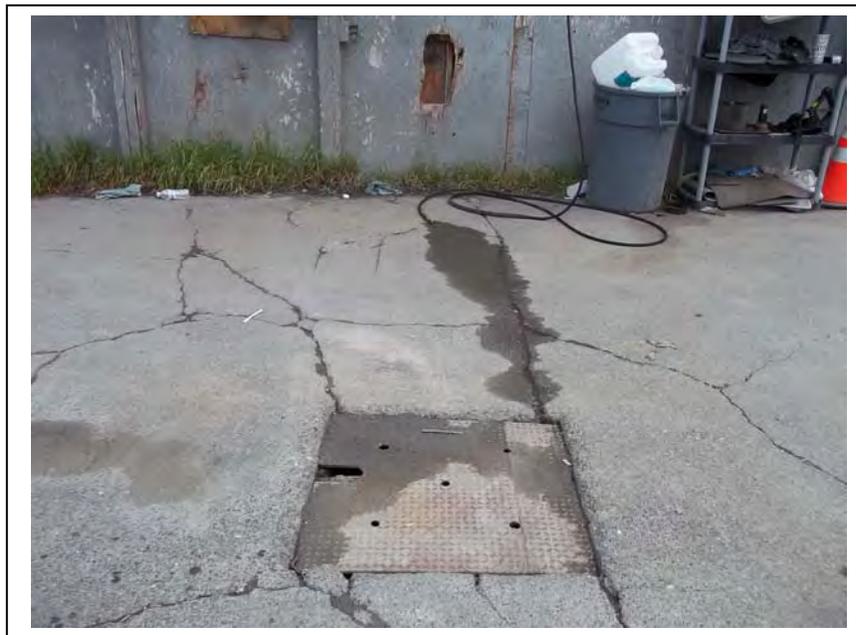
Photo 8: Exterior drain and possible sand trap or oil/water separator; looking north. (August 17, 2012)

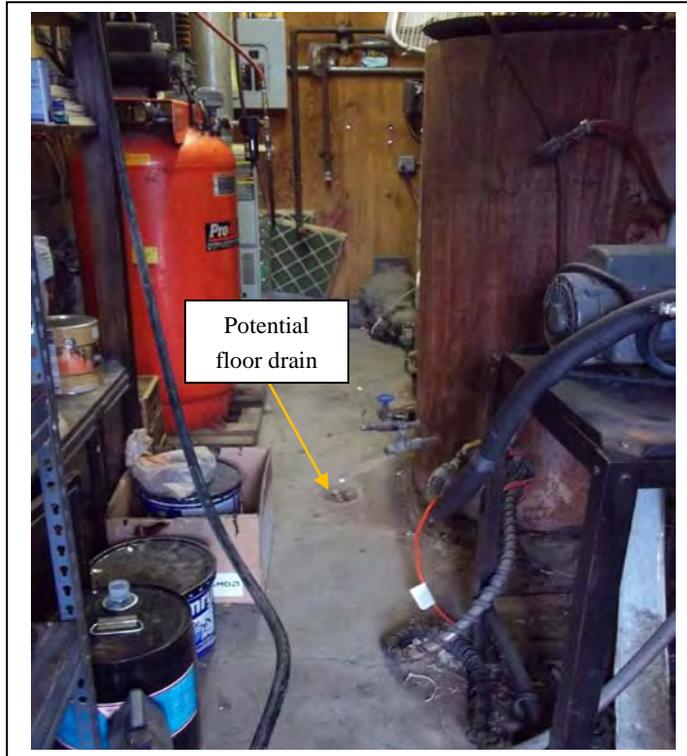
Photo 9: Five-gallon containers of solvent-based tire dressing and motor oil were observed in the eastern storage room of the car wash structure. (August 17, 2012)

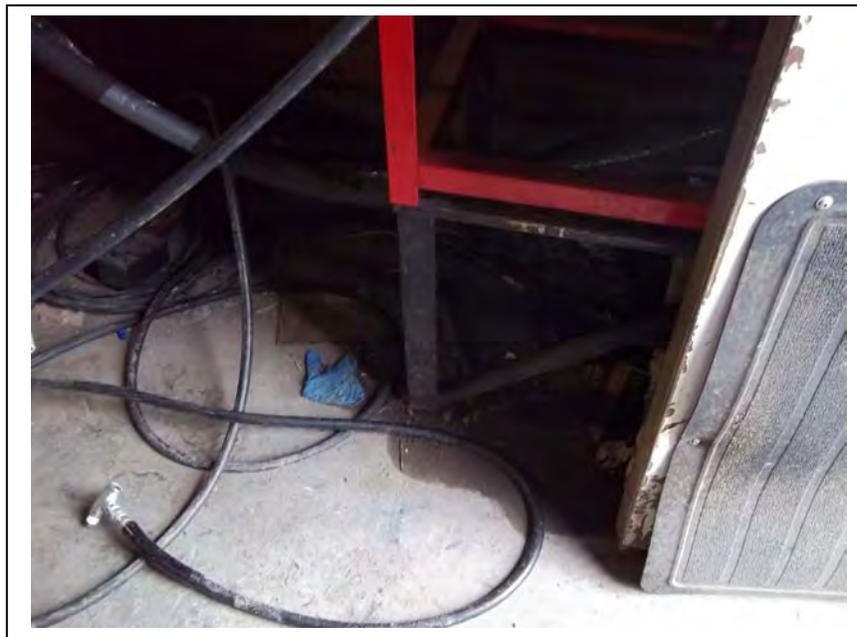
Surface stains were observed on the concrete floor (Photo 10) which was in overall fair condition with surficial cracks observed.

Photo 10: Surface stains were observed in the eastern storage room of the car wash structure. (August 17, 2012)

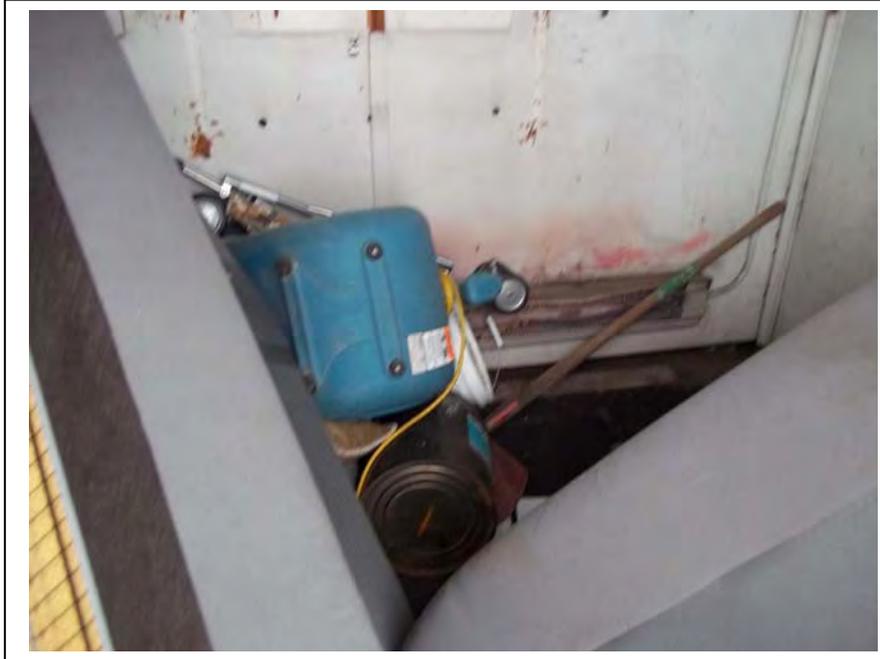
What appeared to be discarded items, including vehicle seats and cardboard boxes were observed in the western storage room. An overturned container of solvent-based tire dressing was observed in the storage room (Photo 11). The concrete floor appeared to be stained in the vicinity of the overturned container.

Photo 11: An overturned 5-gallon container of solvent-based tire dressing was observed in the southern storage room of the car wash structure. (August 17, 2012)

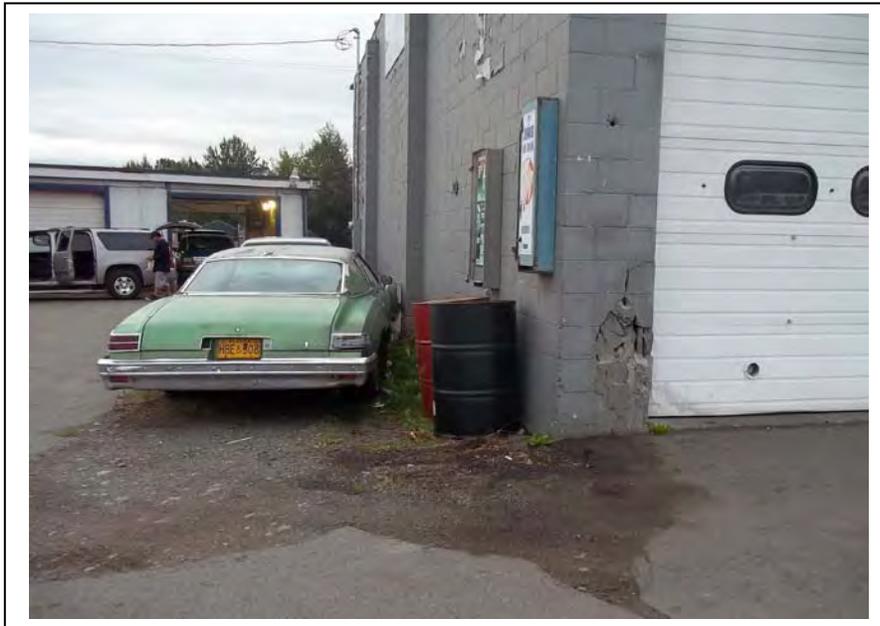
Photo 12: Two empty 55-gallon drums were observed near the northeast corner of the Alpina Auto Repair structure; looking east. (August 17, 2012)

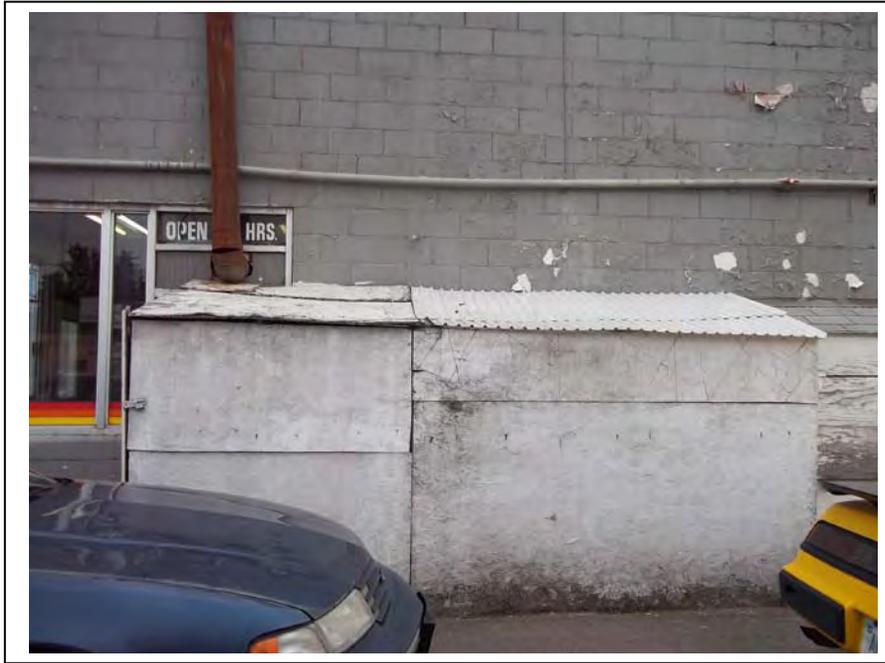
Photo 13: A storage shed is located adjacent to the south wall of the Alpina Auto Repair structure; looking north. (August 17, 2012)

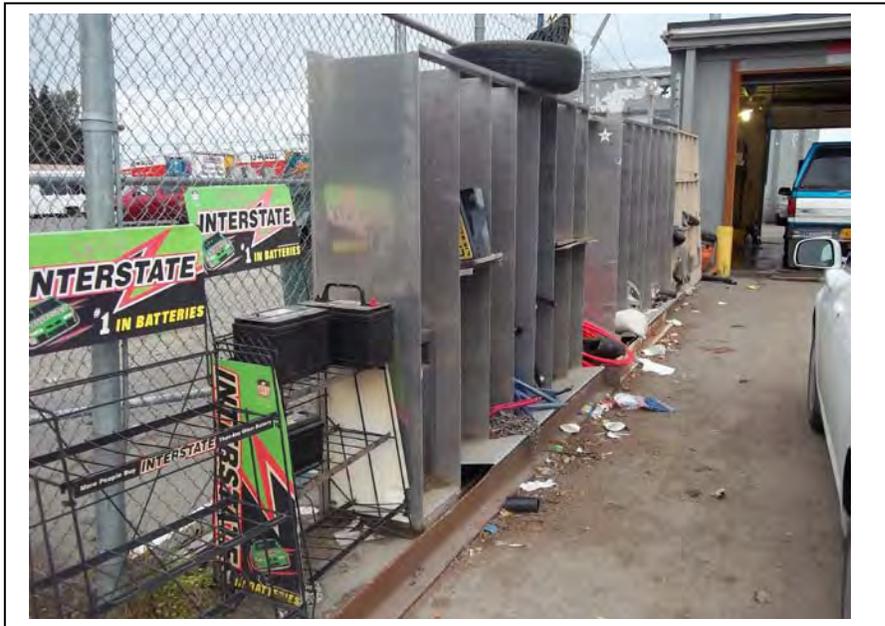
An exterior battery storage area is located east of the car wash structure. In addition, vehicle batteries were observed on top of discarded vehicles in the vehicle storage area in the eastern portion of the Property. There is a potential that weathered and corroded batteries could impact the Property’s soil and/or groundwater.

Photo 14: An exterior battery storage area is located east of the car wash structure; looking west. (August 17, 2012)

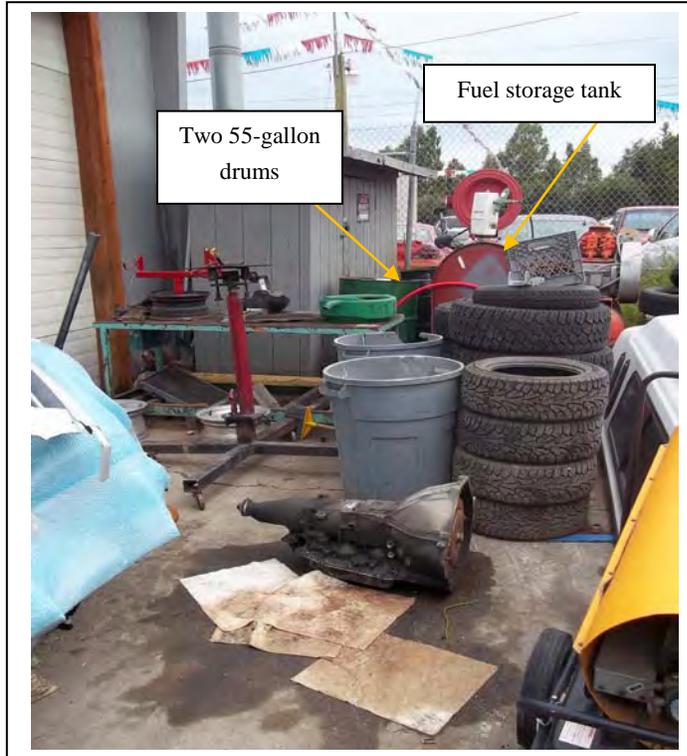
Photo 15: A storage shed, two 55-gallon drums, and a fuel storage tank are located adjacent to and east of the northeast corner of the car wash structure; looking north. (August 17, 2012)

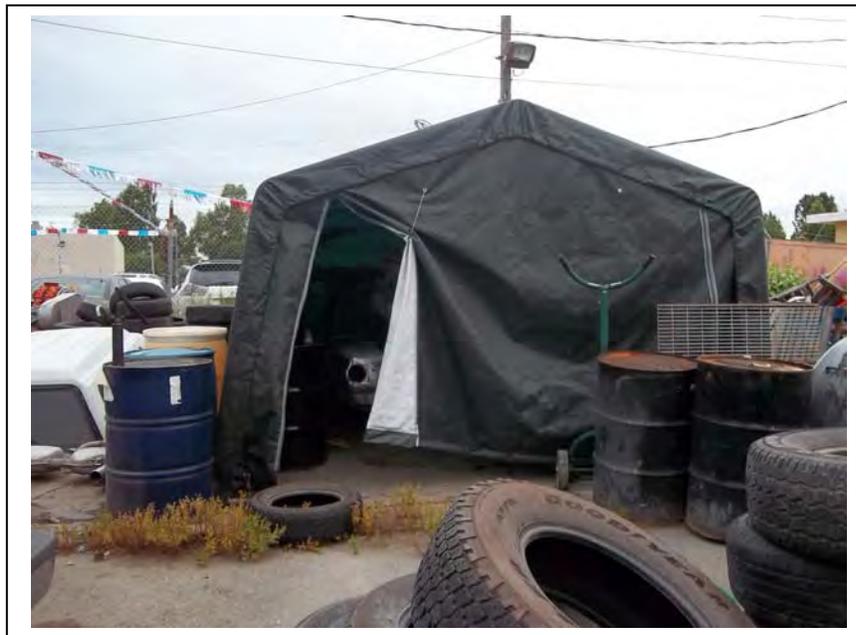
Photo 16: Six 55-gallon drums were observed near a tent east of the car wash structure; looking north. (August 17, 2012)

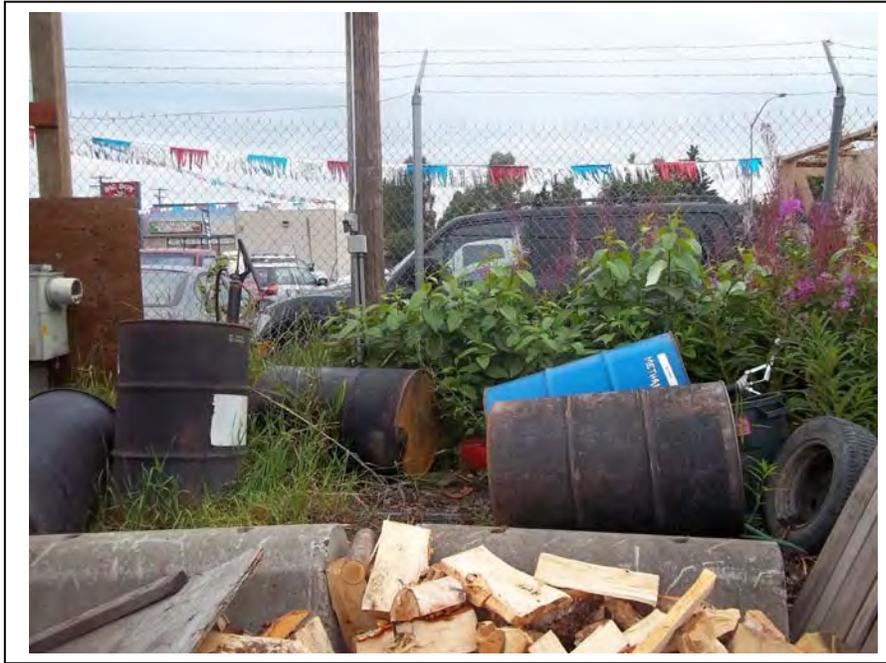
Photo 17: Five 55-gallon drums and a 5-gallon fuel container were observed along the northern Property boundary; looking north. (August 17, 2012)

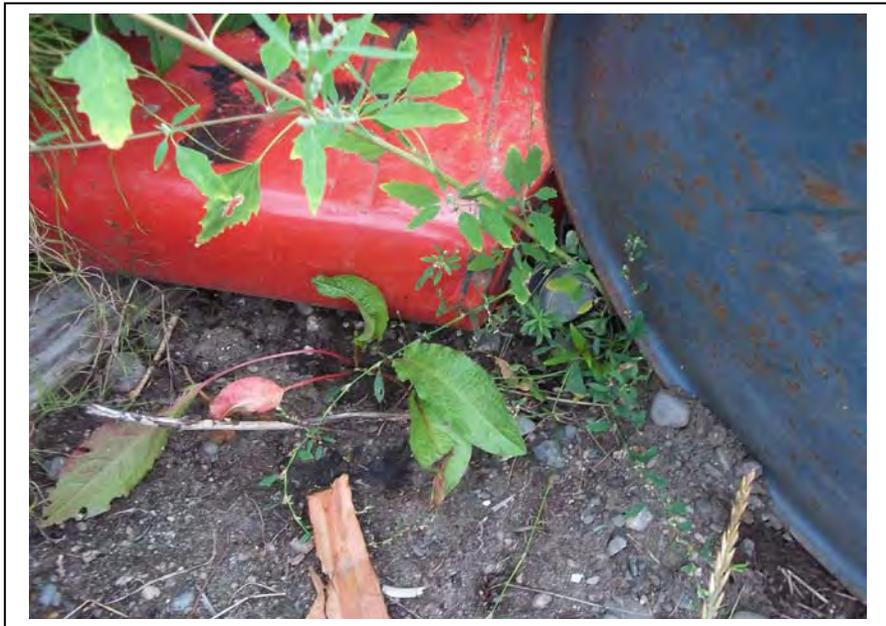
Photo 18: Surface staining was observed near the overturned drums and fuel container. (August 17, 2012)

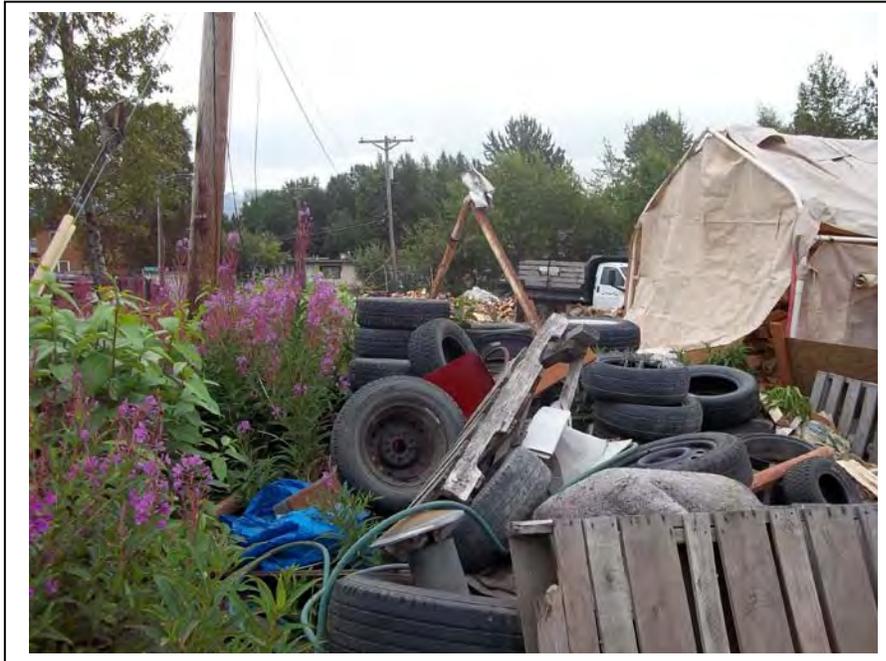
Photo 19: Numerous tires, metal debris, pallets, and other discarded materials were observed east of the overturned drums; looking east. (August 17, 2012)

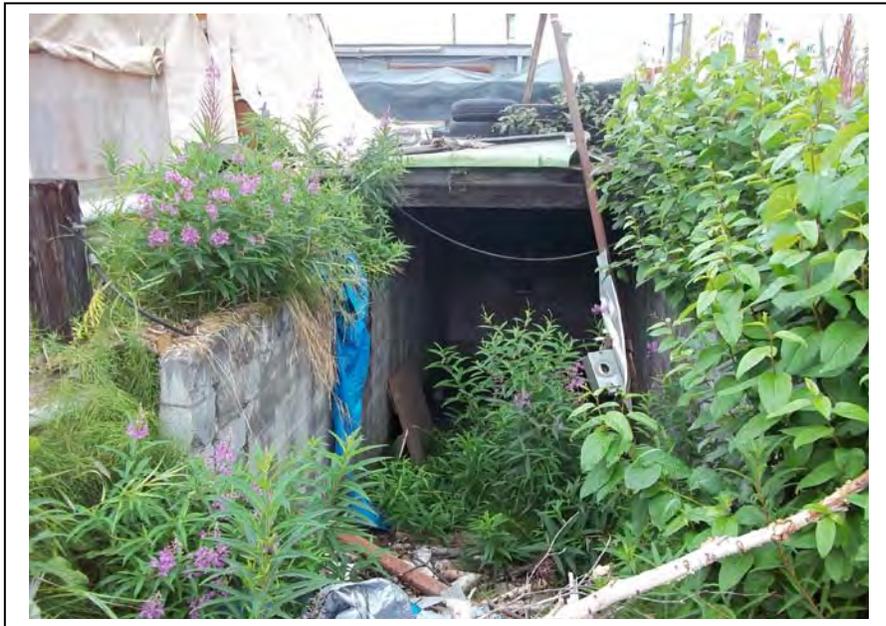
Photo 20: An underground storage space is located along the north-central Property boundary; looking west. (August 17, 2012)

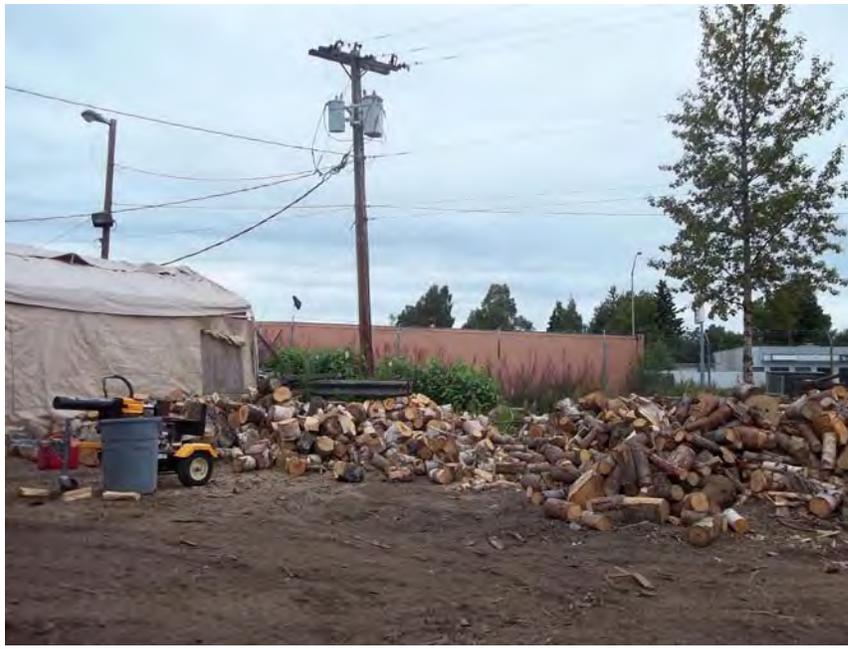
Photo 21: The northeast corner of the Property is used by the Best Split Firewood company; looking northwest. (August 17, 2012)

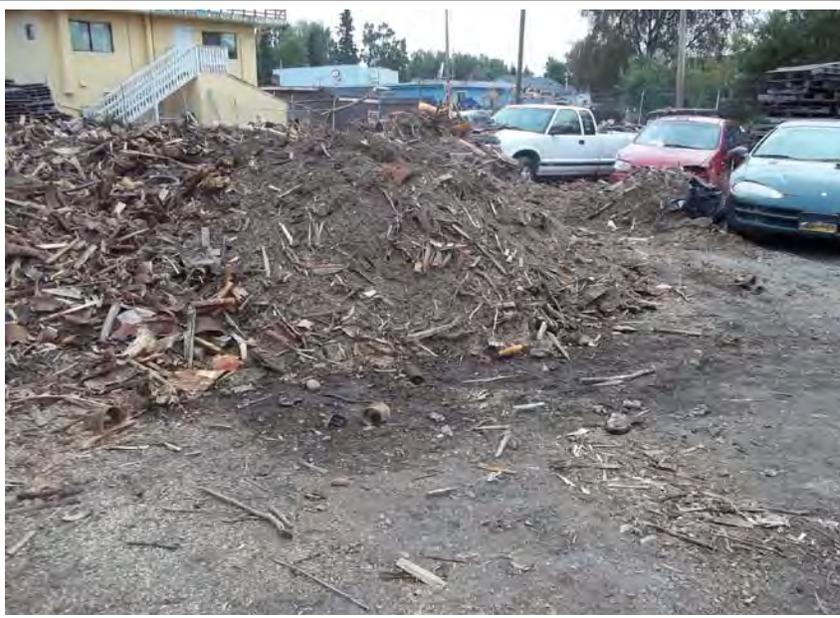
Photo 22: Discolored soil was observed adjacent to a wood debris stockpile; looking northeast. (August 17, 2012)

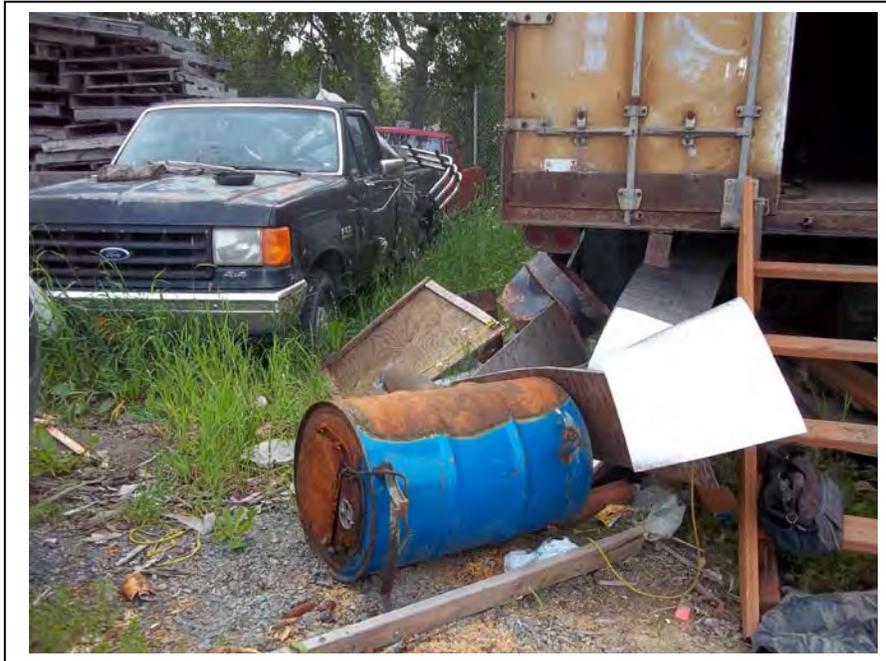
Photo 23: Two empty, modified 55-gallon drums were observed adjacent to a connex storage container; looking east. (August 17, 2012)

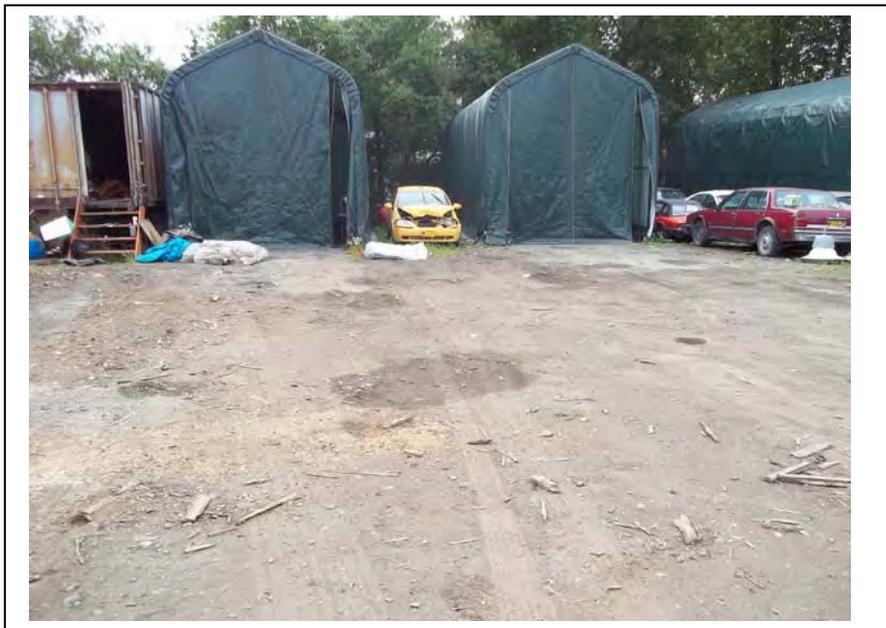
Photo 24: Surface stains were observed on the unpaved surface west of the tents and connex storage container; looking east. (August 17, 2012)

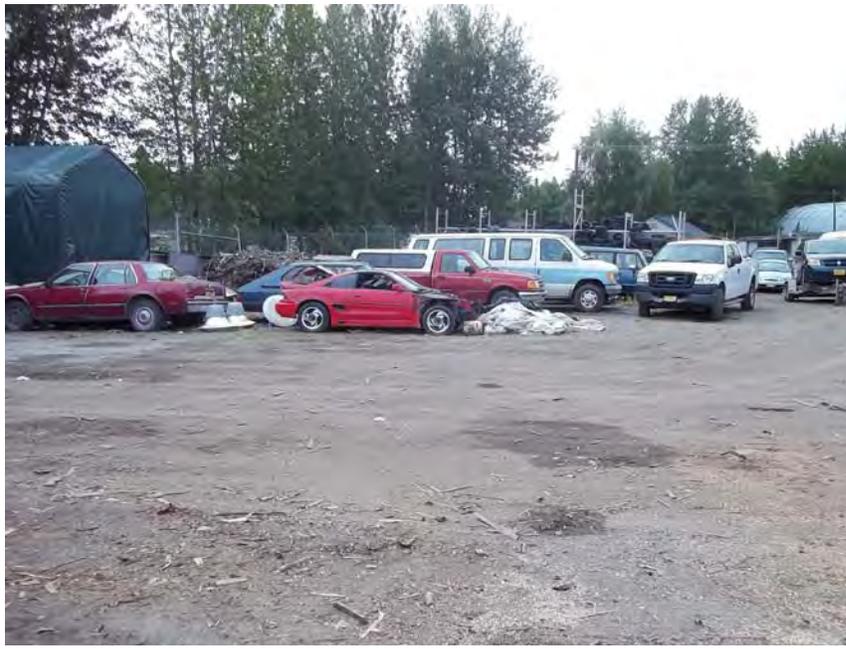
Photo 25: At least 35 unused and/or abandoned vehicles are stored in the eastern and southeastern portion of the Property; looking southwest. (August 17, 2012)

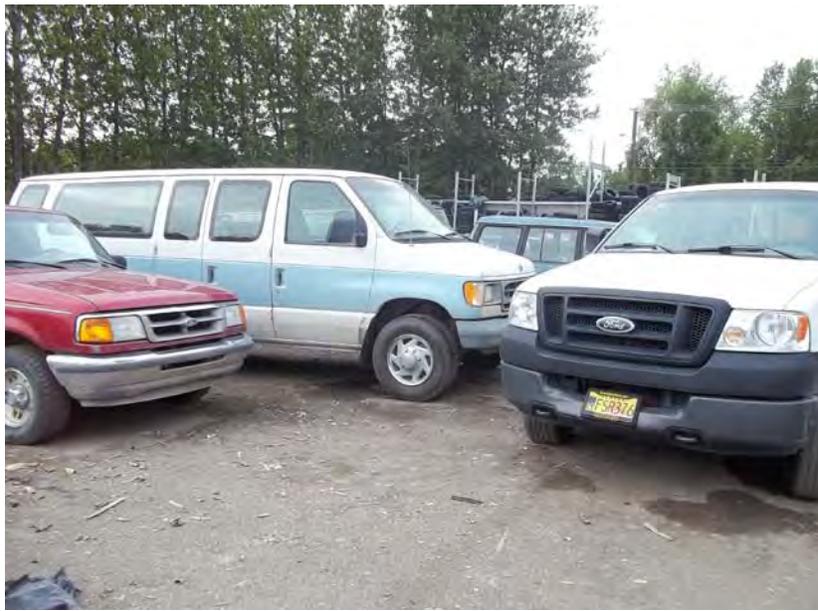
Photo 26: Areas of discolored soil were observed in the vehicle storage area; looking south. (August 17, 2012)

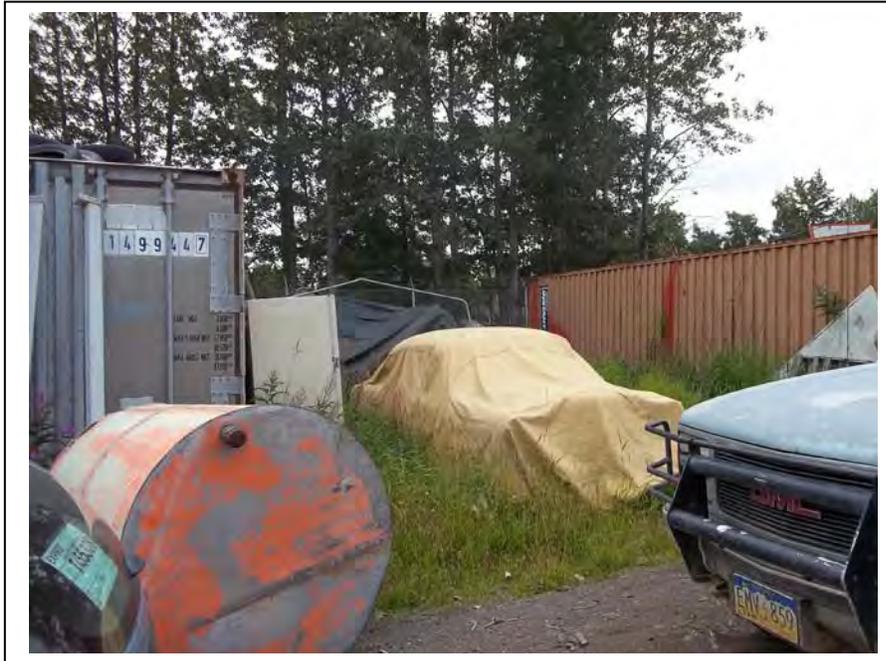
Photo 27: Two connex storage containers and a 300-gallon fuel storage tank are located in the southeast corner of the Property; looking southeast. (August 17, 2012)

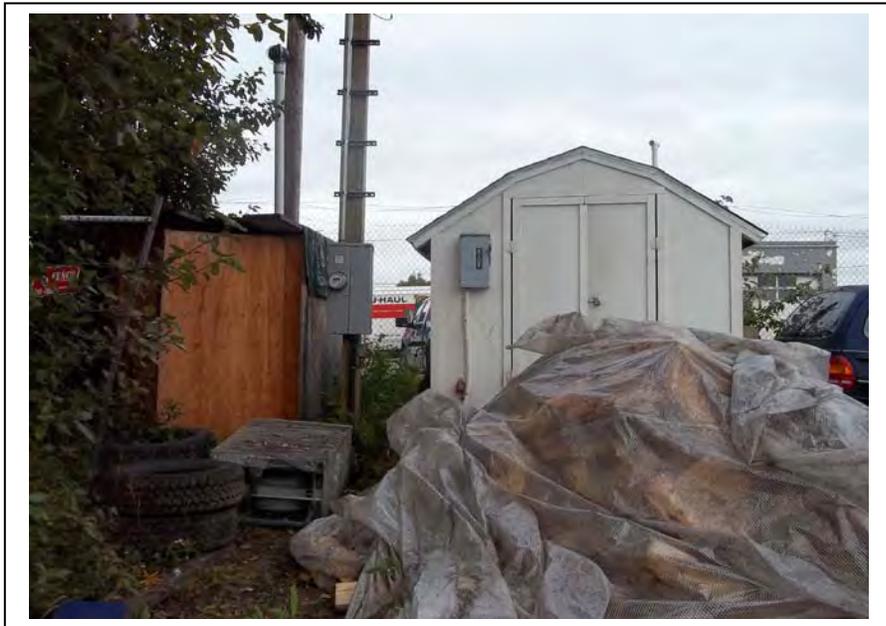
Photo 28: Two outbuildings are located north of the 3609 Spenard Road structure; looking west. (August 17, 2012)

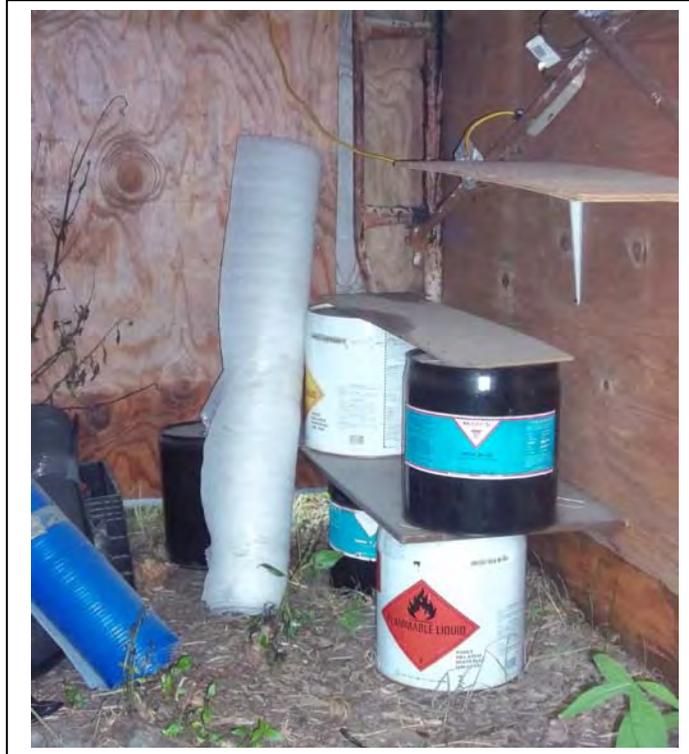
Photo 29: Three 5-gallon containers of solvent-based tire dressing and two 5-gallon containers labeled “paint related materials” are stored in the southern outbuilding. (August 17, 2012)
