**Phase I Environmental Site Assessment
3607 and 3609 Spenard Road
Anchorage, Alaska**

September 2012

32-1-17525-001

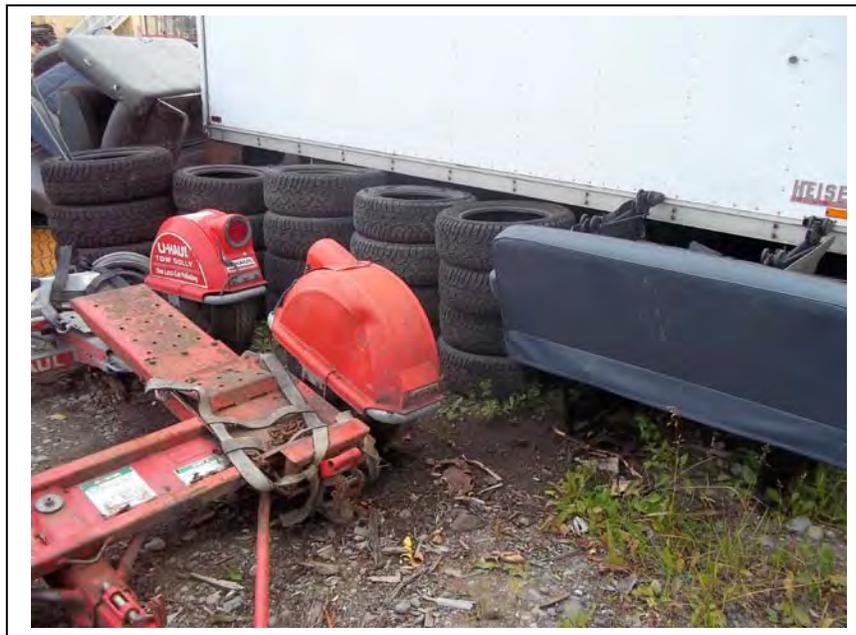
Photo 30: Areas of discolored soil were observed north of the outbuildings. (August 17, 2012)
