**ALASKA DEPARTMENT OF ENVIRONMENTAL CONSERVATION**  
Division of Spill Prevention and Response  
Prevention Preparedness and Response Program  
***SITUATION REPORT (SITREP)***

## **Colville, Dalton Hwy MP 219.4 Truck Rollover**

**SITREP # 2 and Final**

**SPILL #:** 19309904302

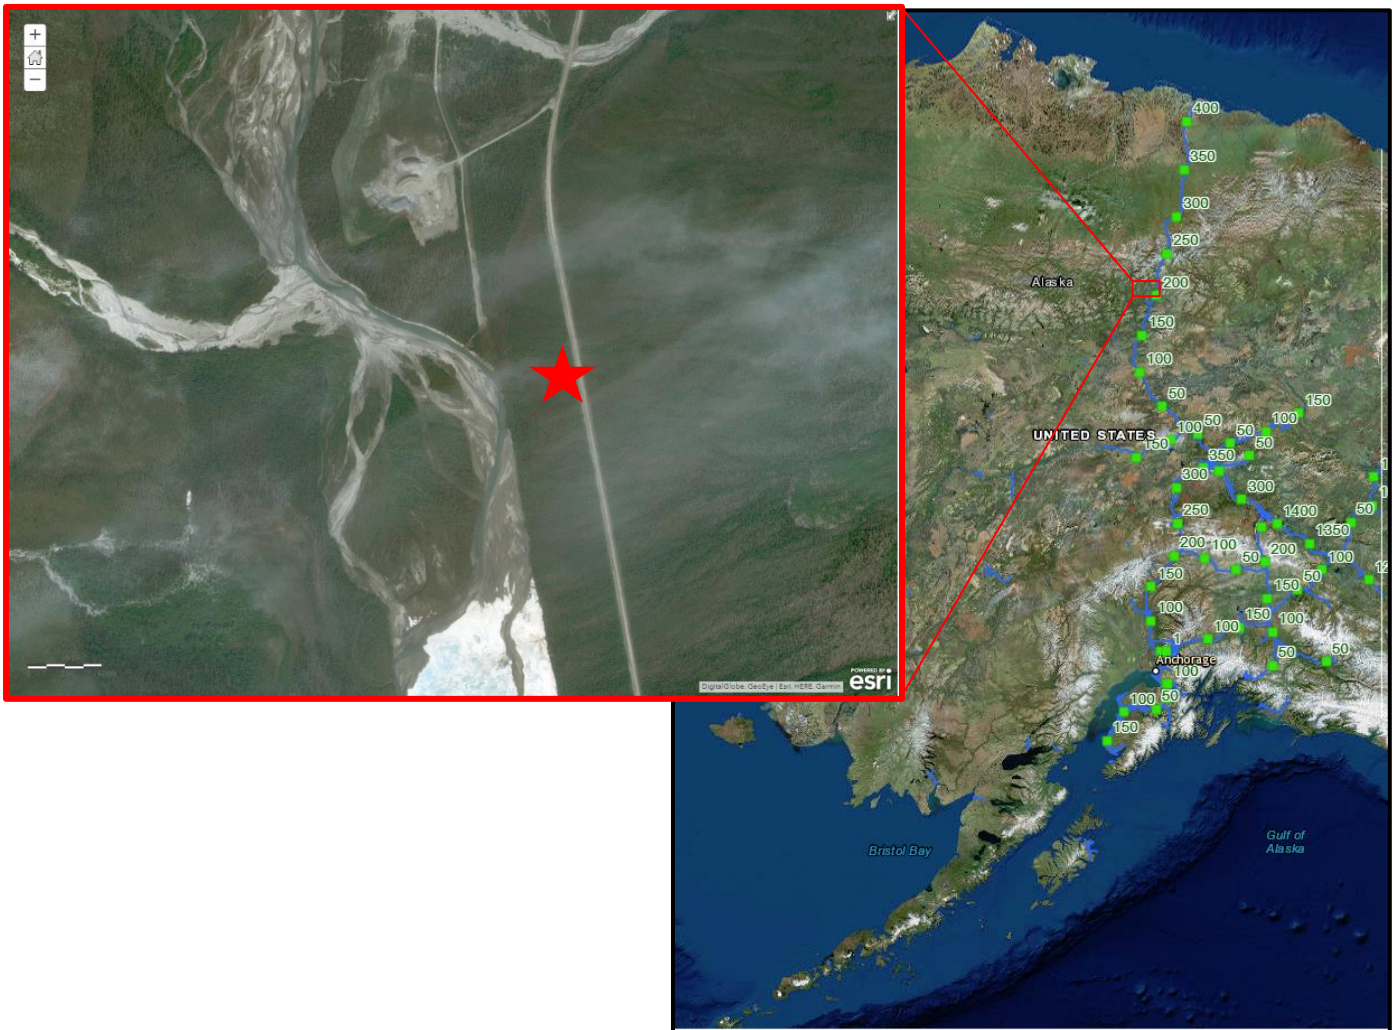
Photos 1 & 2: The incident took place at MP 219.4 Dalton Highway, ~44.4 miles North of Coldfoot, Alaska.

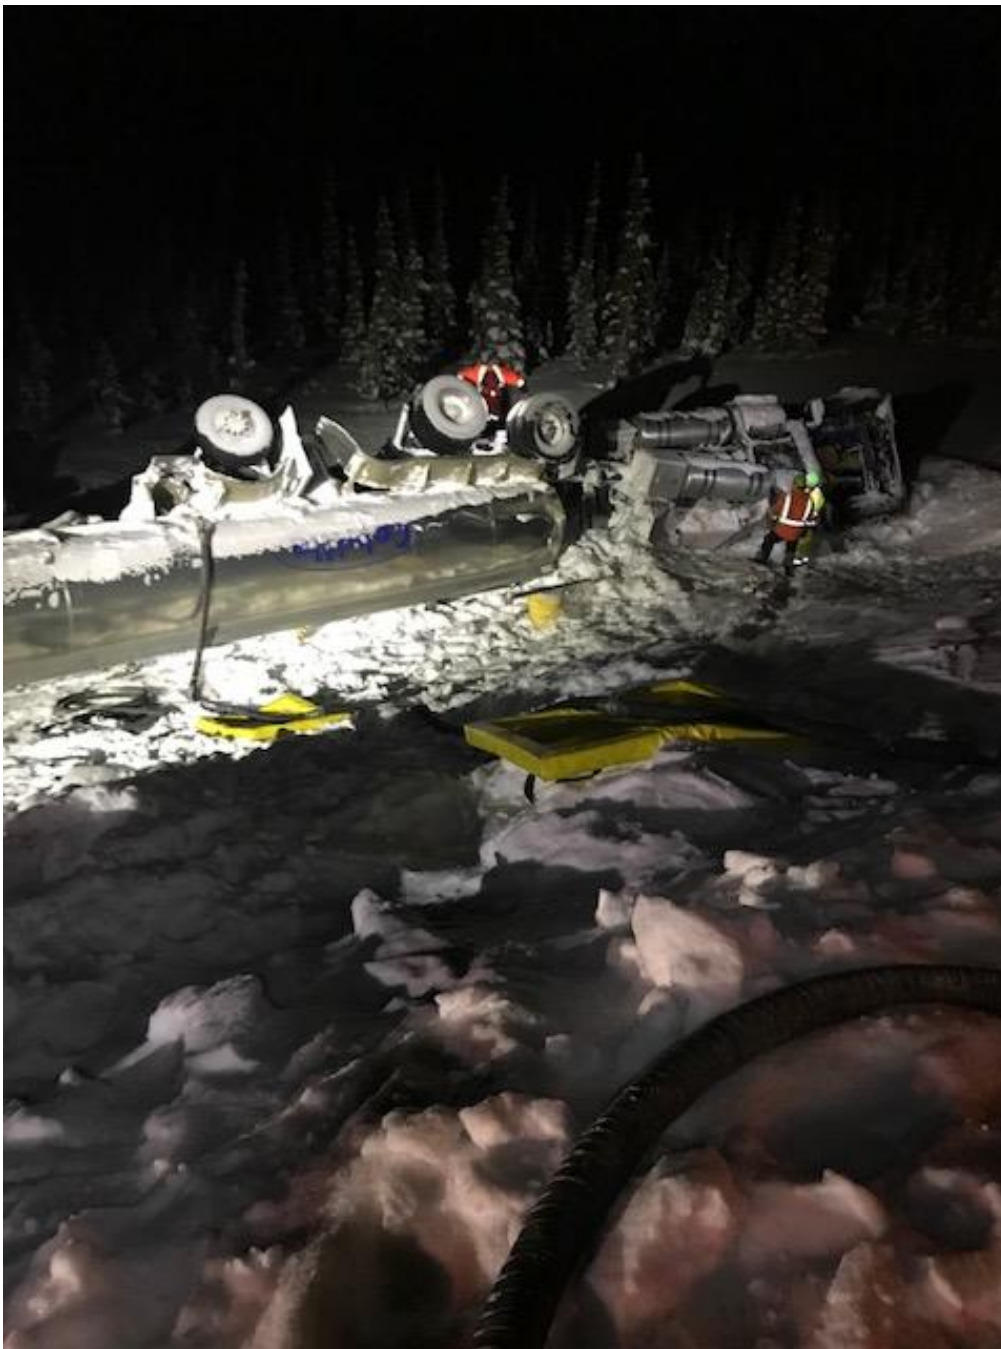
**CAUSE OF SPILL:** The truck departed the Dalton Highway, traveling approximately 70ft down an embankment. **The cause of the spill was due to a vehicle accident.**

Photo 3: Site of the truck rollover incident (Photo provided by Colville).
