Brownfield Assessment

Property Assessment and Cleanup Plan
Larsen Bay Old School
Larsen Bay, Alaska

By:
Shannon & Wilson, Inc.
5430 Fairbanks Street, Suite 3
Anchorage, Alaska 99518

April 2011

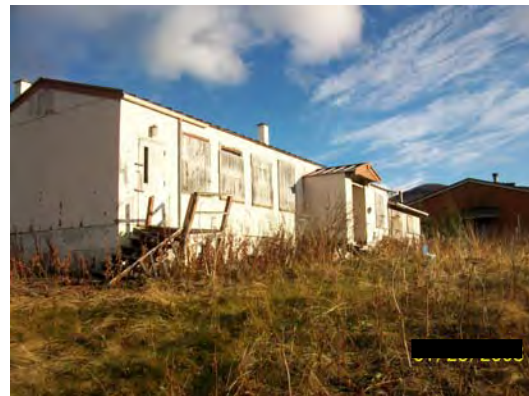
Old School building in Larsen Bay, Alaska, looking south 10/25/2010.

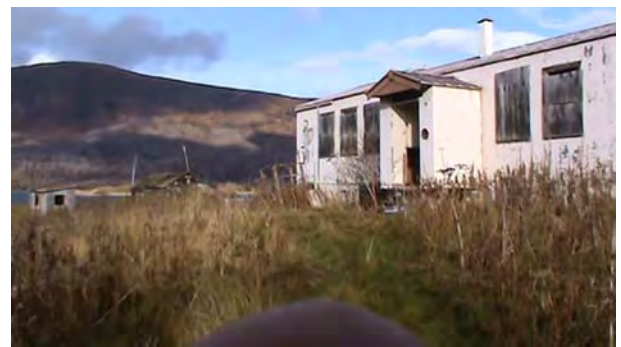
Old School building looking north toward bay from end of fence, 10/25/2010.

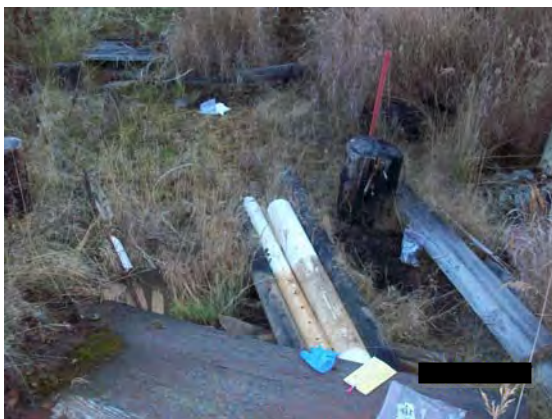
Looking north across former generator shed location, TP5 on the right, TP4 in background, 10/25/2010.

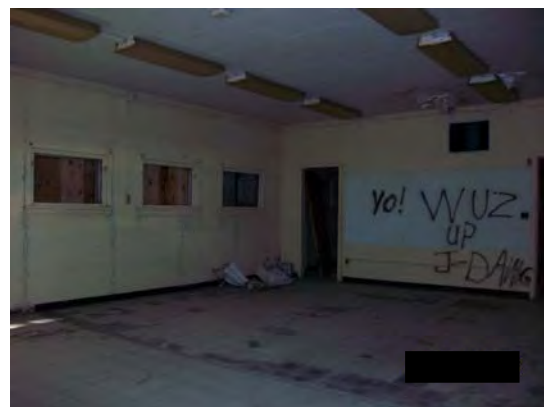
Interior of northern classroom, looking southeast on 10/25/2010.

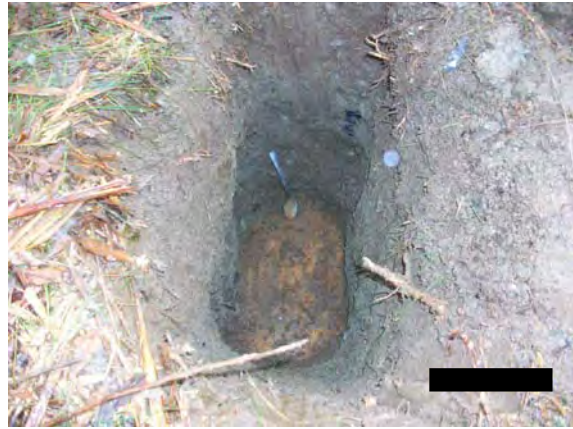
Test Pit TP1 was advanced at the suspected UST location, as depicted in a 1981 site sketch. Steel divining rods were used to aid in locating the tank position. On October 25, 2010, hand excavation with a shovel was found difficult in the gravelly soil, and the test pit was stopped at approximately 2 feet bgs. On October 26, a rock bar was borrowed from the city of Larsen Bay and Test Pit TP1 was reopened. The top of the UST was encountered at 2.3 feet bgs in the test pit. A screening sample was obtained near the surface of the tank. The tank surface was rusty. No contaminant odors were observed. The granular soil encountered in Test Pit TP1 did not have well developed soil horizons, and was dense enough that it may have been mechanically compacted. As Test Pit TP1 was backfilled, a length of 4-inch plastic pipe was left in the hole to mark the location of the UST for future reference.

Top of steel underground storage tank located south-southwest of the Old School building, with table spoon for scale, looking south on 10/26/2010.

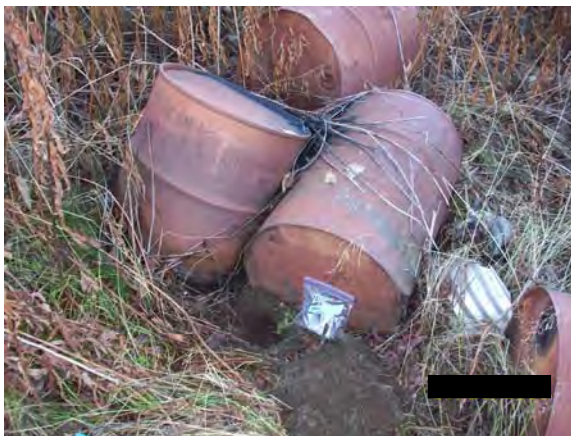
Test Pits TP2 and TP3 were located adjacent to rusty 55-gallon drums that had some evidence of oily staining on the outside. The drums were located south of the former generator

Test Pit TP2, screening Sample TP2S1, and 55-gallon drums, looking west on 10/25/2010.

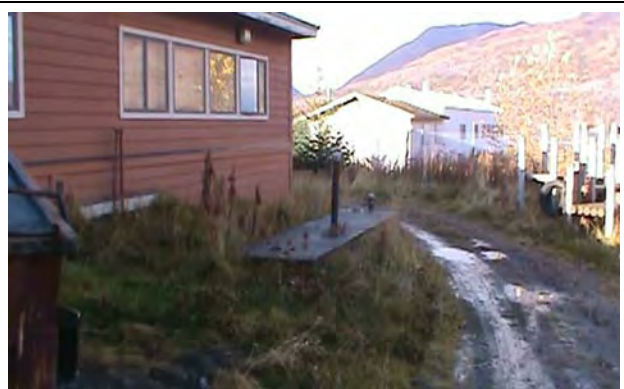
Records of reported spills, cleanup activities, or corrective actions at the Old School property were not found in our research. The DEC UST database has a record that one 2,000 gallon UST was closed in place. This UST is thought to be on the adjacent school property to the south (See Figure 2). The above-ground fittings of a UST were observed at the northeast corner of the new school addition during our site visit. The fittings did not suggest that the UST had been closed.

Underground storage tanks fittings at active Larsen Bay School, looking northwest to Old School, 10/25/2010.

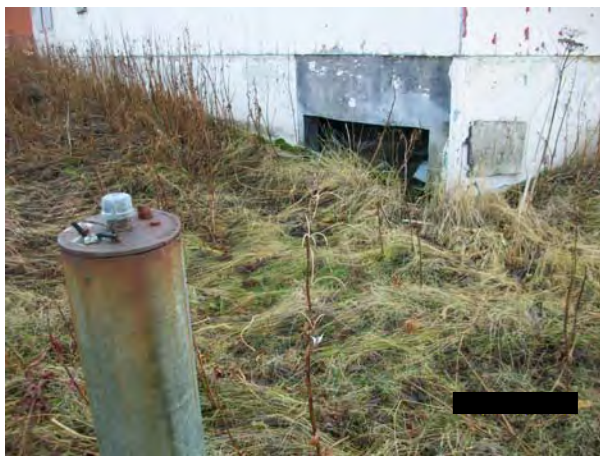
Photo 1: Water well head and northeast corner of Old School building, looking southwest 10/25/2010.

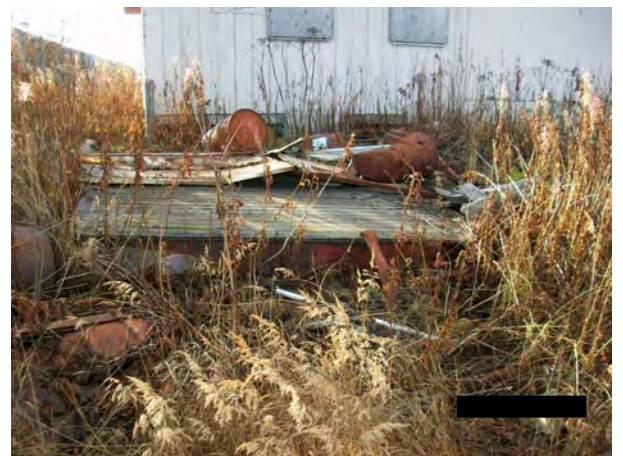
Photo 2: Former sheet-metal shed floor, debris, and drums near southeast corner of Old School, looking west 10/25/2010.

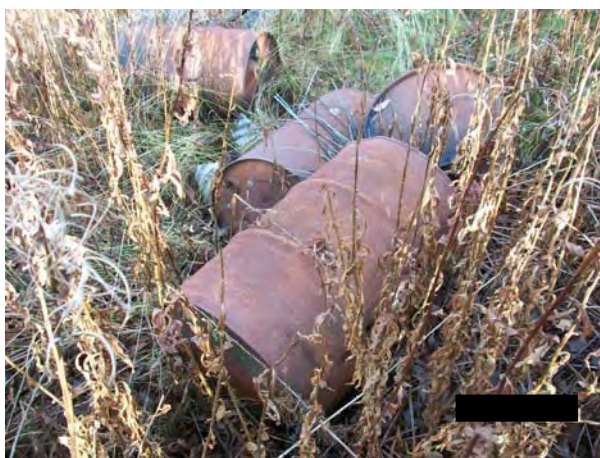
Photo 3: Four 55-gallon steel drums southeast of building and south of former generator, looking north-northwest 10/25/2010.

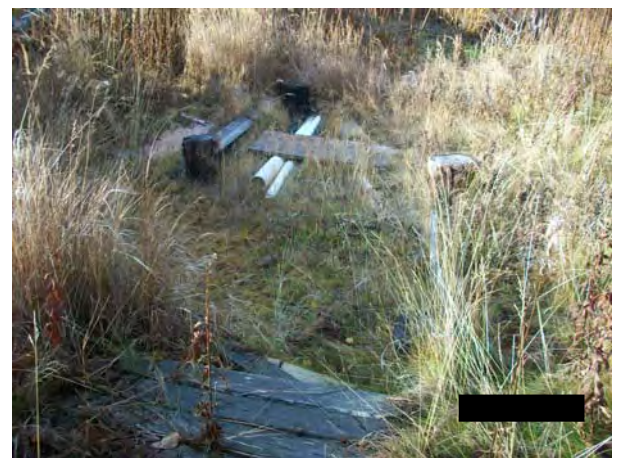
Photo 4: Depression, stressed vegetation, and creosote-treated timber supports thought to be the location of a former electric generator, looking north-northwest 10/25/2010.

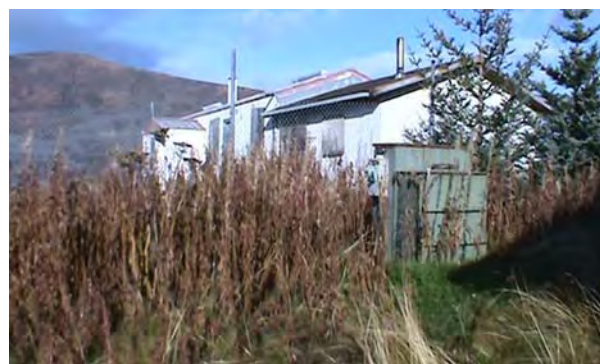
Photo 5: Electrical transformer and southwest corner of Old School, looking north 10/25/2010.

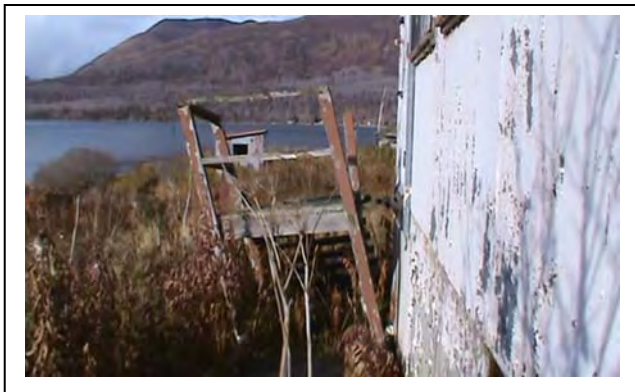
Photo 6: Collapsing stairs at northern Old School entrance, flaking paint, and cement board skirting, looking north-northwest 10/25/2010.

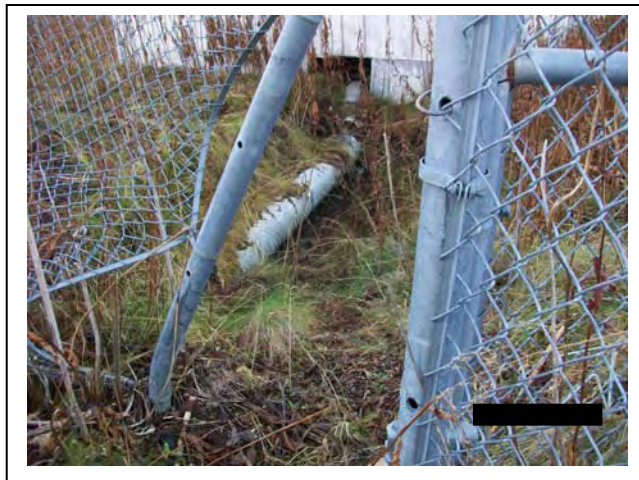
Photo 7: Damaged chain-link fence and exposed, broken sewer line at south end of Old School, looking northwest 10/25/2010.

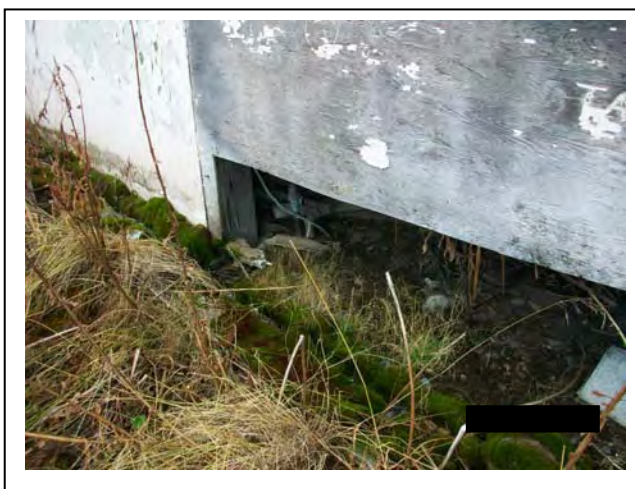
Photo 8: Plywood replacement for cement board skirting at northeast corner of Old School, plastic and galvanized water piping visible under building, looking south 10/25/2010.

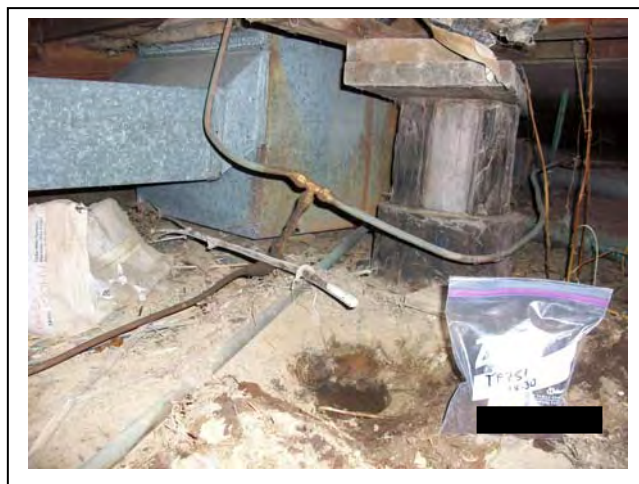
Photo 9: Galvanized duct work for forced-air furnace, copper fuel lines, wood support blocks, and Test Pit TP7 location beneath building, looking southeast 10/25/2010.

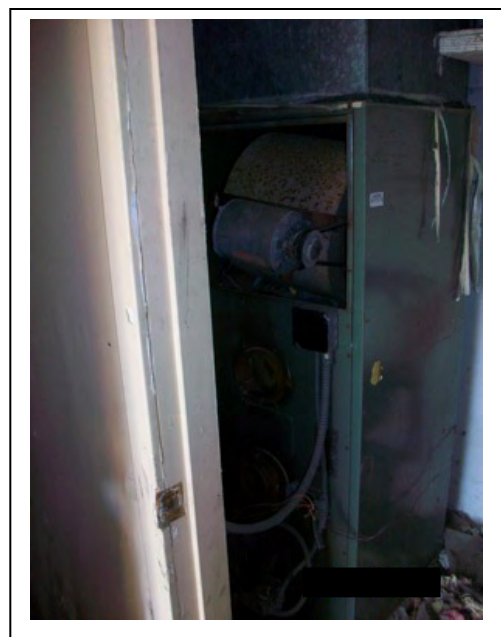
Photo 10: Oil-fired forced-air furnace in mechanical room of Old School, looking north, 10/25/2010.

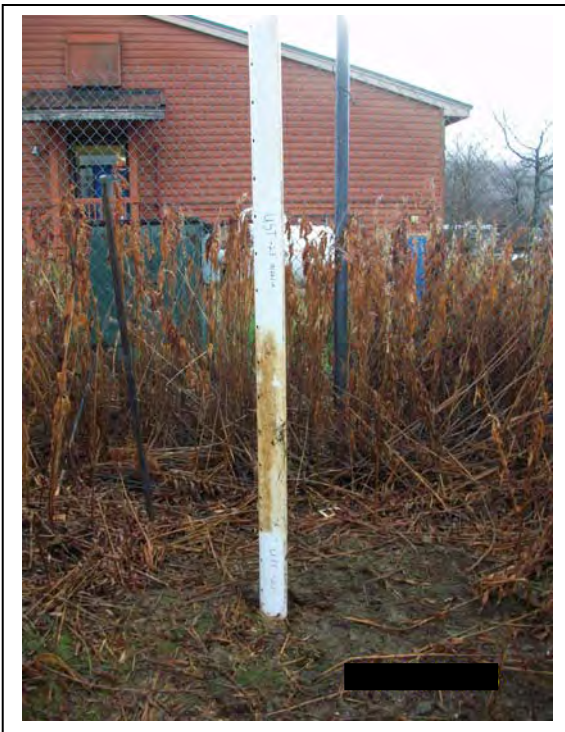
Photo 11: Four-inch plastic pipe placed in Test Pit TP1 location to mark location of UST, active Larsen Bay School, 1,000 gallon AST, and electrical transformer visible behind fence, looking south 10/26/2010.
