Geotechnical Investigation September 2003

GEOTECHNICAL INVESTIGATION
Heavy Duty Boardwalk Improvements
Tuntutuliak, Alaska

DM&A Job No. 4149.019

September 30, 2003

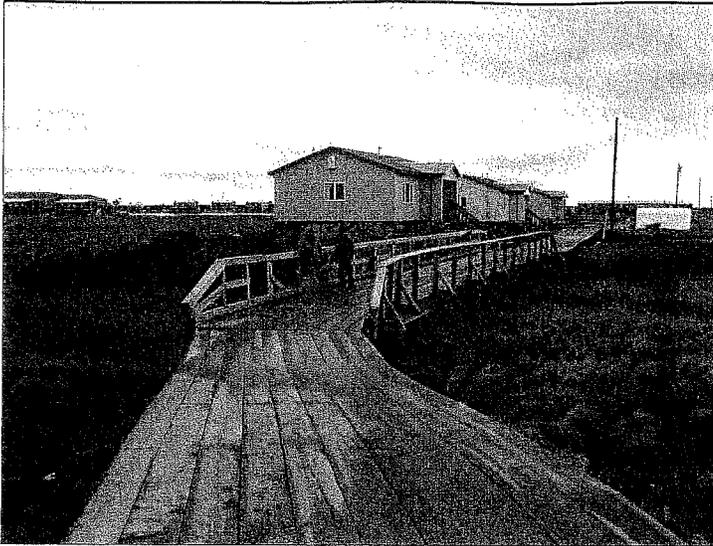
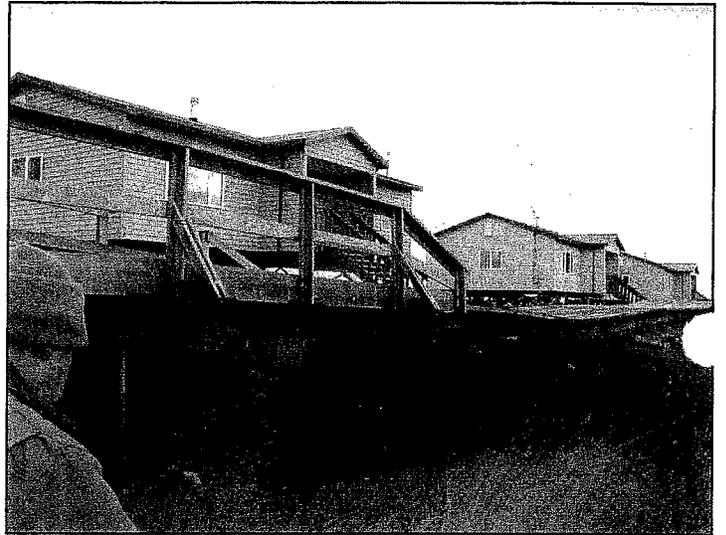
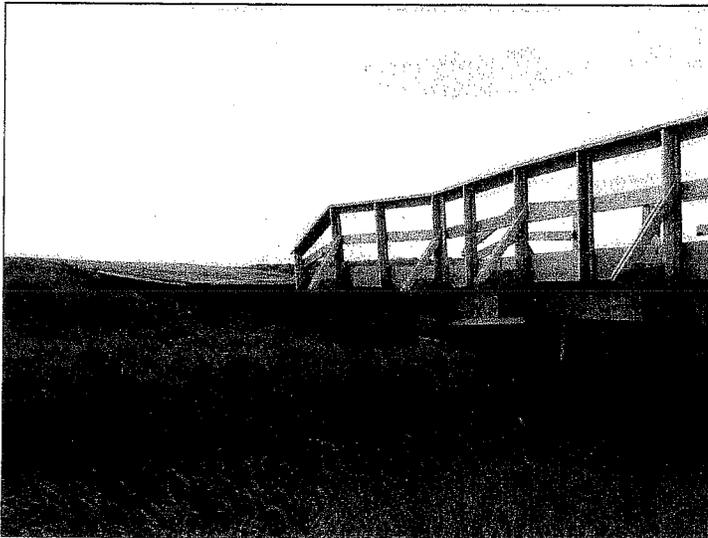
Plate
12

This area is located near new housing along the northwest edge of the village, where the boardwalk crosses a broad, well-defined drainage. Displacement has occurred at either end of the bridge section over the transition between the drainage and surrounding higher ground. Two borings were drilled in this area in April 1994, near each of the transition zones. The borings revealed 4 feet of ice and snow over unfrozen peat and organic silt to depths of 7.5 and 9.5 feet. Below the organic soils, relatively firm inorganic silt with organic lenses and some organic silt was observed to 30 feet. Marginally frozen ground was found below a depth of about 25 feet at each location.

Chance® anchors provide support for the bridge across the drainage. The bridge section appears to be in good shape, with no obvious displacement of the plank surface or underlying anchors. Within the transition zones, the boardwalk rests on cribs placed directly on the natural ground surface which is sloping towards the drainage. Compression of the surface organics and downslope movement of the organic soil has caused much of the cribbing to move down toward the drainage. The loss of support has caused the boardwalk to sag. Over the adjacent, higher ground the boardwalk rests on mudsills and planks which appear to be providing relatively stable support.

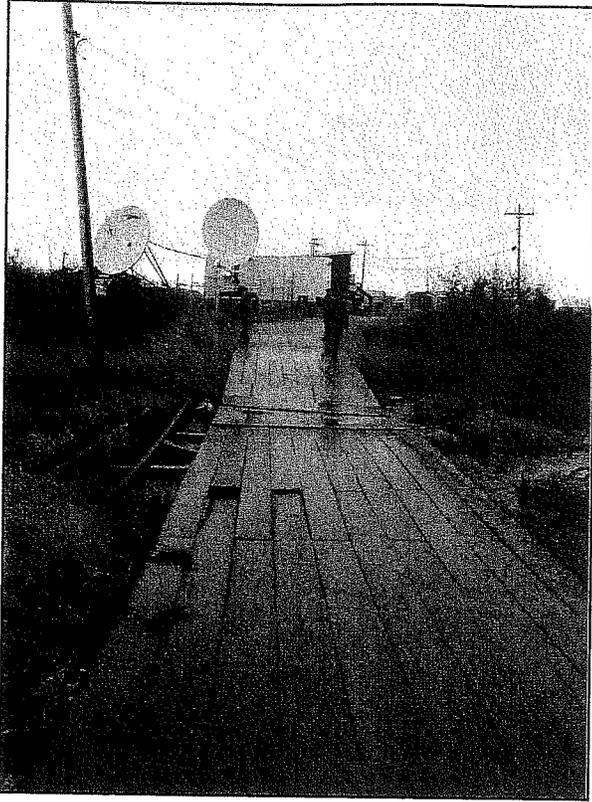
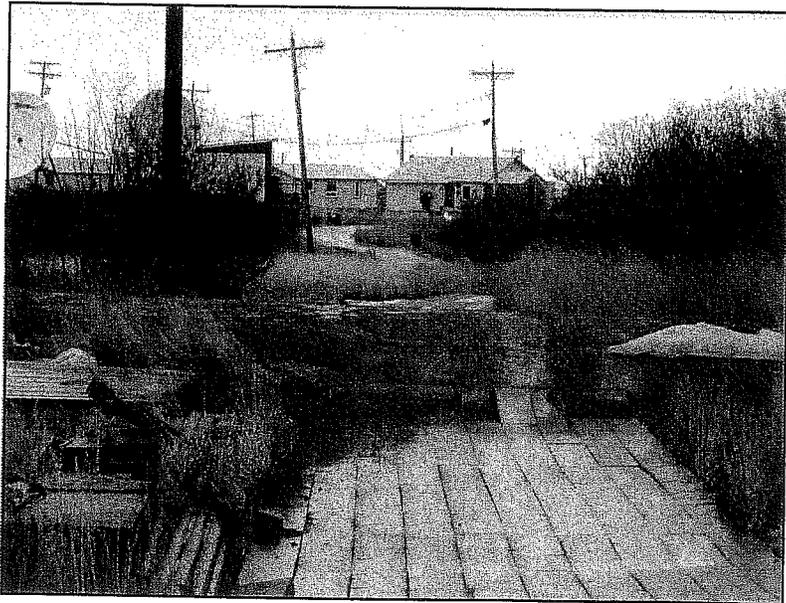
Plate
13

boardwalk is supported on mudsills bearing directly on the ground surface, and Duckbill anchors were installed to prevent excessive movement during floods. Mr. Enoch also noted that the boardwalk will float in approximately 8 inches of water where anchors are absent.

During a 1996 DM&A investigation, a borehole was drilled in this area to a depth of 31 feet. The boring showed a thin organic mat and brown organic silt near the surface, underlain by medium dense to dense gray silt with occasional organics. The soils were frozen below a 3-foot, thawed active layer, with interstitial ice crystals up to 3/8 inch diameter from 5 to 9 feet. The material below 9 feet appeared marginally frozen with no visible excess ice, and measured ground temperatures were very close to the freezing point. High moisture contents in the upper portion of the boring indicate potential for significant thaw settlement.

Photographs taken during previous visits to the village reveal that some settlement has occurred along this section of boardwalk. In places, stress due to differential settlement has caused the individual surface planks to pull free of the support sills at one or both ends. In low areas prone to collecting surface water, earlier photographs suggest that more severe damage has occurred as a result of flooding. Based on conversations with local residents, polystyrene floats may have been added over areas of soft, wet tundra. Residents note that the anchors are either too slack or too few in number to adequately limit movement of the boardwalk during a flood. The boardwalk foundation was concealed by ice and snow at the time of our visit, and the presence of Duckbill anchors and/or polystyrene floats could not be verified.

Where releveling of the boardwalk surface is required, lift the boardwalk using a hydraulic jack and add shims above the mudsills as needed. Remove any floats and replace them with timber sills. Install a sufficient number of Duckbill anchors to resist buoyant uplift forces that occur during high water. The Duckbill anchor must have sufficient slack to allow for a seasonal frost heave movement of about 4 inches.

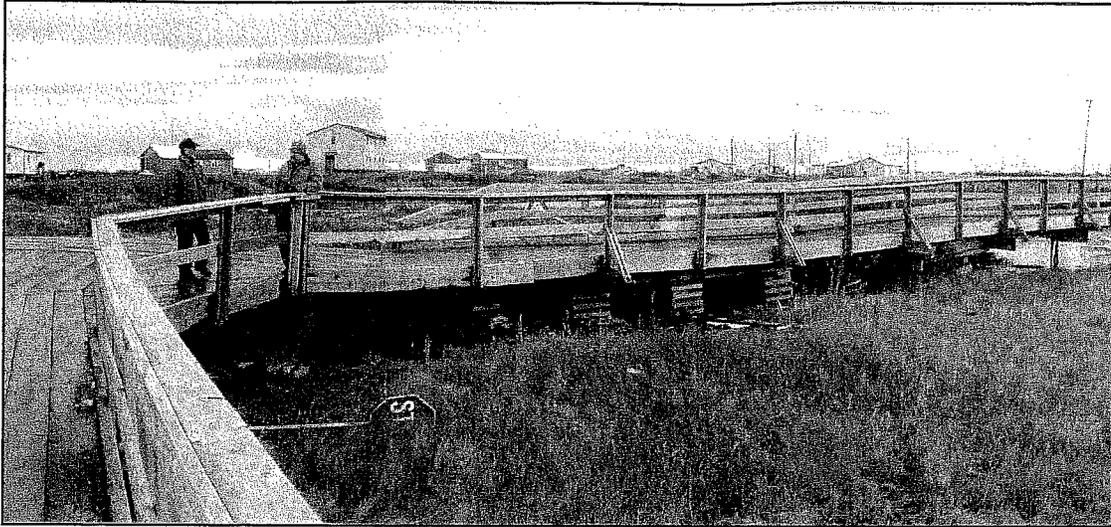
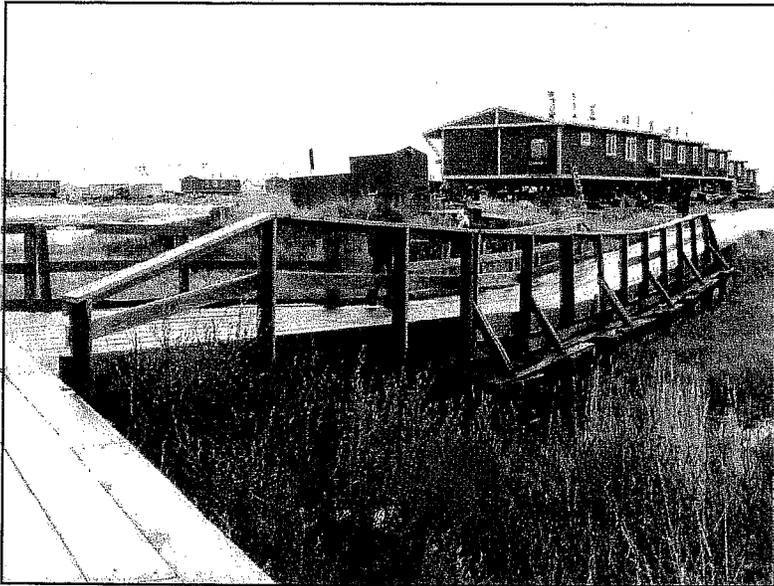
Plate
14

extends west toward the housing development and is supported on floats across a wide drainage. The boardwalk sags dramatically where it crosses the drainage, and portions of the railing are damaged. Near the intersection, a displaced float that appeared in a 2000 photograph was missing in January 2003.

The second bridge runs south from the intersection over a neck of a large pond. The bridge over the pond is supported on Chance anchors. Between the intersection and the pond, the boardwalk rests on cribbing bearing directly on the ground surface. At the northern edge of the pond, at least one polystyrene float was observed beneath the boardwalk. Additional floats may have been obscured by snow at the time of this investigation. Over the Chance anchors, the boardwalk shows no obvious displacement and appears to be in good shape. Near the intersection, however, displacement of the underlying cribbing has caused the boardwalk to drop.

Three borings drilled in 1994 provide soils data for this area. Near the northern bridge intersection, a boring drilled to a depth of 32 feet revealed frozen peat and interlayered silt and organic silt to a depth of 9.5 feet. Below 9.5 feet, unfrozen, interlayered silt and organic silt were encountered to the base of the boring. The depth of frozen soils is greater than that typically expected for seasonal frost penetration. Near the center of the middle bridge, another boring was drilled to a depth of 35 feet. The soil conditions were similar to those described above except only seasonal frost was found in the peat. In the boring drilled at the south end of the center bridge, frost was encountered to 4 feet, and otherwise, similar soil conditions were logged to a depth of 32 feet.

Remove the floats and cribbing that are located within the areas that flood or where the ground is steeply sloping, and replace them with a helical anchor foundation.

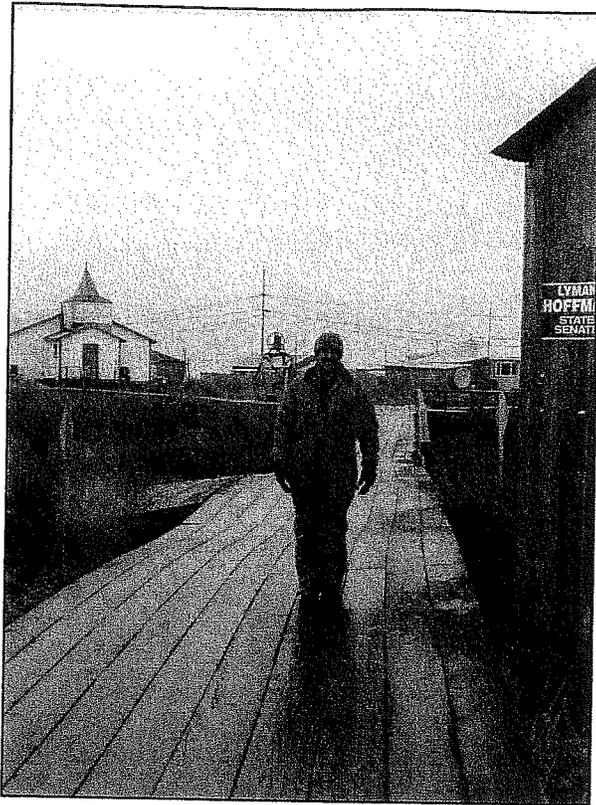
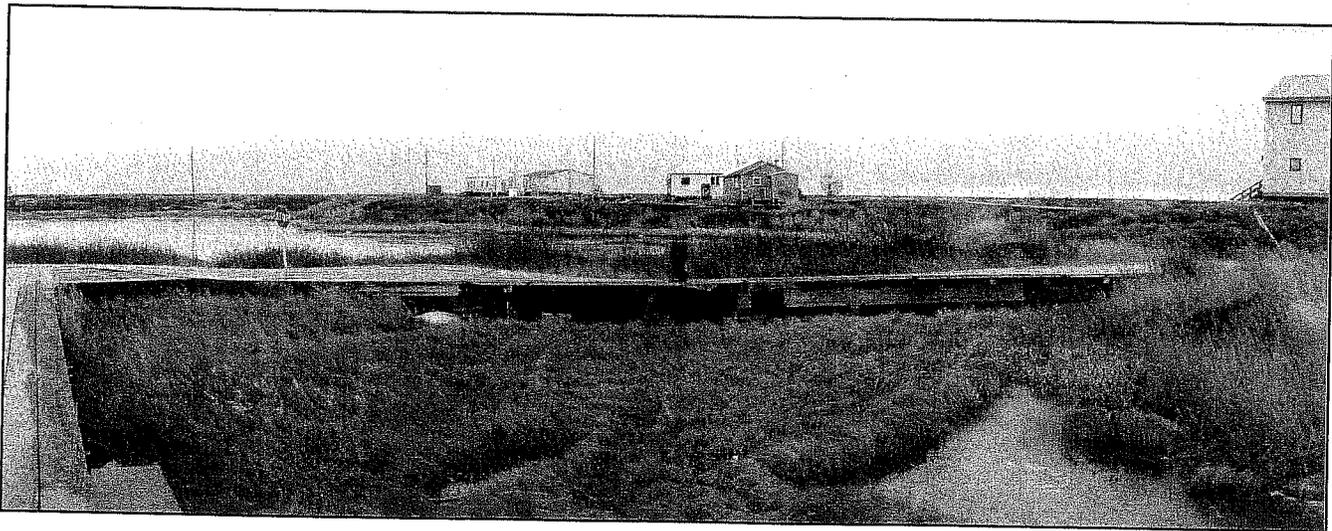
Plate
15

Boring F encountered 3 feet of peat and organic silt over mixed silt and organic silt with occasional layers of firm organics to the base of the borehole at a depth of 16.5 feet. Seasonal frost was present to 2.5 feet, and icy permafrost was encountered below a depth of 10.5 feet.

The soil above the permafrost is highly compressible and settlement of the timber cribbing will continue to occur with time. A positive, long-term solution would be to replace the timber cribbing with helical anchors. Alternatively, the boardwalk could be releveled periodically and shims placed on the settling cribs. Any floats that might be present should be removed and be replaced with either cribbing or helical anchors to be consistent with the rest of the support.

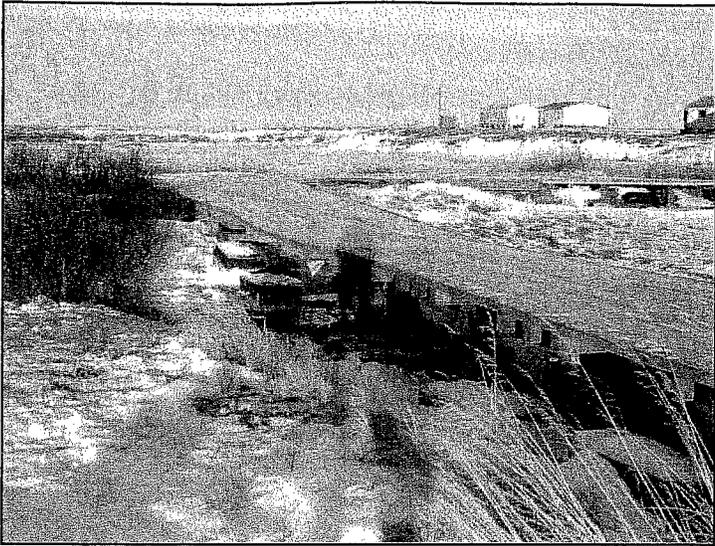
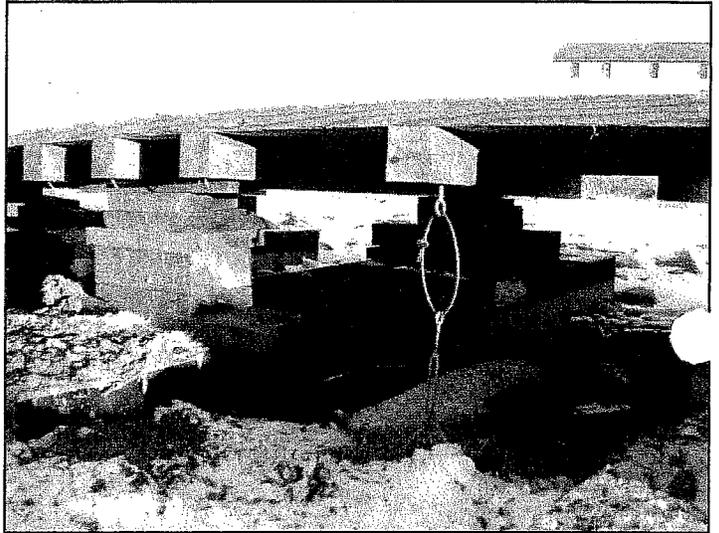
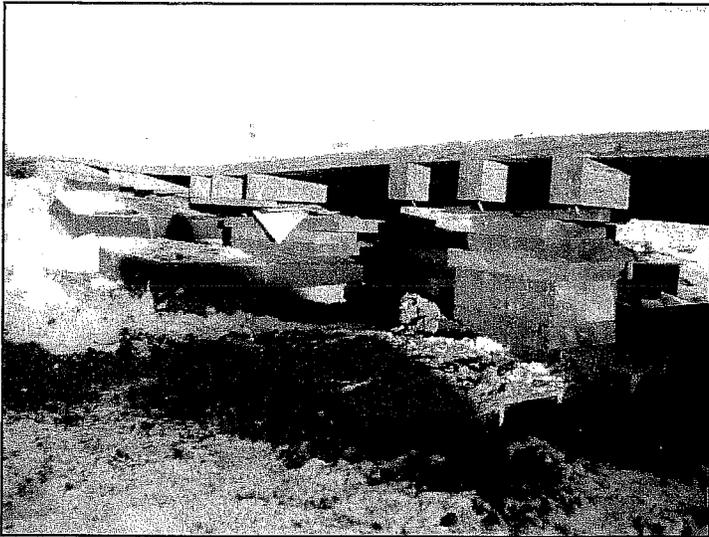
Plate
16

Boring G was drilled to a depth of 31.5 feet near the center of this section, where displacement was most severe. The soils encountered include 2.5 feet of peat over organic silt to a depth of 18.5 feet. Beneath the organic silt, gray silt was present to the base of the boring. The soils were unfrozen below 3 feet of seasonal frost.

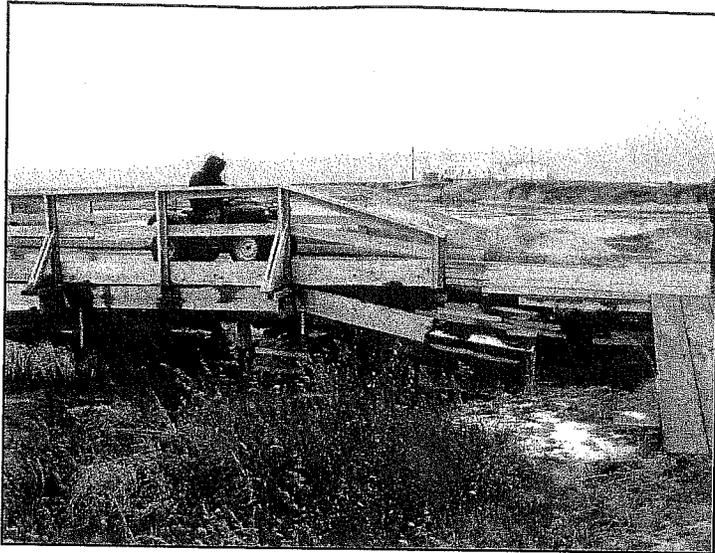
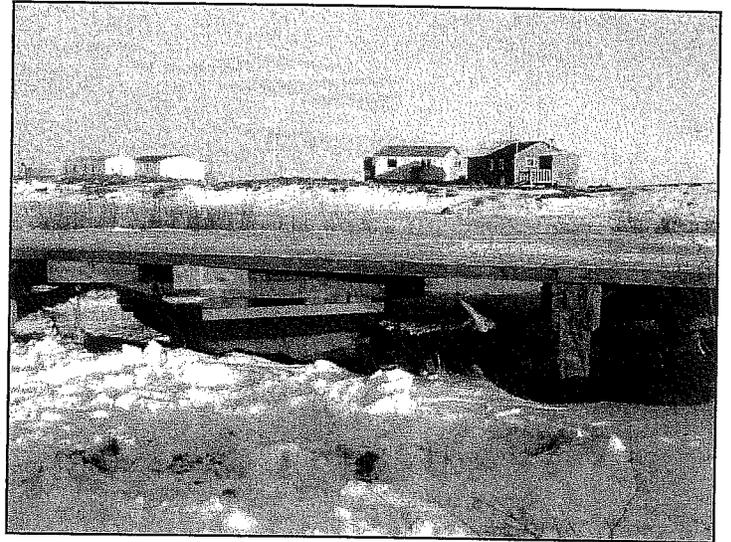
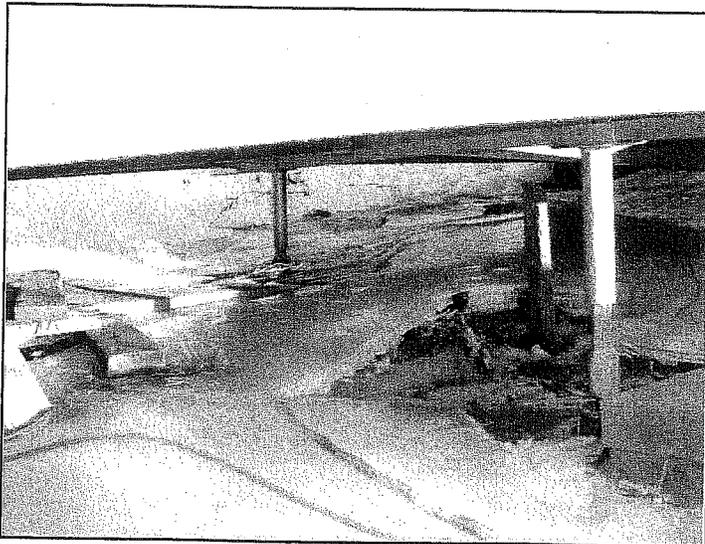
Plate
17

Section H includes a bridge crossing a neck of the lake and the transitions at each end. The bridge section is supported on Chance anchors. The transitions at each end are on floats with Duckbill anchors. Movement has been considerable as evident from the excessive cribbing and displacement of floats. The floats have lifted the bridge almost completely off the Chance anchor at the southeast end. The movement has caused the side planks to break off and has resulted in a slight dip in bridge near west end.

Boring H shows peat and organic silt to 10.5 feet and then medium stiff silt to the depth explored, 31.5 feet. The only frozen soil was a thin layer of seasonal frost.

The soils are highly compressible to a depth of 10.5 feet. The major distress to the transitions appears to be caused by uplift of the floats during flooding. The cribbing and floats should be removed and replaced with helical anchors gaining support in the silt below 10.5 feet.

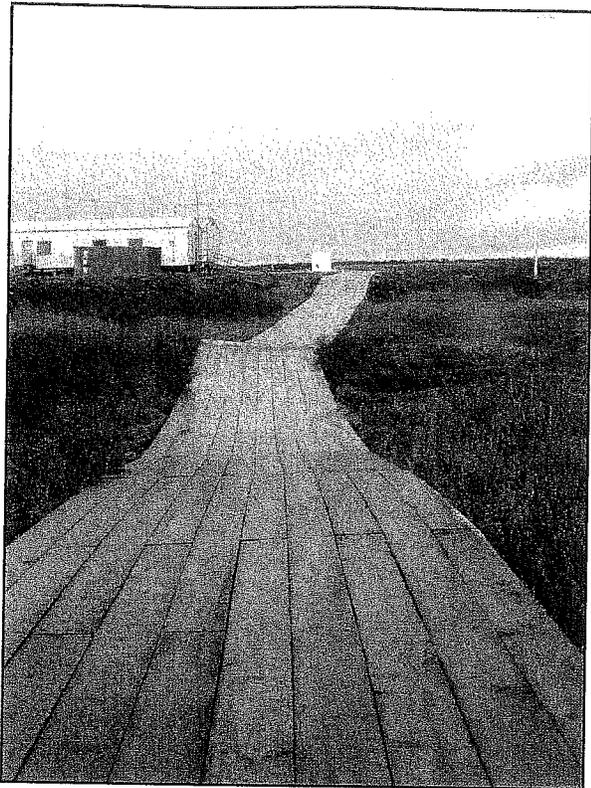
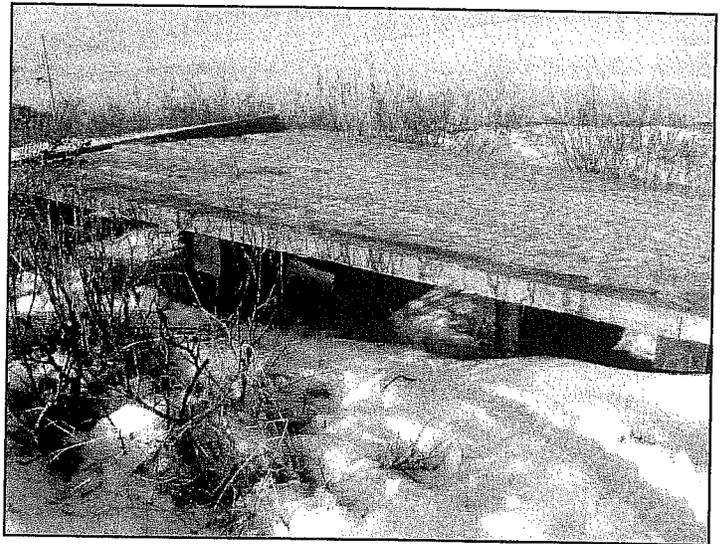
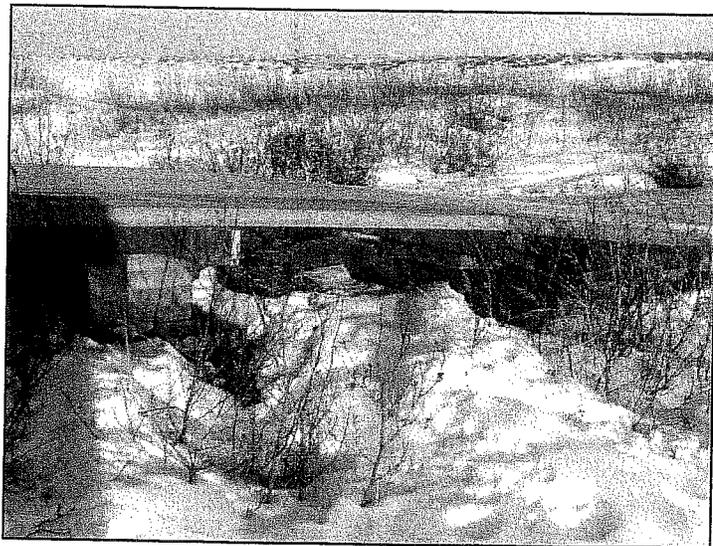
Plate
19

Boring I was drilled at a higher location and found a surface layer of peat to 3 feet overlying silt and organic silt to the bottom of the hole, 8.5 feet. Permafrost was found at a depth of 5 feet. Boring II was drilled in a swale and found 5 feet

of peat over organic silt and silt. No permafrost was found to the depth explored, 11.5 feet.

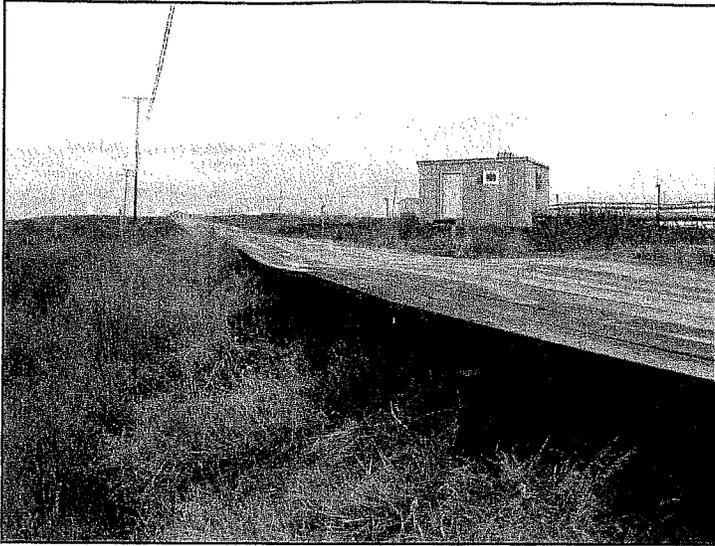
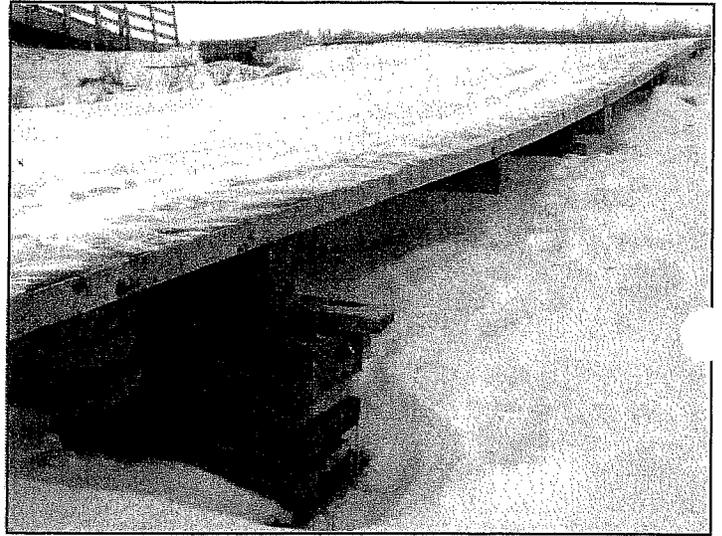
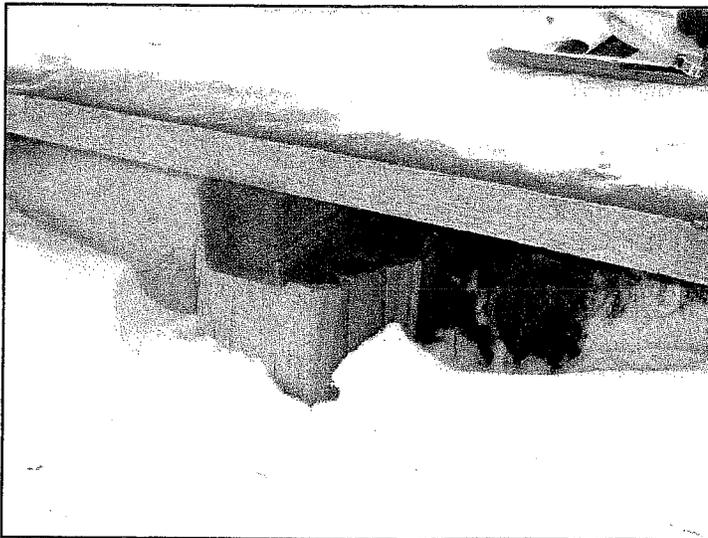
Plate
20

This section of boardwalk is west of school on the sidehill above a pond. The boardwalk is supported on mudsills and cribbing. The cribbing is up to 2 feet high. The cribbing has pushed into the into the surface organics in places. At some locations, the cribbing appears to have moved laterally. The lateral movement could be due to downslope movement of the active layer or a bearing failure of the cribbing.

A boring at this location was not possible because of the cross slope and the very icy conditions in January.

The boardwalk surface could be releveled by jacking up the 6x6 cross pieces and then adding additional shims. To reduce the risk of downslope soil movements affecting the mudsills, the tundra could be dug out at each support point so that the mudsills are bottomed at a depth of about 3 feet below ground surface. If a post is used to provide support between the timber pad and the 6x6 cross pieces, the connection between the post and pad should be adequate to resist the frost heaving forces that will develop each winter. A 6x6 timber post could experience a frost heave force of about 20 kips. The post would have to be laterally braced to resist the downslope soil load.

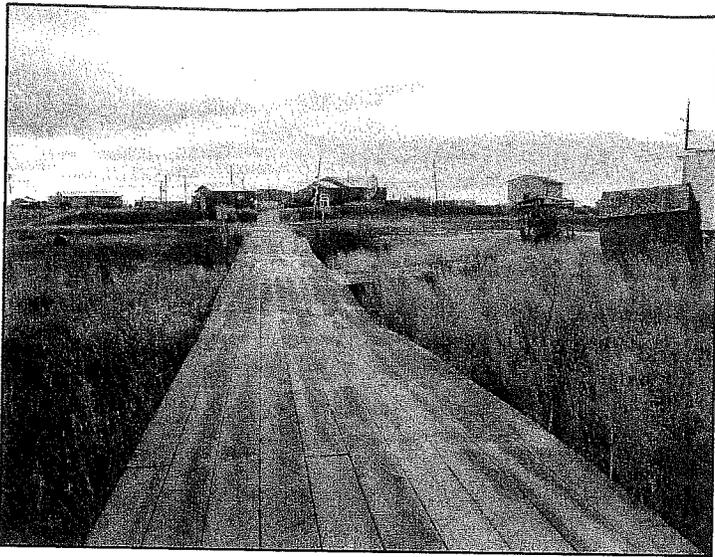
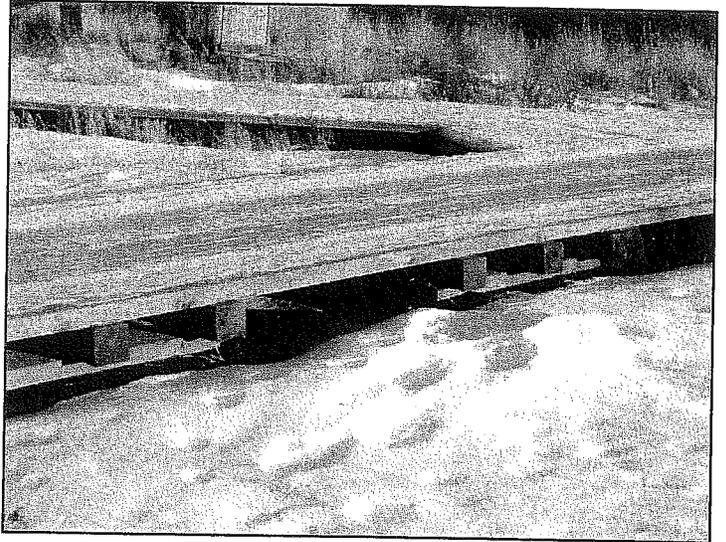
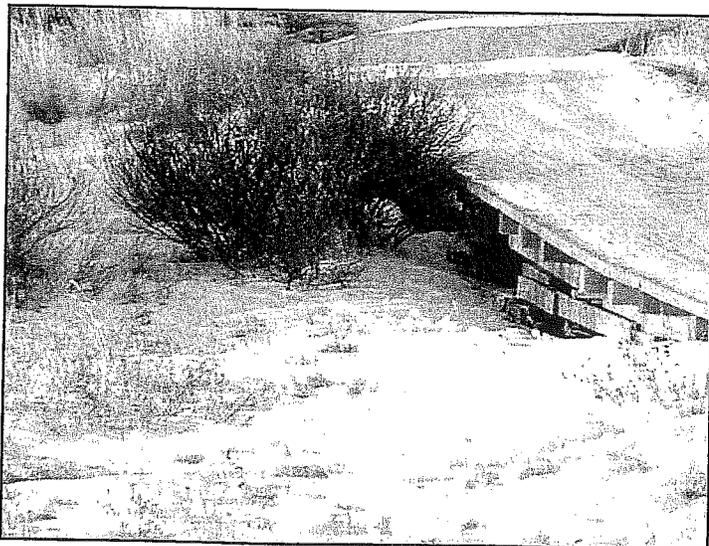
Plate
21

This section of boardwalk is east of the store and runs northeast to southwest along the north boundary of a lake. The boardwalk appears to be supported primarily on floats through this section, though much of the foundation was obscured by snow and ice in January. In the low areas the floats appear to have settled and cribbing has been added between floats and sills. In places, the foundation is only in partial contact with the boardwalk above. Over higher ground, cribbing exists between as well as in place of the floats.

Boring K was drilled to 10.5 feet at a higher location. The hole showed organic silt with peat to the depth explored and permafrost was present below a depth of 5.5 feet. Boring KK was drilled to 10.5 feet at the lower area and showed organic silt mixed with peat to the full depth. Permafrost is present below below 5 feet and contains stratified ice.
