# HAINES BOROUGH STORMWATER INFRASTRUCTURE REPORT

February 2019

ACWA Grant # 18-09

Takshanuk Watershed Council

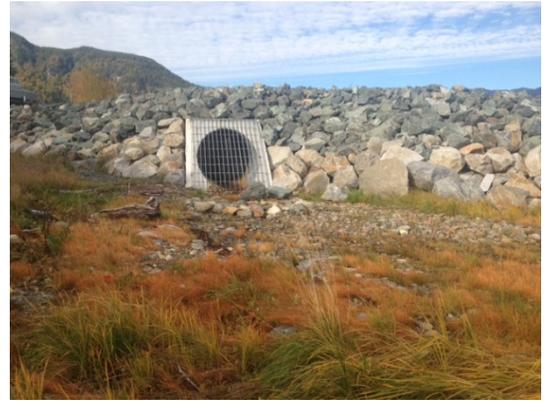
Image 1: Outlet culvert at Harbor parking lot, looking north

1). This culvert drains the majority of stormwater flowing from downtown Haines bound by 3<sup>rd</sup> Ave and Willard St. This area encompasses approximately 55 acres. Stormwater is conveyed into a single “mega ditch” that flows along Mission St. and connects with the new Harbor drainage system (Fig. 3). BMP’s that are already in place in this system include a grate in the ditch at the southern corner of Mission St. and 1<sup>st</sup> Ave to collect large debris and an oil-water separator within the new Harbor drainage system that filters stormwater before it outlets onto the beach. The oil-water separator, however, does not trap sediment from the stormwater.

- Explore options for dispersing stormwater from the outlet of the harbor culvert into adjacent tidelands. The intact tidelands in this area could act as a sediment and pollutant retention area that would reduce these inputs into Lynn Canal. See Image 2 that shows a stitched-together panorama of the outlet. Currently the flow is not dispersing and is directed back into the

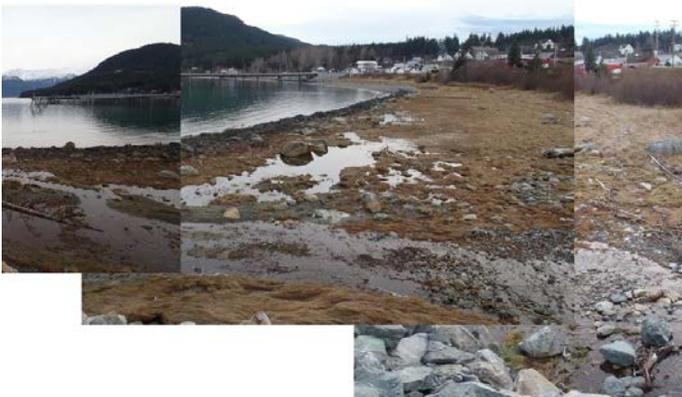
Image 2: Panorama of the Harbor outlet culvert

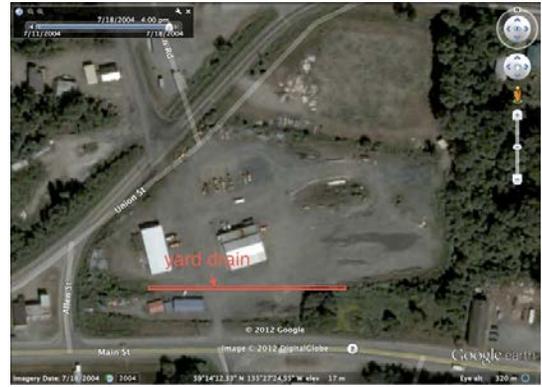
2. DOT Yard: Sawmill Creek was diverted through a culvert running perpendicular to the DOT yard driveway (Image 4). The year this occurred is unknown. The driveway and parking area is not paved and drains into a grate at the top of the culvert. This is a significant sediment source for Sawmill Creek. This sediment source was listed in the 2009 Sediment Sources for Sawmill Creek report (TWC, 2009) and 2014 Haines and Skagway Area Restoration Opportunities Report (TWC, 2014).

Image 4: DOT Yard Culvert Location

- The DOT culvert should be either replaced with a closed-top culvert or removed and the stream daylighted with additional BMP's such as a bioswale and/or riparian buffer to reduce the input of sediment into the channel.

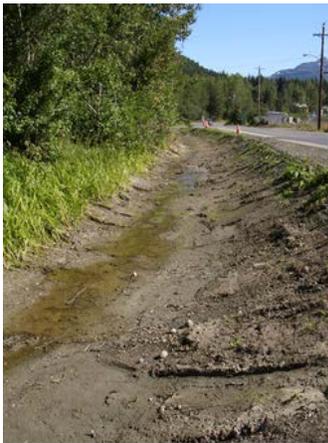
3. Union St. AWC Ditch: The ditch running along Union St. next to the Alaska Marine Lines shipping yard is listed in the Anadromous Waters Catalog for Coho Salmon (Image 5). Road sediment and sediment-laden snow gets deposited in this ditch. Image 6 provides an example of the amount of sediment that is plowed into this channel. This sediment source was listed in the 2009 Sediment Sources for Sawmill Creek report (TWC, 2009).

Image 4: Union St. ditch near AML facility

- Explore options for rerouting the AWC listed ditch along Union St. near the AML facility. There have been discussions with ADFG about possible relocation of the AWC listed ditch to reduce sediment input. Alternative locations should be evaluated.

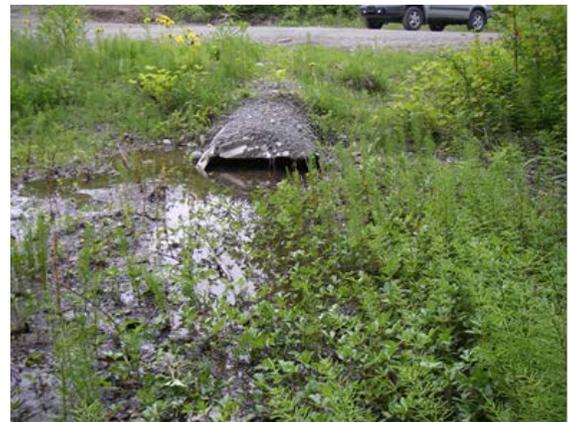
Image 3: Culvert outlet at the AML driveway along Union St.

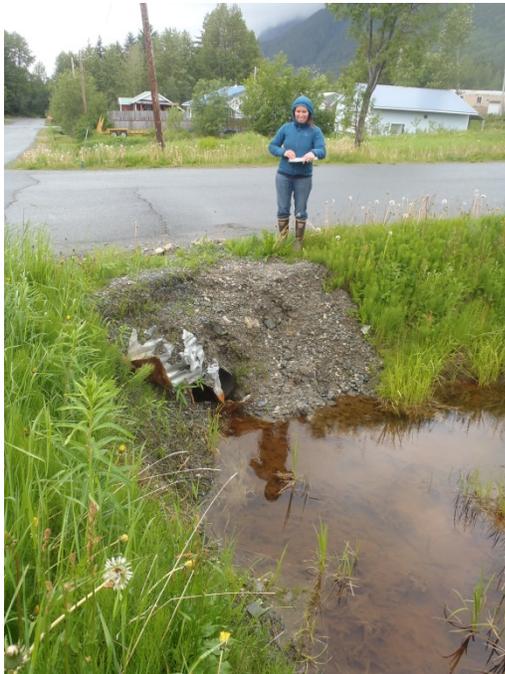
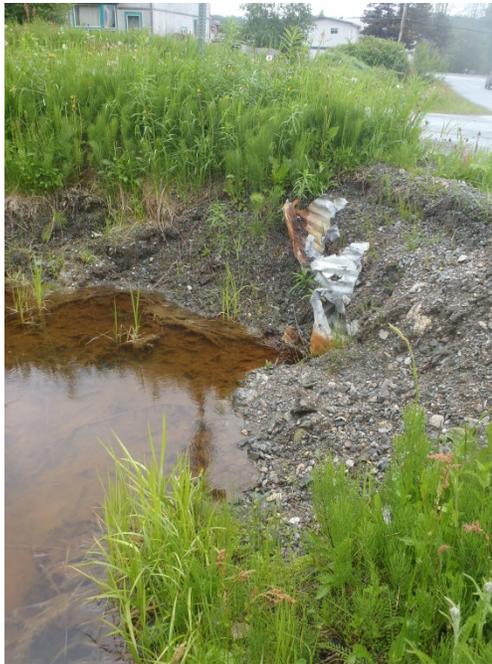
Site 29: 4<sup>th</sup> & Dalton. Culvert has been damaged and sediment is being deposited in the drainage ditch.

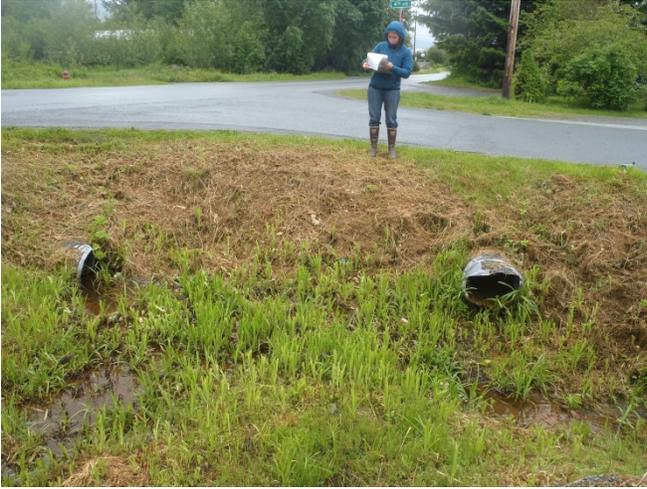
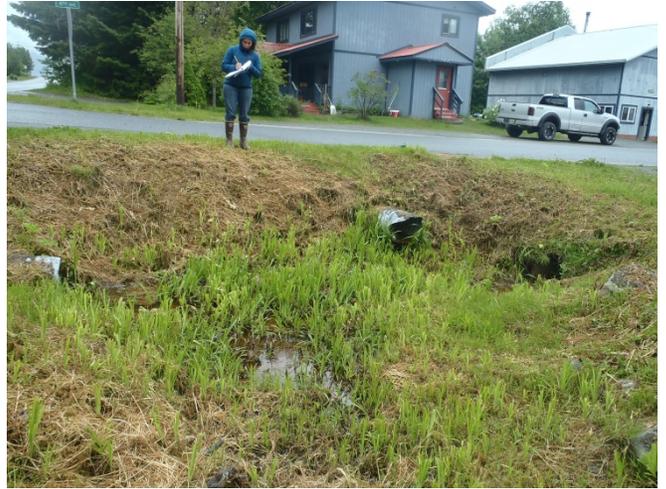
Site 30: 4<sup>th</sup> & Union. Multiple outlet pipes into ditch

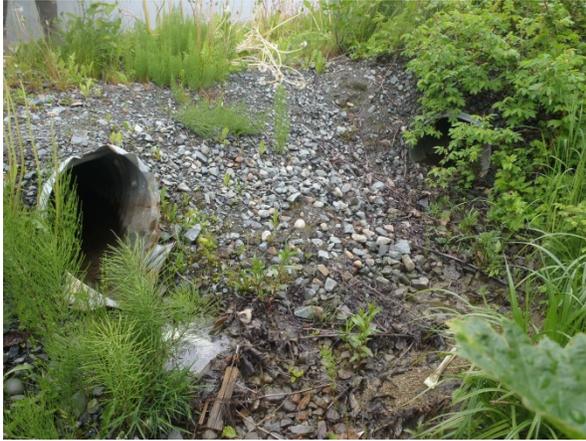
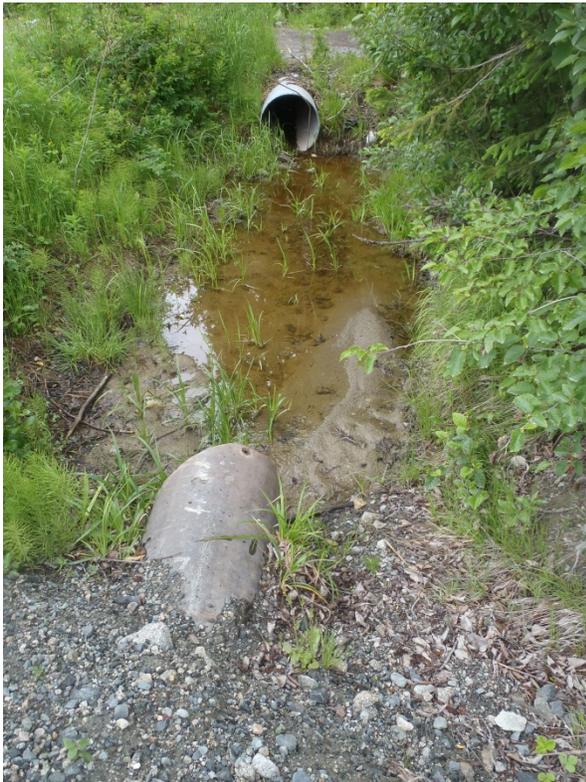
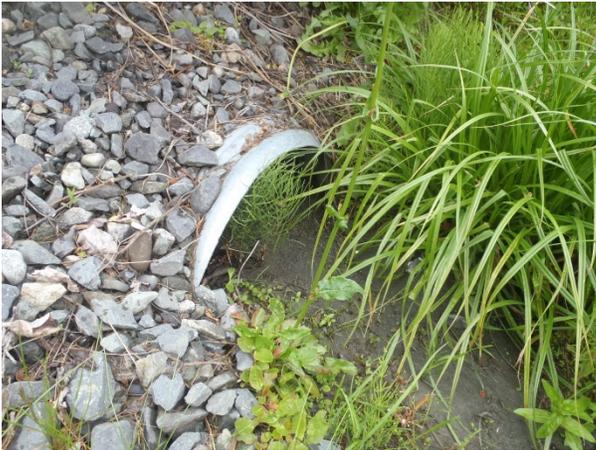
Site 35: 4<sup>th</sup> Ave. Outlet and inlet pipes show high sedimentation.

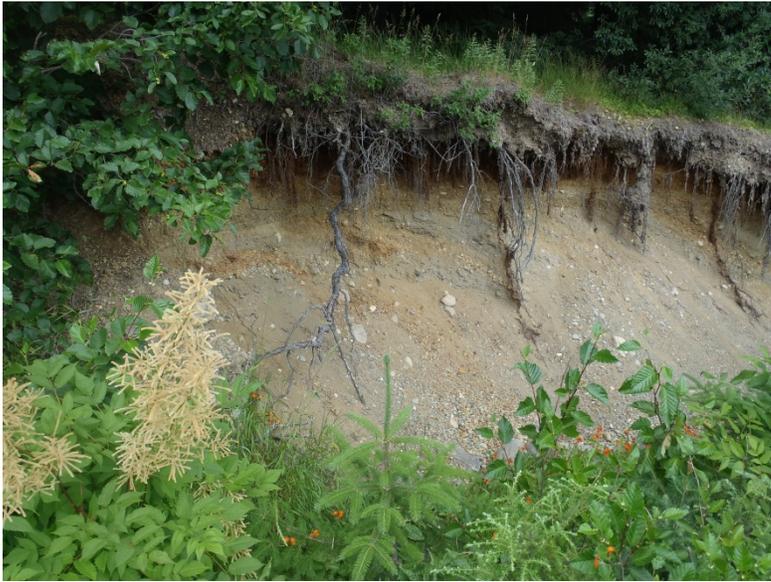
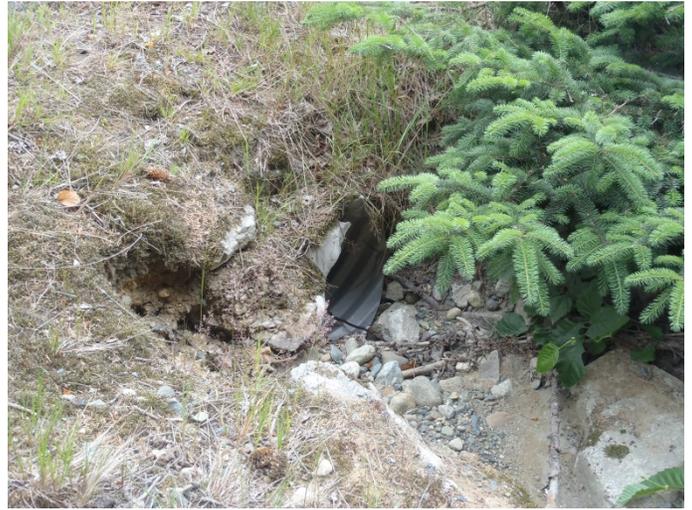
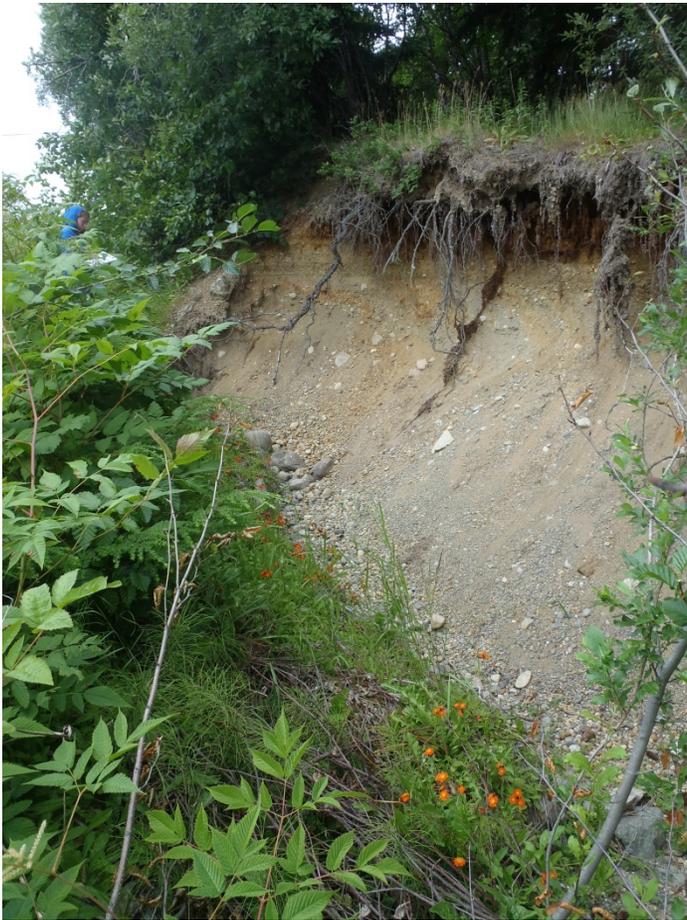
Site 61: View St. Outlet with highly erosive ditch.
