ALASKA DEPARTMENT OF ENVIRONMENTAL CONSERVATION
Division of Spill Prevention and Response
Prevention Preparedness and Response Program

SITUATION REPORT (SITREP)

FS3 4941 Produced Water Release

SITREP # 2

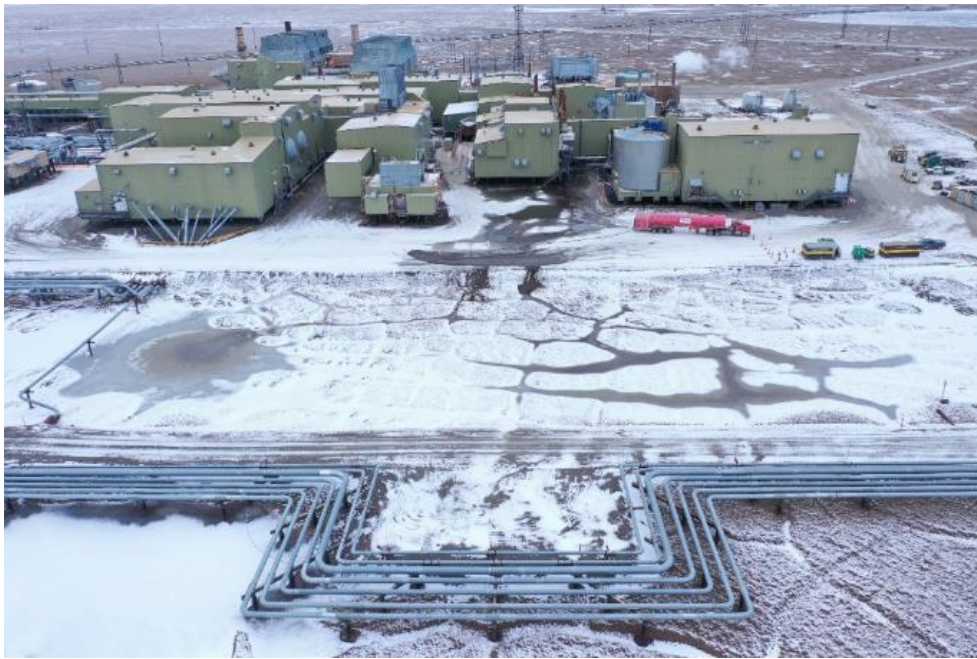
Image collected during an UAV overflight on October 21, 2019, showing the affected area (dark colored fluids on gravel pad and within tundra polygonal troughs). Image collected by ACS and provided by APSC.

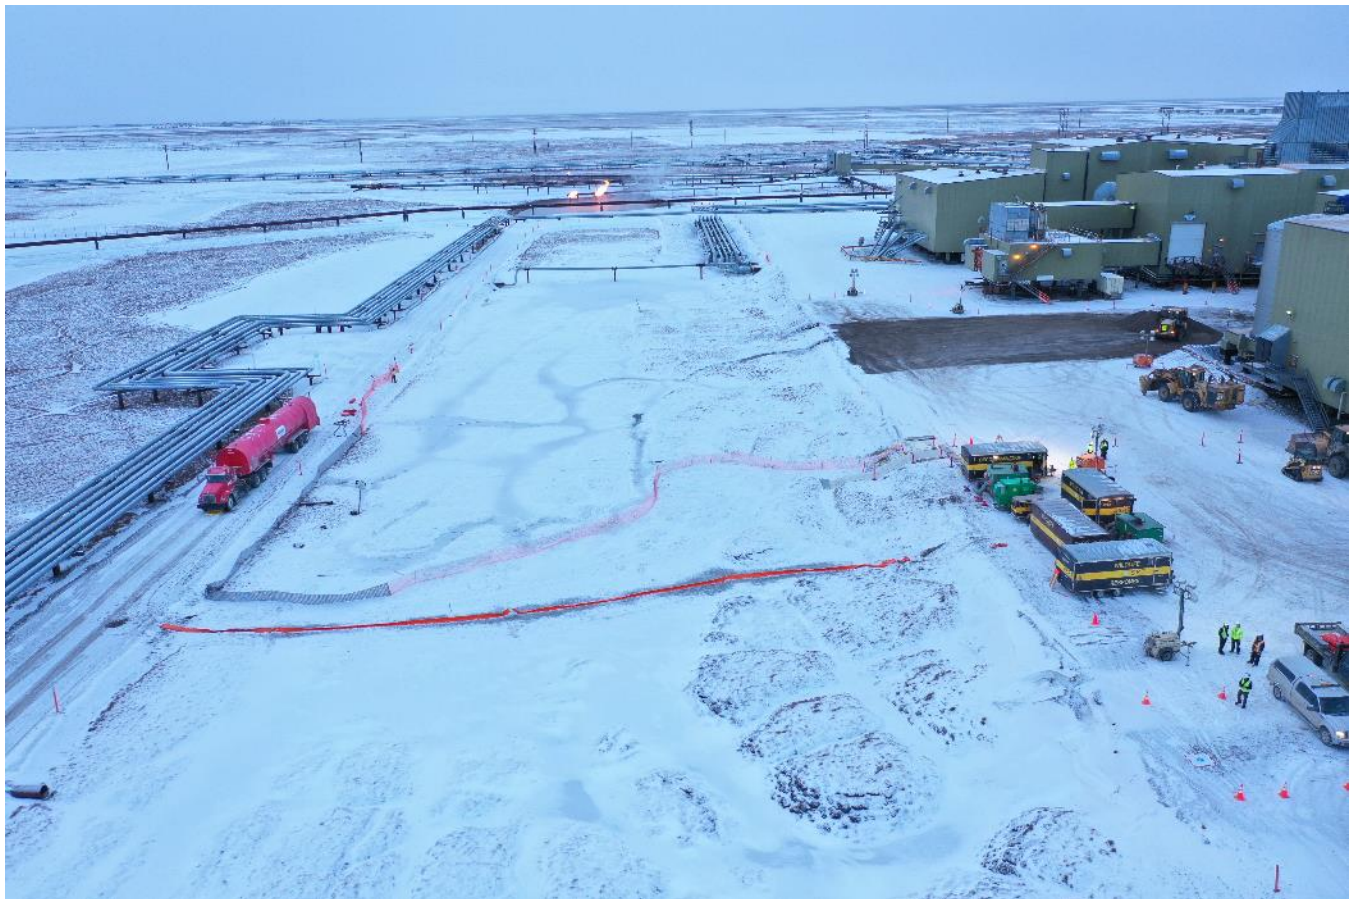
Image collected during an UAV overflight on October 22, 2019, before off pad flush and recovery tactics were initiated but after wildlife fencing had been put up, containment boom deployed, and gravel removal conducted. Image collected by ACS and provided by APSC.
