ALASKA DEPARTMENT OF ENVIRONMENTAL CONSERVATION
Division of Spill Prevention and Response
Prevention Preparedness and Response Program
SITUATION REPORT (SITREP)

Aero Air Plane Crash in Unalaska Bay

SITREP #: 2 and FINAL

SPILL #: 20259901601

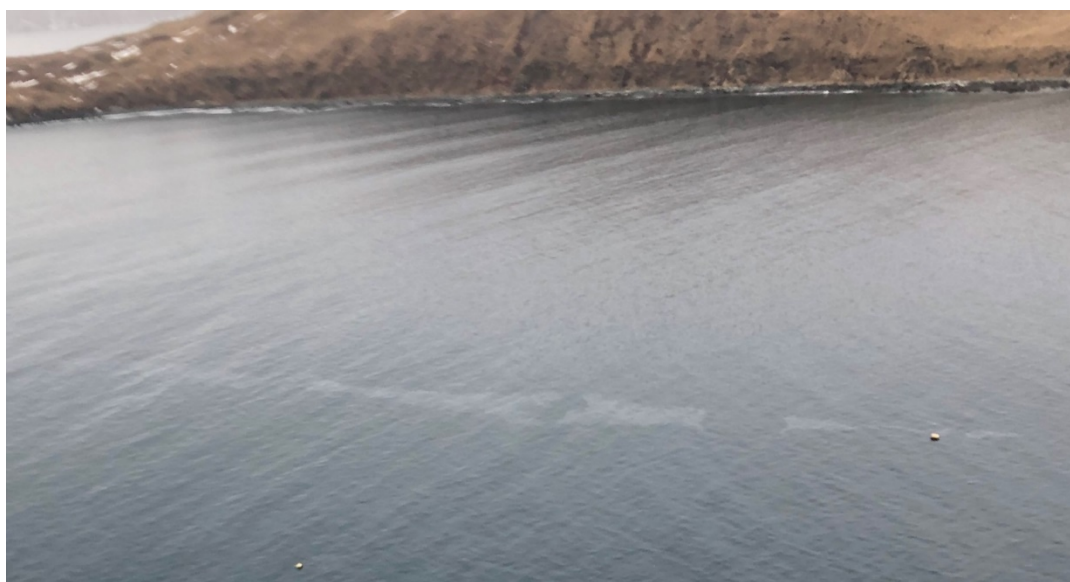
HOW/WHEN SPILL WAS DISCOVERED AND REPORTED: The City of Unalaska initially reported the plane crash to the National Response Center (NRC) at 10:00 am on January 16, 2020. US Coast Guard (USCG) MSD Dutch Harbor personnel reported the pollution event to the Department of Environmental Conservation at 10:20 am on January 16, 2020. **The USCG reported all persons aboard were safely rescued.** There is a visible sheen on the water. **The sheen is estimated to be approximately 50 feet wide and 1,500 feet long.**

An overflight was conducted at 2:00 pm on January 16. The USCG took pictures of the sheen and estimated the size of the sheen visible on the surface of the water.

Sheen visible from USCG overflight on January 16 (photo taken by USCG personnel)

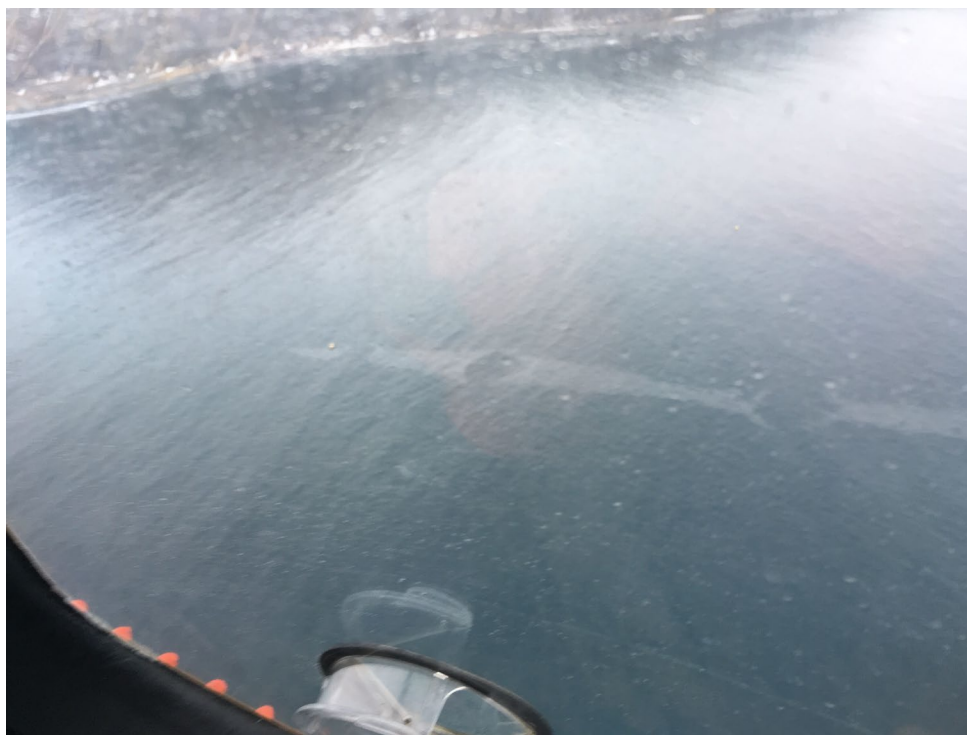
Sheen visible from USCG overflight on January 16 (photo taken by USCG personnel)
