ALASKA DEPARTMENT OF ENVIRONMENTAL CONSERVATION  
Division of Spill Prevention and Response  
Prevention Preparedness and Response Program  
**SITUATION REPORT (SITREP)**

## 2020 VMT Sump Oily Water Spill

**SITREP #:** 5

**INCIDENT LOCATION:** 58-SU-3 Admin Sump, Valdez Marine Terminal

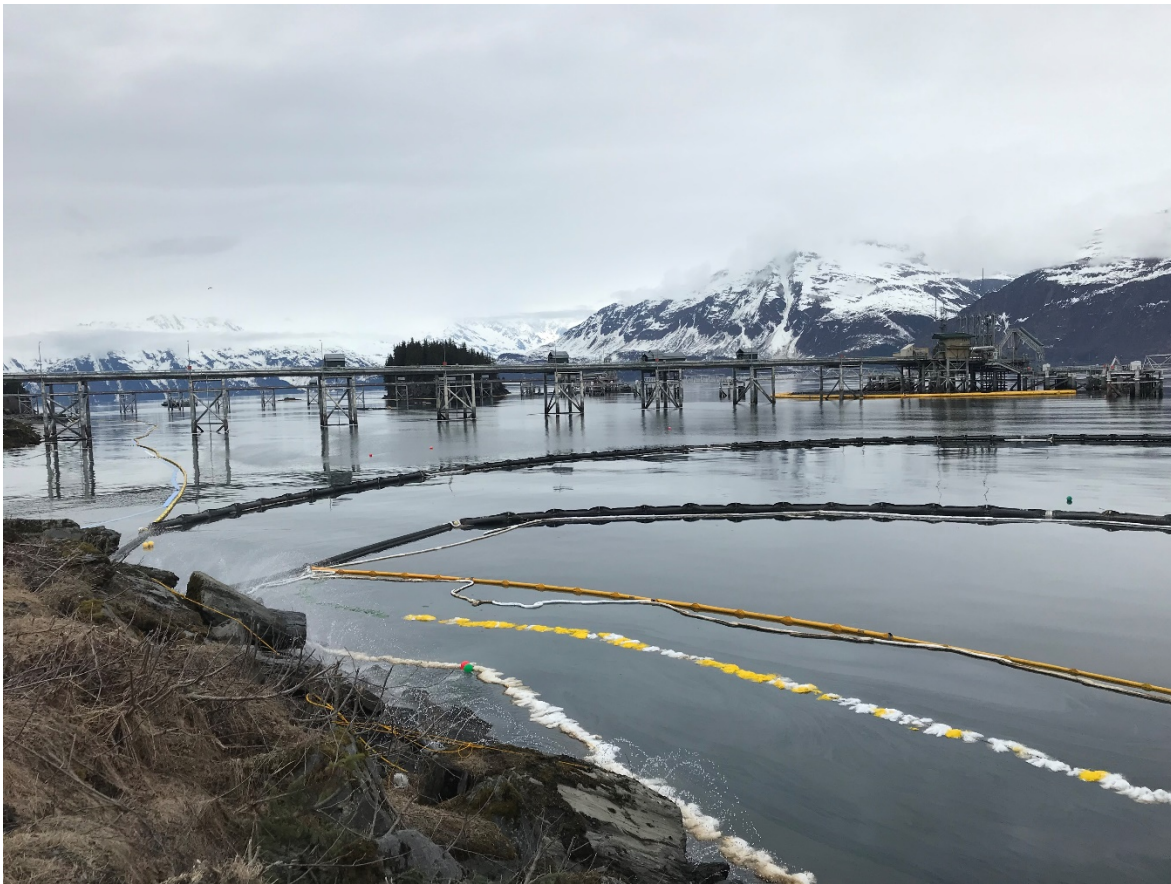
*Figure 1. Containment boom looking west at the VMT on **May 1, 2020**. Courtesy ADEC*
