**ALASKA DEPARTMENT OF ENVIRONMENTAL CONSERVATION**  
**Division of Spill Prevention and Response**  
**Prevention Preparedness and Response Program**  
***SITUATION REPORT (SITREP)***

## **2020 VMT Sump Oily Water Spill**

**SITREP #:** 6 and final

**INCIDENT LOCATION:** 58-SU-3 Admin Sump, Valdez Marine Terminal

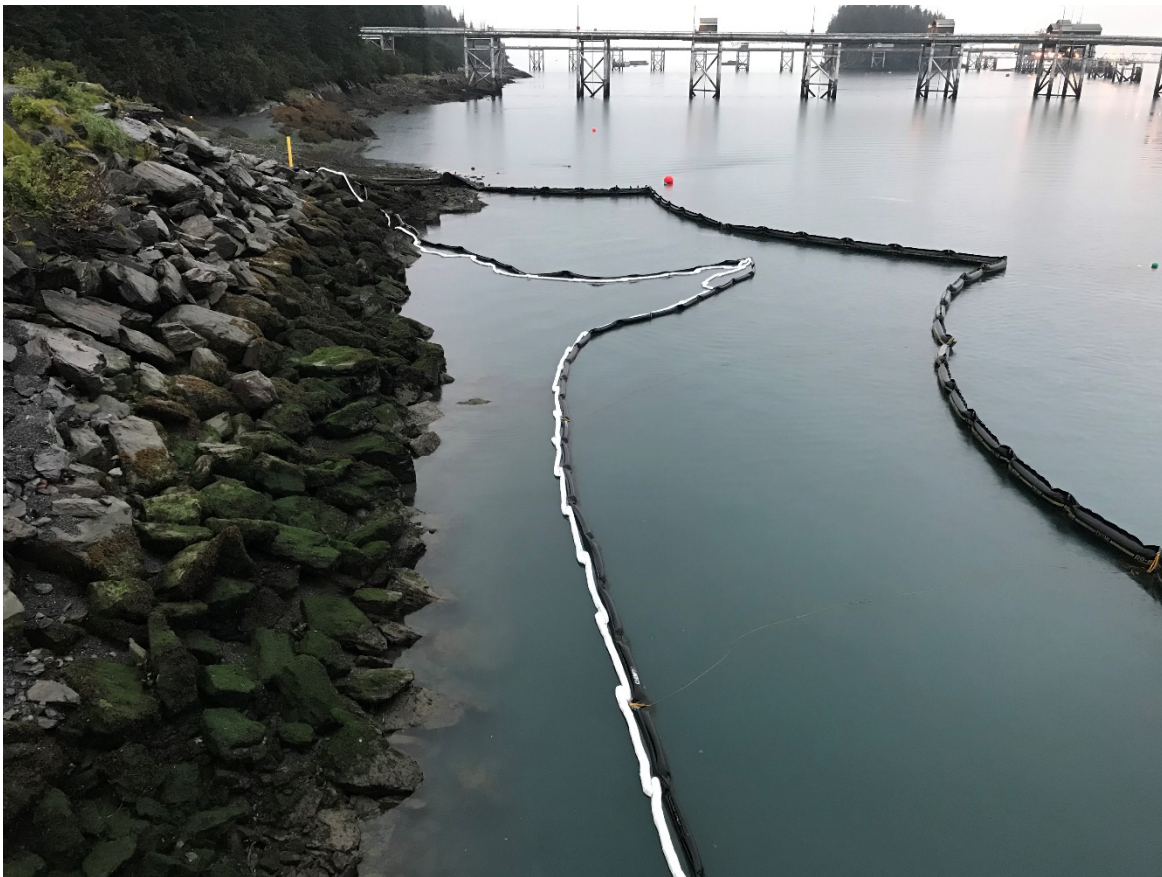
Figure 1. Containment boom looking west at the VMT on September 17, 2020. Courtesy ADEC
