ALASKA DEPARTMENT OF ENVIRONMENTAL CONSERVATION
Division of Spill Prevention and Response
Prevention Preparedness and Response Program
SITUATION REPORT (SITREP)

2026 WNS Rig Move Incident

SITREP #: 4

SPILL #: 26399902301

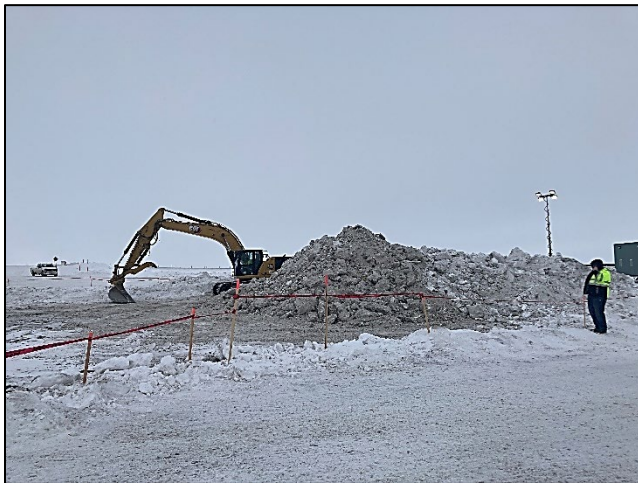
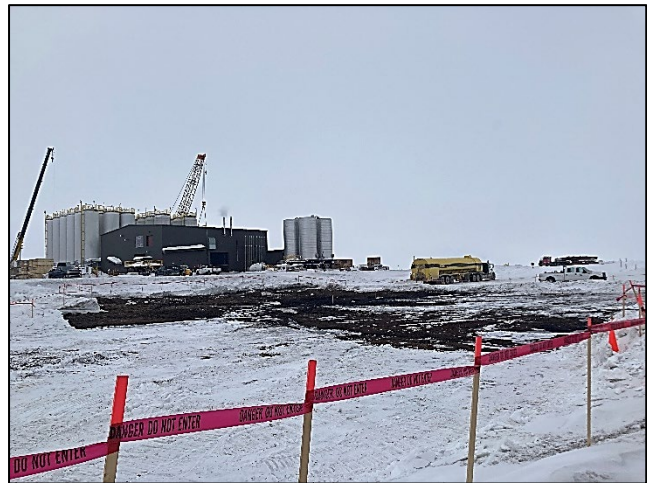
Impacted snow and ice were removed from tundra and staged for off-site disposal (left) to allow response crews to continue flush and recovery tactics (right). Photos from April 14, 2026, taken by DEC.
