PHASE I ENVIRONMENTAL SITE ASSESSMENT

**CAREY PROPERTY
3130, 3142, & 3150 MOUNTAIN VIEW DRIVE**

ANCHORAGE, ALASKA

MAY 2005

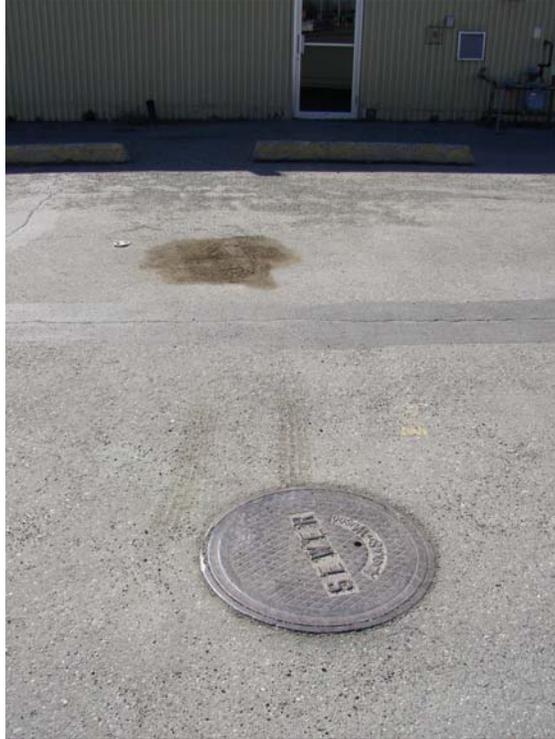
Nearly all of the open space on the property is paved. The pavement is in good condition with minor surface staining. There is a manhole to the municipal sanitary sewer and an RV dumping tank on the northeast side of the property (Photos 3 and 4). It is assumed that the RV dumping tank is connected to the municipal sewer. The gas meter to the building is located on the northeast wall of Building 3. A small pile of debris containing buckets of blacktop sealer was observed in the parking lot at the east corner of the property (Photo 5).

Photo 3. Manhole cover to sewer located in parking lot on northeast side of the building (facing southwest).

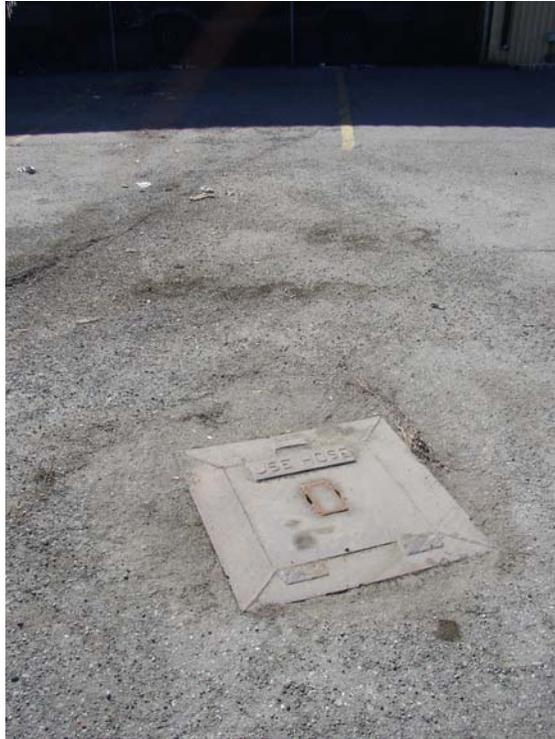
Photo 4. Inlet to the RV dumping tank, located at the east corner of the building (facing southwest).

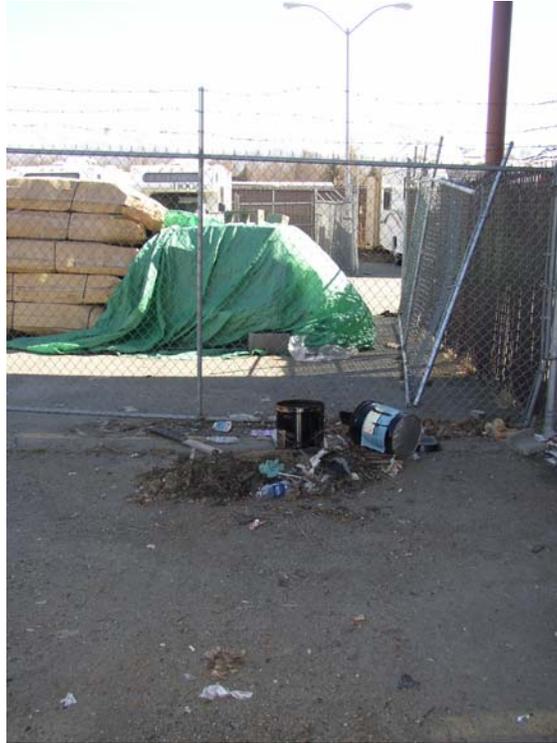
Photo 5. Small debris pile off the east corner of the northeast building (Building 3); buckets are for blacktop sealer (facing southeast).

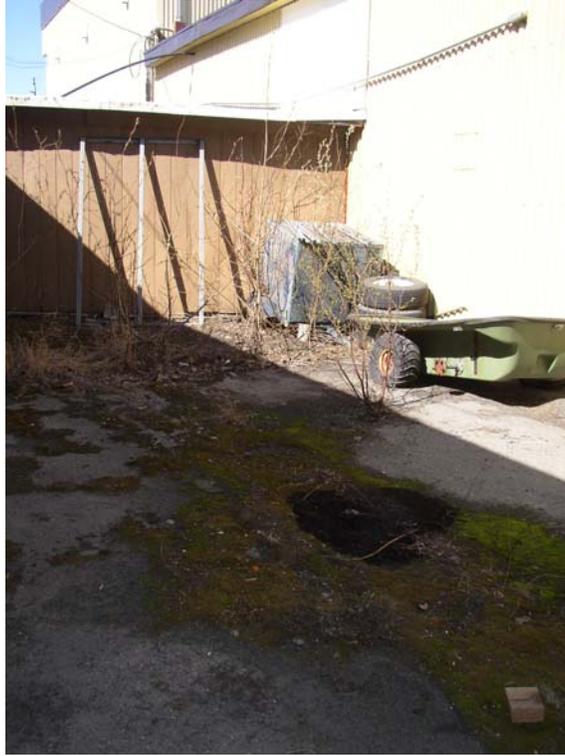
The rear portion of the property is enclosed by a chain link fence (see Figure 2-1), and late-model RVs are parked within the fenced area along the back of the property (Photo 6). There are also two storage containers located behind the RVs, against the fence; these are visible in the 2004 aerial photo in Appendix B. Several vehicles and a forklift were parked beneath the metal canopy at the time of the inspection (Photo 7). There are five automotive repair/maintenance bays in Building 2, with bay doors opening to the back of the property (Photo 8). There is a small area surrounded by the three buildings and the enclosed corridor that has broken pavement and an oil-stained patch of ground (Photo 9).

Photo 9. Enclosed area on the southeast side of the enclosed connecting corridor, oil-stained patch of ground in middle (facing north).

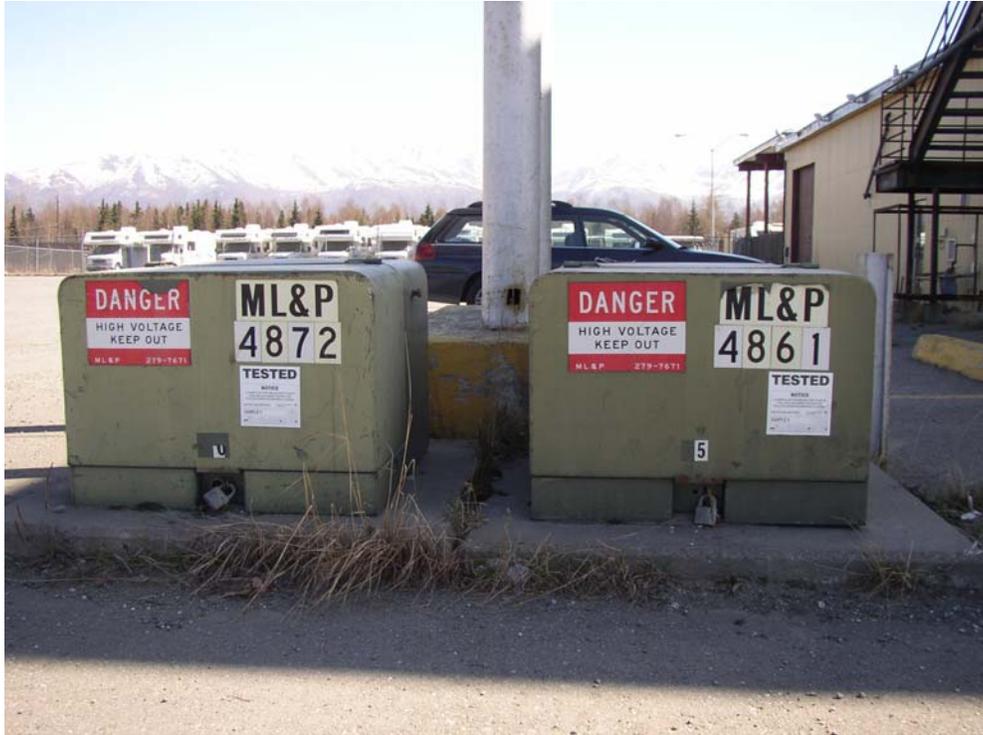
Photo 11. ML&P transformers at the base of the Mobile Trailer Supply sign (facing southeast).

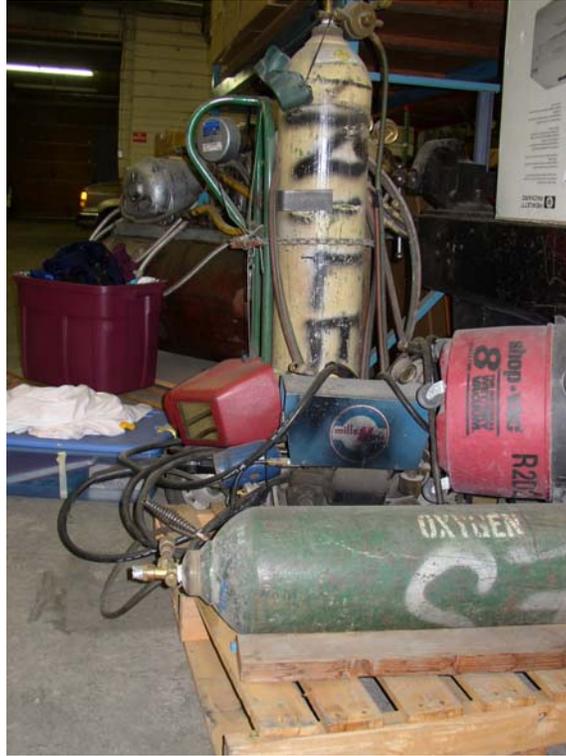
During the site reconnaissance, containers of various chemicals, such as paints, solvents, oil, and adhesives, were noted at various locations around the property. Propane and oxygen tanks were found at various locations as well. It appeared that automobile maintenance work had been performed relatively recently in the third bay from the northeast end of Building 2. Some stained areas were present on the ground surface in and around the buildings.

Photo 13. View of oxygen tanks and air compressor.

- The various chemical containers and the compressed gas tanks should be either removed or inventoried and properly stored.
- Although it is likely that the floor drains have been discharging to the sanitary sewer since the 1960s, it is recommended that dye testing be conducted if the drains will

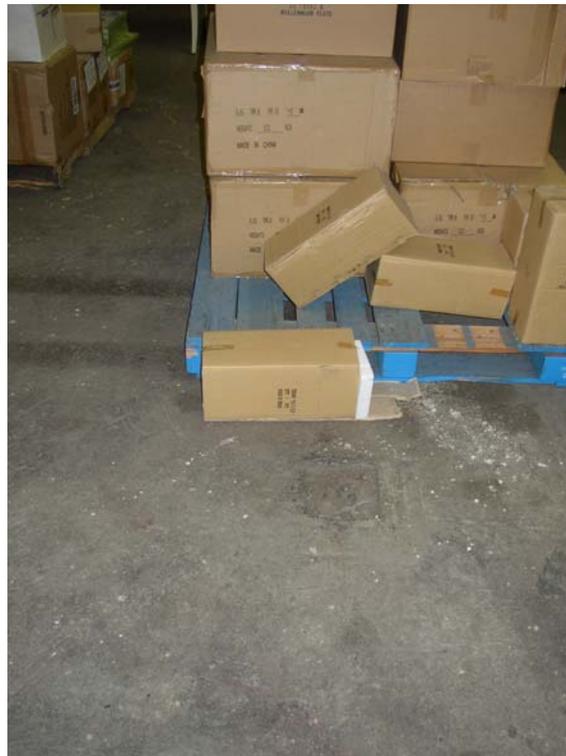
Building 1 is the original Duke Lumber building, which is currently used for storage (Photo 12). Some of the items noted in the building include tires, boxes of new products, a truck, mattresses, fluorescent light bulbs, propane tanks (Photo 13), fire extinguishers, oxygen tanks, and an air compressor. What appears to be a plugged floor drain was also observed in the building (Photo 14).

Photo 14. View of what appears to be a plugged floor drain in Building 1.

continue to be used in the future. Otherwise, it is recommended that the drains be capped to prevent further use.

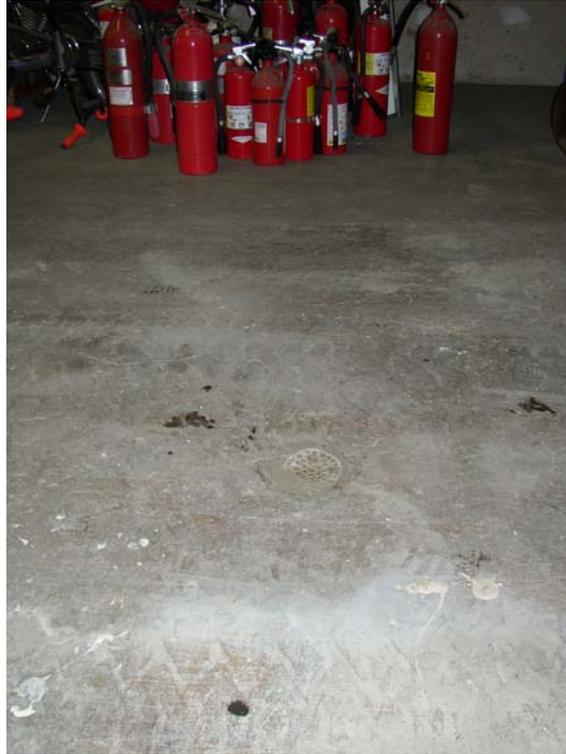
Building 2 is actually an addition to Building 1. The building is positioned perpendicular to Building 1, has a staircase on the northeast side of the building, and has five automotive repair/maintenance bays lined up along the first floor. Floor drains are present in two of the bays: the second and third bays from the northeast edge of the building (Photos 15, 16, and 17). The third bay has a lift, which according to Owen Carey, was used by Mobile Trailer Supply, Inc. primarily for lifting RVs to install hitches. There are oil stains surrounding the floor drain in this bay, which appears to have been used relatively recently. According to Owen Carey, employees of Carey Homes, Inc. currently use the bays periodically for automotive repair activities such as changing oil and tires. The floor drains are thought to be connected to the municipal sanitary sewer.

Photo 15. Floor drain in the second bay from the northeast edge of Building 2, with fire extinguishers piled behind

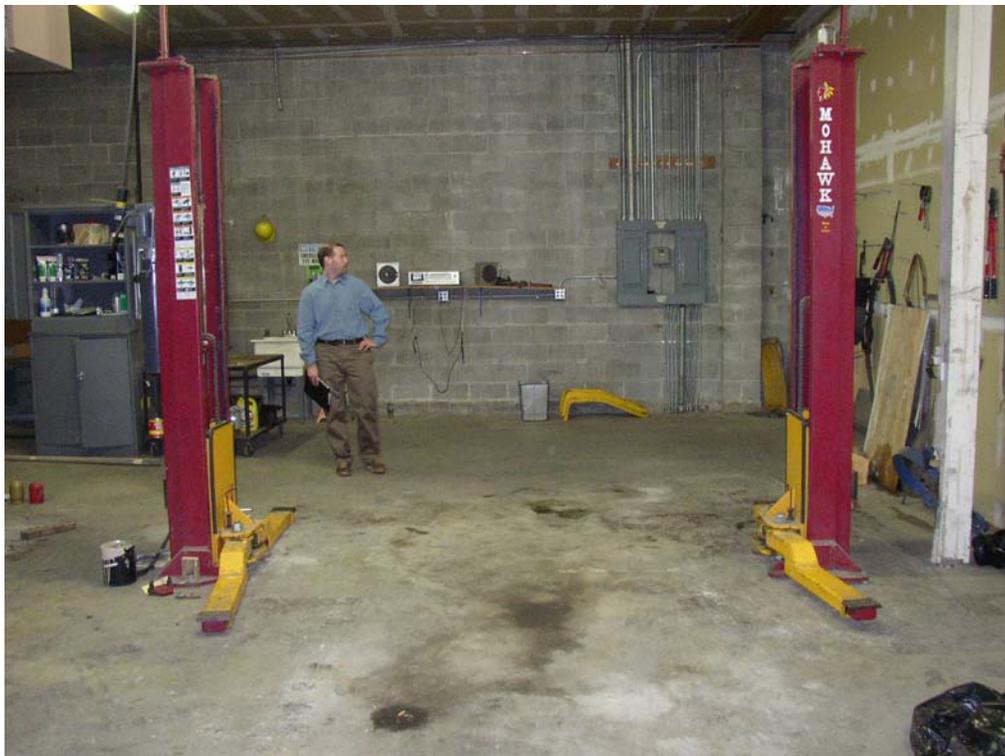
Photo 16. View of auto lift in third bay from the northeast edge of Building 2, with oil staining and floor drain, taken facing toward Mountain View Drive (northwest).

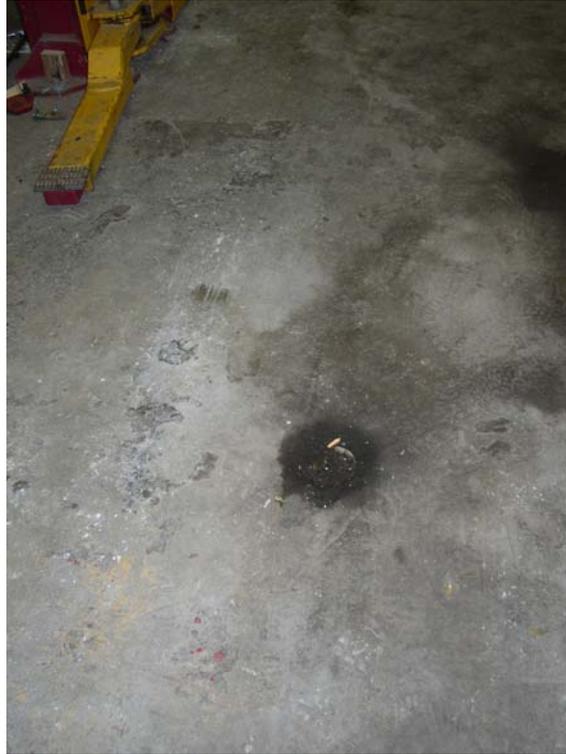
Photo 17. Close up view of floor drain in third bay.

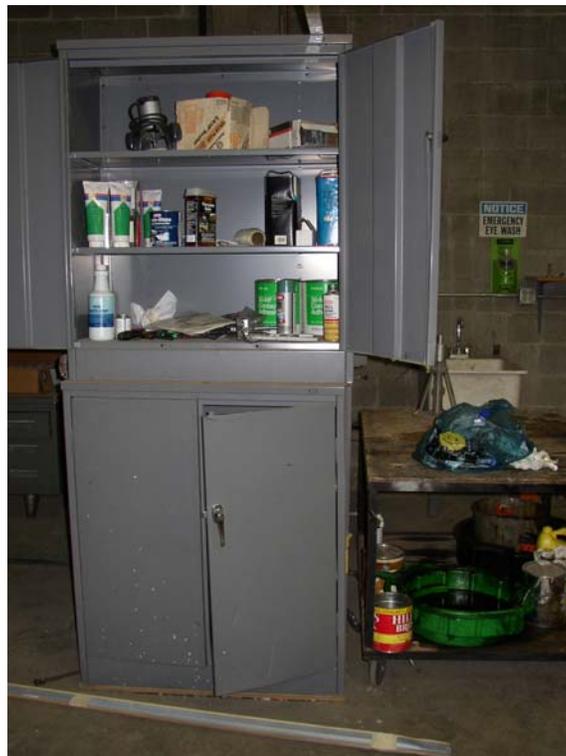
Other items observed in the bays in Building 2 include a large air compressor tank in a closet beneath the stairs; a tire balancing machine; two propane tanks; oxygen tanks; fire extinguishers; two cabinets containing paints, adhesives, and solvents (Photos 18 and 19); used oil; a deep sink (Photo 18); and car batteries.

Photo 18. Cabinet with adhesives and auto cleaners; table with used oil to the right; deep sink along wall in background (facing northwest).

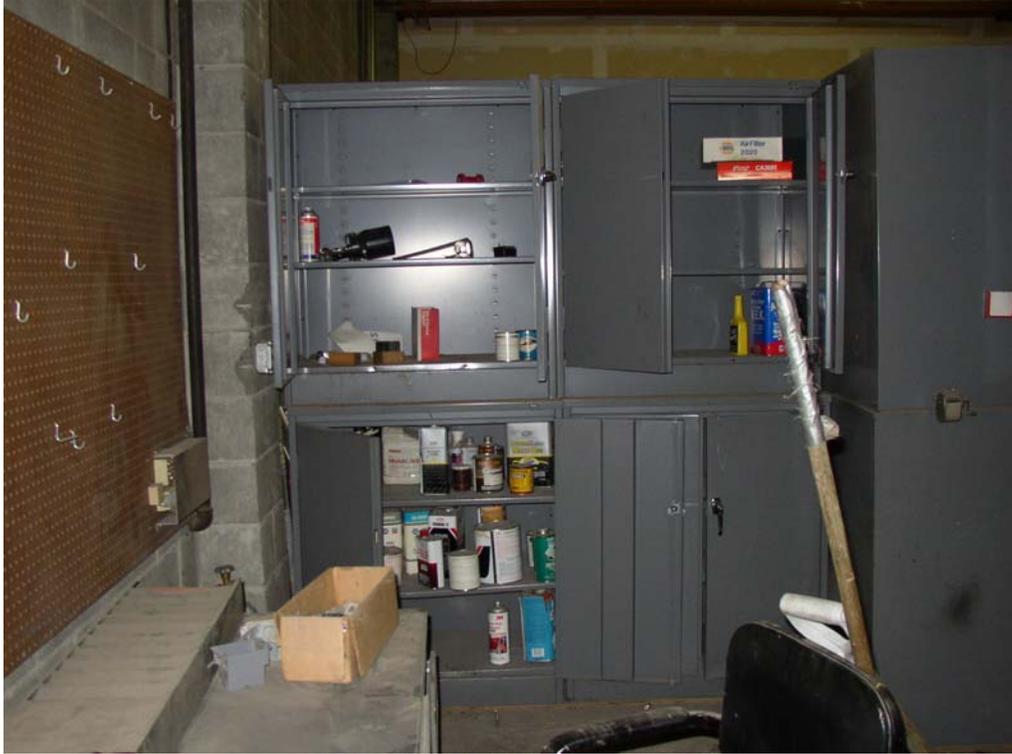
Photo 19. Additional cabinets with paints, car battery, etc (facing northeast).

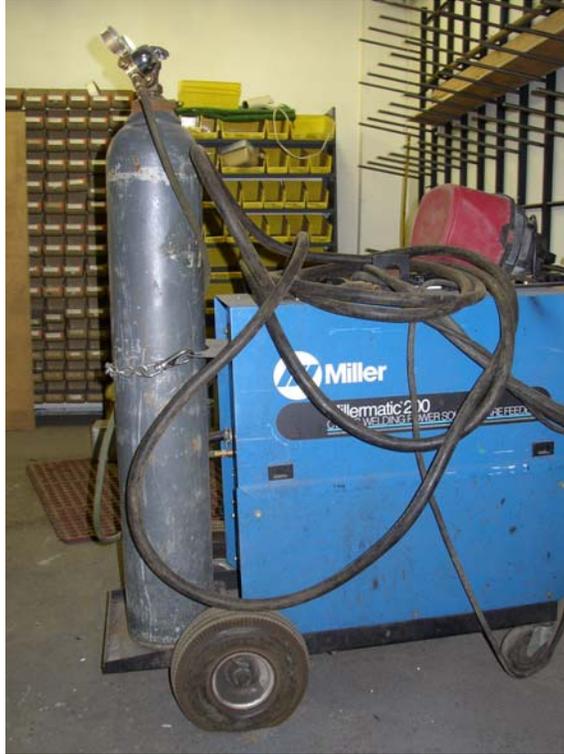
Photo 23. Welding equipment and tanks located to the rear of Building 3.

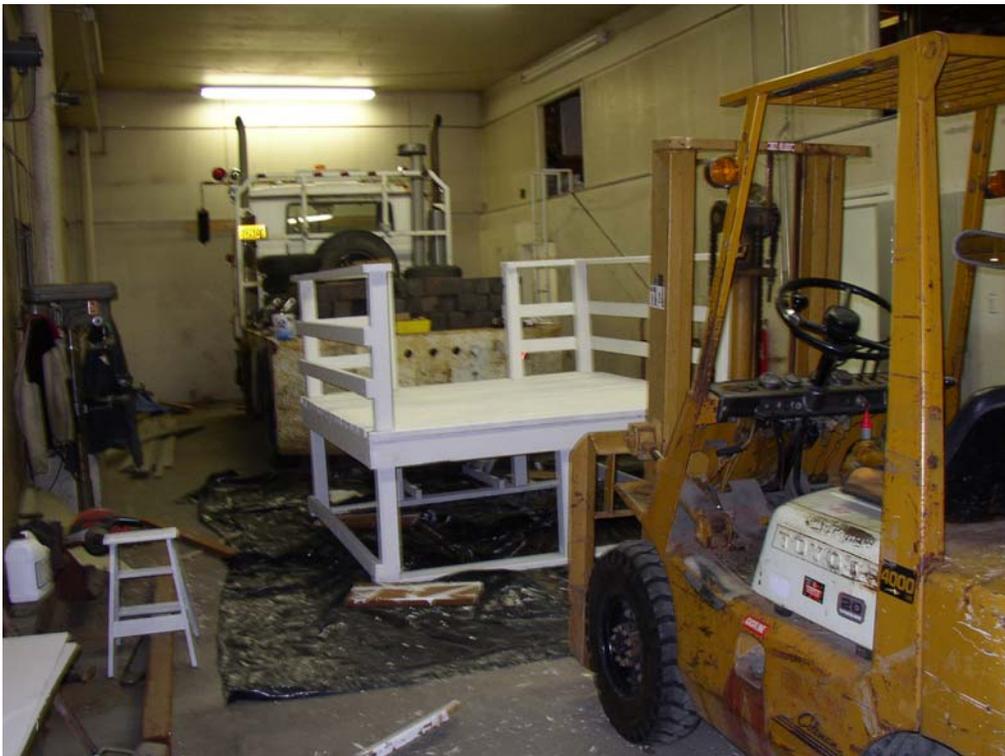
The maintenance bay in Building 3 contains a forklift, a truck, cans of paint, and mechanical equipment (Photo 24). A door in this bay opens out onto the back of the property, beneath the metal canopy. No floor drain was evident in this area. A loft area is accessed from the bay, which is used for storage (Photo 25). A 5-gallon can of Stoddard solvent was observed in the loft area (Photo 26).

Photo 24. Auto maintenance bay located to the rear of Building 3, with vehicles, paint cans, etc (facing northeast).

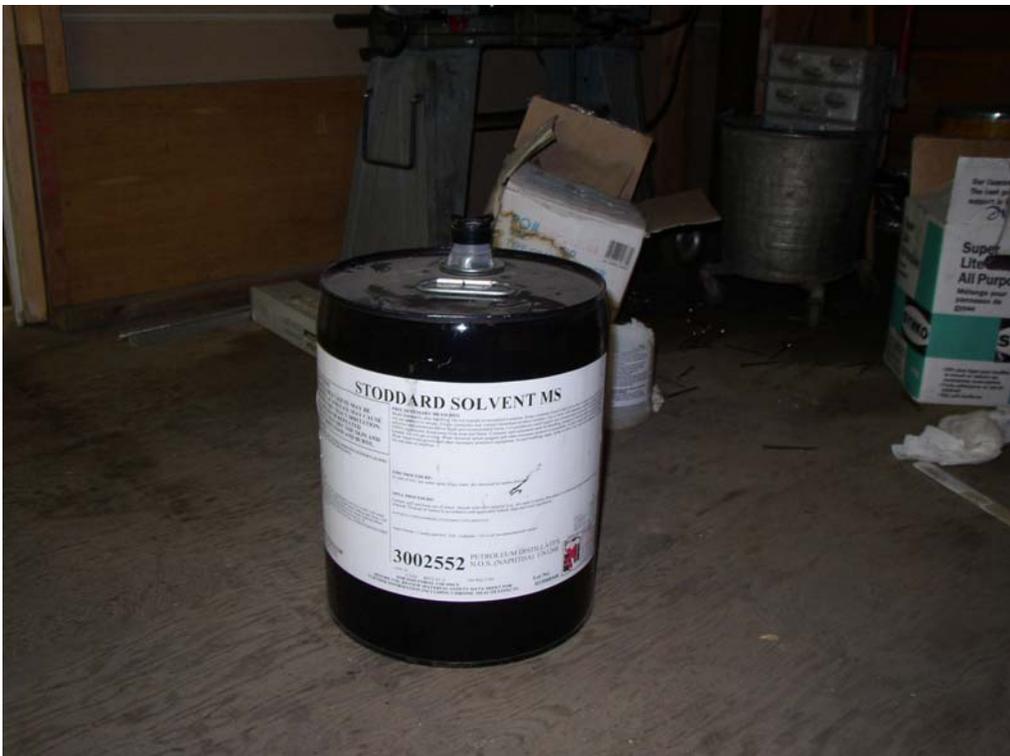
Photo 26. Can of Stoddard solvent located in the loft area over the auto maintenance bay located to rear of Building 3.
